Advanced Technical Information

Brake Squeal

Binder - Advanced Technical Information
This bulletin replaces bulletin Group 4,
#1605, dated 03/24/2016.

Concern: Customer reports that vehicle brakes squeal.

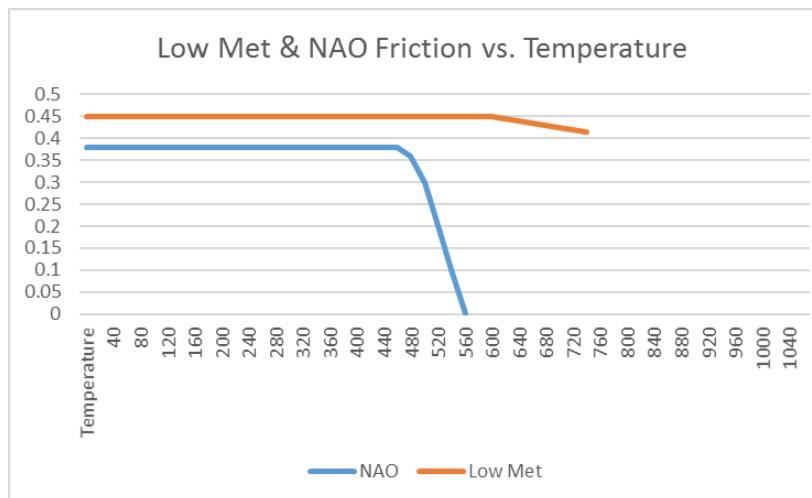
The graph below illustrates the difference in fade characteristics between NAO & Low Met friction materials:

Low met performance characteristics are necessary to maintain the balance of performance in the Porsche vehicle as a whole.

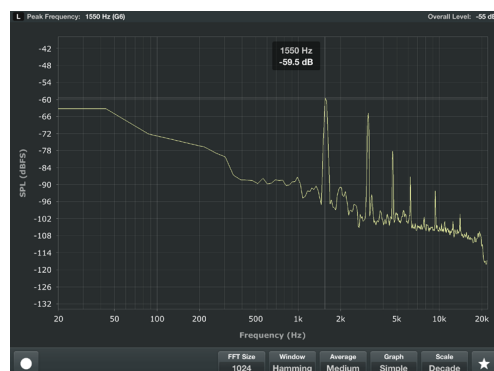
Two real life examples from Porsche vehicles are illustrated:

The base frequency shown (1550 Hz) is the noise where the problem is coming from. The other five peaks are all harmonics. This means that if the base frequency is eliminated, the others will go away as well.

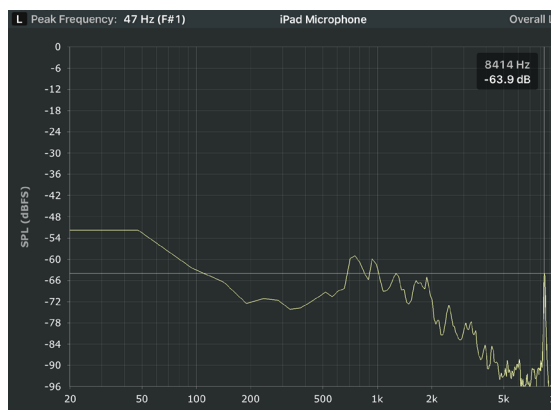
In a second example, we see a squeal frequency without harmonics. This frequency is over five times higher than the last example. The countermeasure required for this noise will be completely different from the last example.

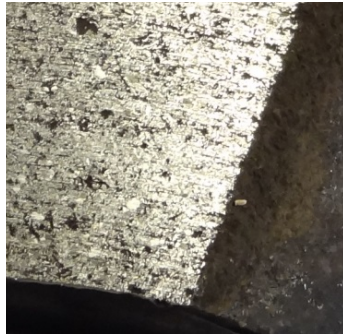
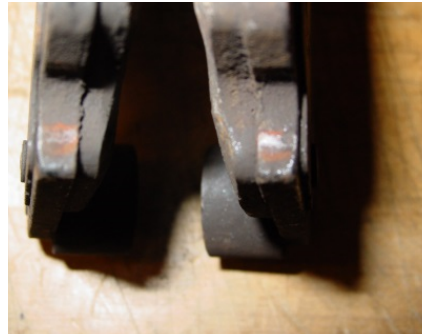
Brake Pads

- Glazed surface
- Cracks from overheating
- Dust buildup at edges
- Contamination from sprays such as tire dressings
- Wear at contact points
 - Piston contact on pad shows even or uneven pressure distribution
 - Pad to caliper contact points show how pad moves in caliper
 - Spring to pad contact shows how well spring tensions pad

- Sanding the pad and chamfering the edges
- Insuring the contact points are smooth
- Lubricating contact points with optimol grease
- Insure proper fit and lubrication of shims and/or dampers

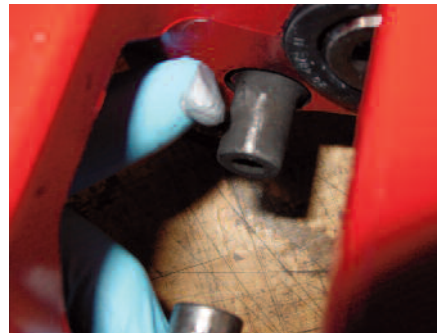
Calipers

- Pad Mounting Pins – witness marks indicate movement between pad and caliper pin

- Make sure the pins are smooth first
- Lubricate contact points with a small amount of optimoly grease and insure proper fit of components

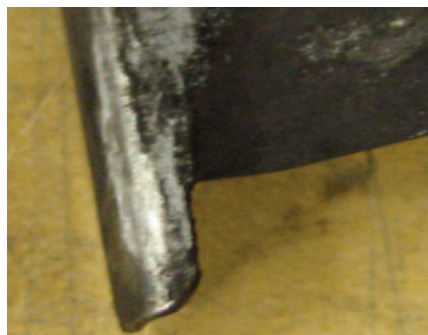
Tension spring

- Movement between spring and pads will vary as spring tension varies. The witness marks will reflect this.
- Push upwards on pad against spring, release the pad and you should hear a clack. Excessive stiffness or weakness in the spring is not acceptable.

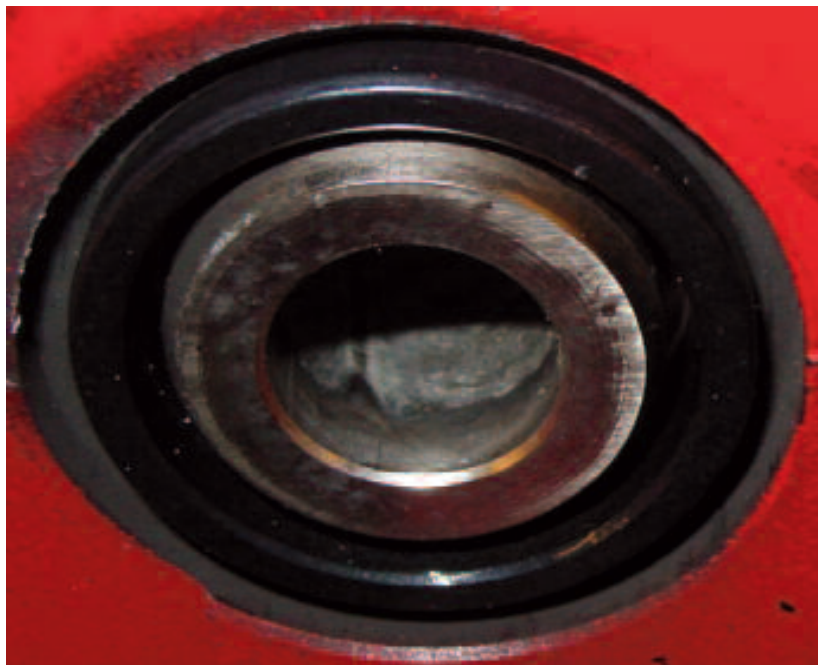
Caliper Pistons

- Wear marks from movement of pad against piston. This is an indication of pressure distribution from the piston to the pad. Brake squeal is affected by pressure distribution, especially at low pedal pressures.

- Inspect pistons to see if there are any that may not be returning completely.
- Exercising the caliper pistons can restore the movement of the piston to normal operation (the brake fluid must also be clean).

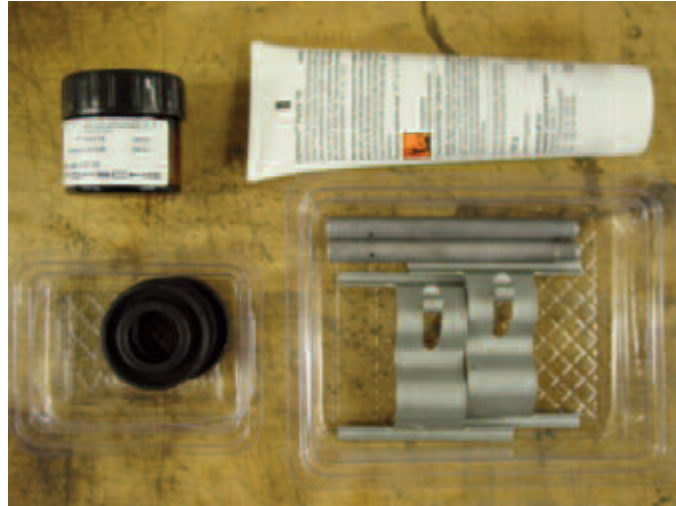
- Clean brake caliper so that there are no contaminants present when the dust seals are removed

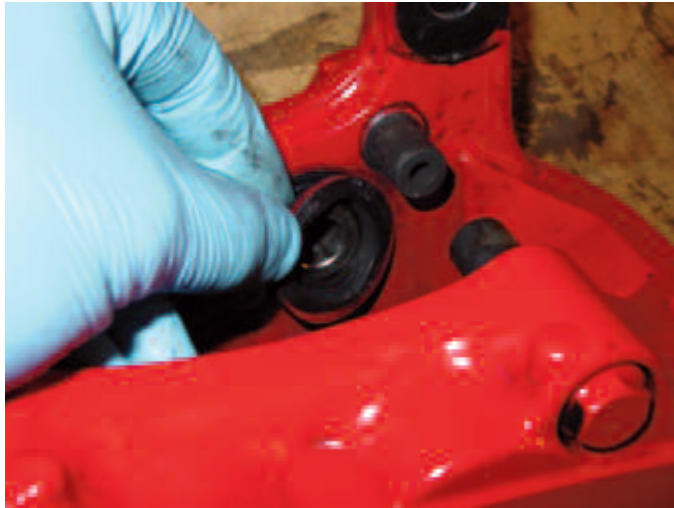
- Extend the pistons against a block of wood to keep them from coming out of the caliper. (It may be necessary to retract and extend the pistons several times to free up the movement)
- Apply brake caliper paste to the piston and install new dust seals on the pistons
- Retract the pistons and seat the dust seals
- Install pads and new hardware
- Install caliper on vehicle
- Flush brake fluid
- Test-drive the vehicle
