2010146/4

Supersedes Technical Service Bulletin Group 87 number 06-03 dated Aug. 28, 2006 to add 2008 model years and for reformatting.

Unpleasant odor from heating and ventilation system

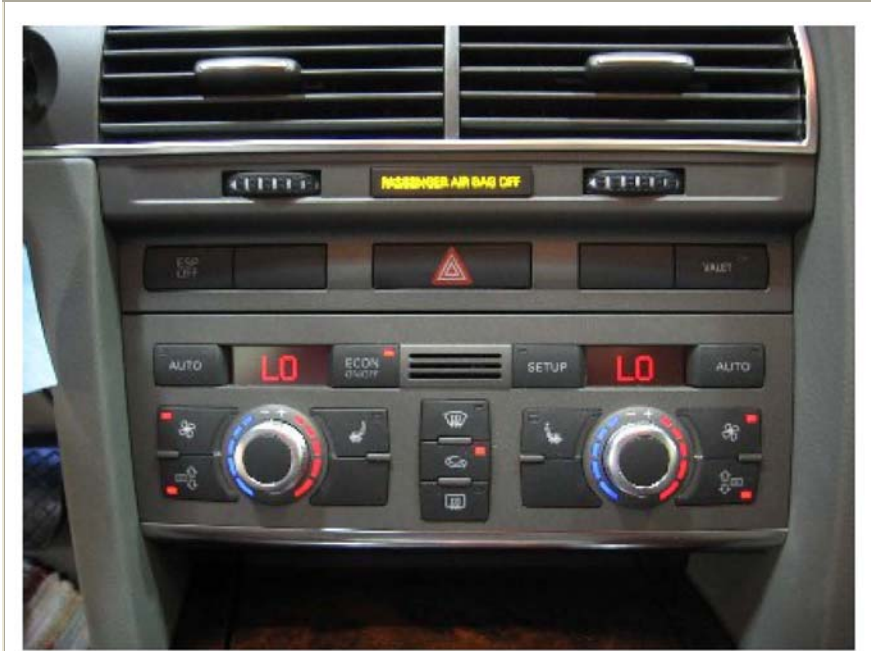
Figure 1. Climate control settings.

3. Set climate control temperature to its lowest setting. Set fan speed to its lowest setting. Set airflow direction to the dash vents only. Activate recirculation and ECON modes.

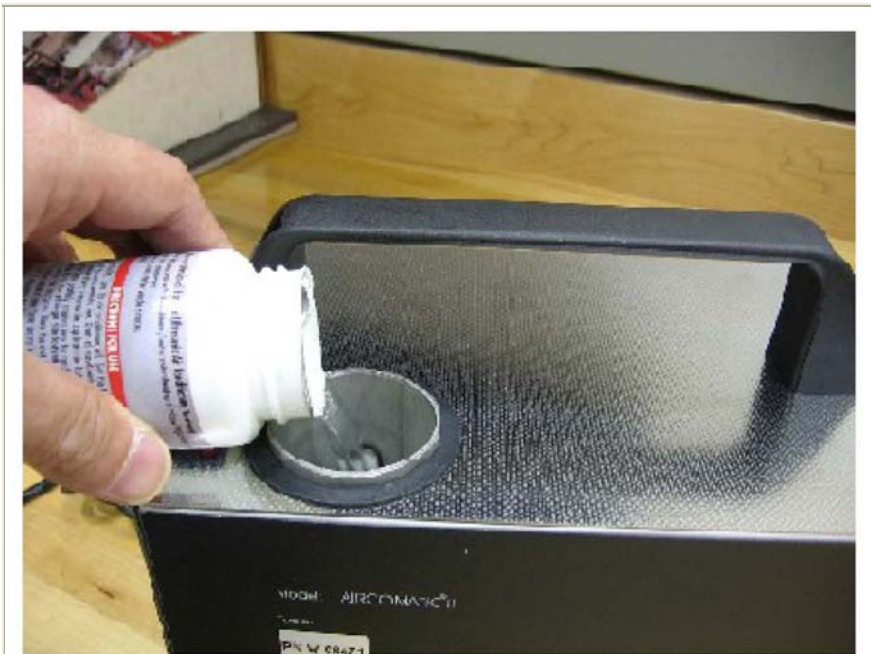
Figure 2. Pouring the treatment into the filling chamber.

4. Thoroughly shake a 100ml bottle of treatment and empty the bottle into the filling chamber

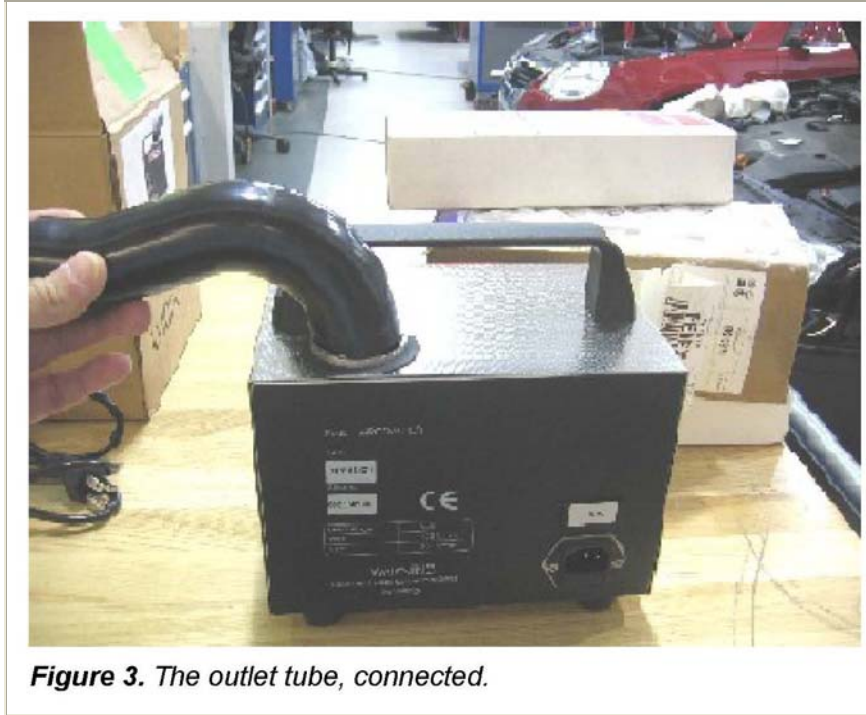
Figure 3. The outlet tube, connected.

5. Connect the outlet tube.

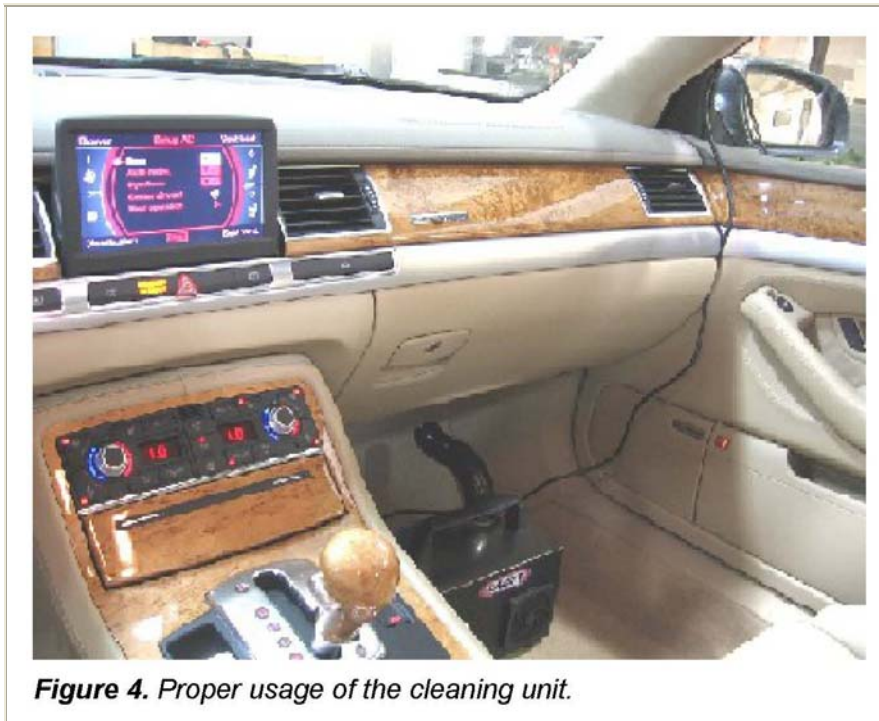
Figure 4. Proper usage of the cleaning unit.

6. Place the cleaning unit into the passenger footwell, making certain that the unit is as level as possible. Connect the power cord and route it through a slightly opened window. The remaining windows and sunroof should be completely closed.

7. Switch unit on and position the outlet tube such that the vapor is drawn into the recirculation air intake, generally in the passenger footwell area. Refer to the appropriate repair information for exact location. Close all doors. The atomized cleaning fluid will begin coming out of the vents. After about 15-20 minutes, the treatment stops automatically.

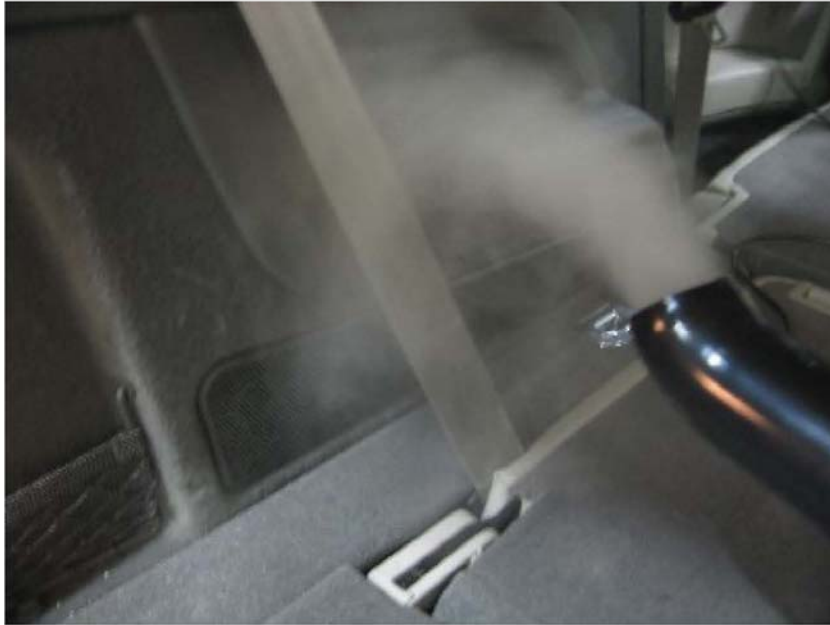
Figure 5. Correct positioning of the outlet tube.

8. If the vehicle is an Audi Q7 with 4 zone climate control, the rear A/C unit is to be treated as well. Repeat the procedure for the rear A/C unit. Use the same A/C settings as were used for the front A/C unit. Position the outlet tube toward the vent on the left of the rear compartment.
9. Air out the vehicle after the procedure for about 10 minutes.
10. Check the Aircomatic® manual for instructions for unit [maintenance](#) after each use.
