Applications of Finite Element Analysis (FEA)

*NWCCC 2019
Real Solutions to Real-World Project Problems*

ANVIL
Engineering and Procurement Solutions

Michael Mettler, PE
Mech. Equipment/Piping Engr.
September 26, 2019

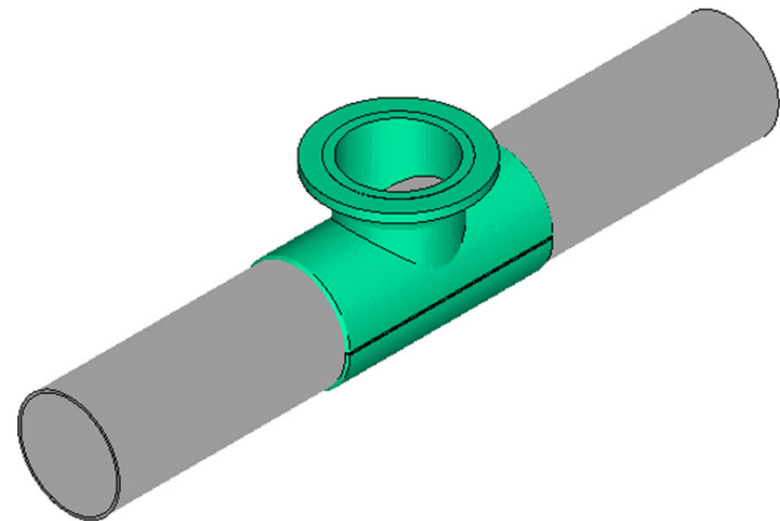
Piping Hot Tap w/Full Encirclement Tee

- Apply heat input per actual weld procedure (WPS) (based on volt/amp settings and travel speed)
- Apply ambient conditions (e.g., maximum temperature w/no wind)
- Apply bulk temperature and film coefficient of process fluid running inside pipe
- Run transient thermal analysis to verify metal temperature is:
 - Not too low for WPS (i.e., meet preheat requirements)
 - Not too high for process fluid (e.g., does not cause ignition of fluid)

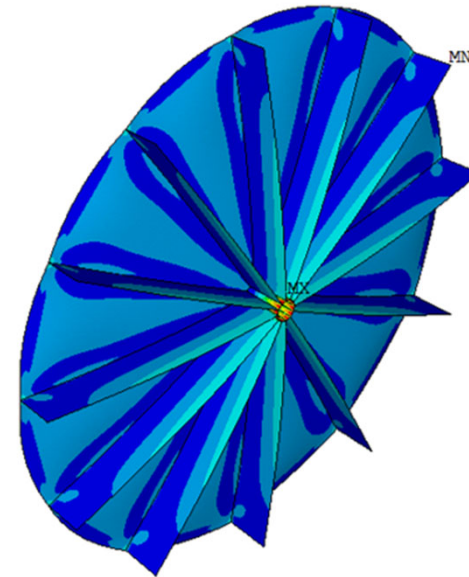
Heat Exchanger Cover Flange

- Optimize nozzle-to-shell/head connection for piping loading (e.g., reinforcement, determine corner radii to reduce stress concentration)
- Optimize refractory design at nozzles and other junctions to provide necessary insulating value while also reducing harmful thermal gradients
- Optimize insulation thickness and transition to reduce thermal gradients (e.g., skirt hot-box design, dissimilar weld at transition from hot-wall to cold-wall designs)

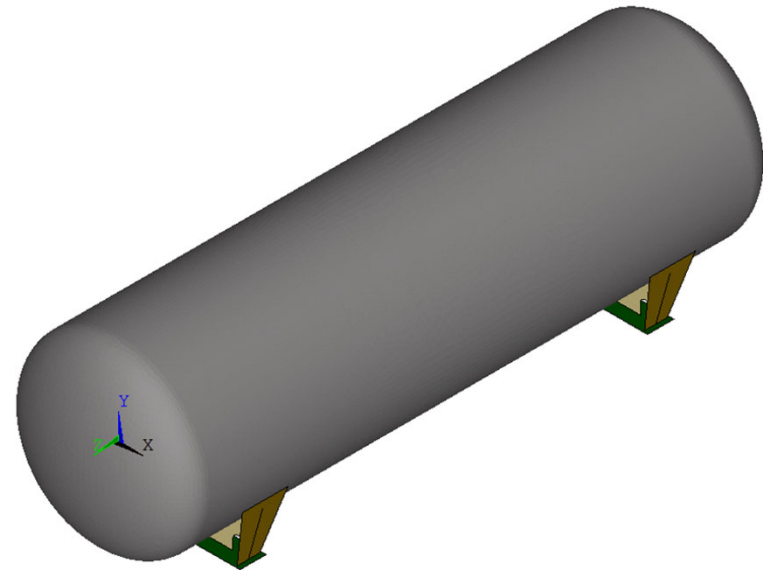
Model

- Horizontal vessel on saddles was being re-rated to a higher design pressure and temperature
- ASME code calculation software (COMPRESS) was used to perform the re-rate, but it indicated that the saddles would fail due to buckling
- Any welding on the vessel would require PWHT which was a significant increase in the scope of work for the re-rate
- The standard calculations in COMPRESS were not directly applicable for verifying the buckling capacity of the saddles, so COMPRESS was used to check typical local stresses using the Zick method, and FEA was used to determine the buckling capacity of the saddles
- FEA verified that the saddles were adequate with no modifications needed, which saved time and cost on the field implementation of the re-rate

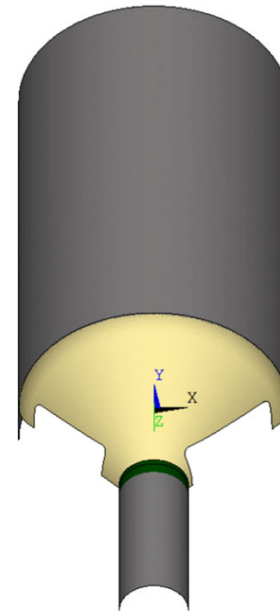
Model X-Section

- T/A execution plan included replacement of two large nozzles on bottom cone, as well as catalyst transfer lines below the vessel
- Rather than cutting transfer lines into small pieces to allow them to be removed between the platform decks, the execution plan included lifting the transfer lines up through the temporary nozzle openings in the cone
- The cone was also used to install temporary lifting lugs to allow the lines to be hung from the cone during rigging transfers
- FEA was used and determined that no temporary bracing was needed for the cone
- Maximum loads were provided for the lugs based on stress limits, as well as deflection limits to allow for fit-up during installation of the new nozzles

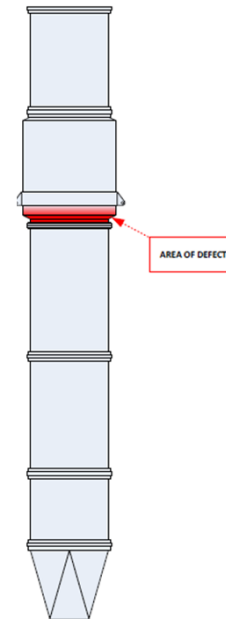
Sketch

- Stacks had been in service for approximately 25 years prior to flaws being discovered via inspection
- Four (4) identical solar turbine exhaust stacks experienced similar cracking
- Cracks were in circumferential direction, propagating along a weld/HAZ, and typically located coincident with stiffening gussets
- Longest crack measured approximately 18"
- Lower section of silencers experienced severe corrosion as well
- Thinnest measured corroded area was 0.090", nominal was 0.250"

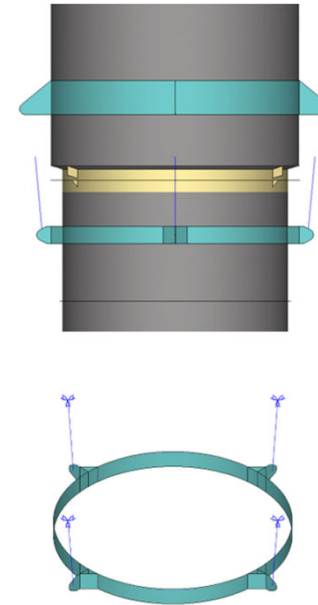
Temporary Turnbuckle Support

- Analysis was not intended to justify continued use of the stacks with the observed corrosion and cracking
- Intention was to replace the damaged sections of the stacks
- Purpose of analysis was to understand the root cause(s) of the failures so that targeted improvements could be made in the design of the new replacement components to prevent repeat failures in the future
- Analysis provided a relative comparison of the different options for improvement to help identify which provided the most return on investment
- Analyze impact of temporary turnbuckle support/collar installed by client to prevent a complete collapse

- New design could eliminate need for stiffening gussets, thus removing associated stress riser
- If temporary turnbuckle is permanently implemented, leave turnbuckles loose at start-up and snug-tighten once normal operating temperature is reached

- Eliminates additional stress caused by differential thermal growth between stack and turnbuckles

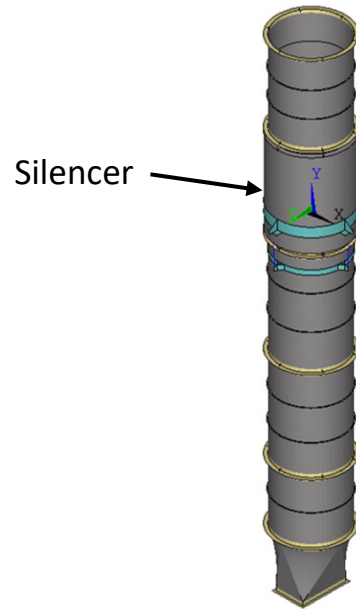
Full Stack Model (Shell)

- Full stack (shell element model)
 - Used to analyze global effect of weight and wind loading
 - Also used to analyze impact of temporary turnbuckle band
- Silencer (brick element model)
 - Submodel for more precise results in silencer section where failures occurred
 - Included insulation and internal liner for thermal analysis
 - Used to determine stresses caused by large thermal gradient

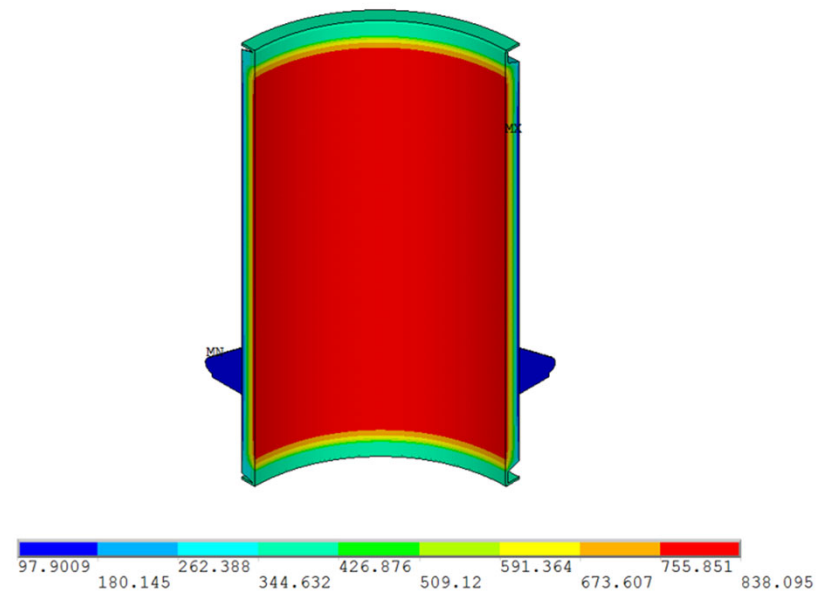
Temperature Gradient

- Steady state (normal operating during summer and winter)
- Transient (start-up / operating / upset / shut-down during summer and winter)
- Internal film coefficient based on gas flow inside stack
- External film coefficient based on effects of wind and radiation

- Large thermal gradients in lower silencer section caused high stress levels which are cyclic in nature due to operating cycles and changing ambient conditions

- Thermal gradients caused by presence of acoustic insulation, which abruptly changed from full thickness to uninsulated in conical section
- Stress risers caused by sharp corner at cone-to-shell weld, as well as stiffening gussets

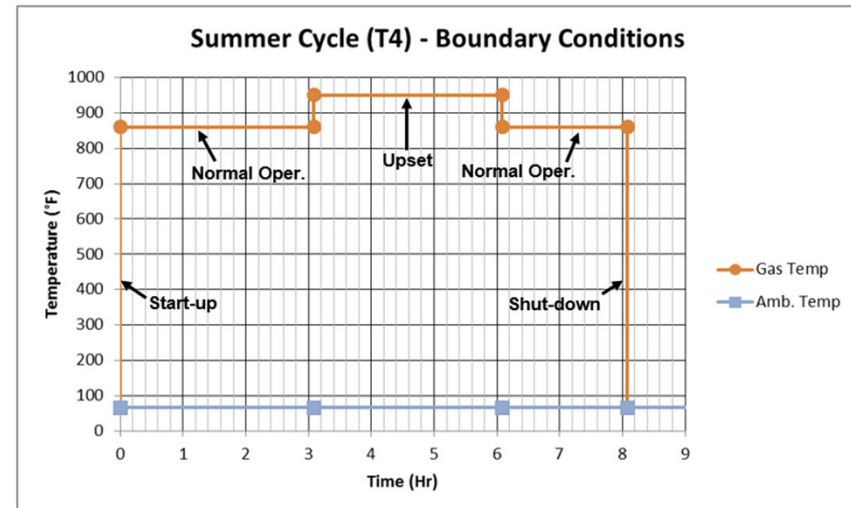
Operating Cycle

- Weld joint inspection level and initial flaw size
 - Considered visual examination (VT) only
 - Initial flaw size of 1/16"
- PWHT and residual stress due to welding
- Environmental affect
 - Considered knockdown in fatigue life due to corrosive environment
- Fatigue improvement (grinding/smoothing, etc.)
 - No improvement considered

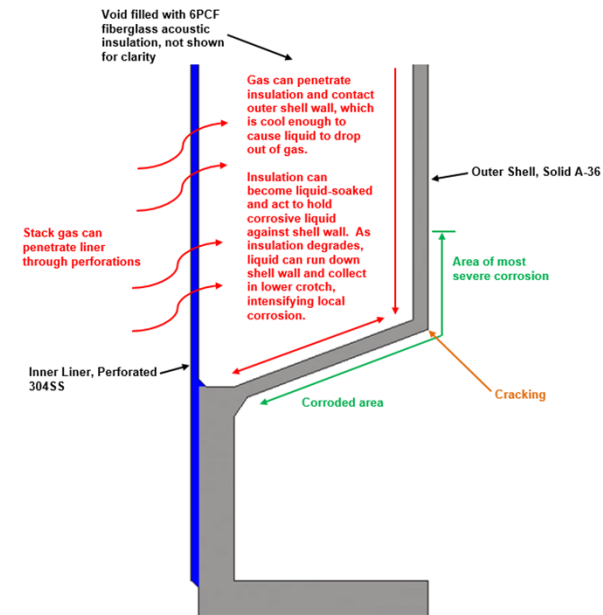
Corrosion Sketch

- Corrosion local to cone-to-shell weld seam weakened junction and contributed to accelerated crack growth
 - Corrosion was a result of stack gas condensing when contacting the outer shell of the silencer which typically operates below the dewpoint of the gas. Liquid formed and accumulated in the acoustic insulation and crotch between the conical section and inner liner, intensifying corrosion in that area

- Reduce and/or prevent corrosion:
 - Coat internal surface to prevent corrosion if stack gas condenses
 - Select different internal insulation material to provide required noise attenuation while improving liquid repellency

- Coat external surface of silencer to prevent CUI and cover with external insulation to maintain steel temperature above gas dewpoint, above CUI critical temperature, and below creep regime
