# APS/NRC Meeting

Discussion of A600 Repair/Inspection  
issues and associated relief requests

# **Palo Verde Unit 1 and 3 Pressurizer Heater Sleeve Repair And Remnant Sleeve Flaw Evaluation**

# Pressurizer Heater Sleeve Repair

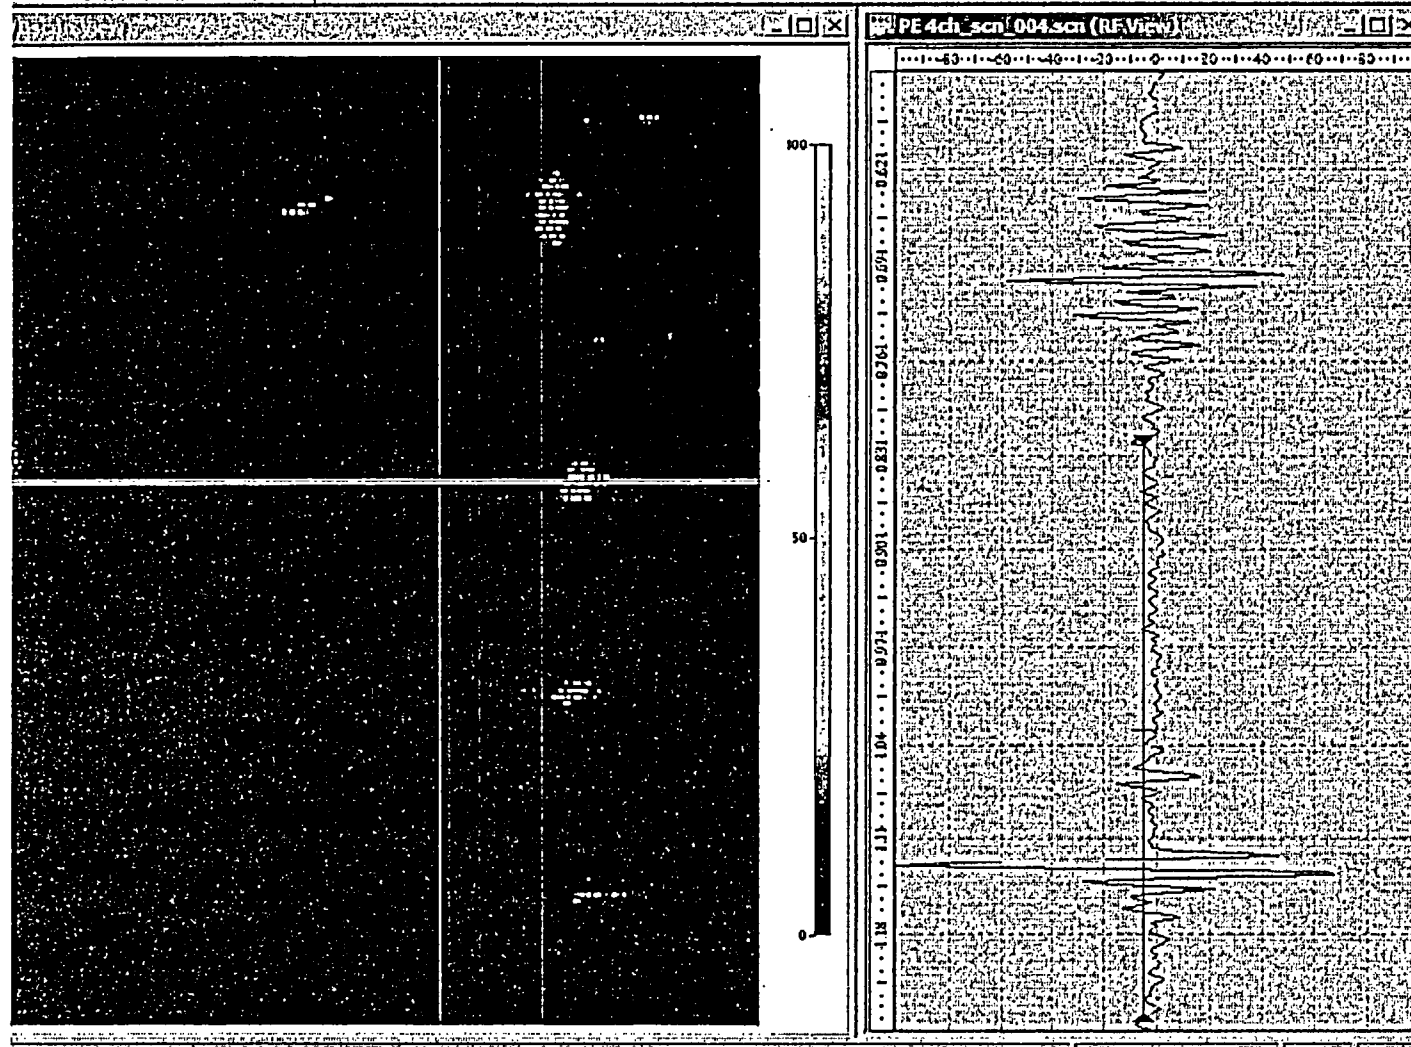
# NDE of OD Axial EDM Notched Sleeve

- Demonstration of Midwall Repair NDE
  - Volumetric Examination
    - Straight beam examination
      - Welded mockup with flat bottom holes
    - Angle beam examination
      - Welded mockup with OD/ID circumferential and axial EDM notches and end drilled holes
