ARCHAEOLOGICAL EVALUATION
OF THE EXTRAMURAL
MONUMENTAL COMPLEX
(‘THE SOUTHERN CANABAE’)
AT CAERLEON, 2011

An Interim Report

By
P. Guest, M. Luke & C. Pudney

SPECIALIST REPORT NUMBER 33

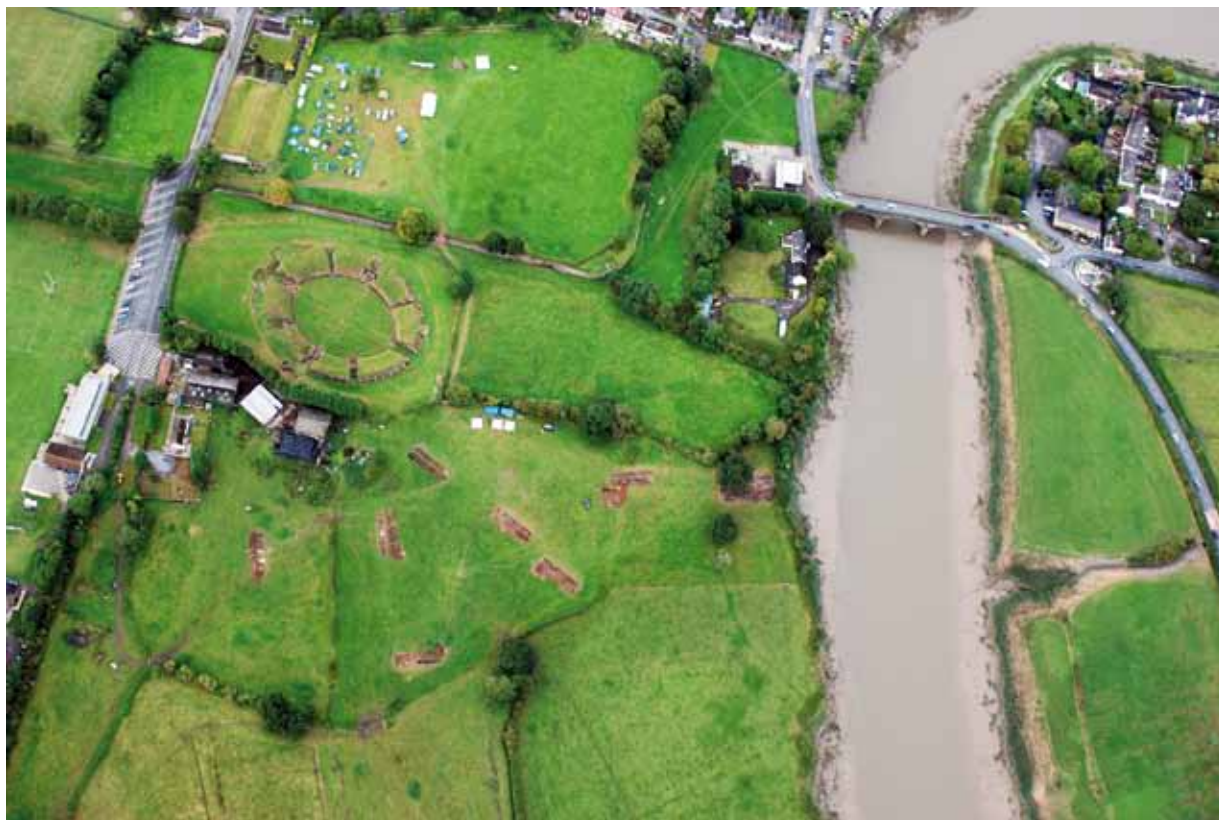
Fig. 1. Aerial photograph of the 2011 Caerleon Southern Canabae trenches, the River Usk and the legionary amphitheatre

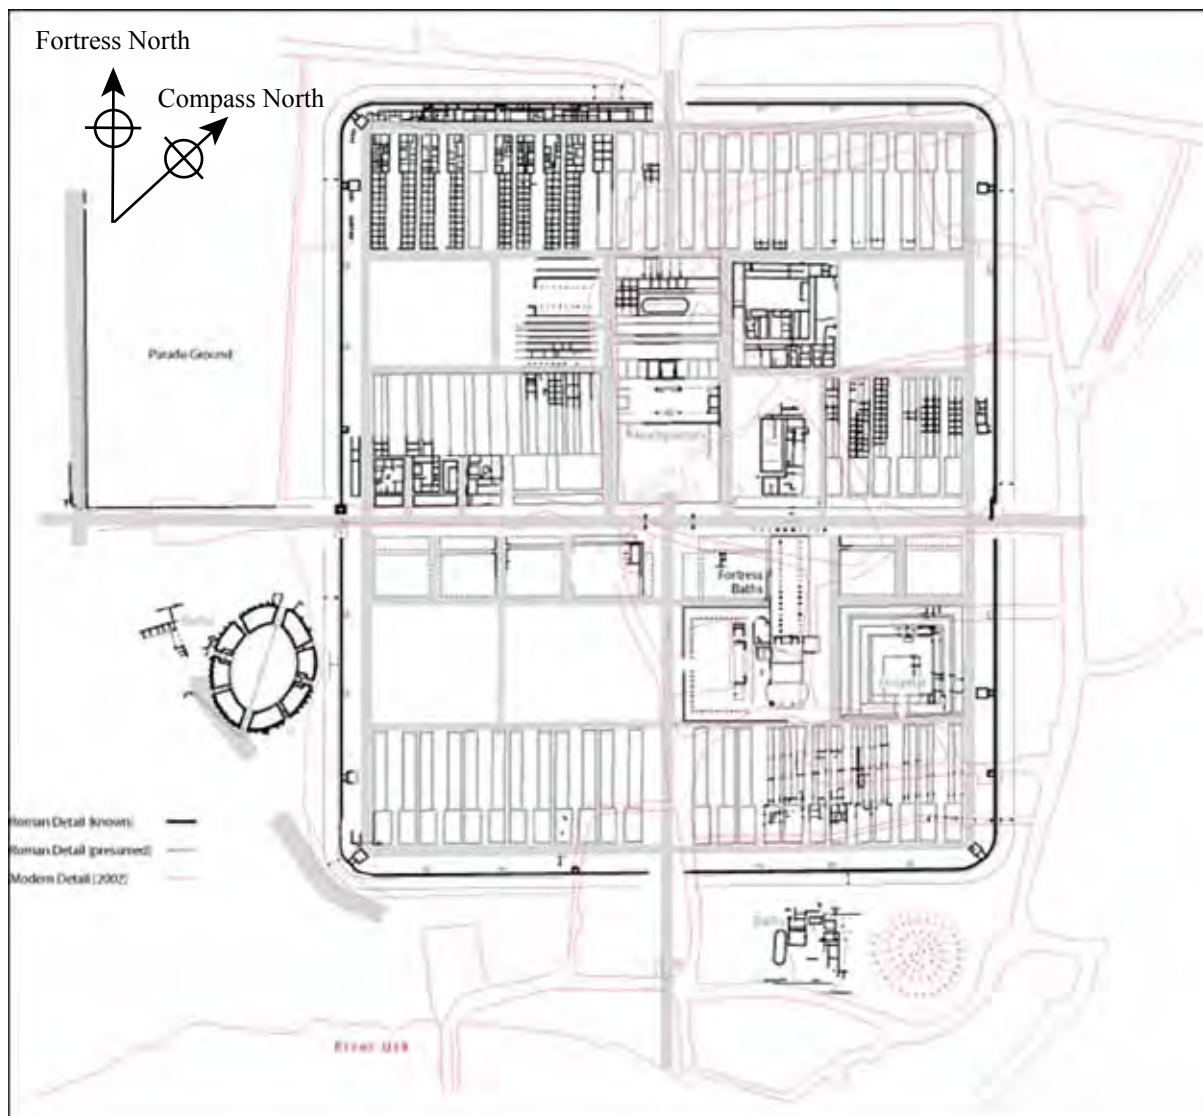
Fig. 4. Plan of the legionary fortress of *Isca* at Caerleon as known in 2002

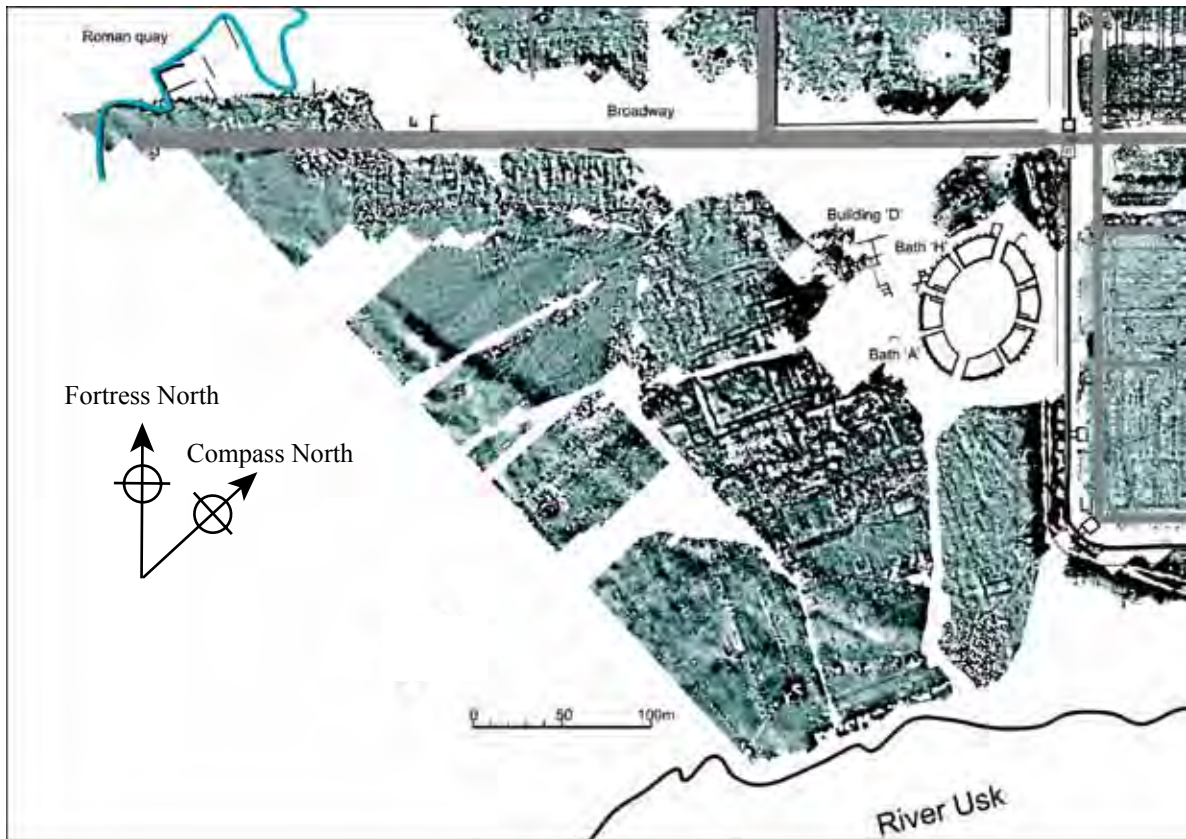
Fig. 6. Combined results of the gradiometer surveys to the south of Caerleon 2008-11 (© GeoArch)

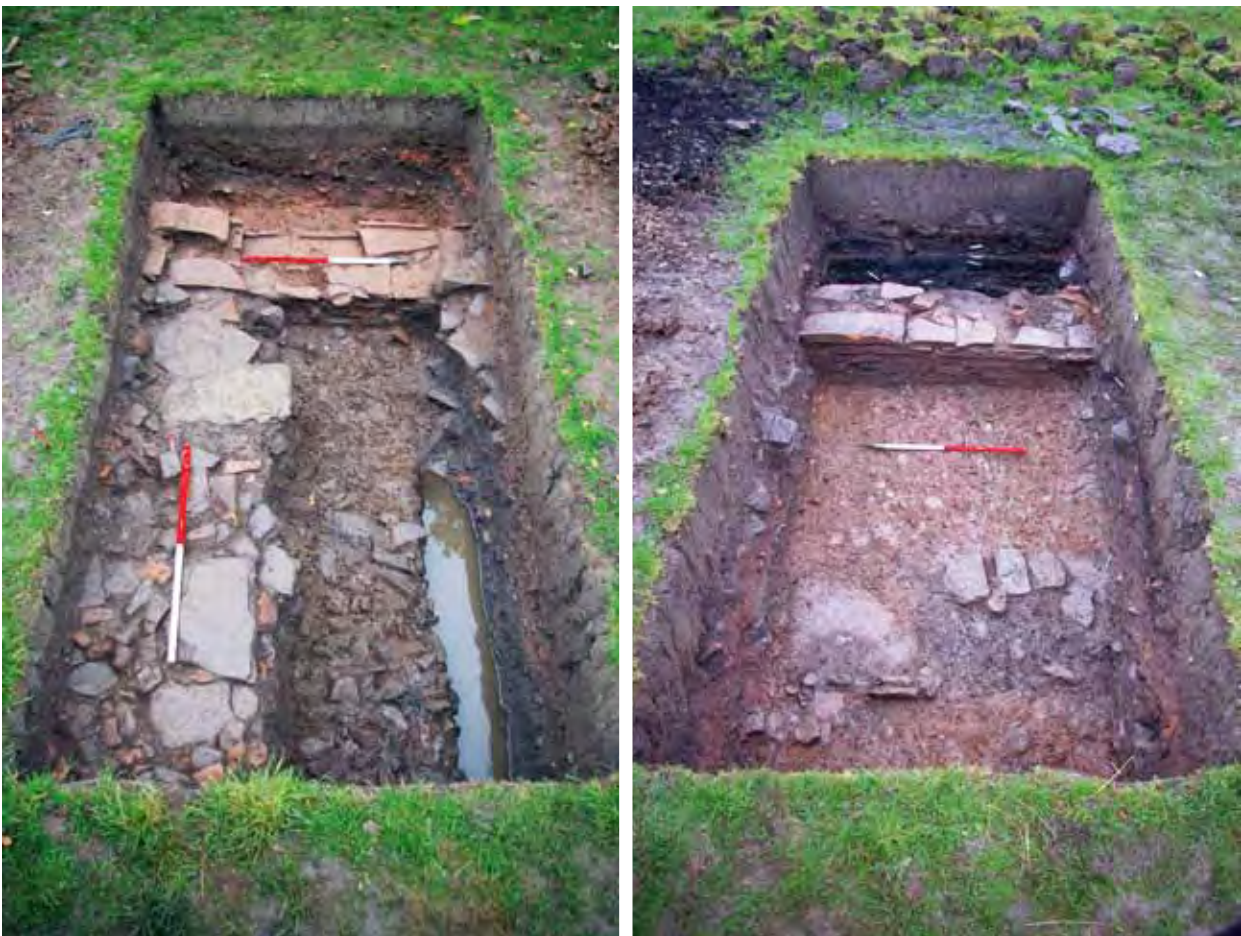
Fig. 8. Test pits 1 and 2 excavated in 2010 close to the right bank of the river Usk

Two small trial trenches excavated in 2010 over the southern range of the very large courtyard building closest to the Usk (Zone 1), revealed a wall constructed from deliberately broken and relaid *tegulae* (roof tiles), which was thought to be part of Roman Caerleon's main quay on the Usk. Material dumped outwards from this wall was interpreted as the remains of landing stages or jetties projecting out into the river to allow larger ships to dock at Caerleon. The 2010 trial trenches suggested that the Roman remains survive very well in this part of Caerleon's outskirts, and there was little evidence for extensive medieval and modern disturbance (Gardner and Guest 2010).

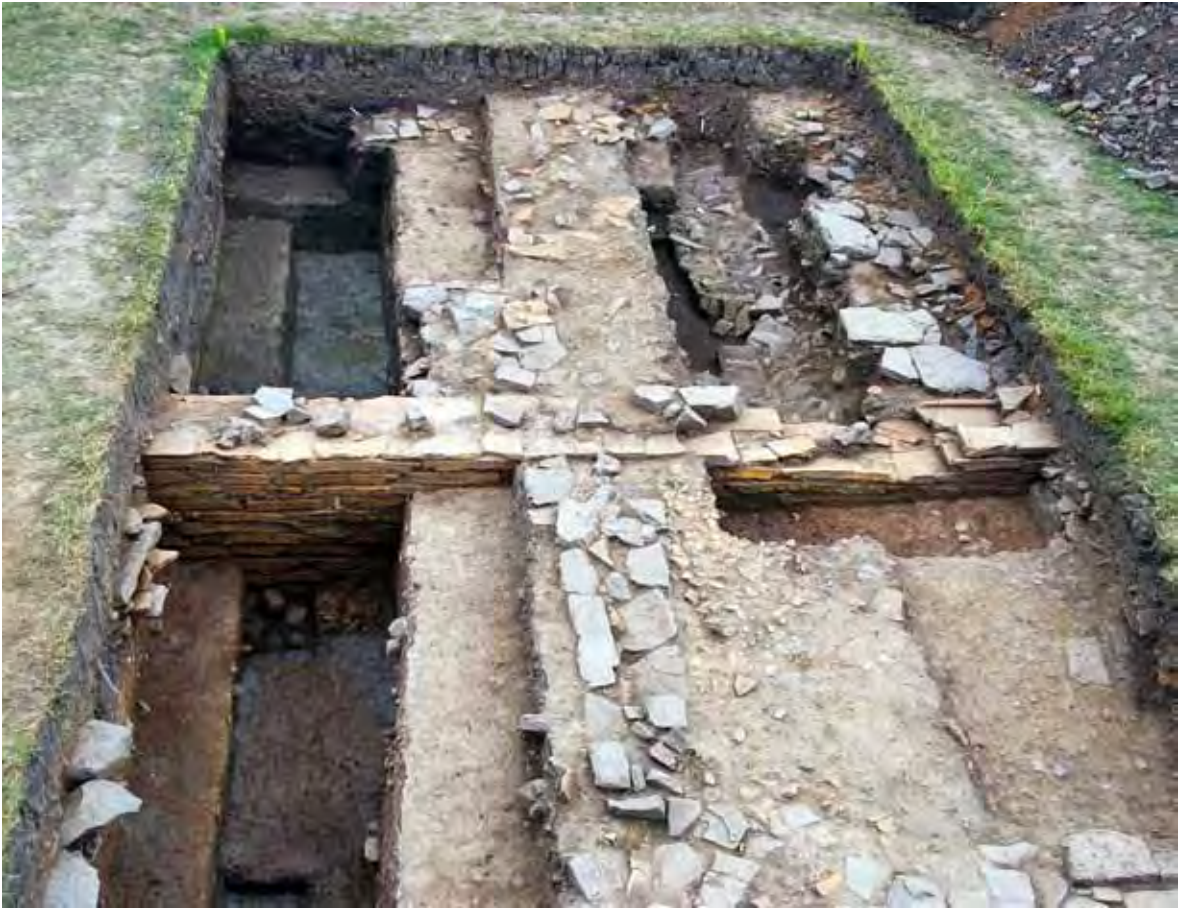
Fig. 13. East end of Trench 1 showing tegula wall [115] and associated structures in Areas 1.1, 1.2 and 1.3

The *tegula* wall [115] passed through the full 5m width of the trench (Fig. 13). The wall was built over cobbled footings (190), offset on the wall's western side by 0.4m, which seem to have been constructed on top of the underlying surface rather than within a foundation trench (Fig. 14). A line of large stones (175) above the remains of a wooden plank/beam (193) on the eastern side of the wall possibly represent revetting against which the footings had been piled in order to stop these slipping down the natural slope (Fig. 15).

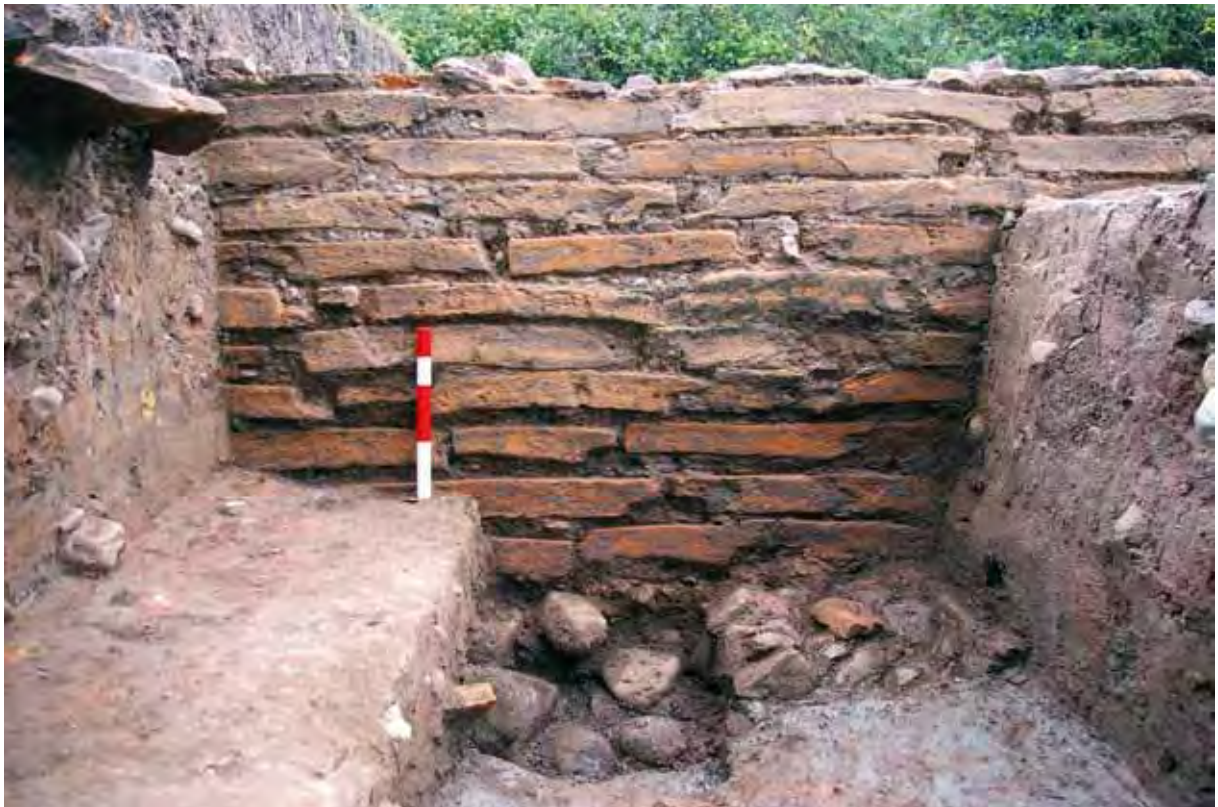
Fig. 14. West face of tegula wall [115] and underlying cobbled foundations (190)

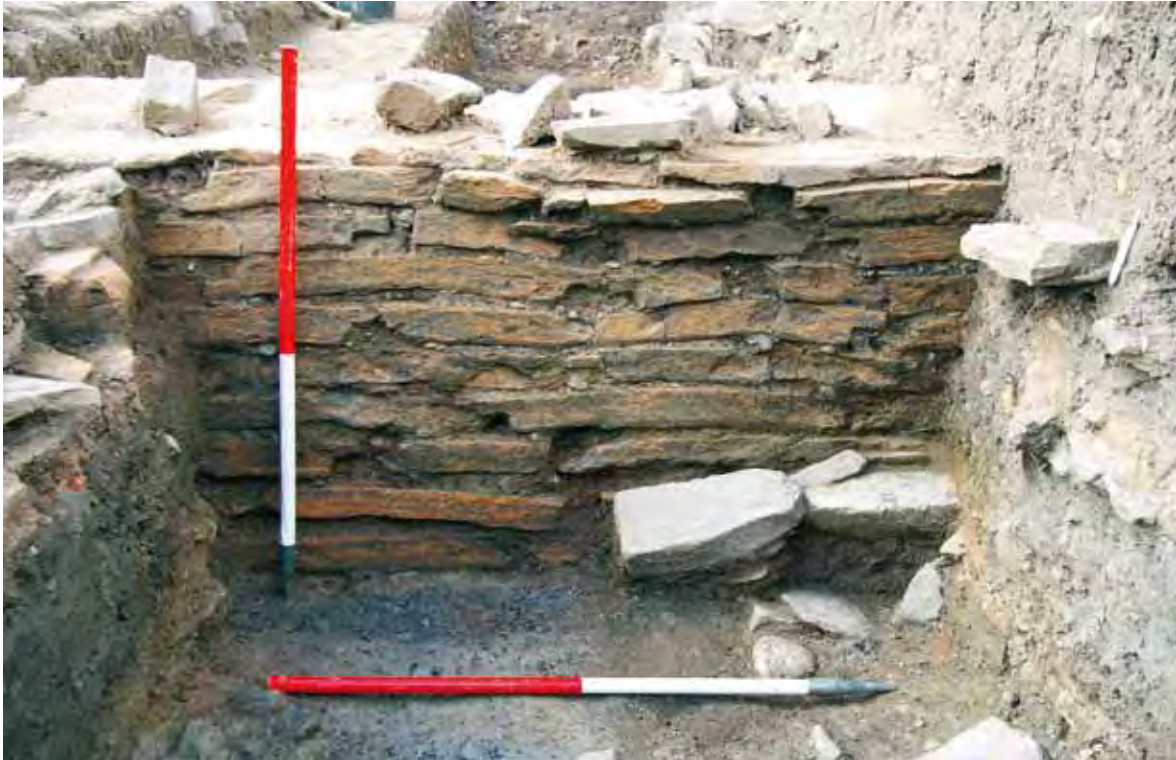
Fig 15. East face of tegula wall [115], showing underlying burnt wooden beam (193) and large stones (175) against the wall's face

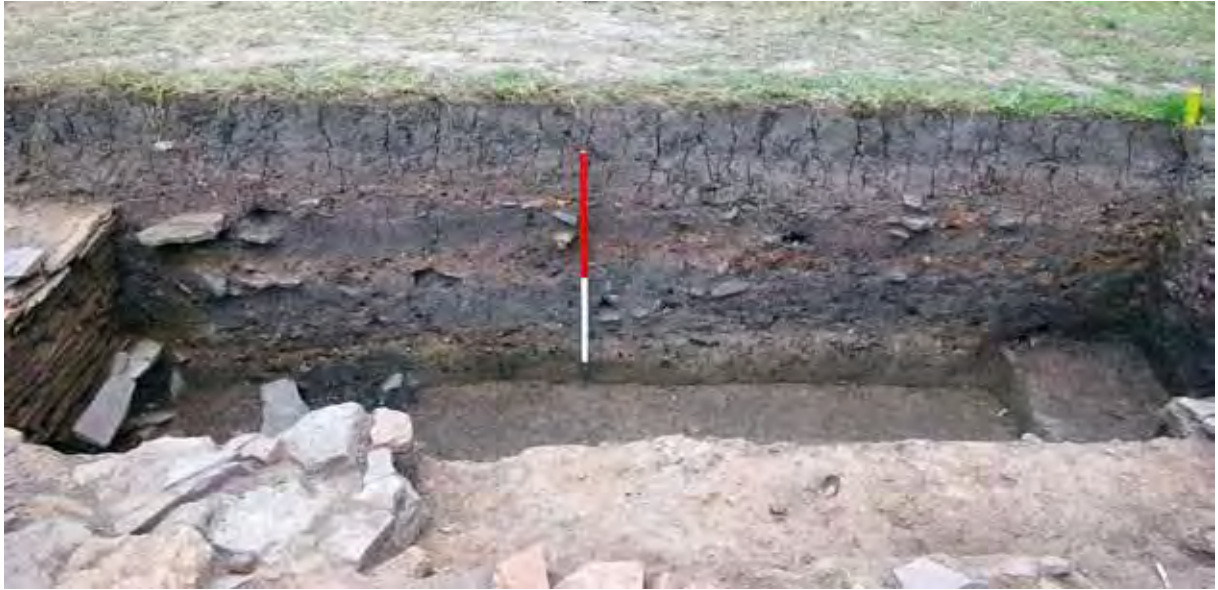
Fig. 16. North section of Trench 1 showing natural clays and levelling deposits on the riverward side of tegula wall [115]

In the corridor building 1.5, possible evidence for demolition/collapse deposits consisted of rubble and CBM (119/126) which were in turn overlain by a very compact clay (111). These were similar to layers (107) and (108) in the eastern half of the trench. In general, however, the deposits that seem to be related to the decay and abandonment of the buildings in Trench 1 are much shallower than comparable layers in the other trenches. This might be explained if these buildings had been abandoned and dismantled earlier than elsewhere, or if this part of the *Southern Canabae* closest to the River Usk had been subjected to extensive flooding which led to these buildings' abandonment and also carried away much of the material that remained after their demolition. The effects of the flooding experienced in this part of Caerleon are shown in the thickness of alluvial clay (106) that overlies all of Trench 1 (Fig. 16).

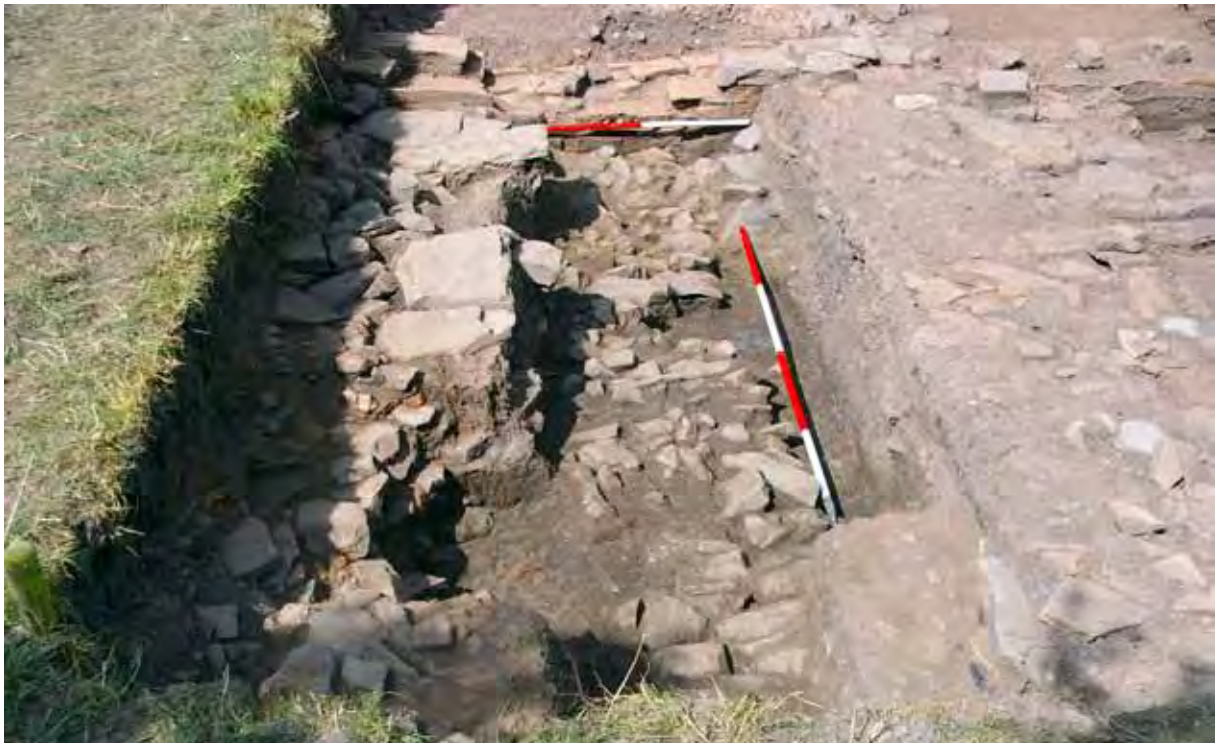
Fig. 17. East-facing view of foundations [148] and surface 149 in Area 1.1 (on left of photograph)

The footings of an east-west wall were identified in the southeastern corner of the trench (excavated in the 2010 test pit). The wall had been robbed but the 0.6m wide foundations survived, comprising closely packed angular stones [148]. The sequence of clay make-up deposits to the north and south of the foundations were different and the wall must have been upstanding when the ground was raised. The surfaces either side of the wall were also different indicating that it separated different buildings, or separate rooms within a single building (Fig. 17).

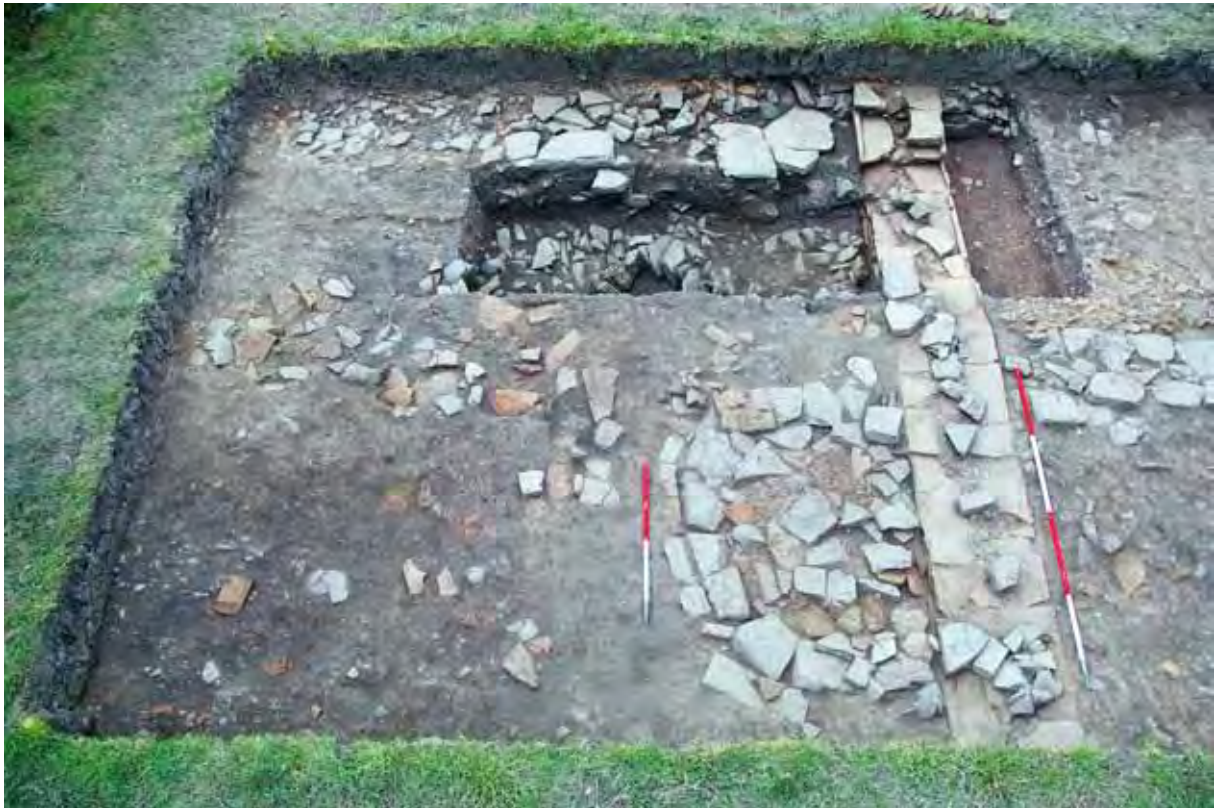
Fig.18. Semi-circular feature (116) in Area 1.2 (bottom) and surface 149 in Area 1.1 (top)

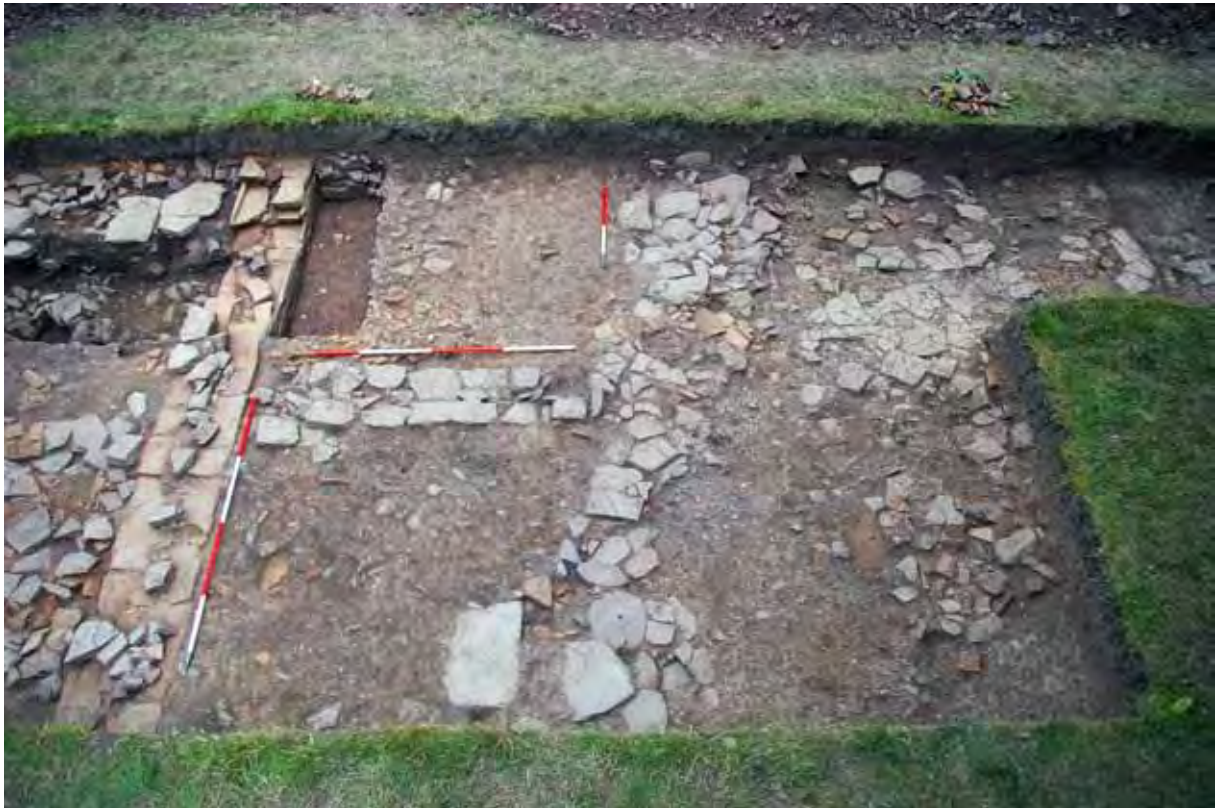
Fig. 19. Area 1.3, including wall [128], and the patched roadway 1.4 west of tegula wall

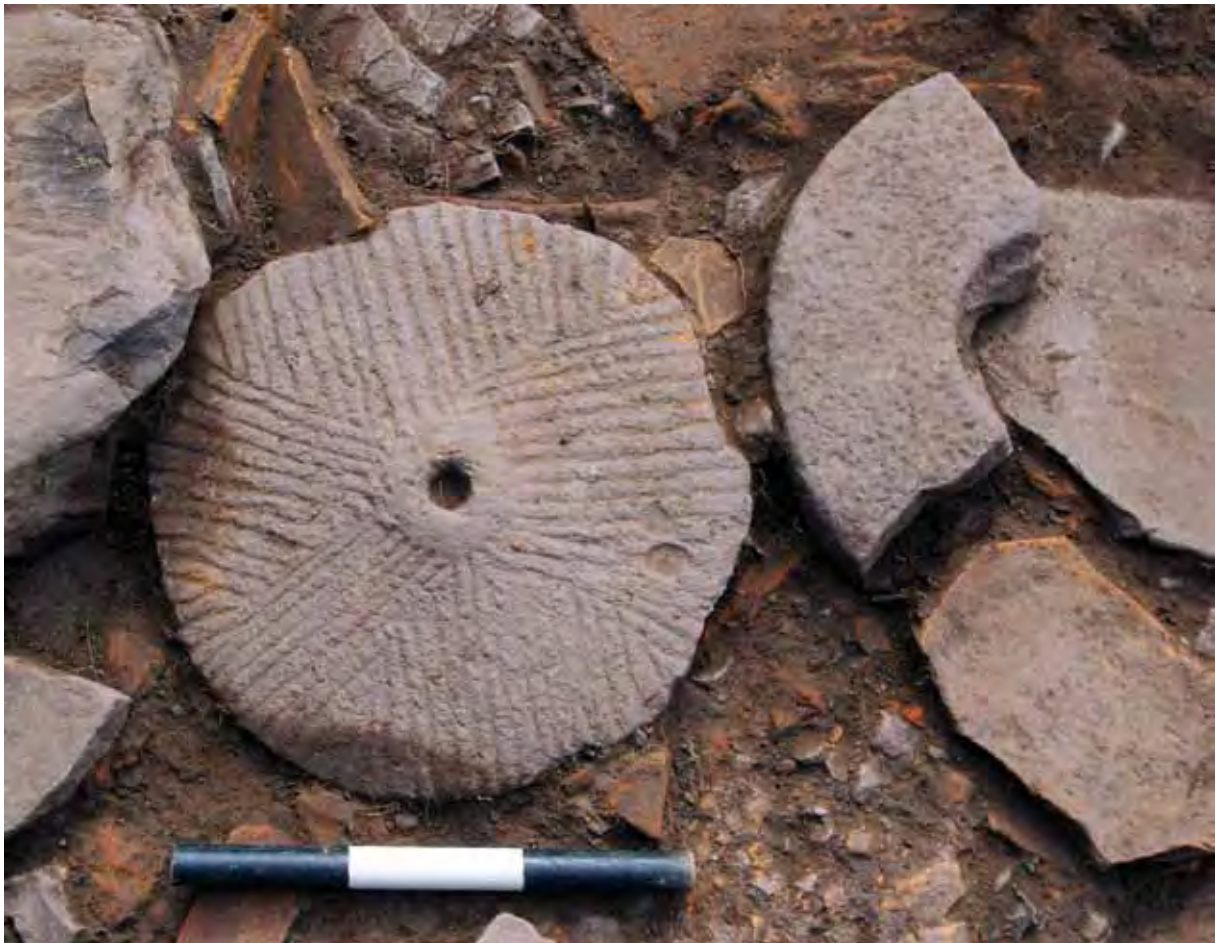
Fig. 20. Quern stones reused in patching of roadway 1.4 (132)

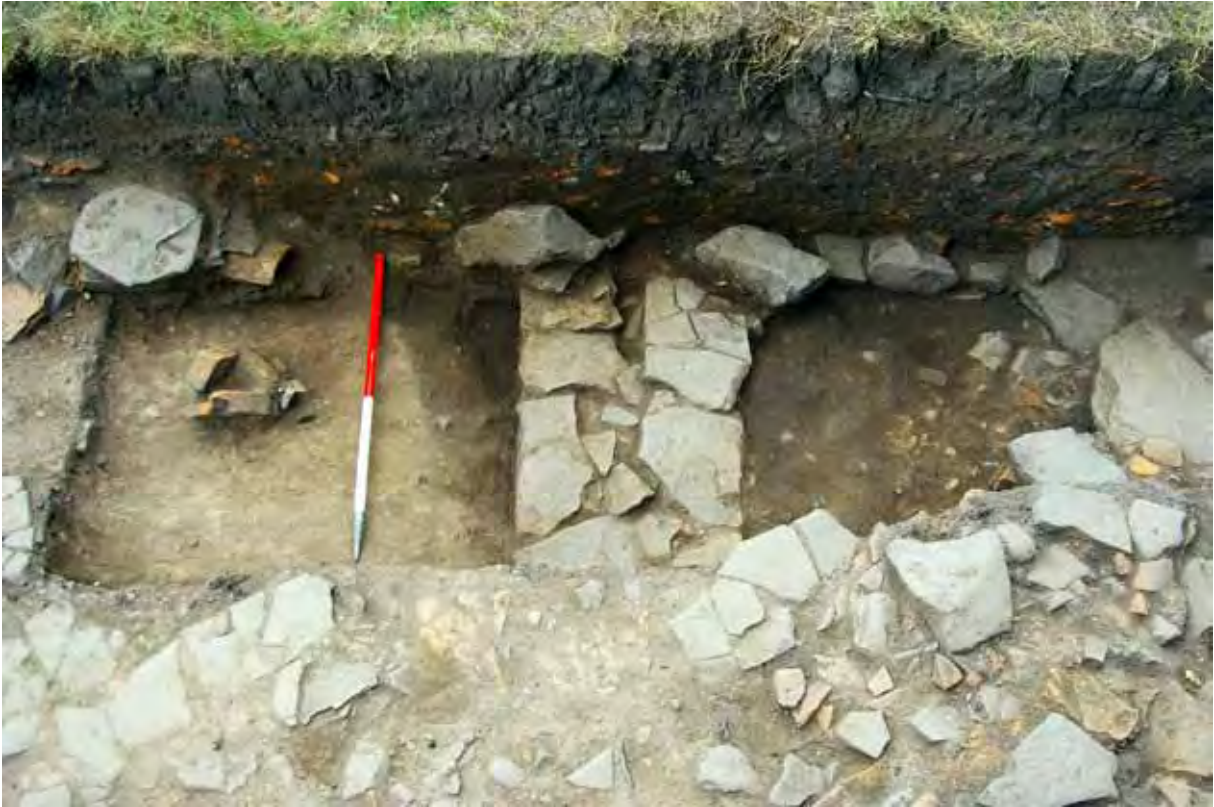
Fig. 21. North-south wall [168] separating roadway 1.4 (on left) from building 1.5 (on right)

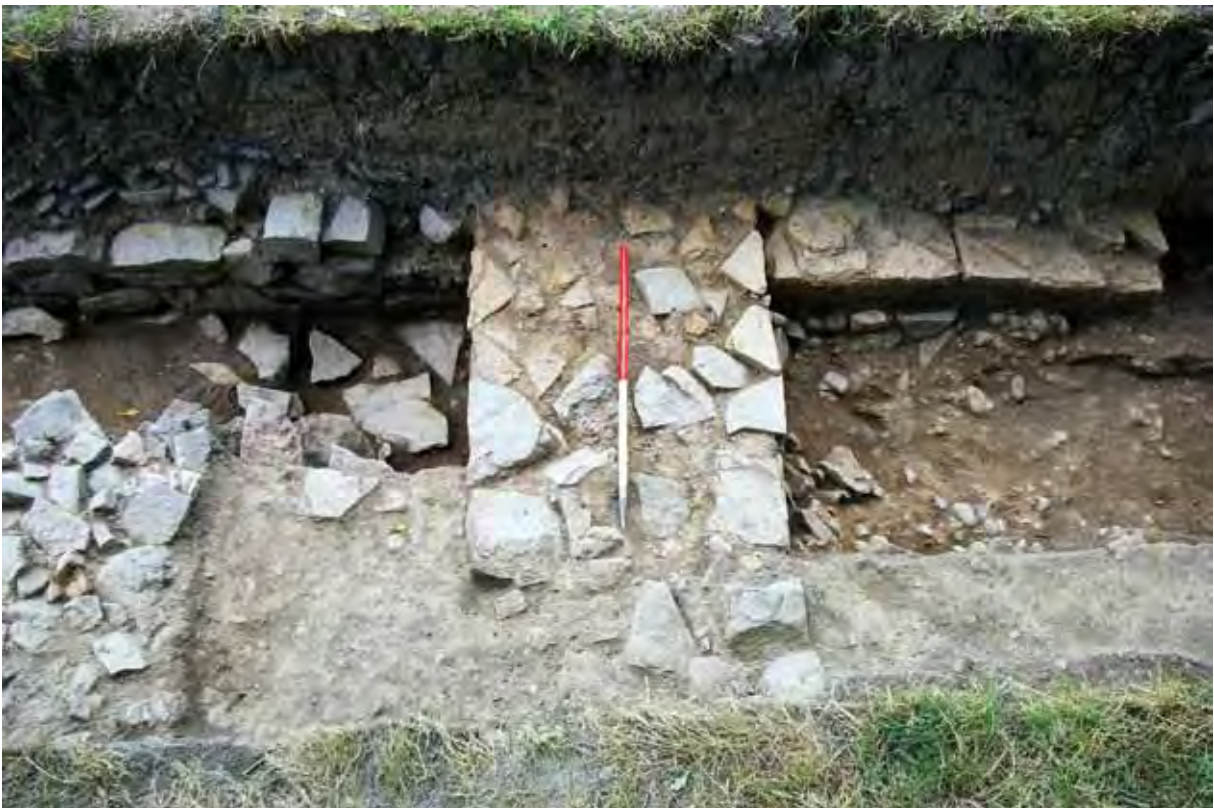
Fig. 22. North-south wall [120] separating building 1.5 (on left) from courtyard 1.6 (on right). The two east-west walls in the trench edge ([171] to left and [127] on right) possibly mark the southern side of an entranceway into the courtyard.

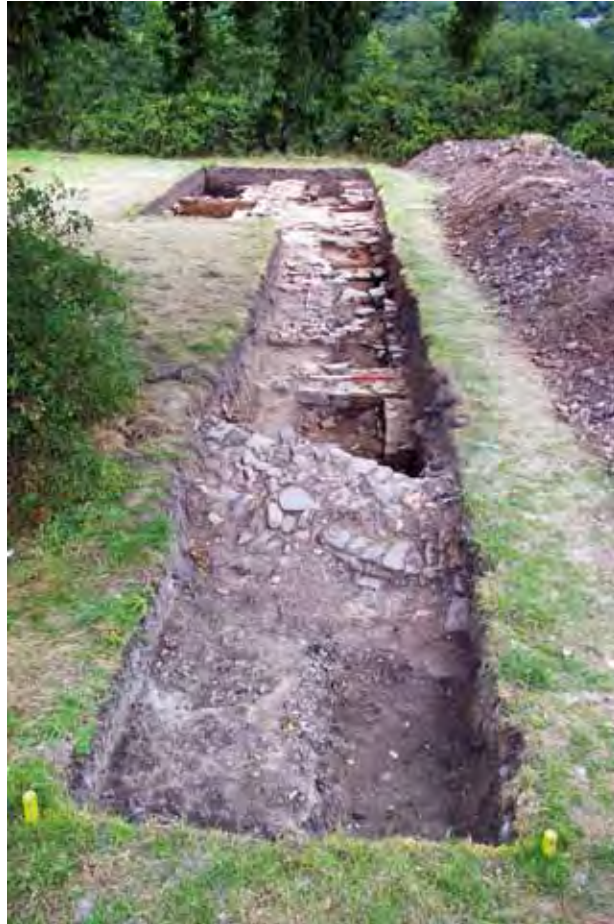
Fig. 24. West end of the Trench 1 extension showing the oblique medieval or post-medieval field boundary and Roman structures beyond

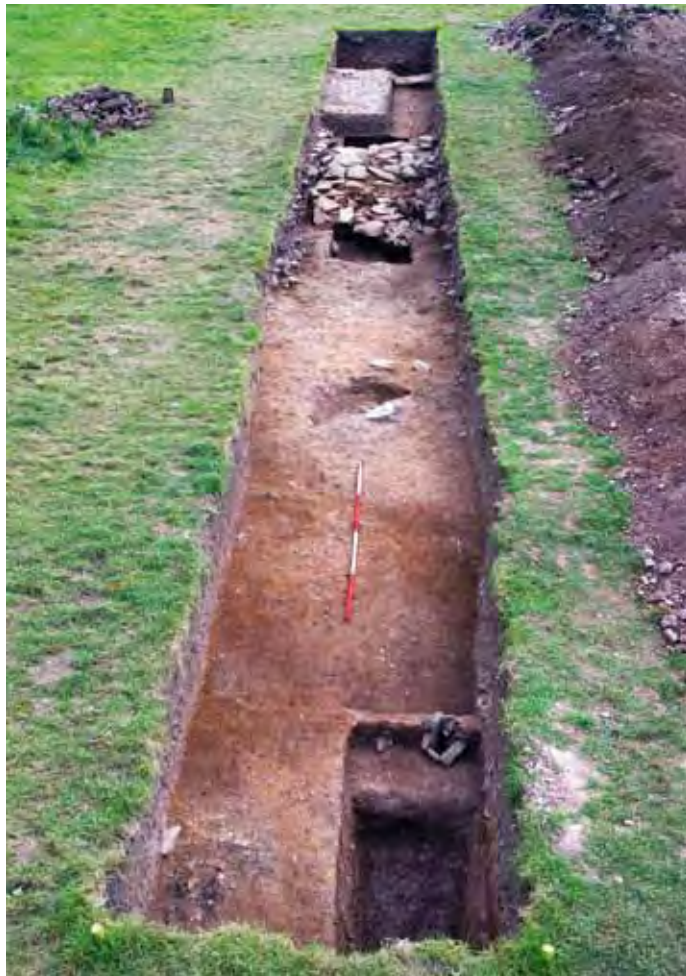
Fig. 30. Trench 2 from west, showing latest cobbled ground level cut by post-hole [219] and pit [225] in foreground

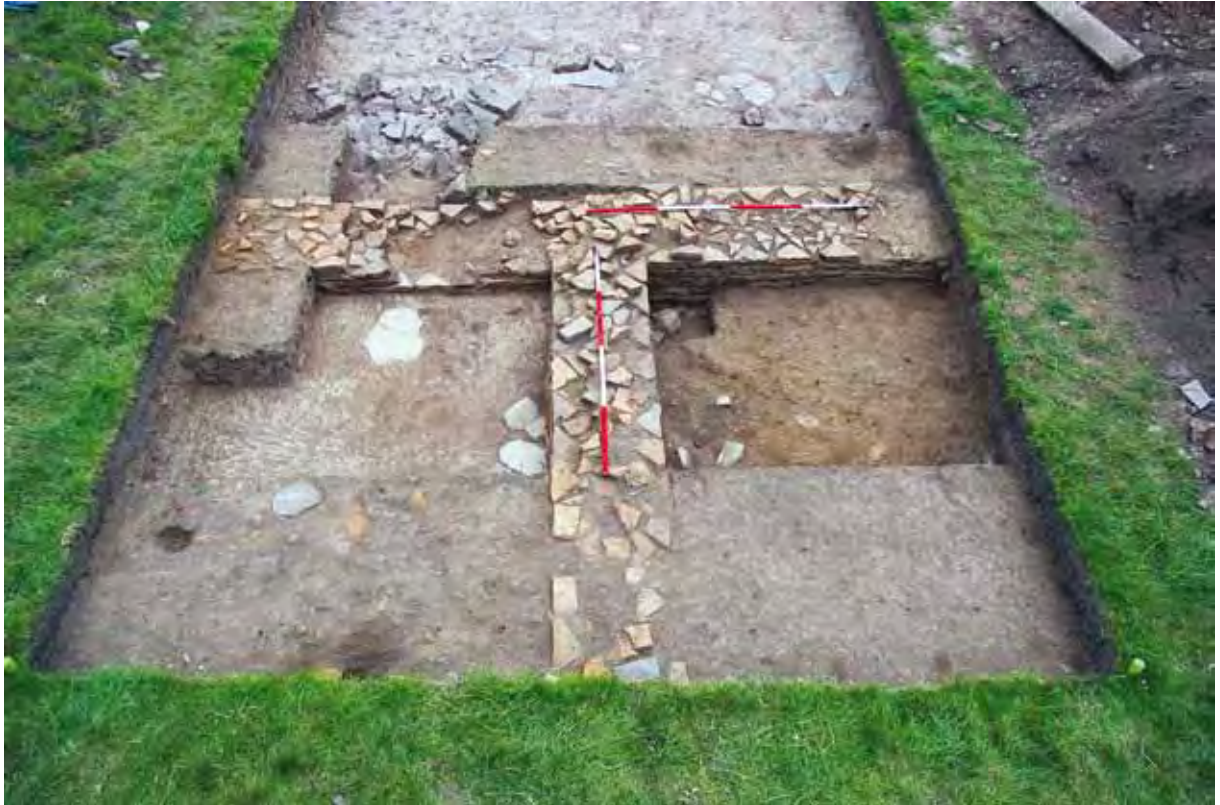
Fig. 33. Structure 3.1 from south

Both walls were clay-bonded and consisted of faces of triangular bricks on either side of a core of large pieces of broken brick. The walls were bonded together and had therefore clearly been constructed as part of the same build. Up to six courses survived of the outer wall and five of the narrower internal wall. No foundations for

Trench 3 showed that the anomaly on the magnetometer results was a rectangular brick-built structure some 9m wide and aligned southeast to northwest. It is more difficult to be certain about its length but it must have

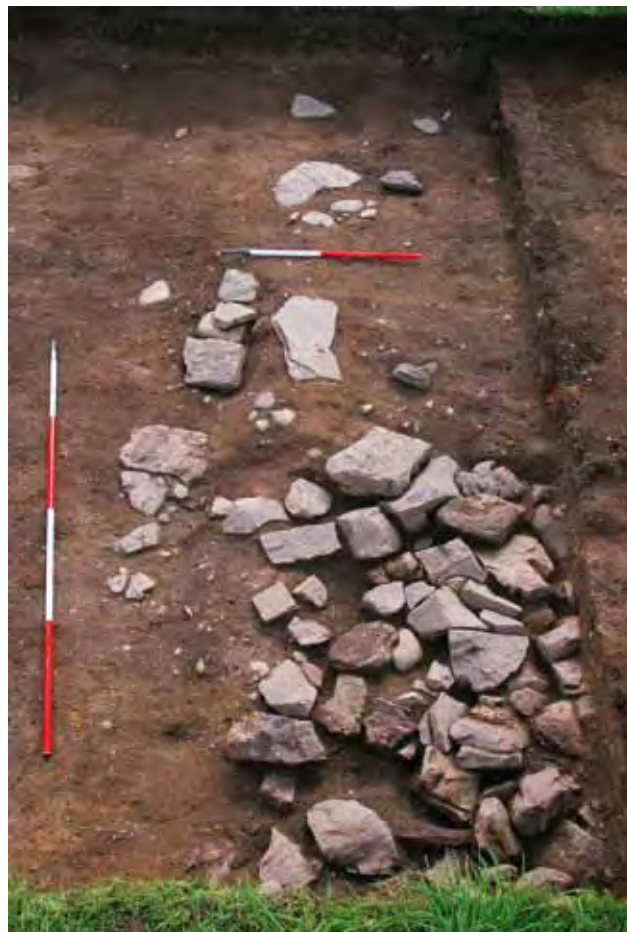
Fig. 34. Rubble spread (310) and possible post-pads (315-319) in Area 3.2

Several individual and groups of large flat stones (315/316/317/318/319) were found embedded in the top of the clay subsoil (Fig. 34). The stones were irregularly

shaped and individually measured *c.* 0.3m by 0.2m (315/316), while some seem to have been placed together to form roughly semi-circular groups *c.* 0.6m by 0.6m in extent. These were found close to the brick structure and they are tentatively interpreted as post-pads (although there was no obvious spatial patterning and similar flat stones (314) were found within the brick structure too).

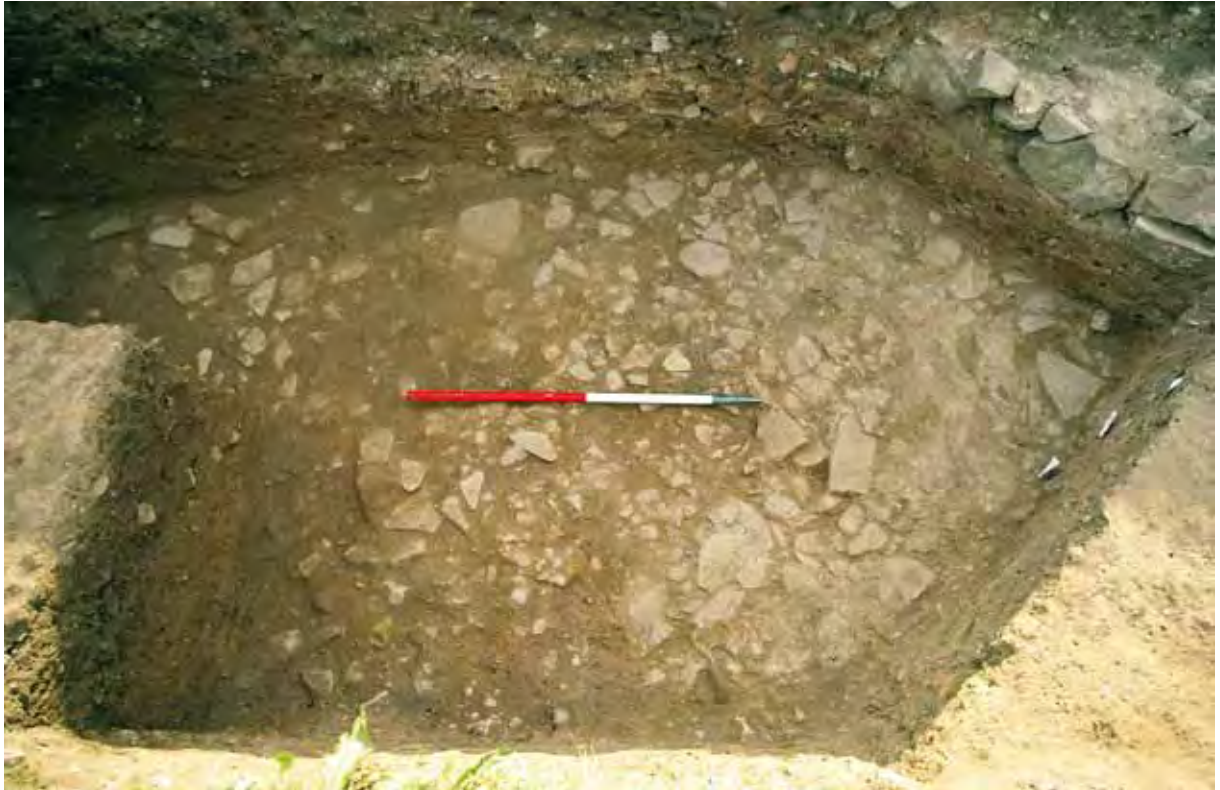
Fig. 36. Earliest stone and cobbled surface (431) in the northern part of Trench 4. Stone and white mortar layer (416) is visible in the top right-hand corner

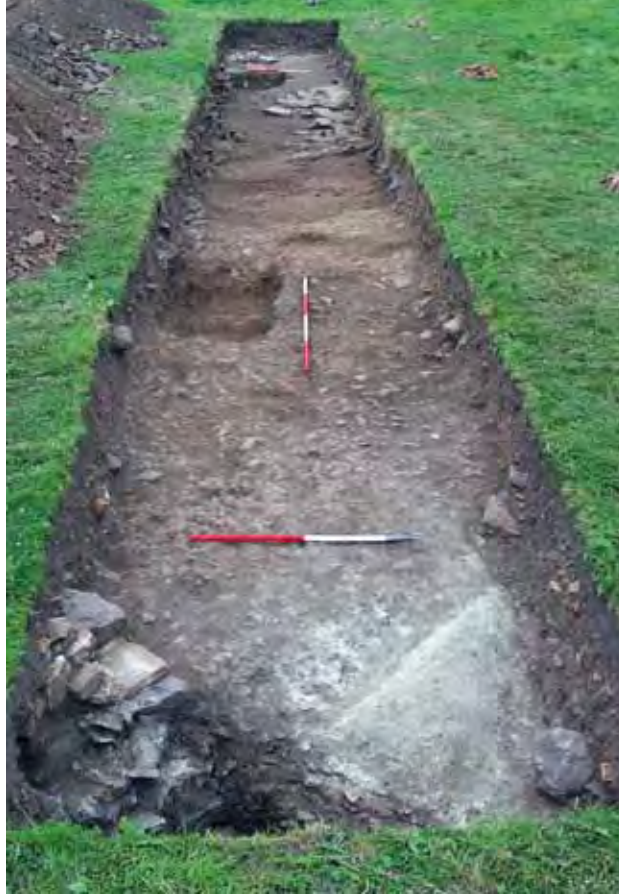
Fig. 39. Trench 4 looking north, showing stone surface (415) and white mortar surface (433) in the foreground, pebbled surface (420) in the middle ground, and possible rubble surface (421) beyond

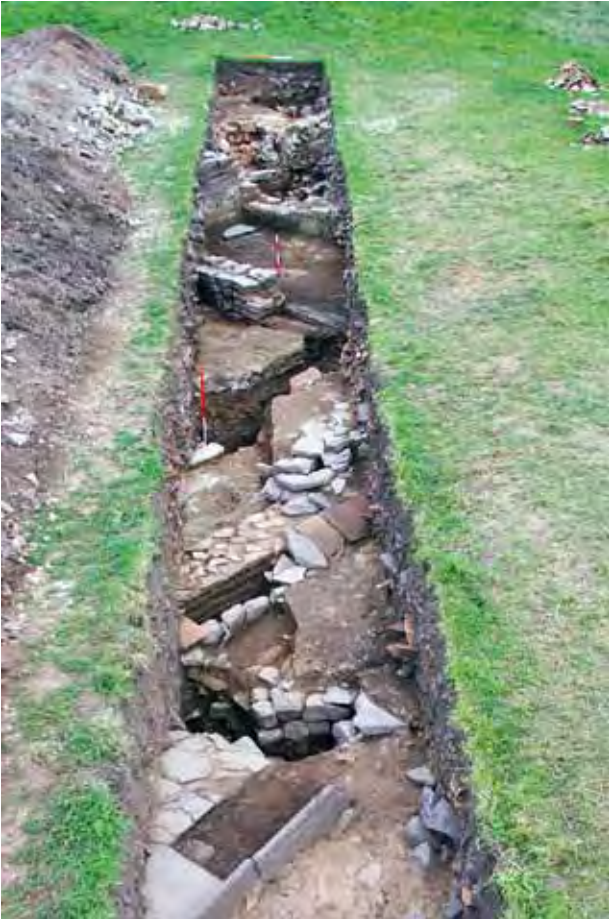
Fig. 41. Trench 5 from south as excavated

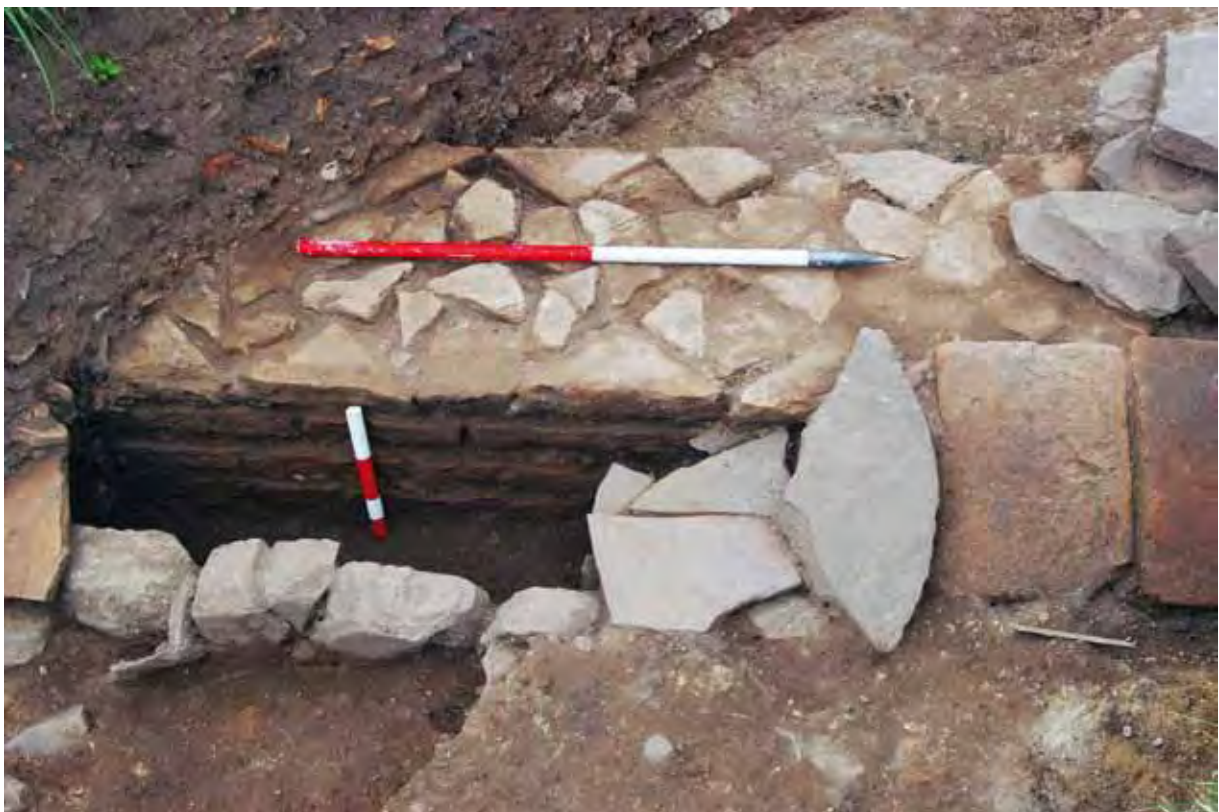
Fig. 43. Wall [523] and adjacent drain with sloping capstones in situ. Looking northwards from Areas 5.1 to 5.2

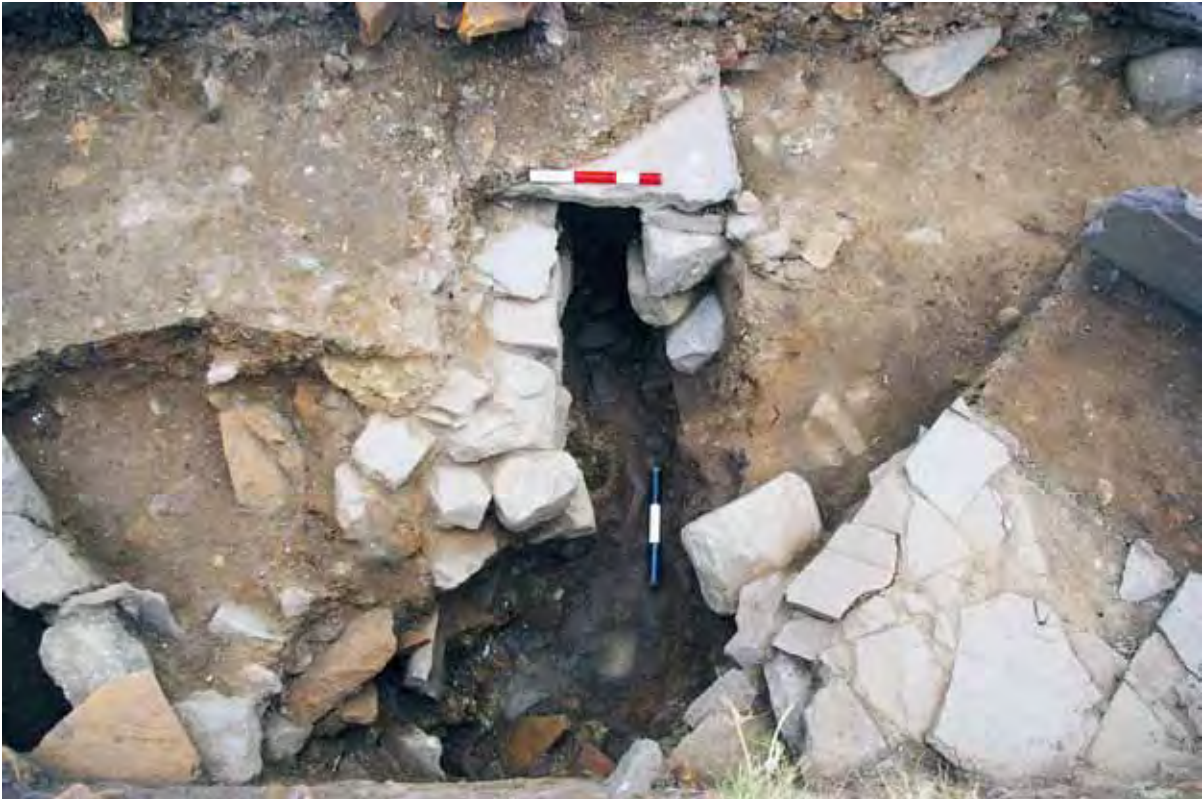
Fig. 44. Drain [529] in Area 5.1, from west

(540). This was some 0.3m higher than (541) and gave the appearance of a rough yard surface that had seen considerable use. Set within bedding layer (540) and sealed by the surface (517) was a second stone-lined drain (529), this time not on the same alignment as the buildings. The edges of the drain were formed by two courses of unmortared irregular ORS, blocks and one large flat ORS capstone was found *in situ* at its eastern end (Fig. 44). The drain did not extend across the full width of the trench, but instead terminated some 1.10m in from the eastern trench edge (the western end of the drain ends obliquely with its southern side extending only 0.9m into the trench). Like the previous drain, no stones lined the bottom but, unlike the first drain, the fill (542) produced quantities of pottery, animal bone and small finds.
