ARCHAEOLOGICAL EVALUATION
OF THE EXTRAMURAL
MONUMENTAL COMPLEX
(‘THE SOUTHERN CANABAE’)
AT CAERLEON, 2011

An Interim Report

By
P. Guest, M. Luke & C. Pudney

SPECIALIST REPORT NUMBER 33

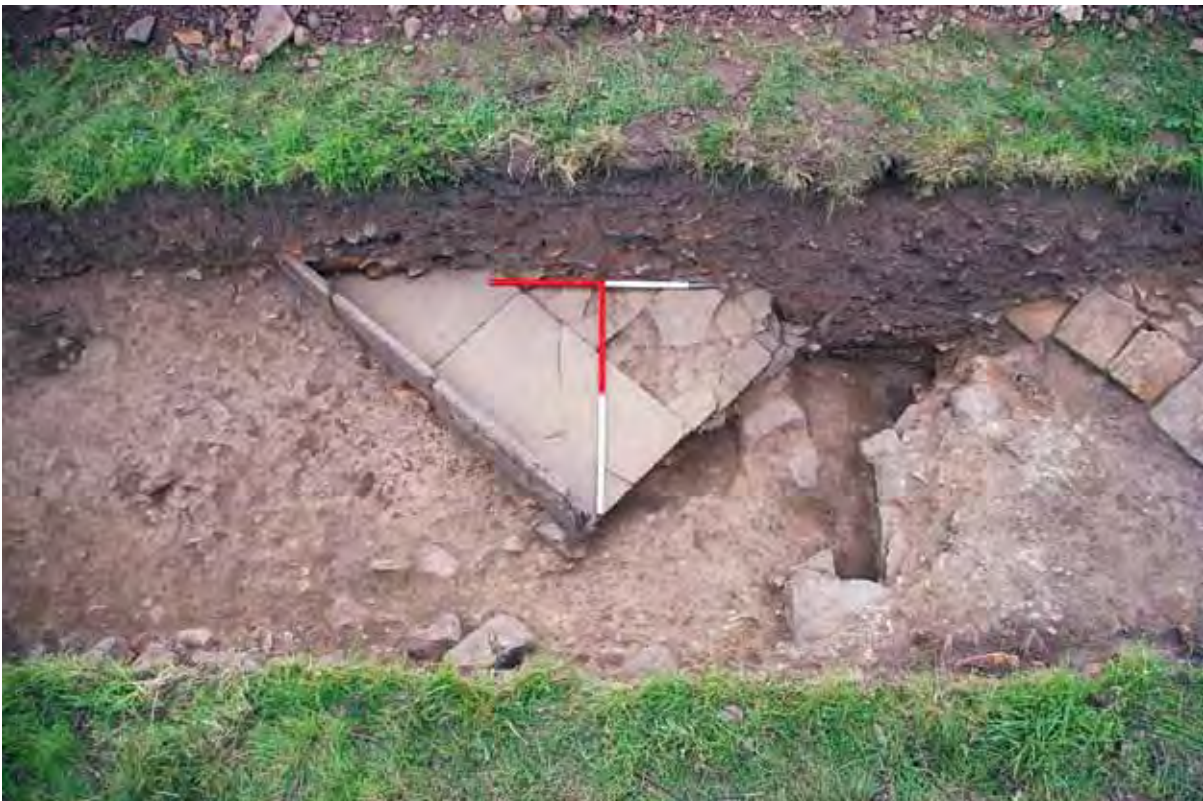
Fig. 45. Flagstone feature (528) in Area 5.1, from east. Drain [529] cuts across the trench from the near edge

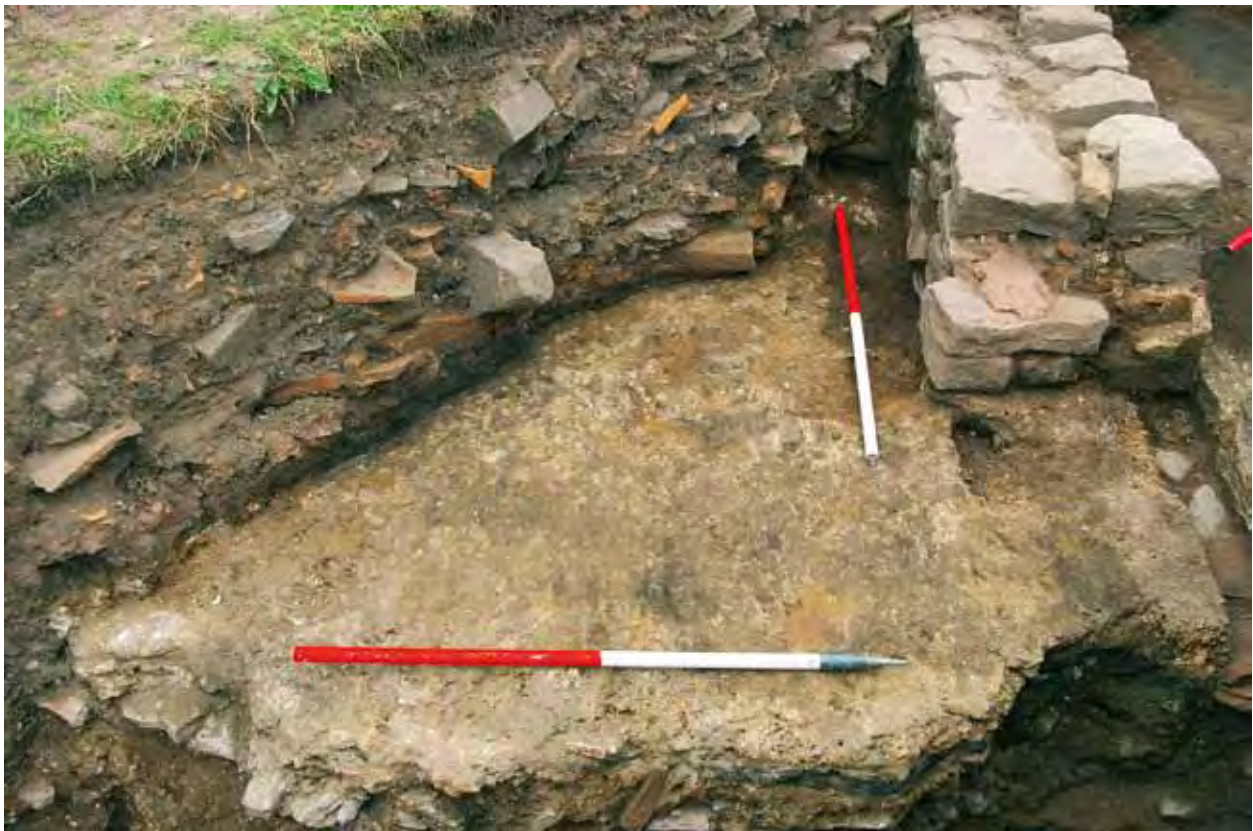
Fig. 46. Room 5.3 from southeast, showing latest floor (548), internal dividing wall [530], and beam slot (543)

The two rooms upslope of the main wall were separated by an internal north-south partition wall [530] and a slot (543). Wall [530] was some 0.5m wide and had been built with roughly faced ORS blocks set in a friable silty-sand mortar. The face of this wall in room 5.3 was unrendered and the southern end of the wall appears to sit directly on top of an earlier surface without any foundations (explaining the uneven nature of the wall's courses). The slot (543) was some 0.2m wide and extended for a distance of 1.1m from the southern end of wall [530] to the robber trench for the main wall (which formed the eastern side of the room). Originally the slot would have been filled by a wooden beam at the base of a doorframe between rooms 5.3 and 5.4. Concrete was poured into the rooms thereby preserving the position of the original beam, which was either removed or had simply rotted away. The floor in room 5.3 consisted of a yellow-brown concrete mixed with small pebbles but no crushed tile (548), which butted against the lowest course of wall [530] (Fig. 46). This floor was not excavated, but the sequence of deposits beneath it was observed in the side of robber trench [516], which showed that it had been laid on top of a bedding layer consisting of stones, broken brick and tile, as well as a thin deposit of burnt material in the area of the beam slot (upon which the beam itself had originally sat). There was no evidence for an earlier floor in this room, suggesting that the dividing wall [530] was an original feature.

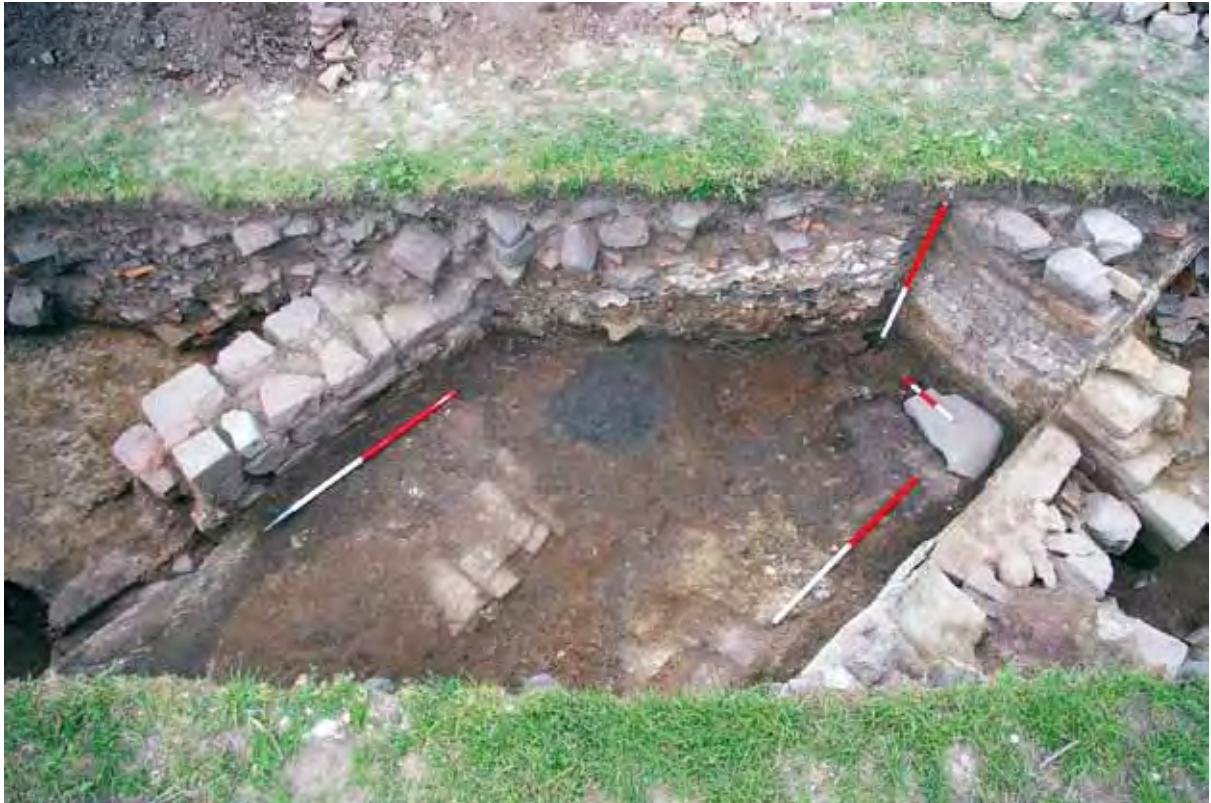
Fig. 47. Room 5.4 from east, showing latest floor (551)

Room 5.4, some 2m wide and 4m deep, was adjacent to room 5.3 and was formed by walls [530] to the south, [533] to the north, [505] to the west, and robber trench [516] to the east (Fig. 47). Wall [533] was more substantial than the others, measuring 0.9m wide and built with mortared courses of large neatly faced blocks either side of a rubble core (it's northern face had been partially robbed). Painted plaster was found adhering to the surviving face of this wall in room 5.4, decorated with horizontal and vertical red lines above the floor (552). Wall [505] butted up to the continuation of [533] and was clearly a later addition. Although only a short length of this wall was exposed in the trench, it survived to a height of eight or perhaps nine courses above the floor. Some 0.4m wide at the top, it seems to have been built in two episodes: the lowest six or seven courses use small neatly cut and faced stones, while the uppermost two courses do not appear to have been bonded with mortar and were made with larger more roughly-hewn stones and a brick (it is not certain whether the upper part of this wall is Roman or post-Roman reuse of a truncated wall). The face of this wall in room 5.4 had been rendered with course plaster, as was the north face of the southern wall [530], though in neither case was there any indication that they had been decorated.

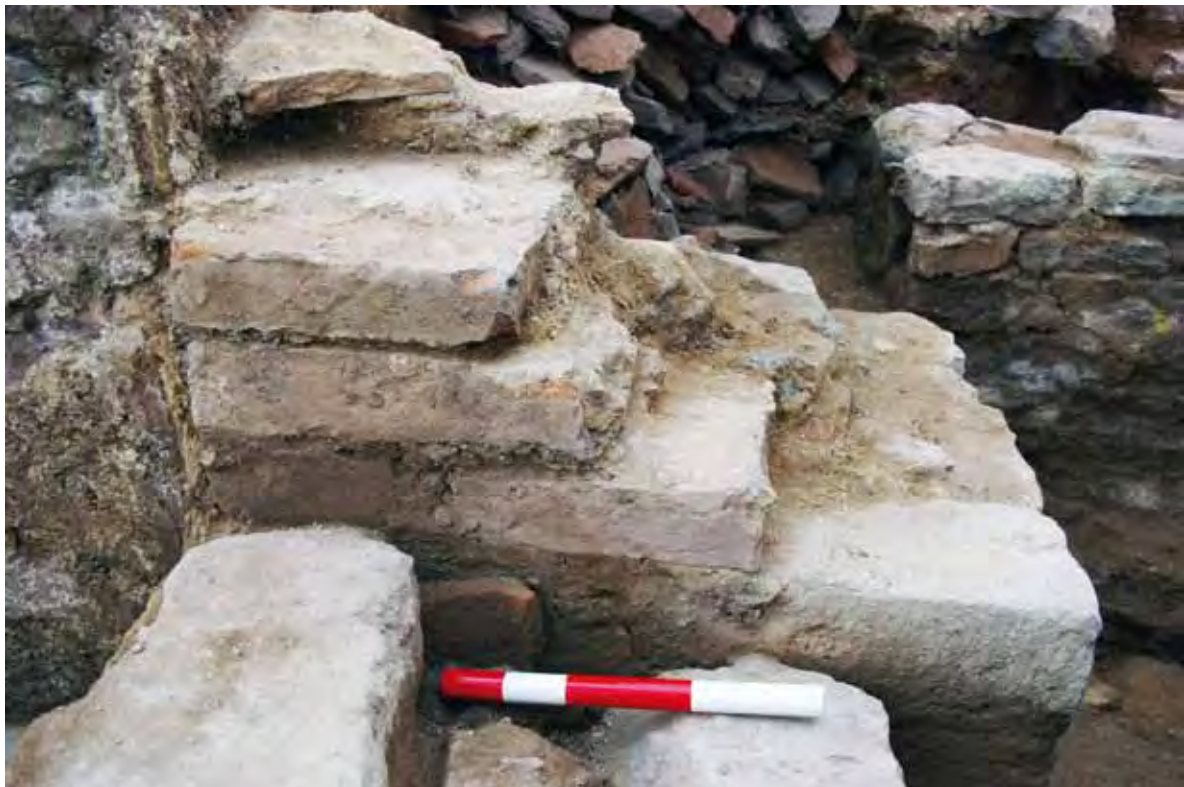
Fig. 48. Brick end of wall [555/556] from room 5.3. Butted against by wall [505] on left and [533] in the foreground

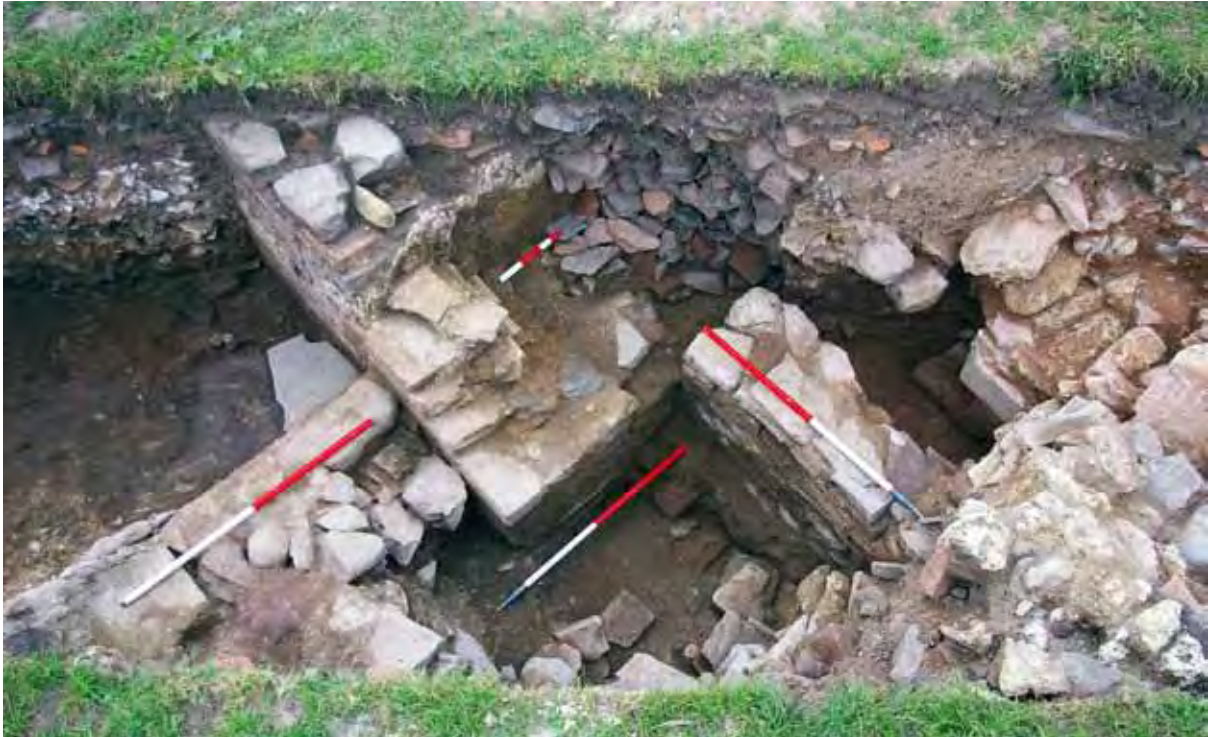
Fig. 49. Area 5.5 from east, showing walls (from left to right) [533], [505], [555/556], [557] and [560]. Note the possible filled doorway in [533] (below left-hand ranging rod)

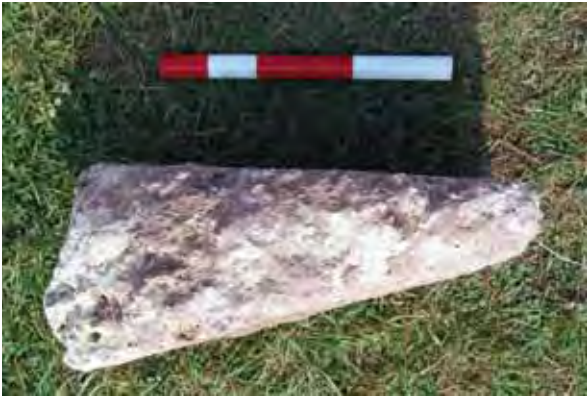
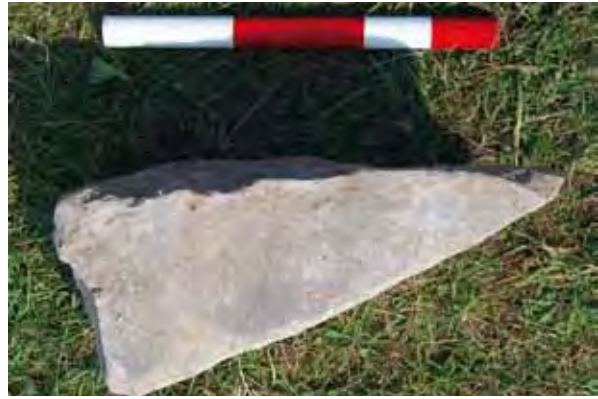
Fig. 52. Tufa and Old Red Sandstone voussoirs from Area 5.5

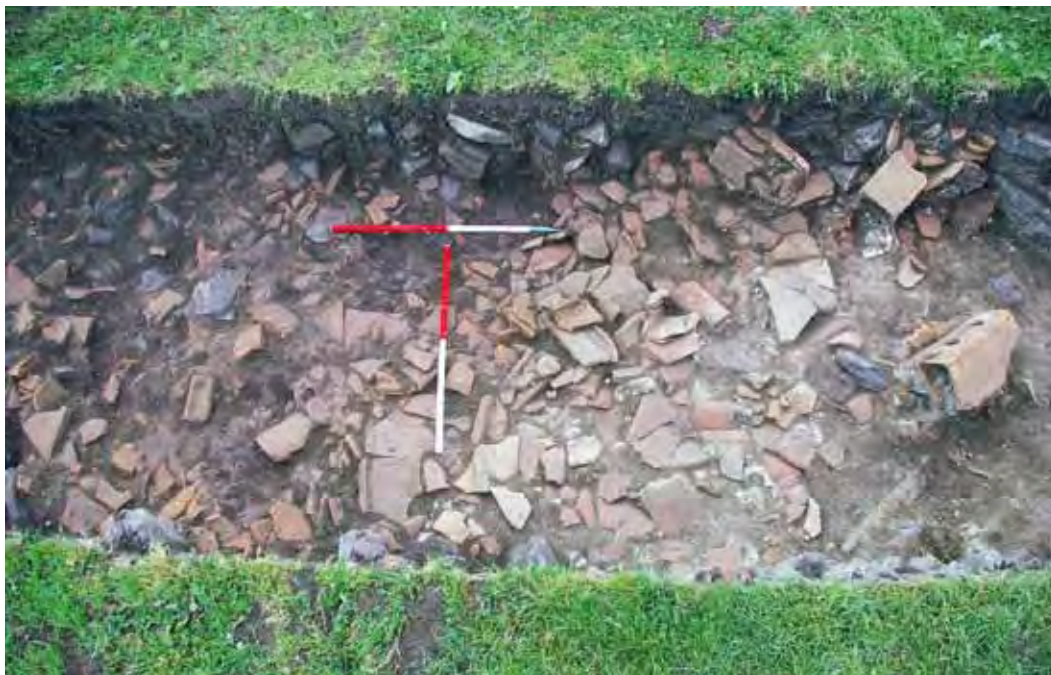
Fig. 56. Deposit of broken roof tiles and box flue tiles (507) in Areas 5.1 and 5.2

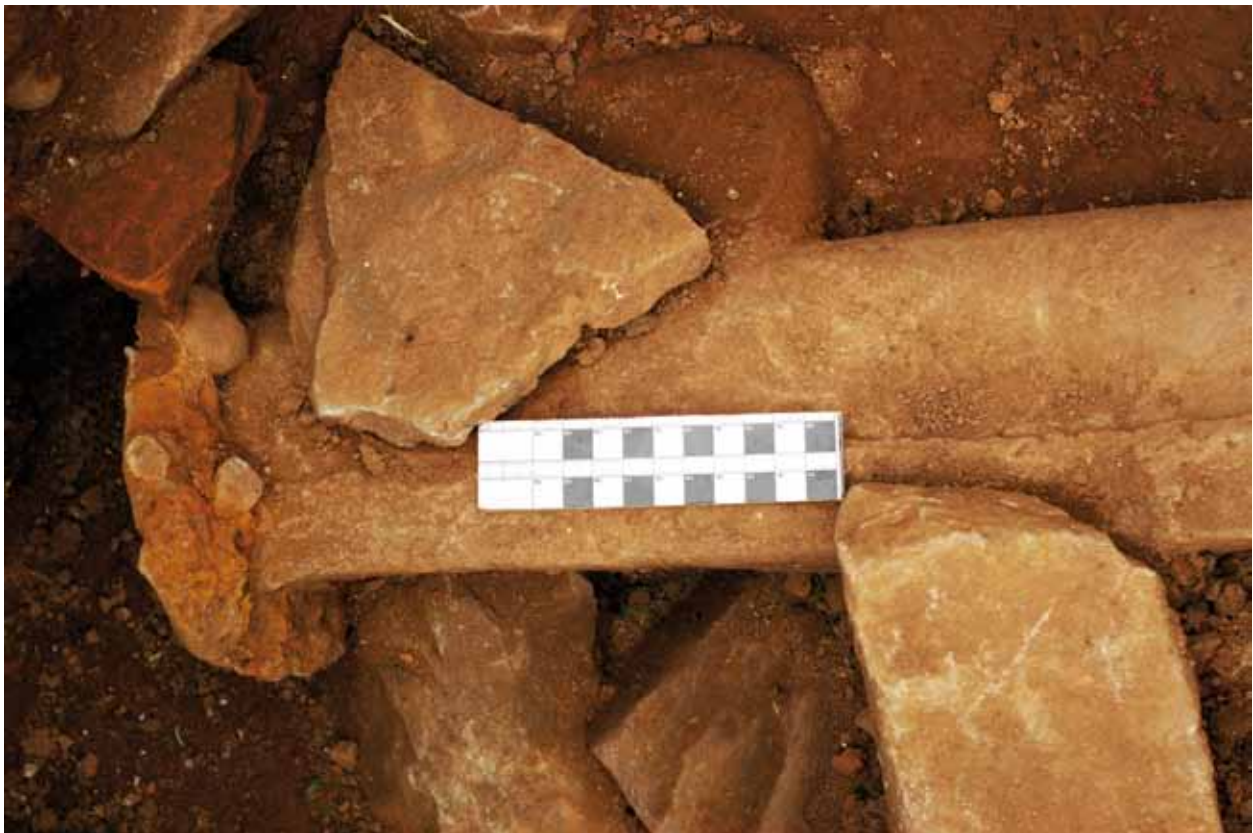
Fig. 61. Northwestern end of water-pipe (634) showing collar and iron nail heads

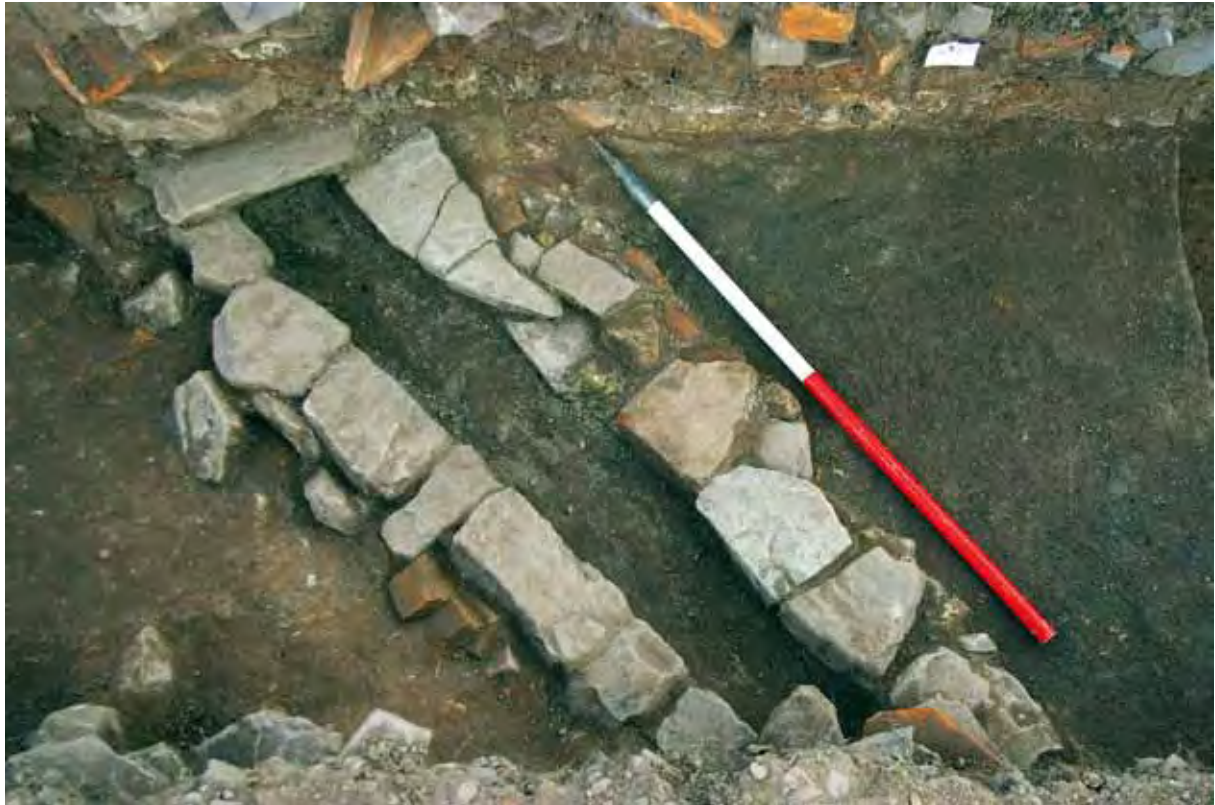
Fig. 64. Drain (629) in Area 6.2, from west

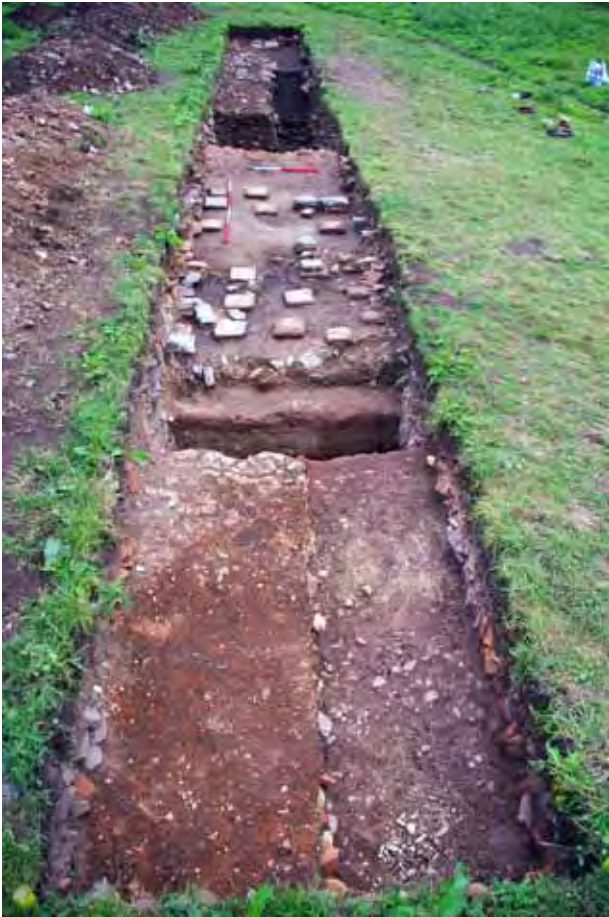
Fig. 66. Trench 7 fully excavated, from west

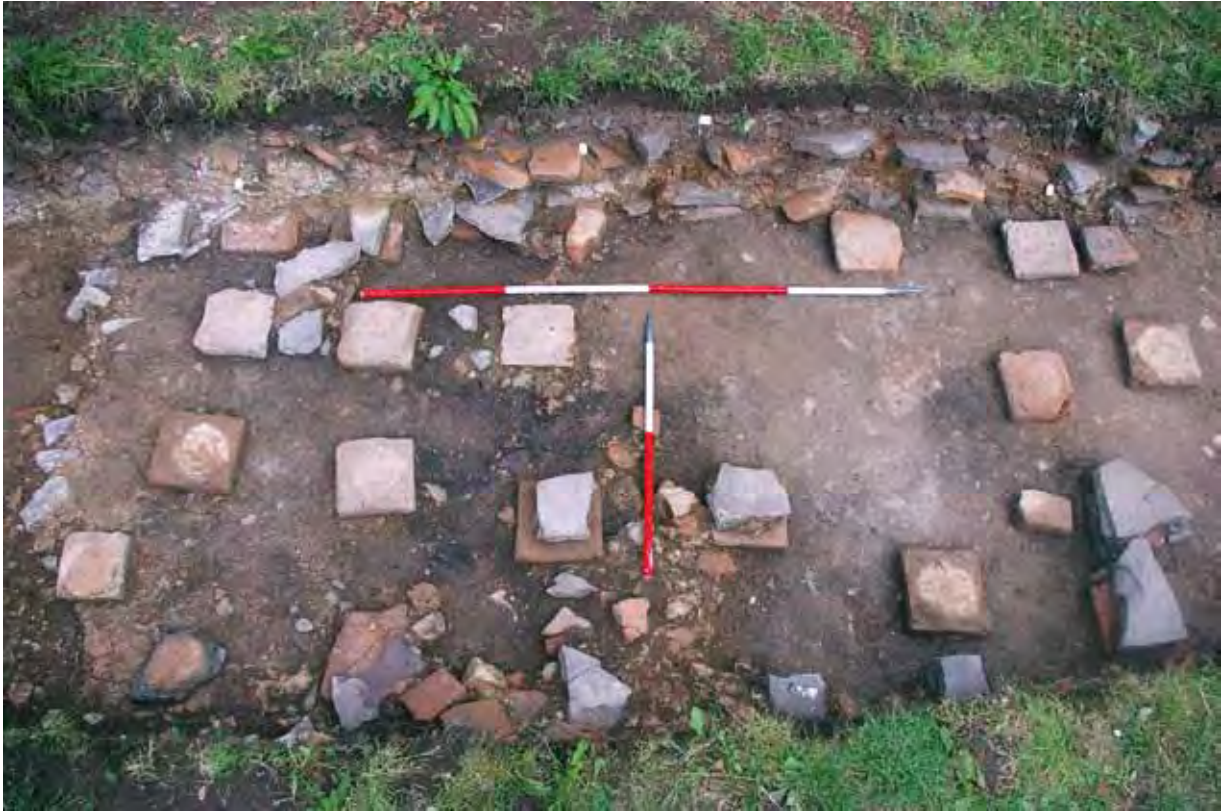
Fig. 68. Hypocaust in room 7.2 showing bases of pilae (718) on concrete bedding (714). Photograph taken from south

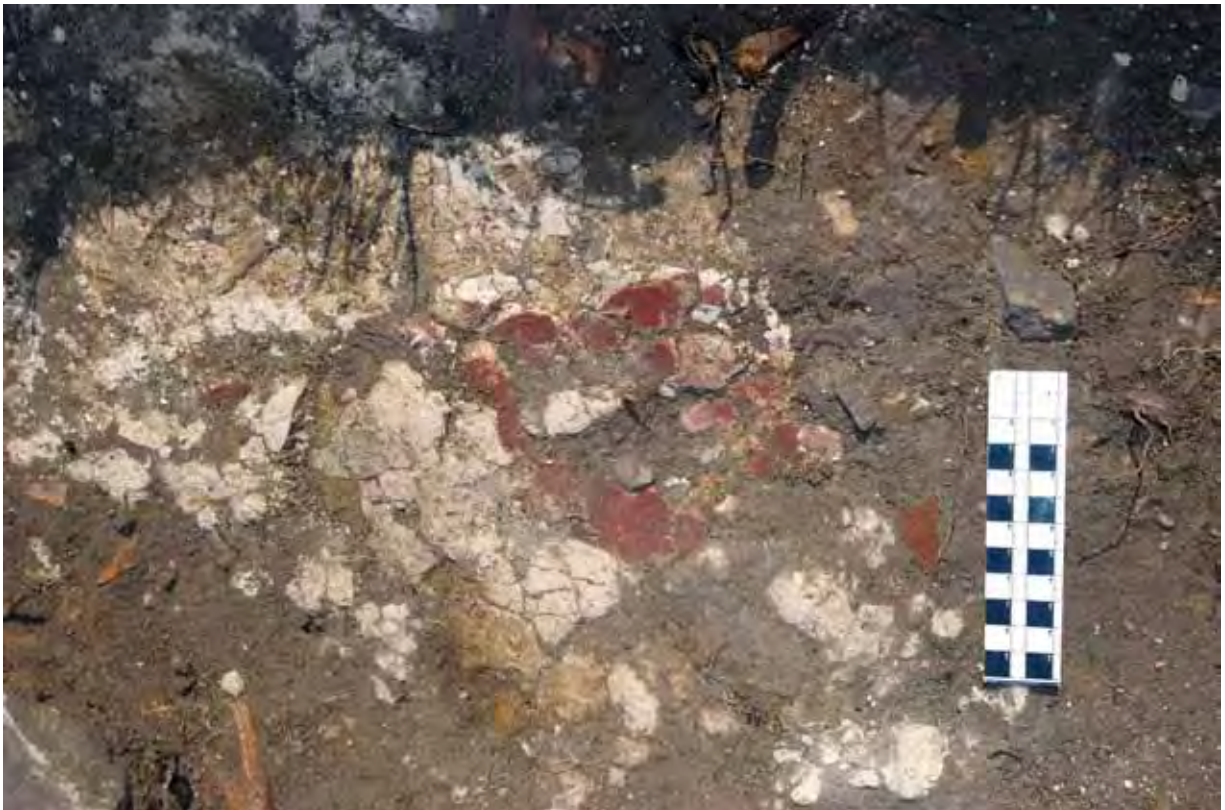
Fig. 69. Painted plaster overlying the hypocaust pilae in room 7.2

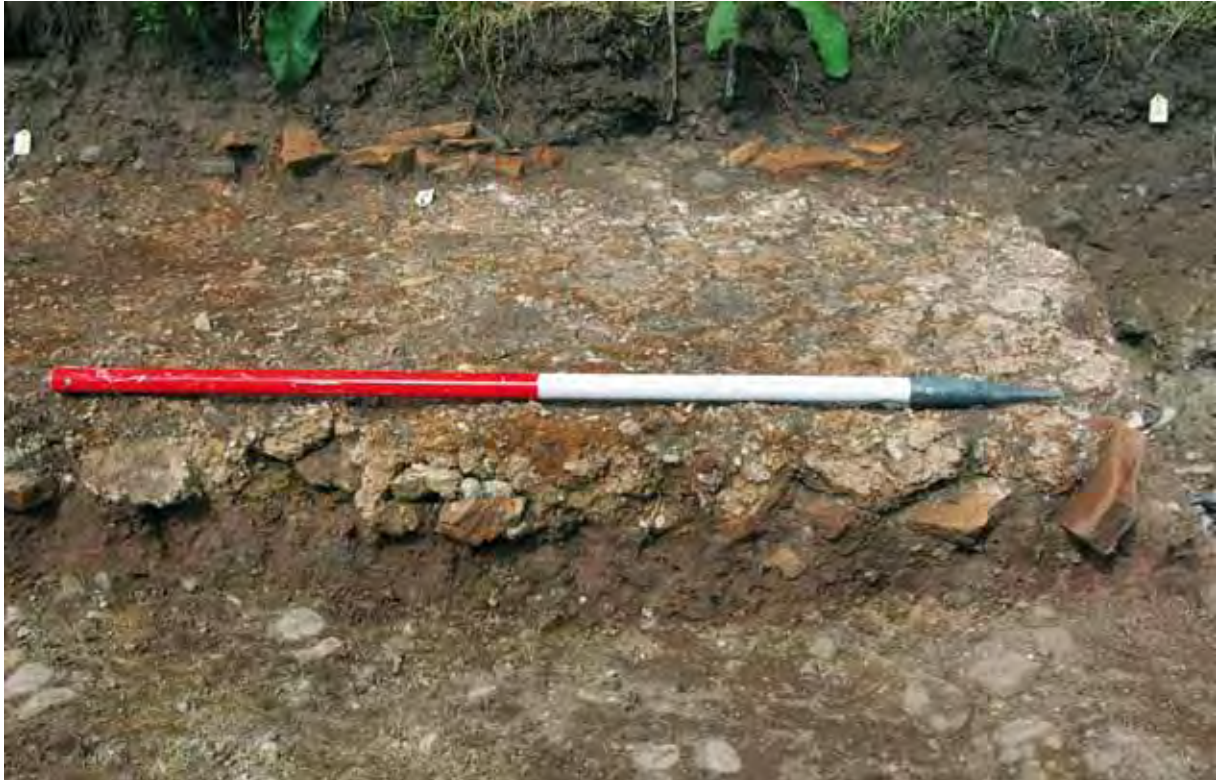
Fig. 70. Half-section through room 7.1 from east, showing levelling deposit (730), stone and brick bedding layer (729), followed by an *opus signinum* surface (709)

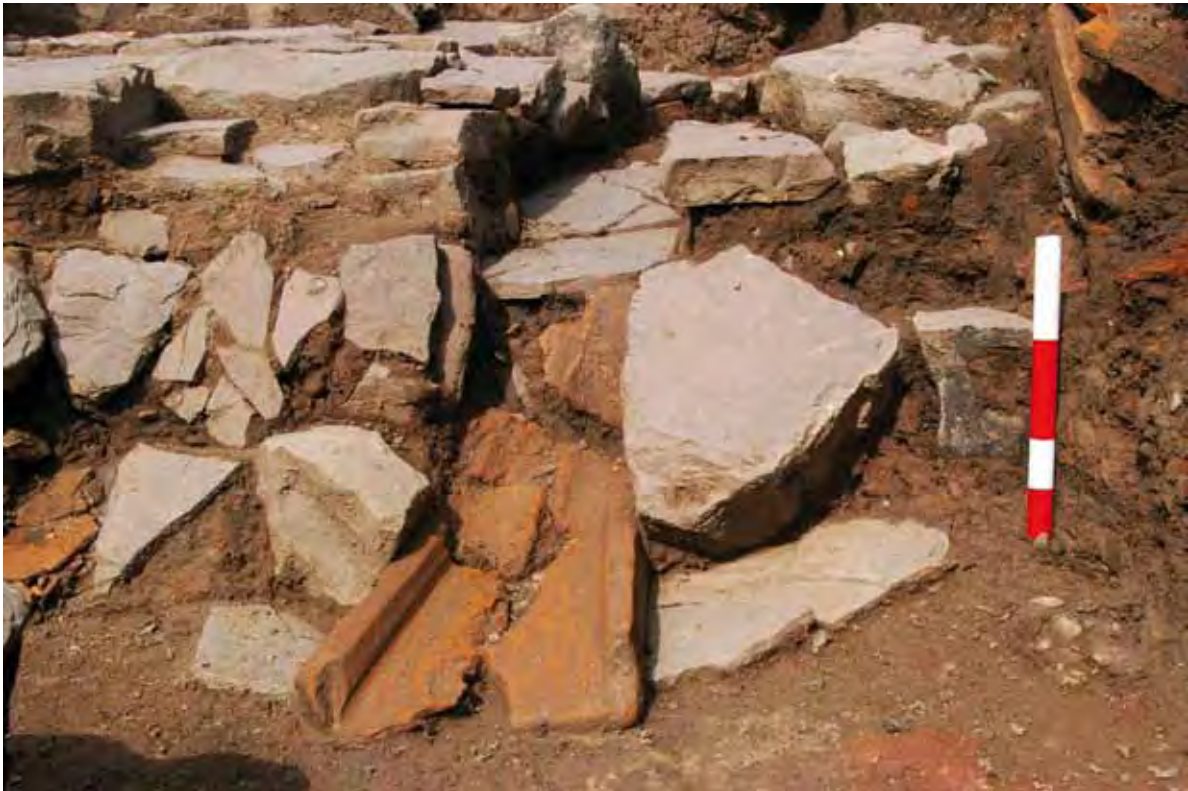
Fig. 75. Outlet of drain (825), consisting of broken tegula. Taken from the south

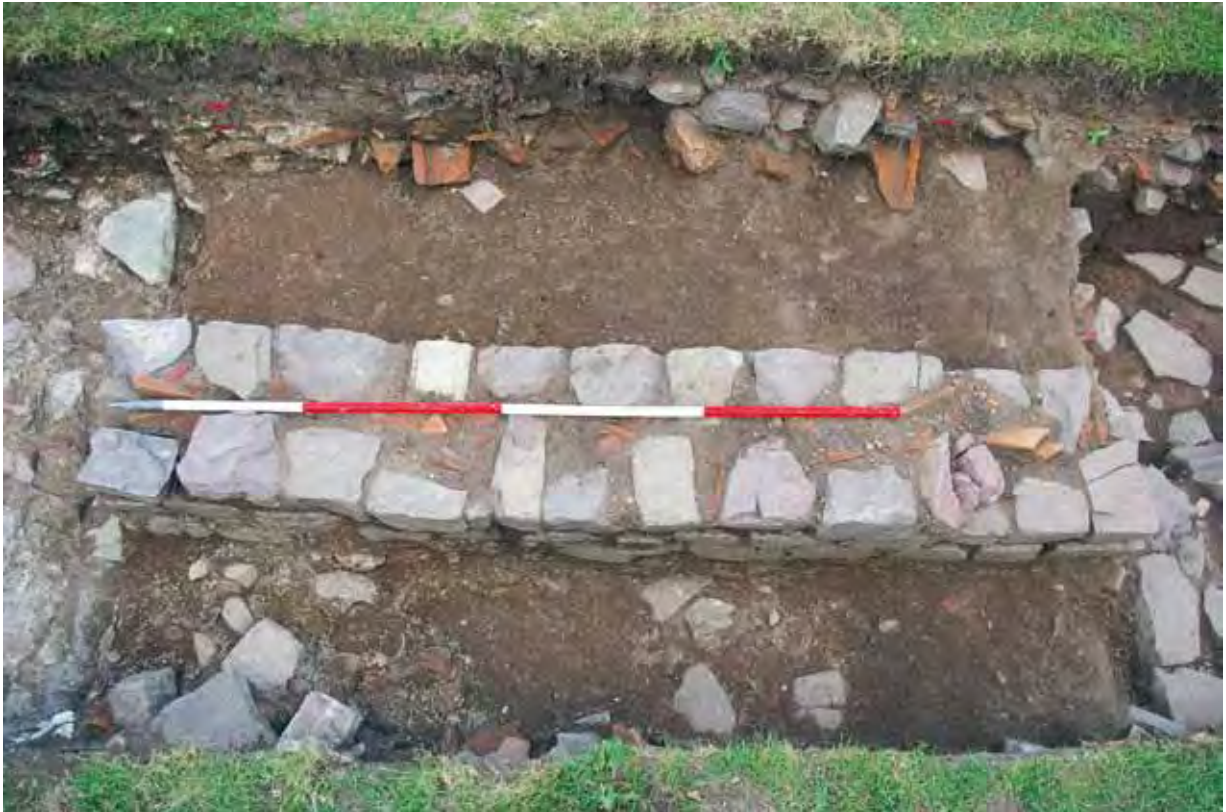
fig. 76. Wall [805] separating rooms 8.2i (top) from 8.2ii (bottom). Taken from the east

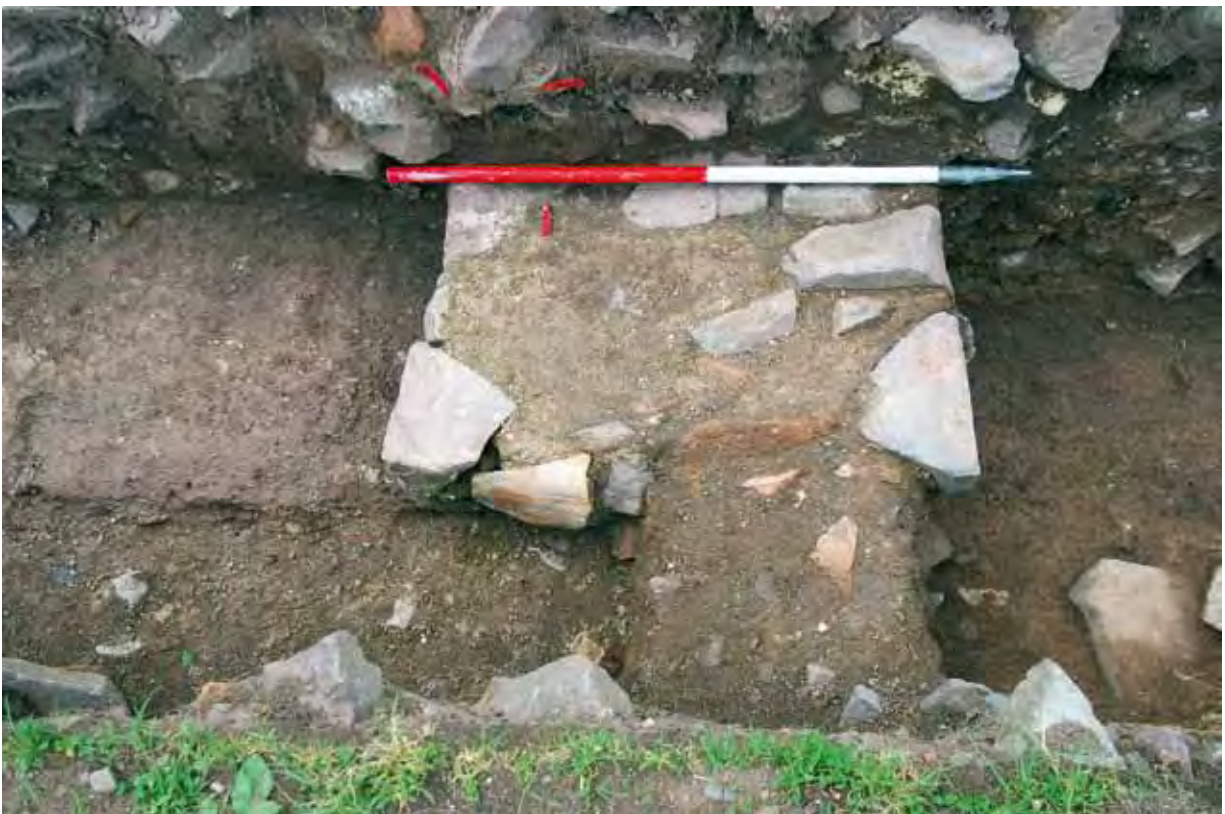
Fig. 77. Section of wall [838] from the east. The wall separated rooms 8.3i (left) from 8.3ii (right), and probably butted against a north-south wall that has been robbed (edge of robber trench [353] cuts the clay surface in 8.3i)

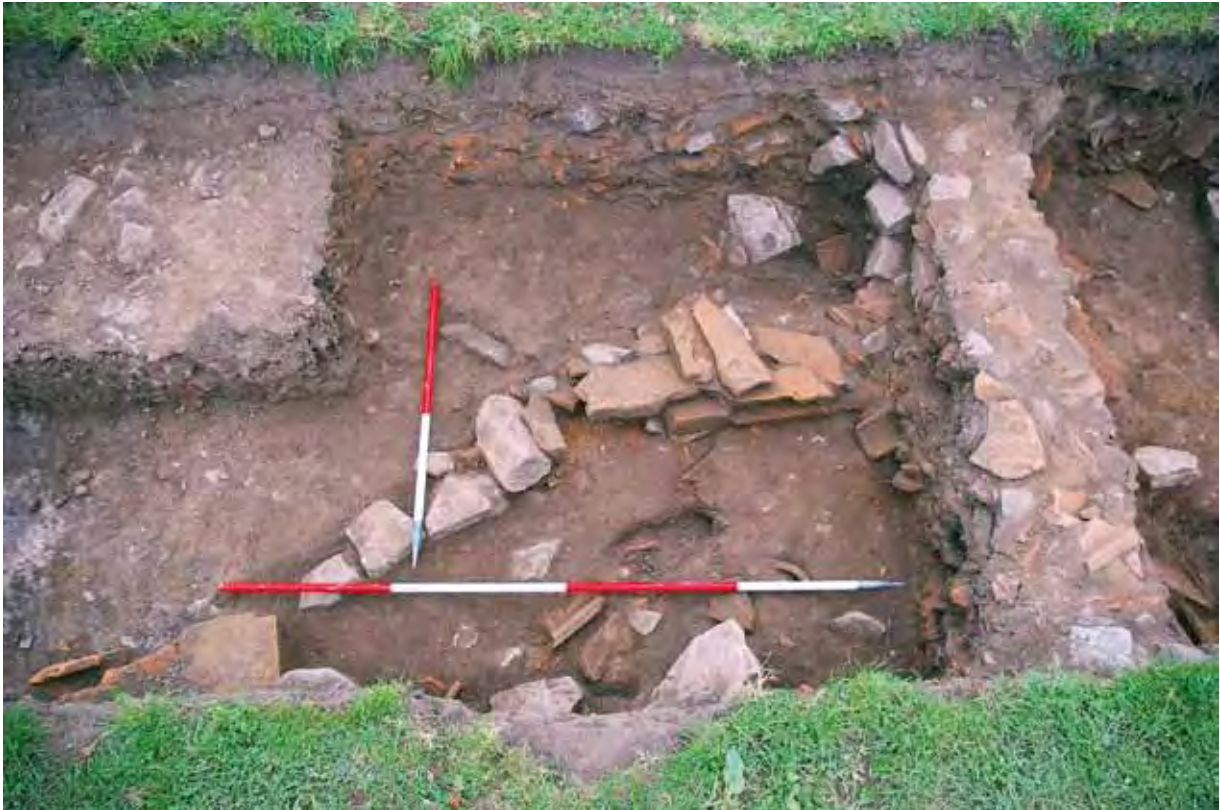
Fig. 78. Arrangement of stones and CBM in Area 8.1

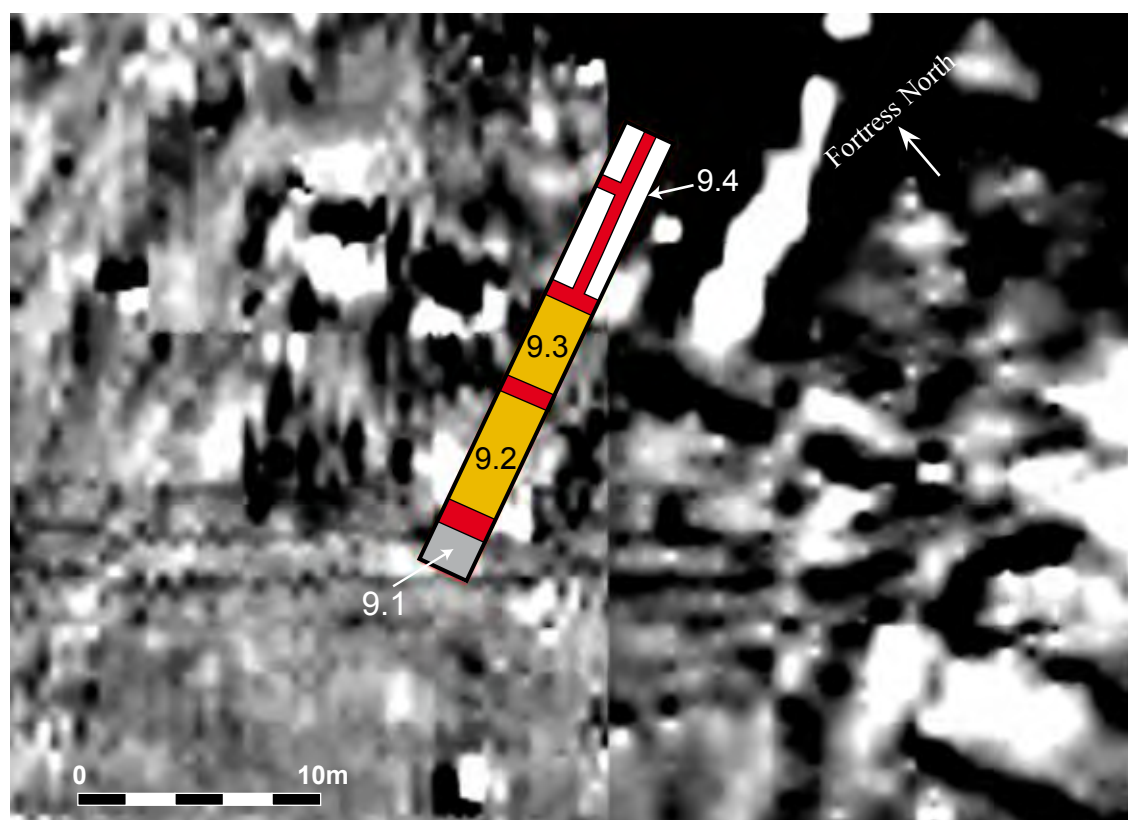
Fig. 79. Trench 9 showing walls and surfaced areas superimposed over gradiometer results. Numbers refer to 'Areas' as described in the trench discussion

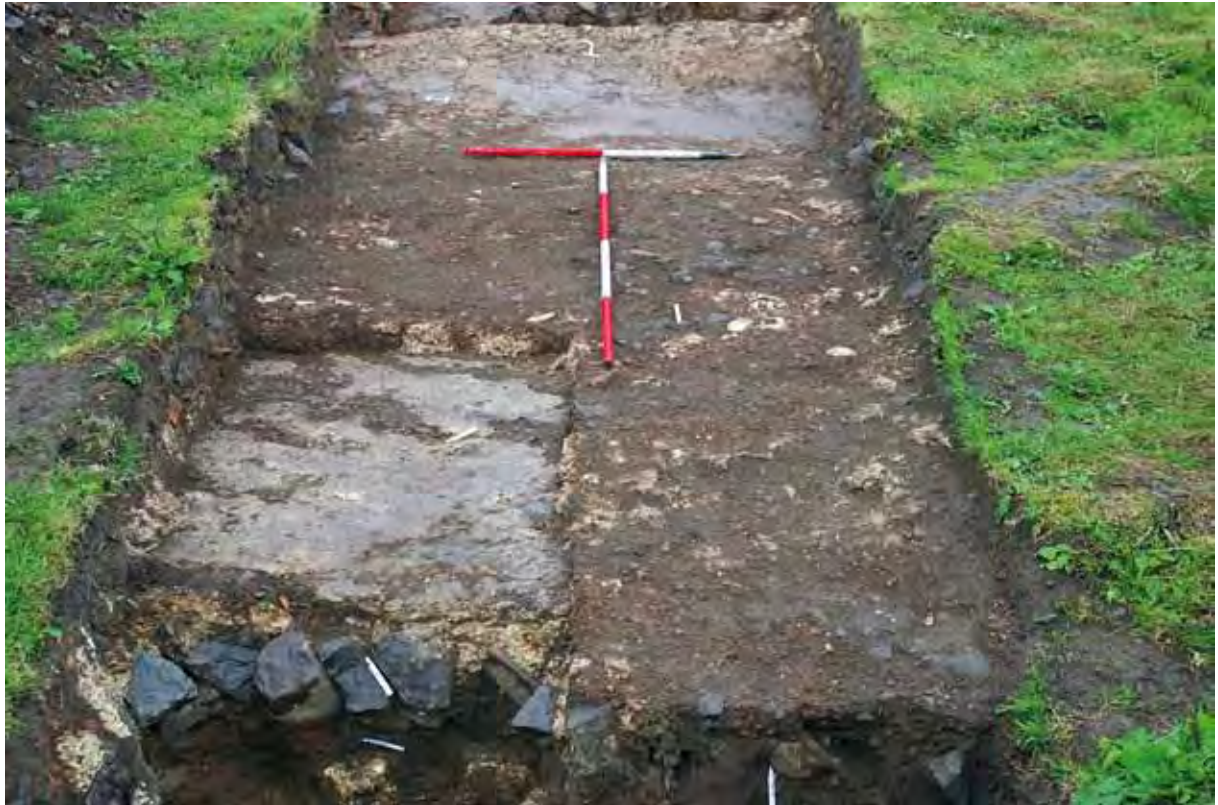
Fig. 82. Room 9.2 from south, showing earliest *opus signinum* floor (941) beneath second *opus signinum* floor (907/914)

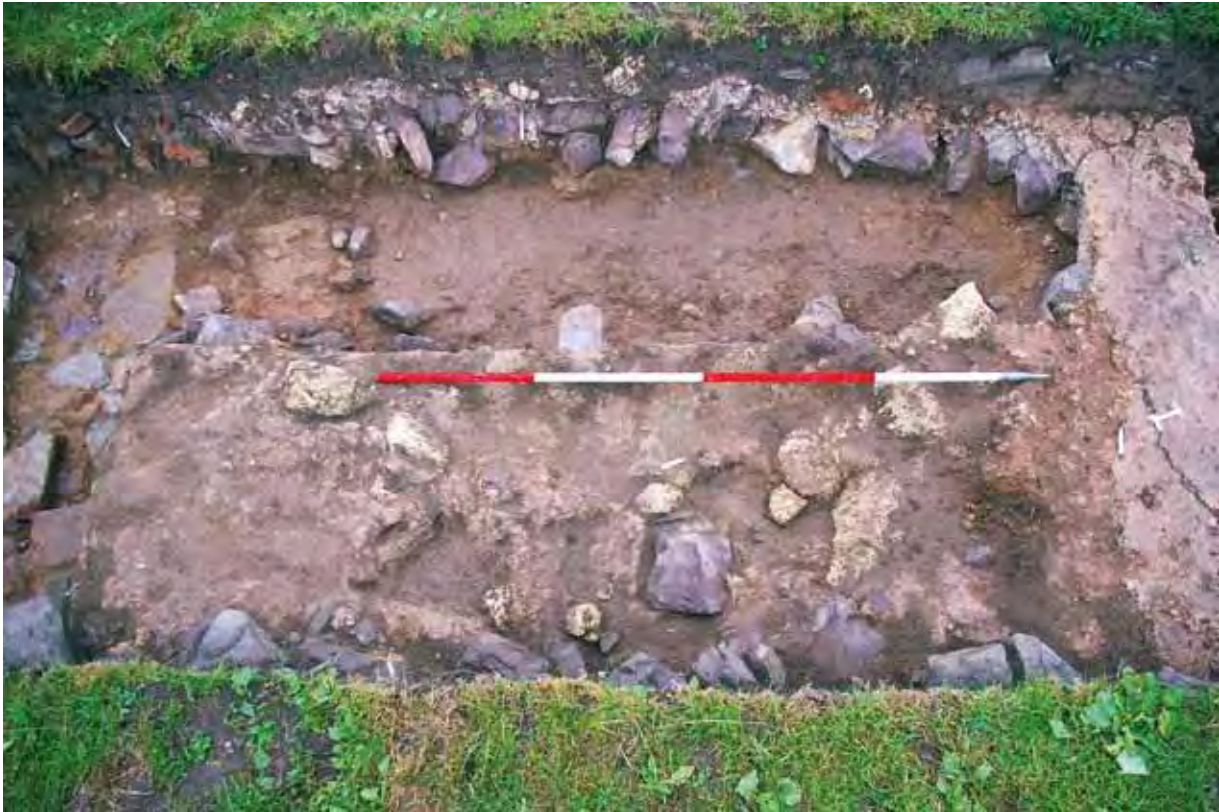
Fig. 83. Room 9.3 from east, showing half-sectioned pit [924], and opus signinum floor (910) on right

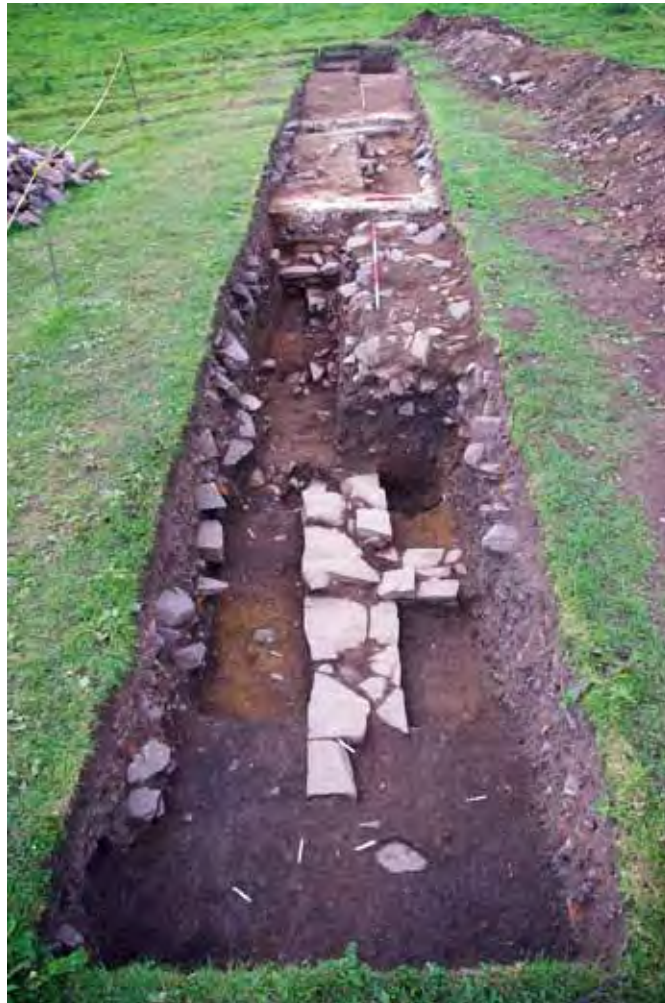
Fig. 84. Area 9.4 from north, showing walls [932] and [958]

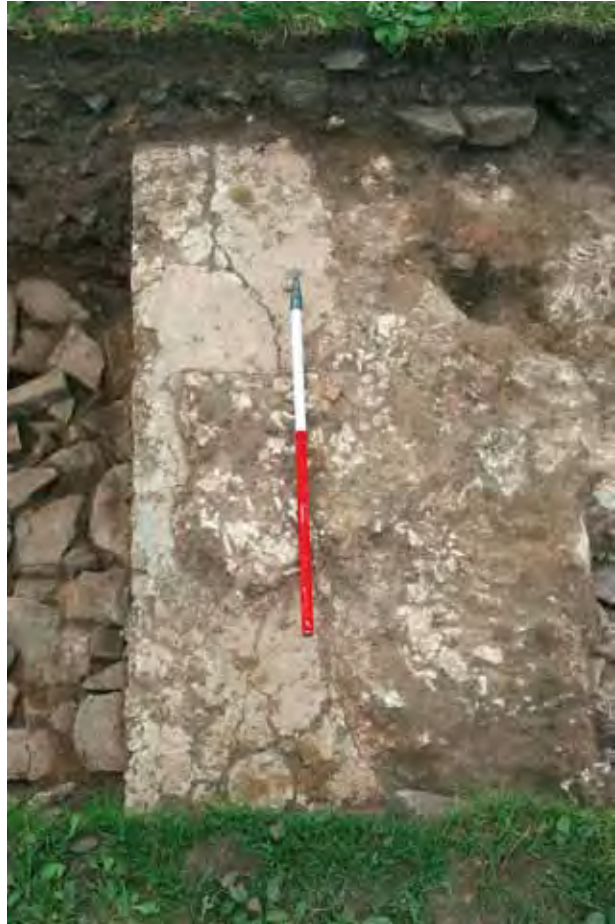
Fig. 85. Area 9.3 from west, showing collapsed wall plaster (909) above the opus signinum floor (910). The foundations of wall [917] are visible on the left of the photo

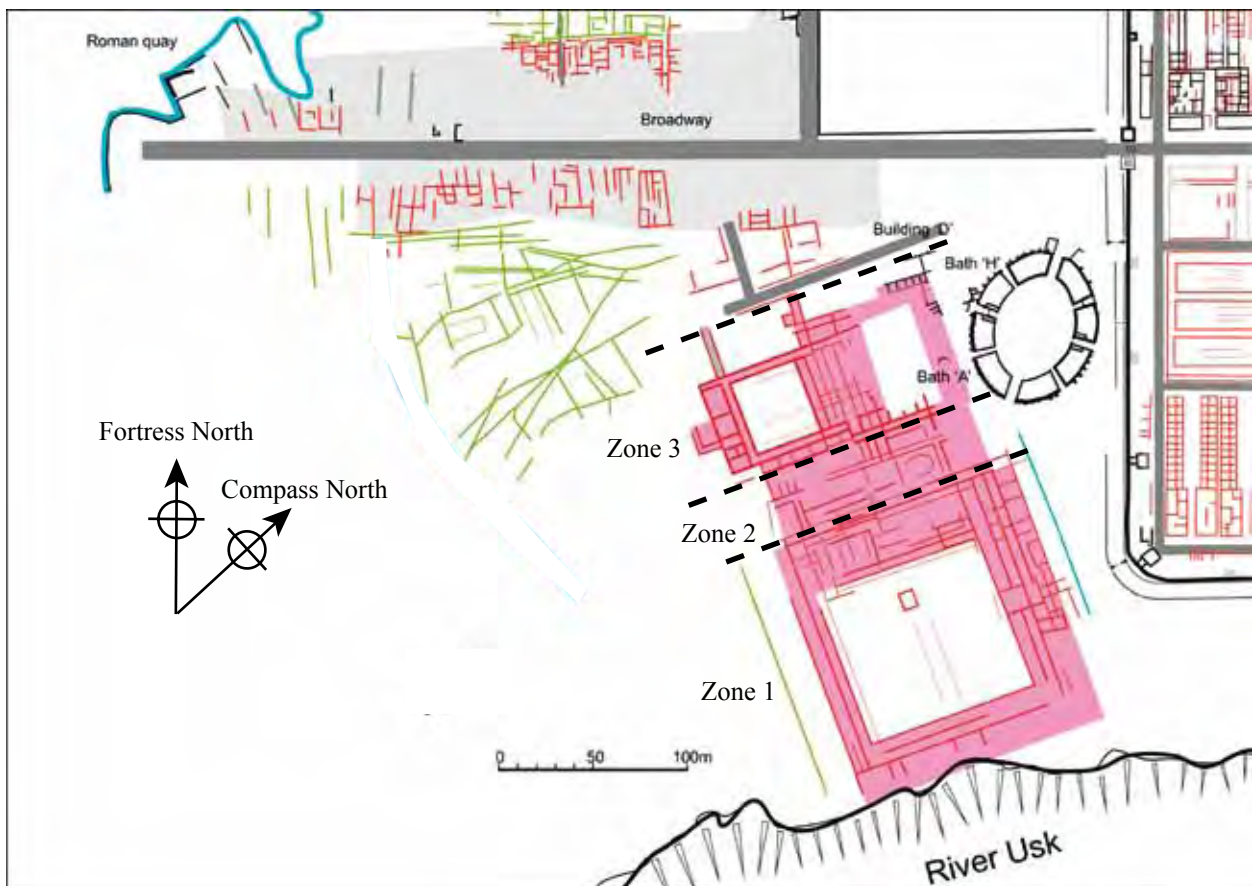
Fig. 94 Interpretation of the geophysical results showing the Southern Canabae complex and the 3 'zones' of buildings that comprise it.

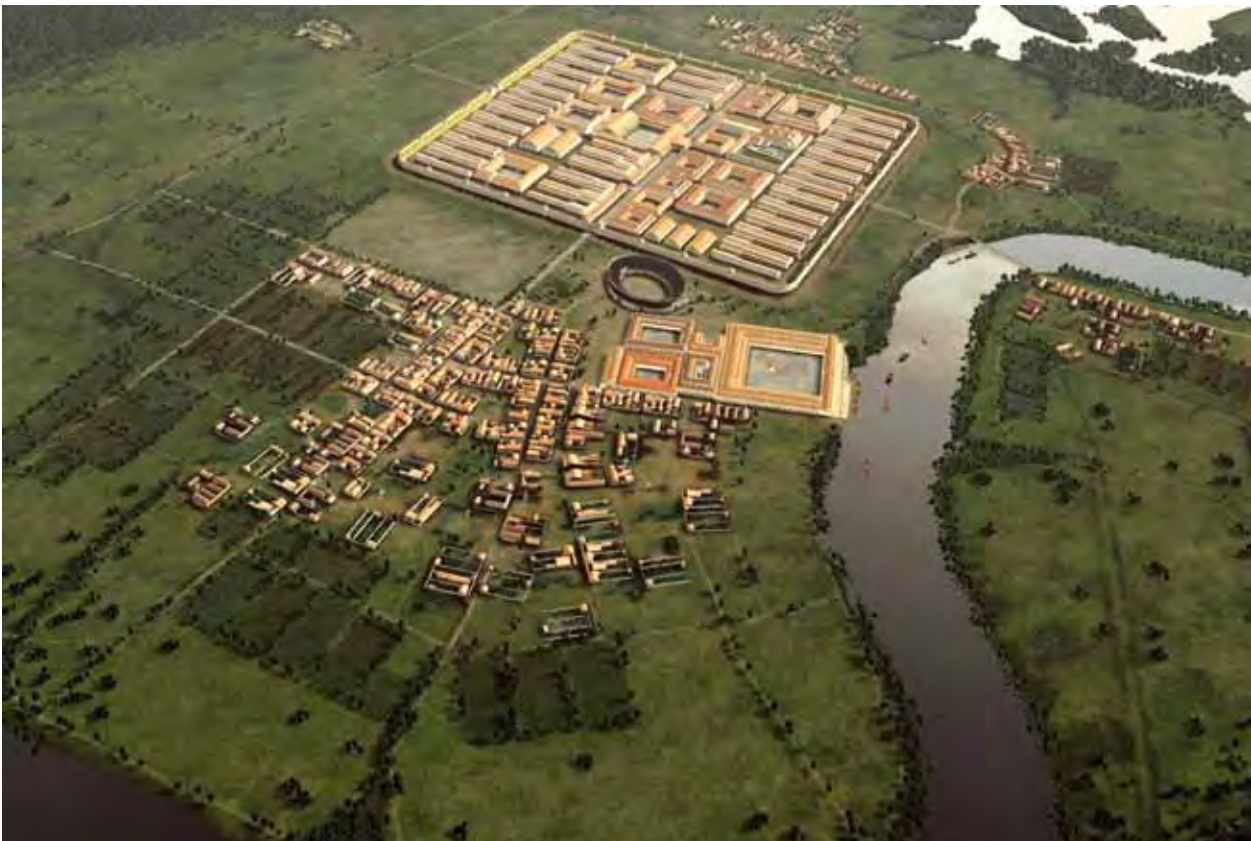
Fig. 97. Reconstruction of Isca and the Southern canabae (©7reasons)
