DEVELOPMENTAL HALT Report R-00000350

Product Tested: UX4 and UX6 PowerPac Power Supplies
XgA, XgB, XgC, XgD and XgL powerMods

Service Proposal #: S00000350

Test Site: Anecto Ltd.
Accelerated Reliability Test Centre
Mervue Business Park
Mervue
Galway
Ireland

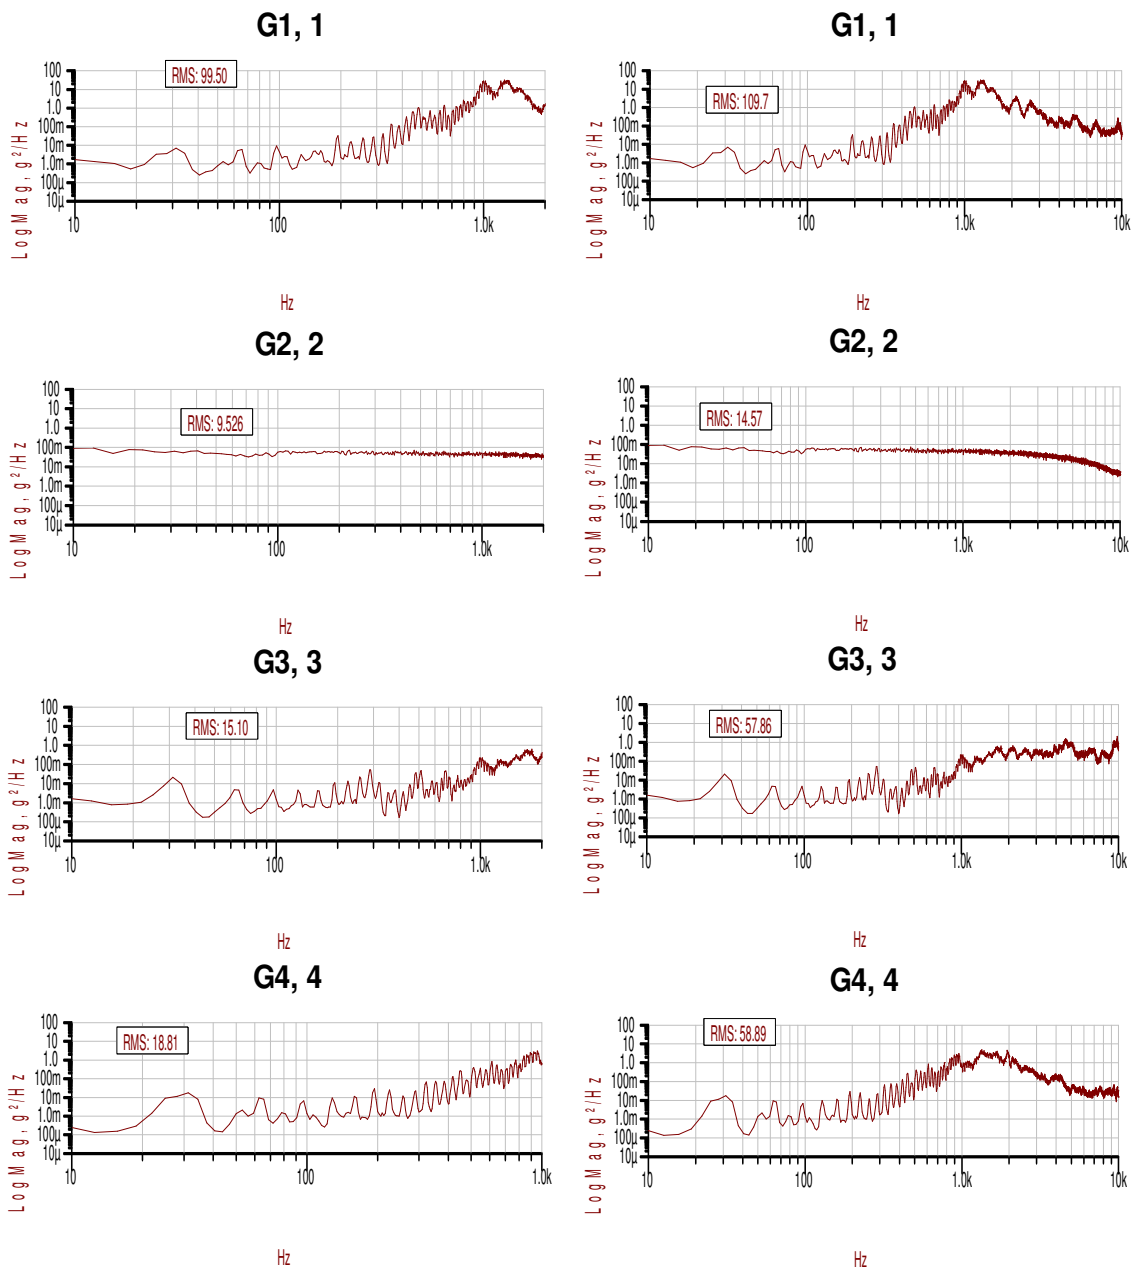
Figure 2 60G Vibration Profiles

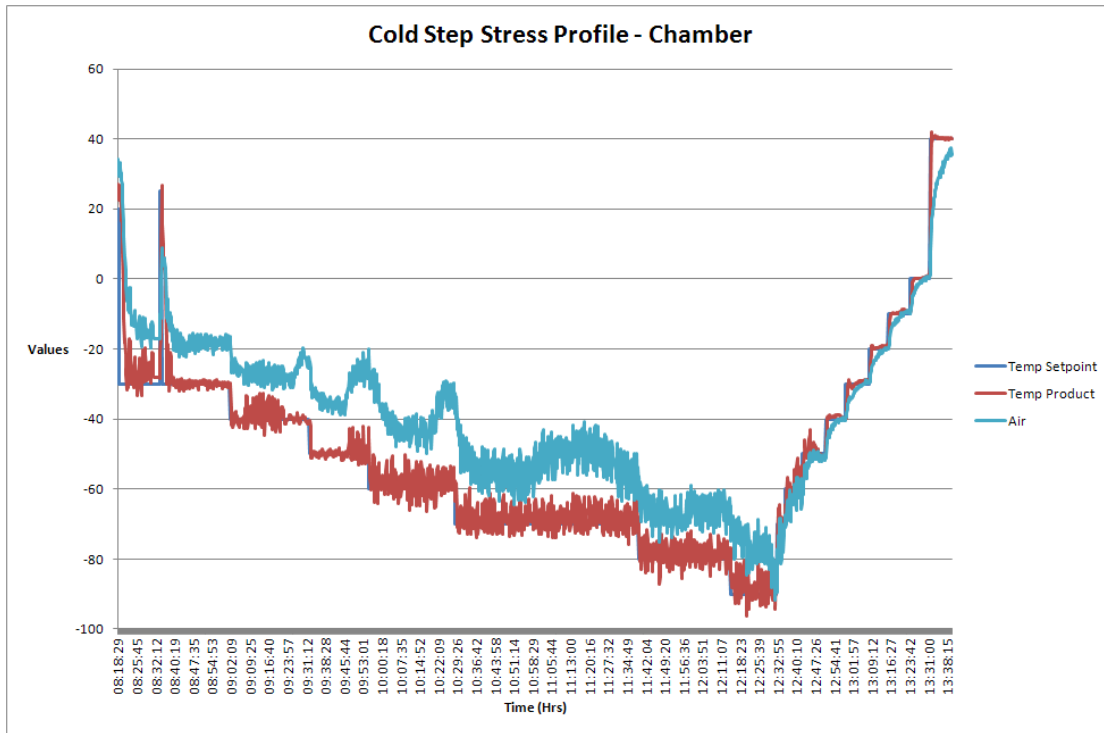
Figure 3 Cold Step Stress Profile from Chamber

The test units were subjected to cold thermal step stress beginning at +20°C. The chamber was then ramped to -20°C and the temperature was decreased in 10°C increments. Once the thermocouples located on the units stabilized, the unit remained at that setpoint for a minimum of 15 minutes. A function test was performed at the end of each dwell. Once cold thermal step stress was completed, the unit was returned to +20°C and remained there until the thermocouples located on the unit stabilized.

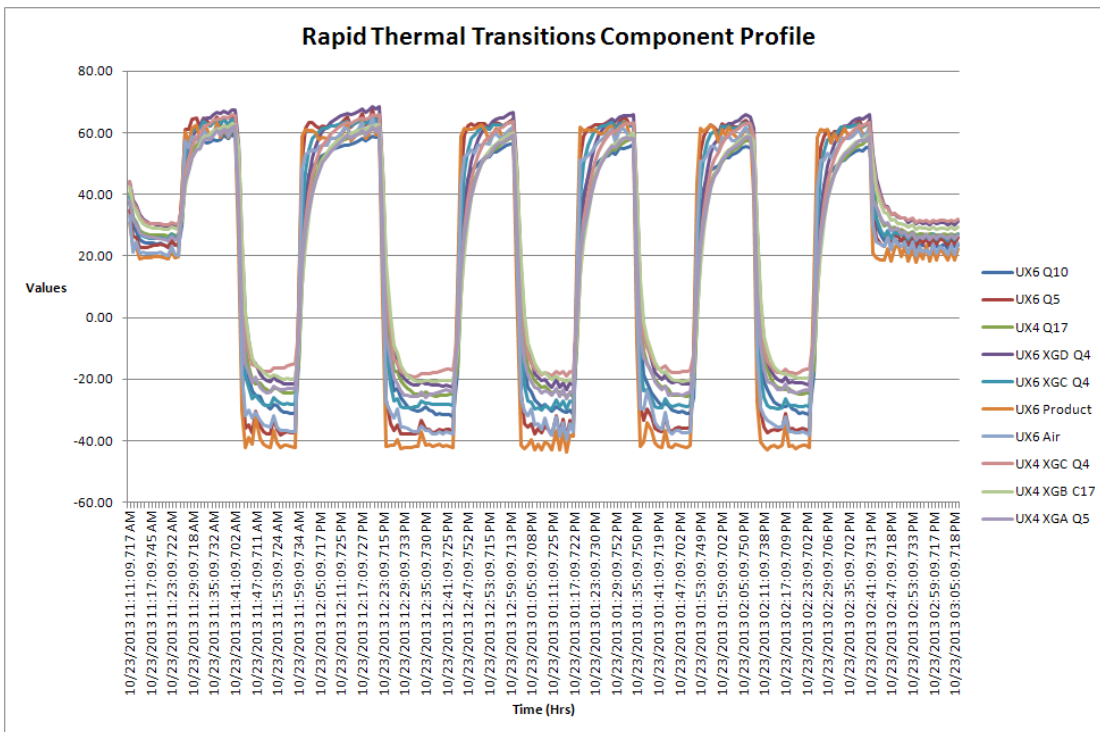
Figure 8: Rapid Temperature Transitions Component Profile

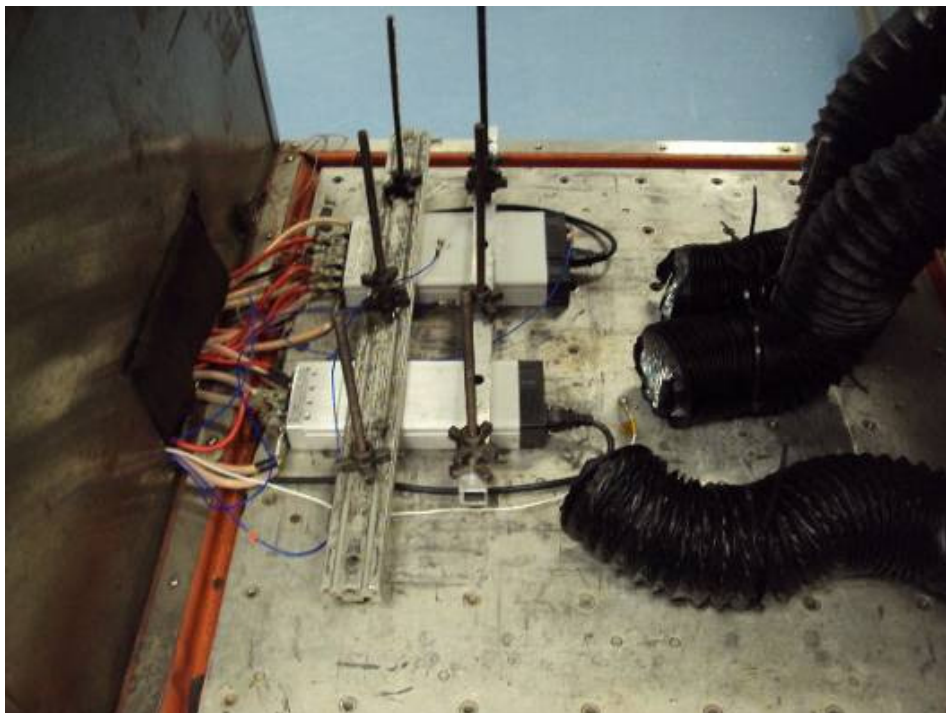
Figure 12: Vibration Setup

The units were placed in the environmental chamber and secured to the vibration plate using threaded bars vertical bars and horizontal bars secured with bolts.

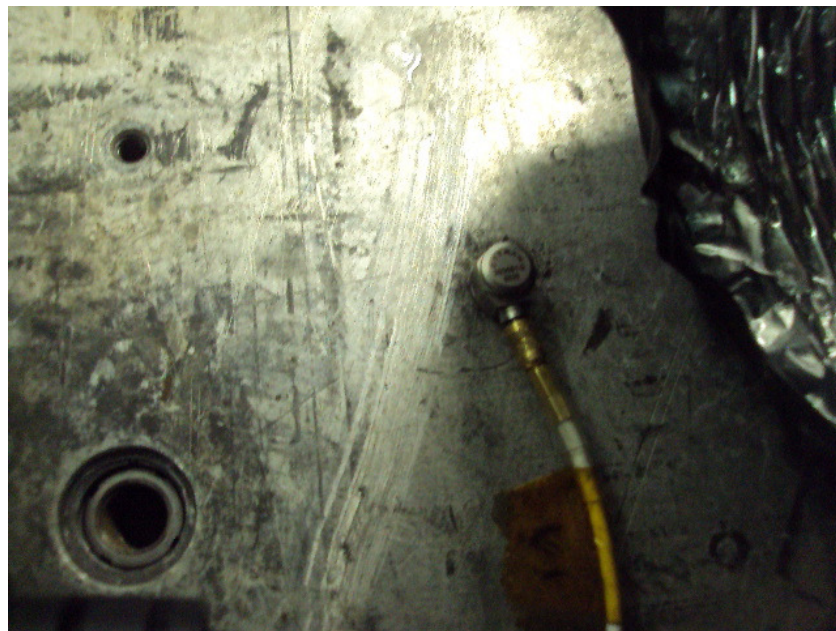
Figure 19: CH 2 Vibration Plate (Z)

Channel	Location	Axis
1	Centre top of chassis UX6	Z
2	Qualmark Vibration Plate	Z
3	Side of chassis UX6	X
4	Front of Fan UX6	Y
