# Aspen Art Museum Roof Structure

Gregory R. Kingsley  
KL&A Inc., Structural Engineers and Builders  
USA-Golden, Colorado

## 1. Introduction

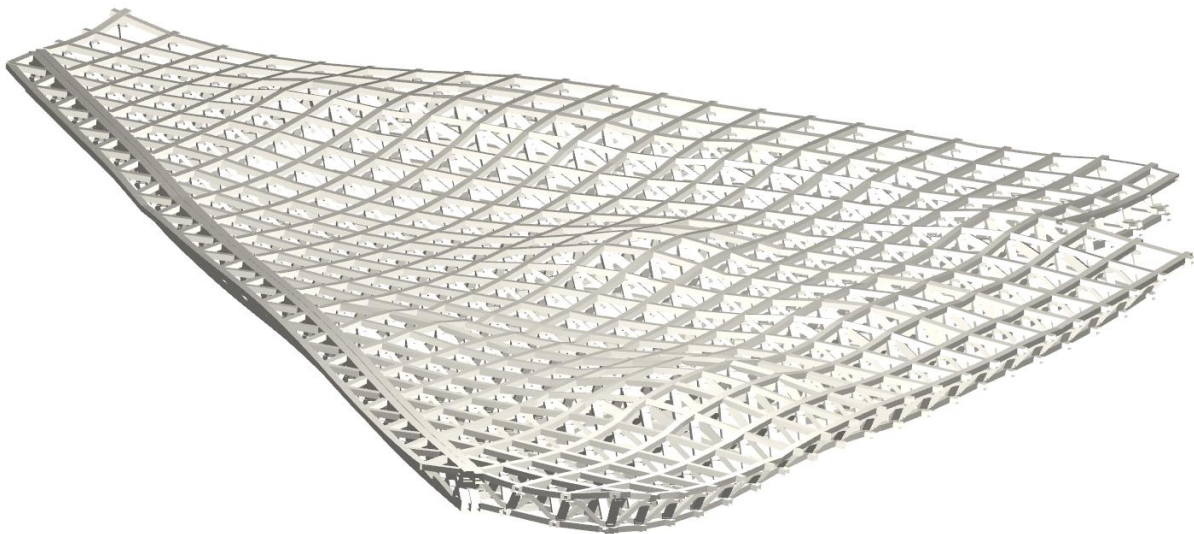
Figure 11: Exaggerated deflected shape of the structural model

Once the construction sequence and connection typology was established, final structural analysis could be completed. Ultimately, typical member sizes were chosen to control deflections under design dead and snow loads (Figure 11), while increased member sizes and steel reinforcements were used to address local regions of high stress. A continuous edge beam, consisting of two Douglas fir glulams, was introduced along the diagonal edge, to control deflections there. At the architect's request, this beam was penetrated with a series of holes to lighten its appearance (Figure 17).

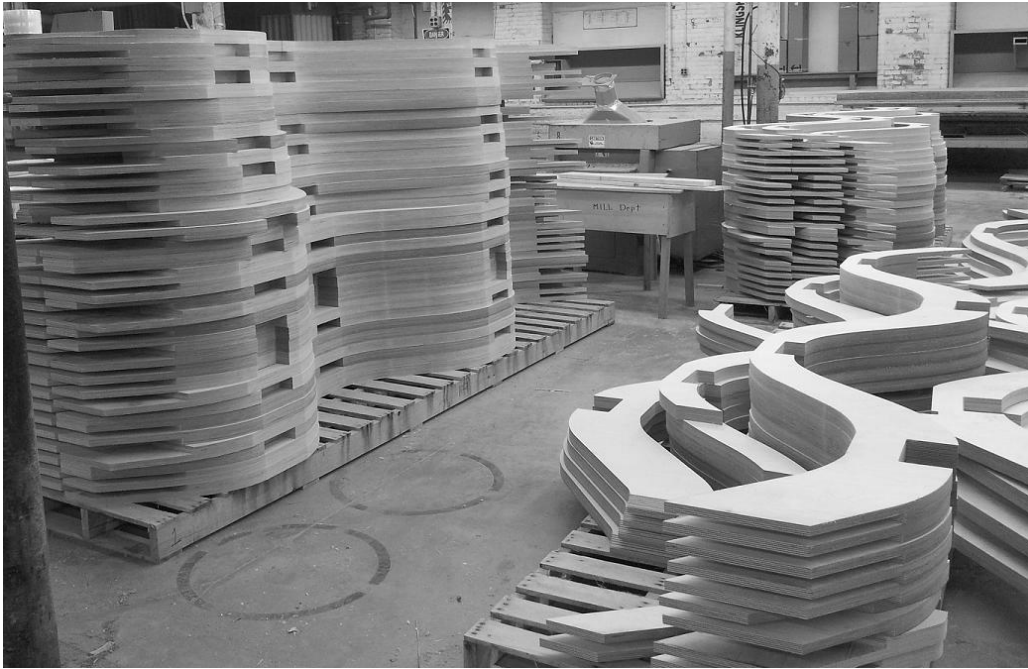
Figure 12: Web laminations after cutting

A single digital model created by Spearhead with direct input from SJB was used to control five different CNC fabrication machines in four facilities. The birch plywood and Kerto chords were manufactured in Finland and shipped to the US. The plywood panels made a stop in New Hampshire where CW Keller made the first cuts for the curved web members (figure 12). All material was shipped to Nelson BC where the four plies of the web members were laminated by hand and cured in a custom-made press (Figure 13). Samples from every gluing operation were prepared and tested for shear strength and cyclic delamination in accordance with AITC standards. All wood was protected with Nano-Perl 119, an ultra thin water repellent coating before being shipped to the site.

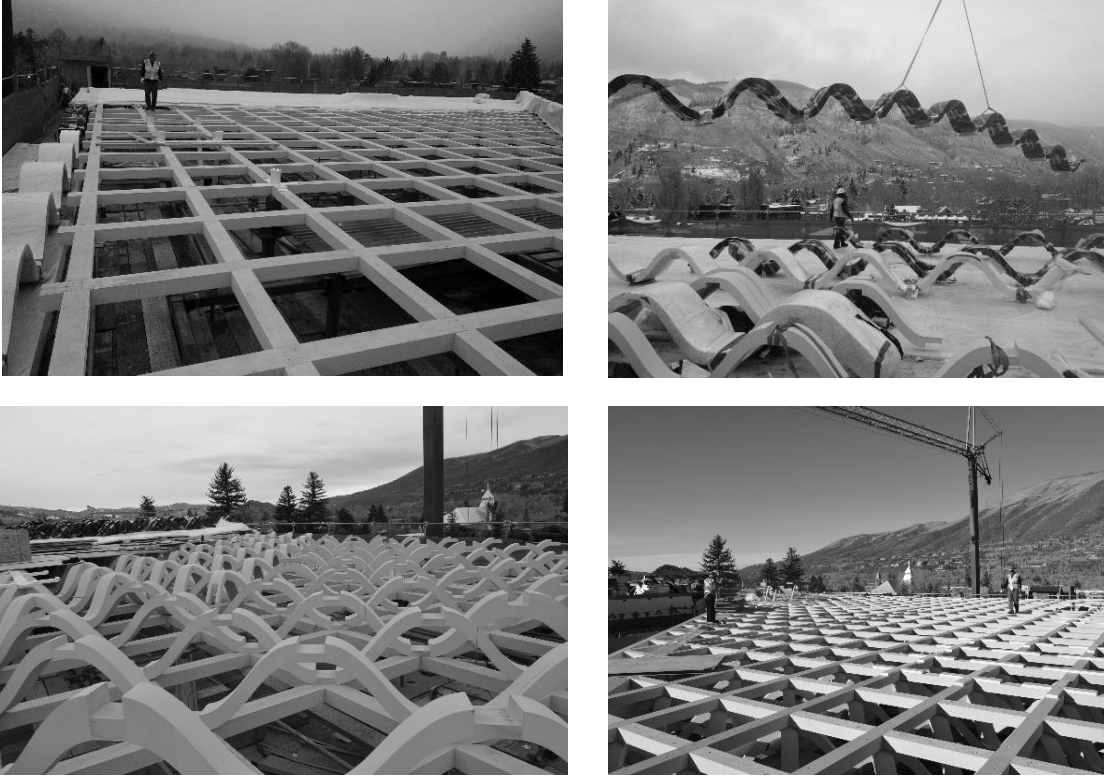
Figure 14: Construction of the truss, showing the bottom chord layer, the web layer, and the top chord layer at each phase of construction.

The truss was constructed from October to December 2013. Great care was taken to minimize exposure of the wood to snow and water (Figures 14 and 15).

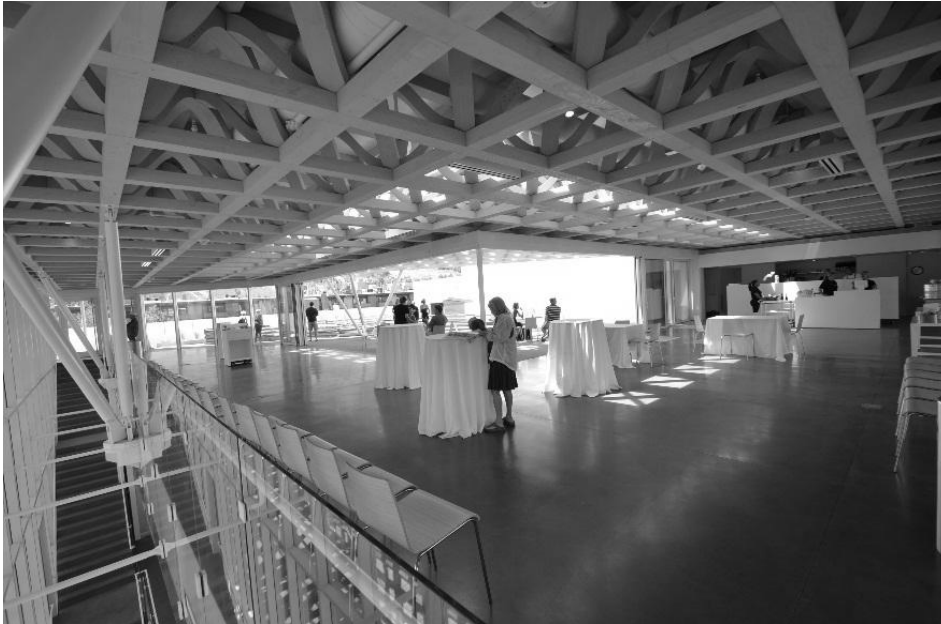
Figure 16: View of the finished truss on opening day - interior

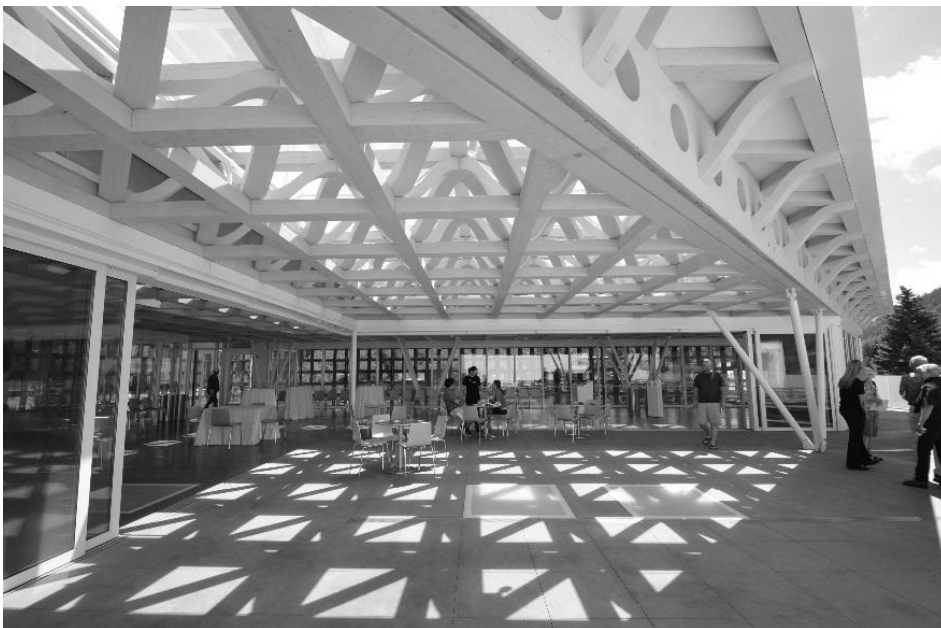
Figure 17: View of the finished truss on opening day - exterior
