TO: ALL U.S. & CANADIAN VOLVO RETAILERS
RE: SERVICE CAMPAIGN 253

**Service Campaign 253: Thermal Expansion Valve (TXV)
Model Year 2012 S60, S80, XC60, XC70**

Service Campaign 253: Thermal Expansion Valve

REF NO:
TJ 26630

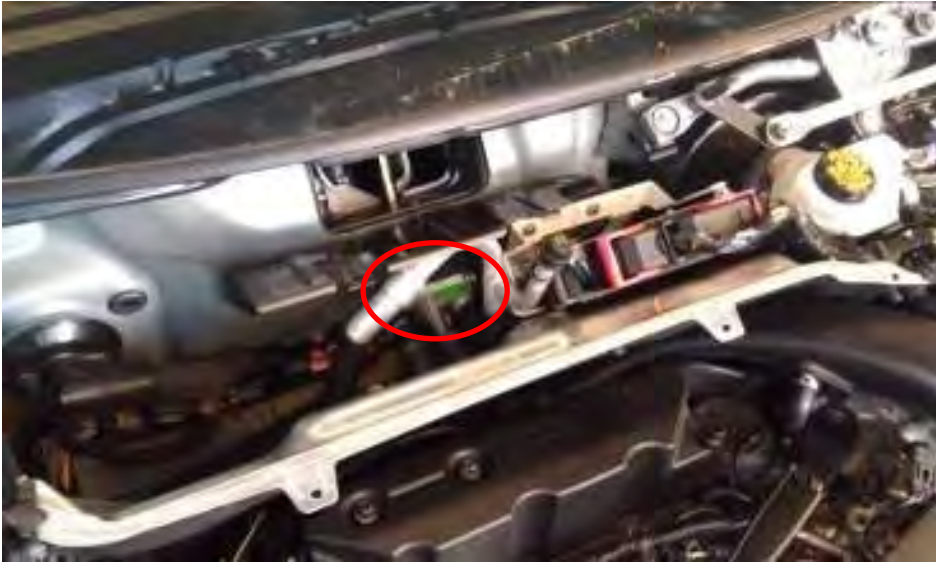
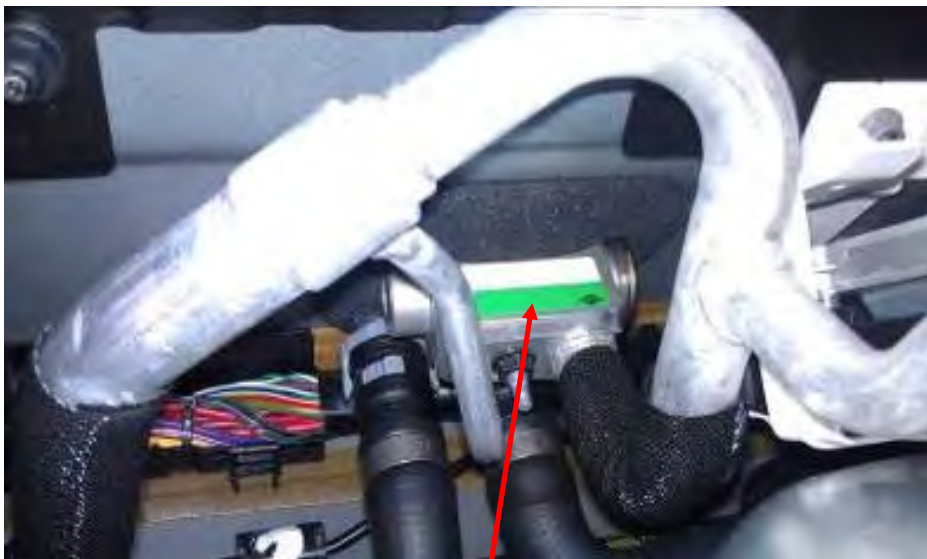
1. A white-green label indicates that adjustments are necessary unless there is a dot on the label as shown in the following picture.

Note: Pictures show valve out of the vehicle just for clarity. It is not necessary to discharge the system or remove the valve to perform this.

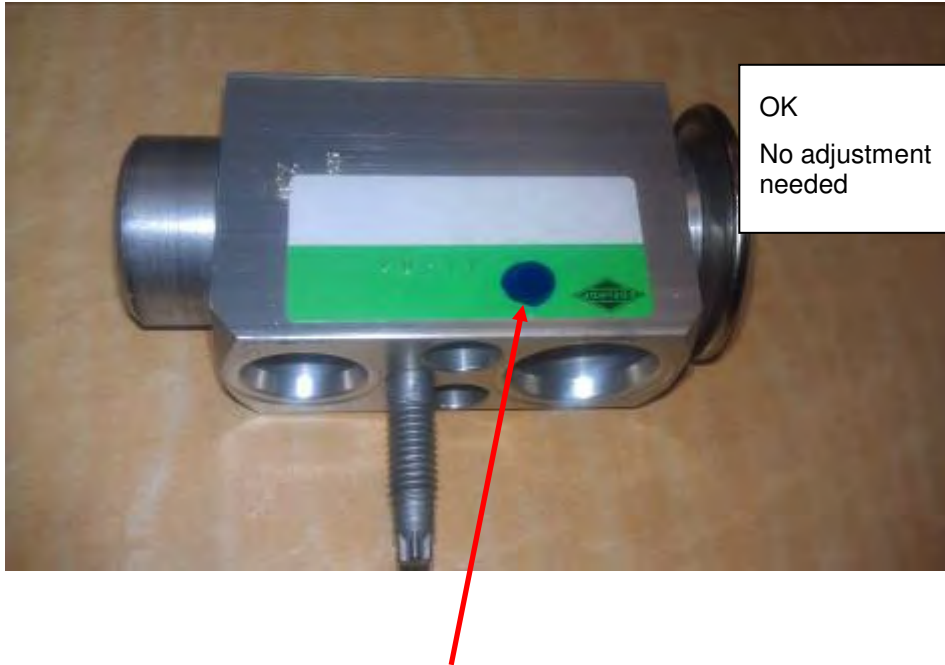
2. If there is a marking on the label, do not perform adjustment.

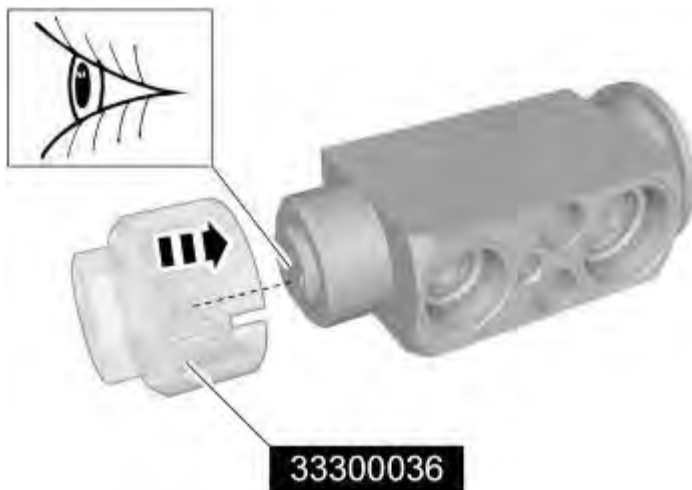
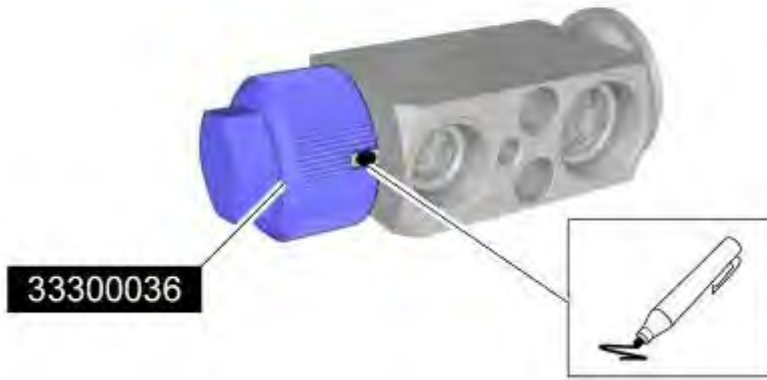
Special Tool P/N 33300036

Use marker pen and place a dot within the tool opening.

Take note of the 2 cut outs in the tool.

One side of the tool has a short cut and the other side has a long cut.

Place the mark in the short cut.

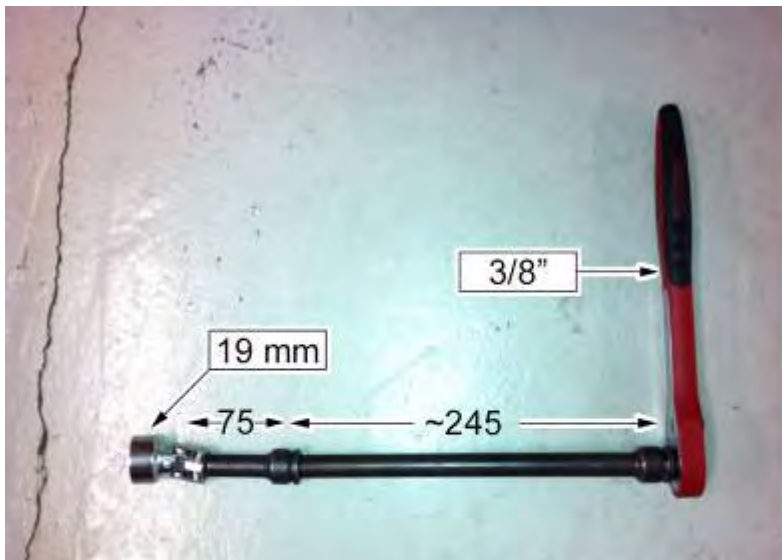
Example of the tools needed to access the adjustment tool once it is installed on the TXV valve.

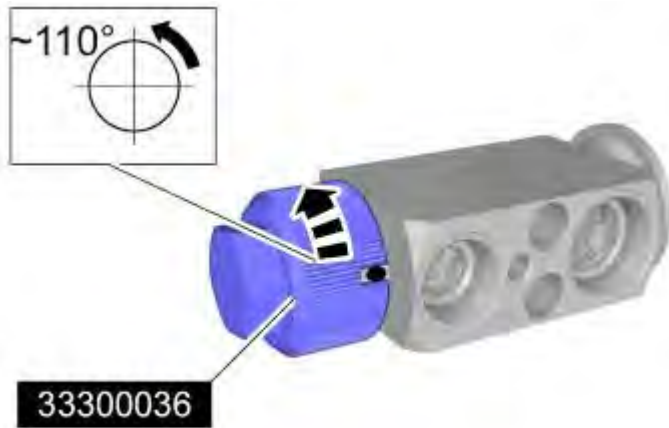
Turn valve counter clockwise until the long cut in the tool lines up with the dot placed there earlier.

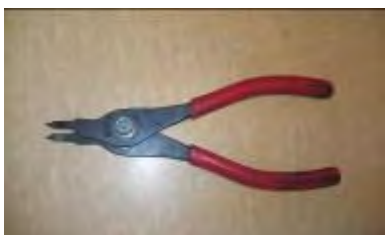
Use snap ring pliers or similar to make the adjustment.

Note: Pictures show valve out of the vehicle just for clarity. It is not necessary to discharge the system or remove the valve to perform this.

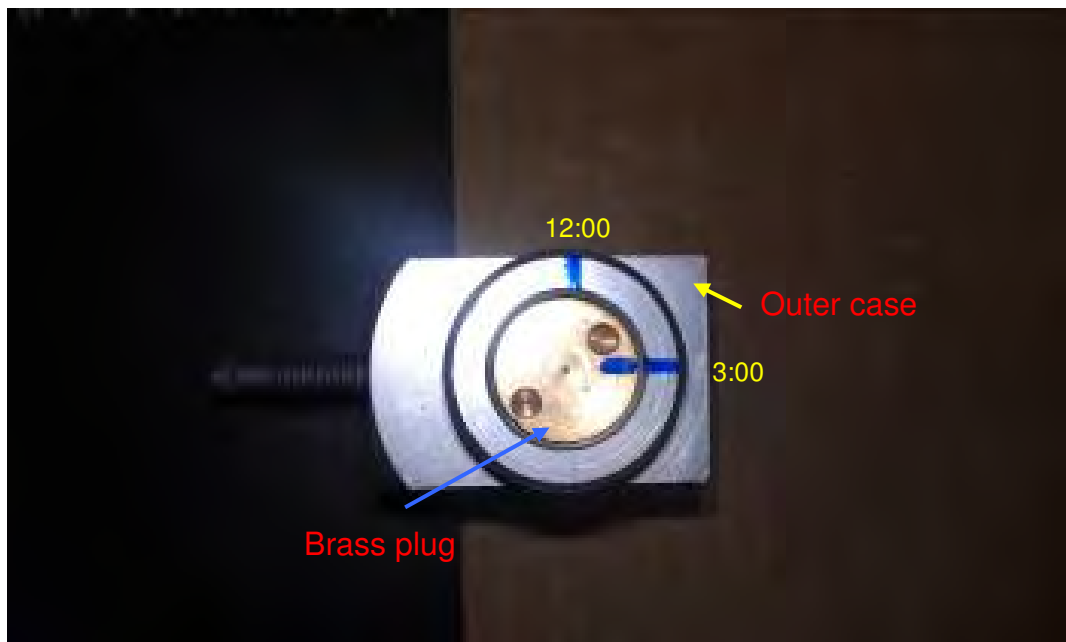
Mark valve outer case at the 12:00 and 3:00 position then mark the brass plug part of the valve at the 3:00 position only.

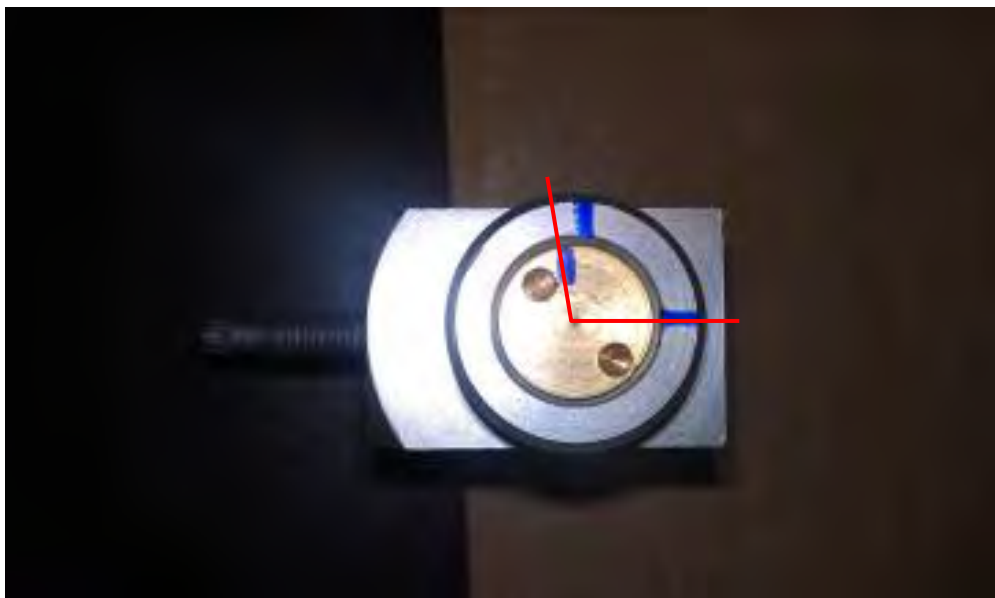
Rotate valve back to the 11:00 position.
Be sure to go no further or severe damage to the A/C system will occur.

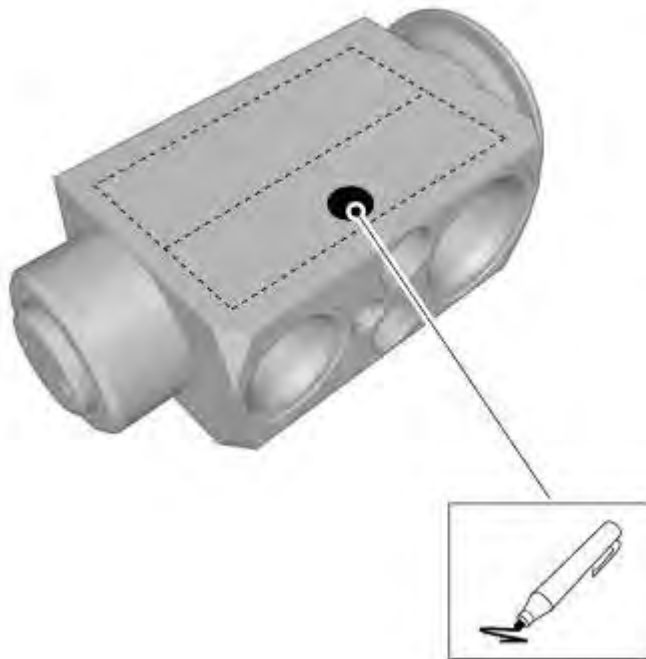
When completed place a dot on the sticker to indicate the valve has been adjusted.
