BIG LAKE, SKAGIT COUNTY 2011

Big Lake – Year End Report 2011

Prepared by AquaTechnex, LLC.

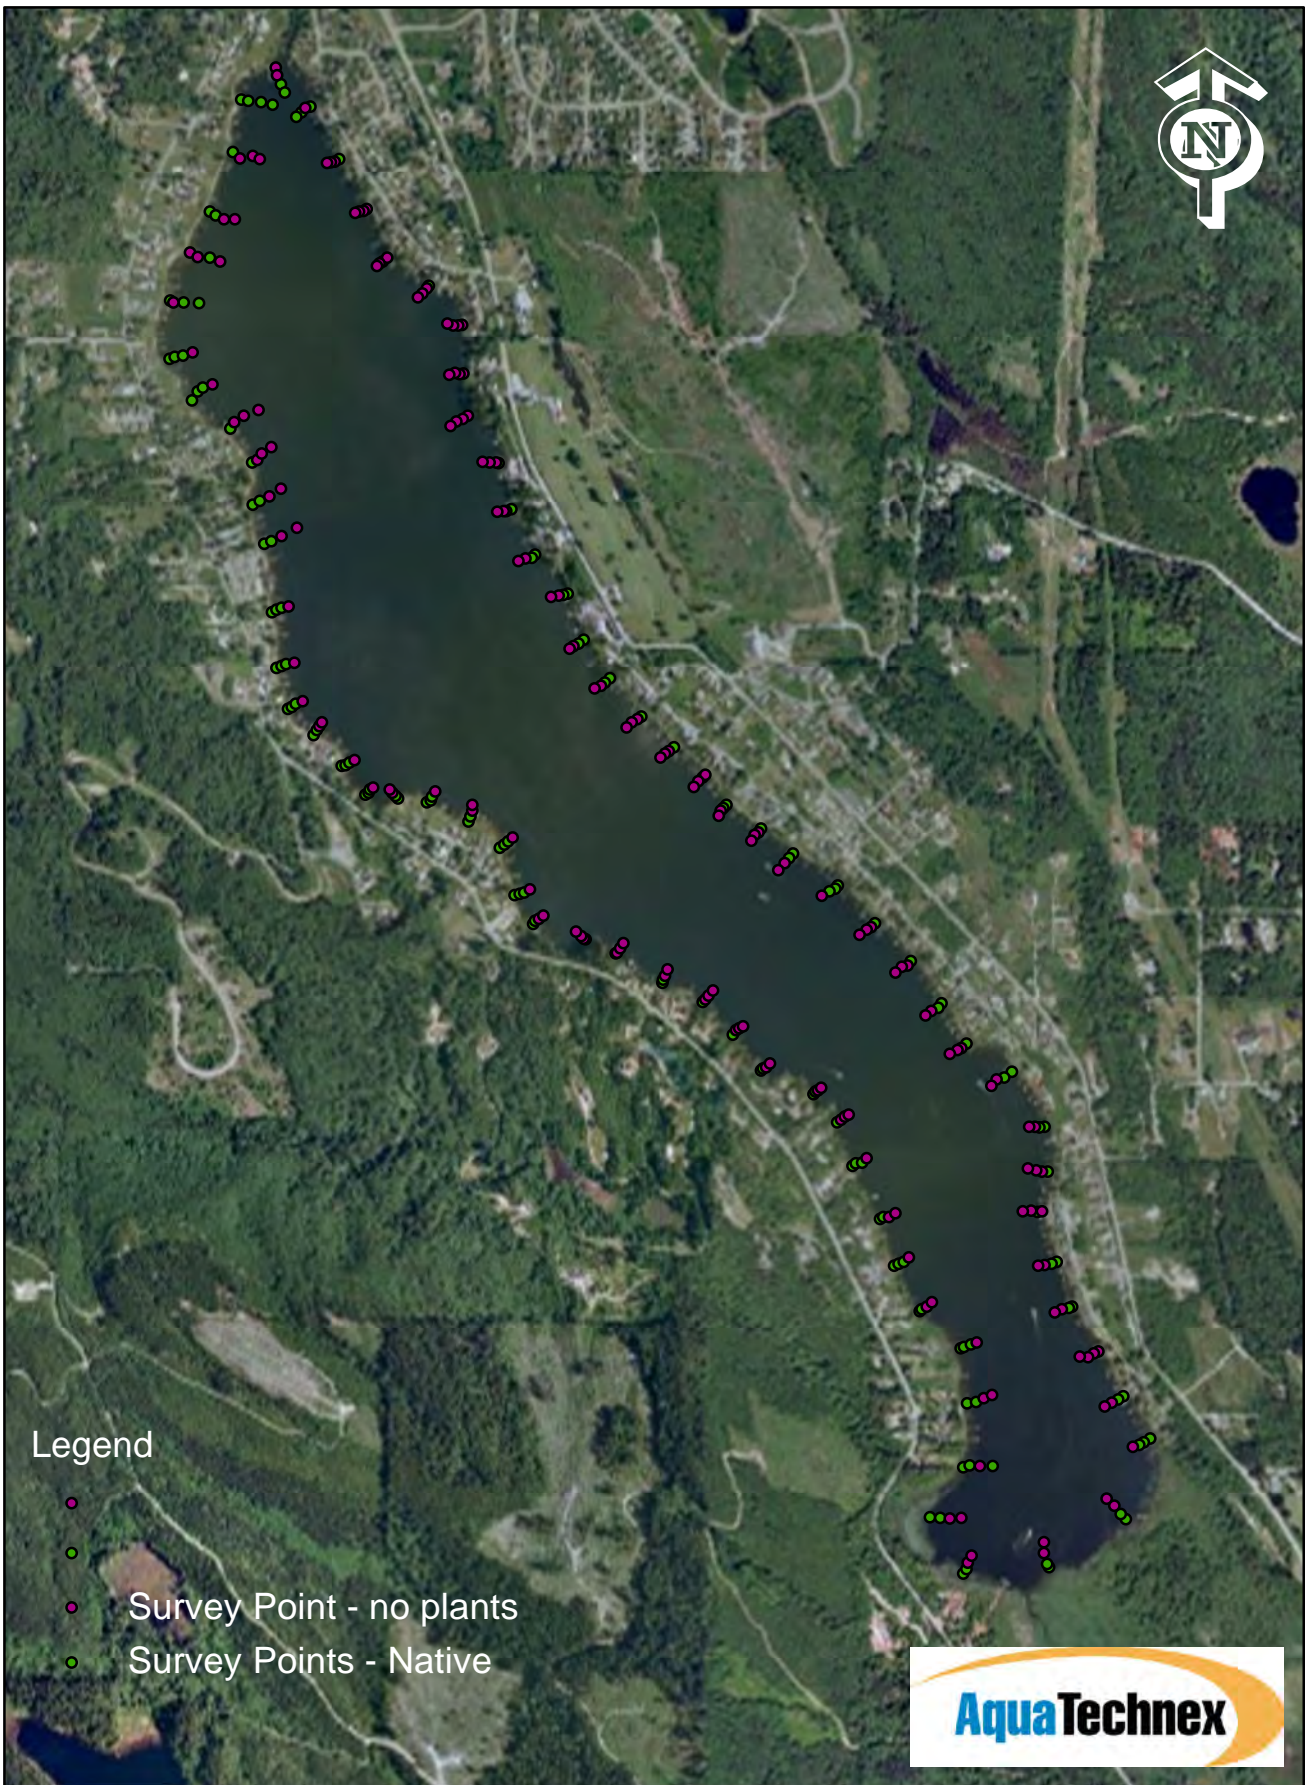
Big Lake Survey Points 2011

The objective of the annual survey is to determine the extent and coverage of the aquatic plant community in Big Lake and to identify the locations and densities of any aquatic plants currently on the state noxious weed list. The survey focuses on the littoral edge of the lake to map the extent of floating and submerged aquatic plants.

Prior to arriving at Big Lake, past mapping efforts were reviewed in order to gain an understanding of previous plant community composition. This is important so more useful observations during the survey can be made as to shifts in plant communities. The survey team navigated the shoreline mapping surveying transects at regular intervals around the lakes noting the conditions present. At these points the species collected were noted, overall dominance was determined, along with the estimated percent of bottom covered. This data was entered into the database at each data collection point.

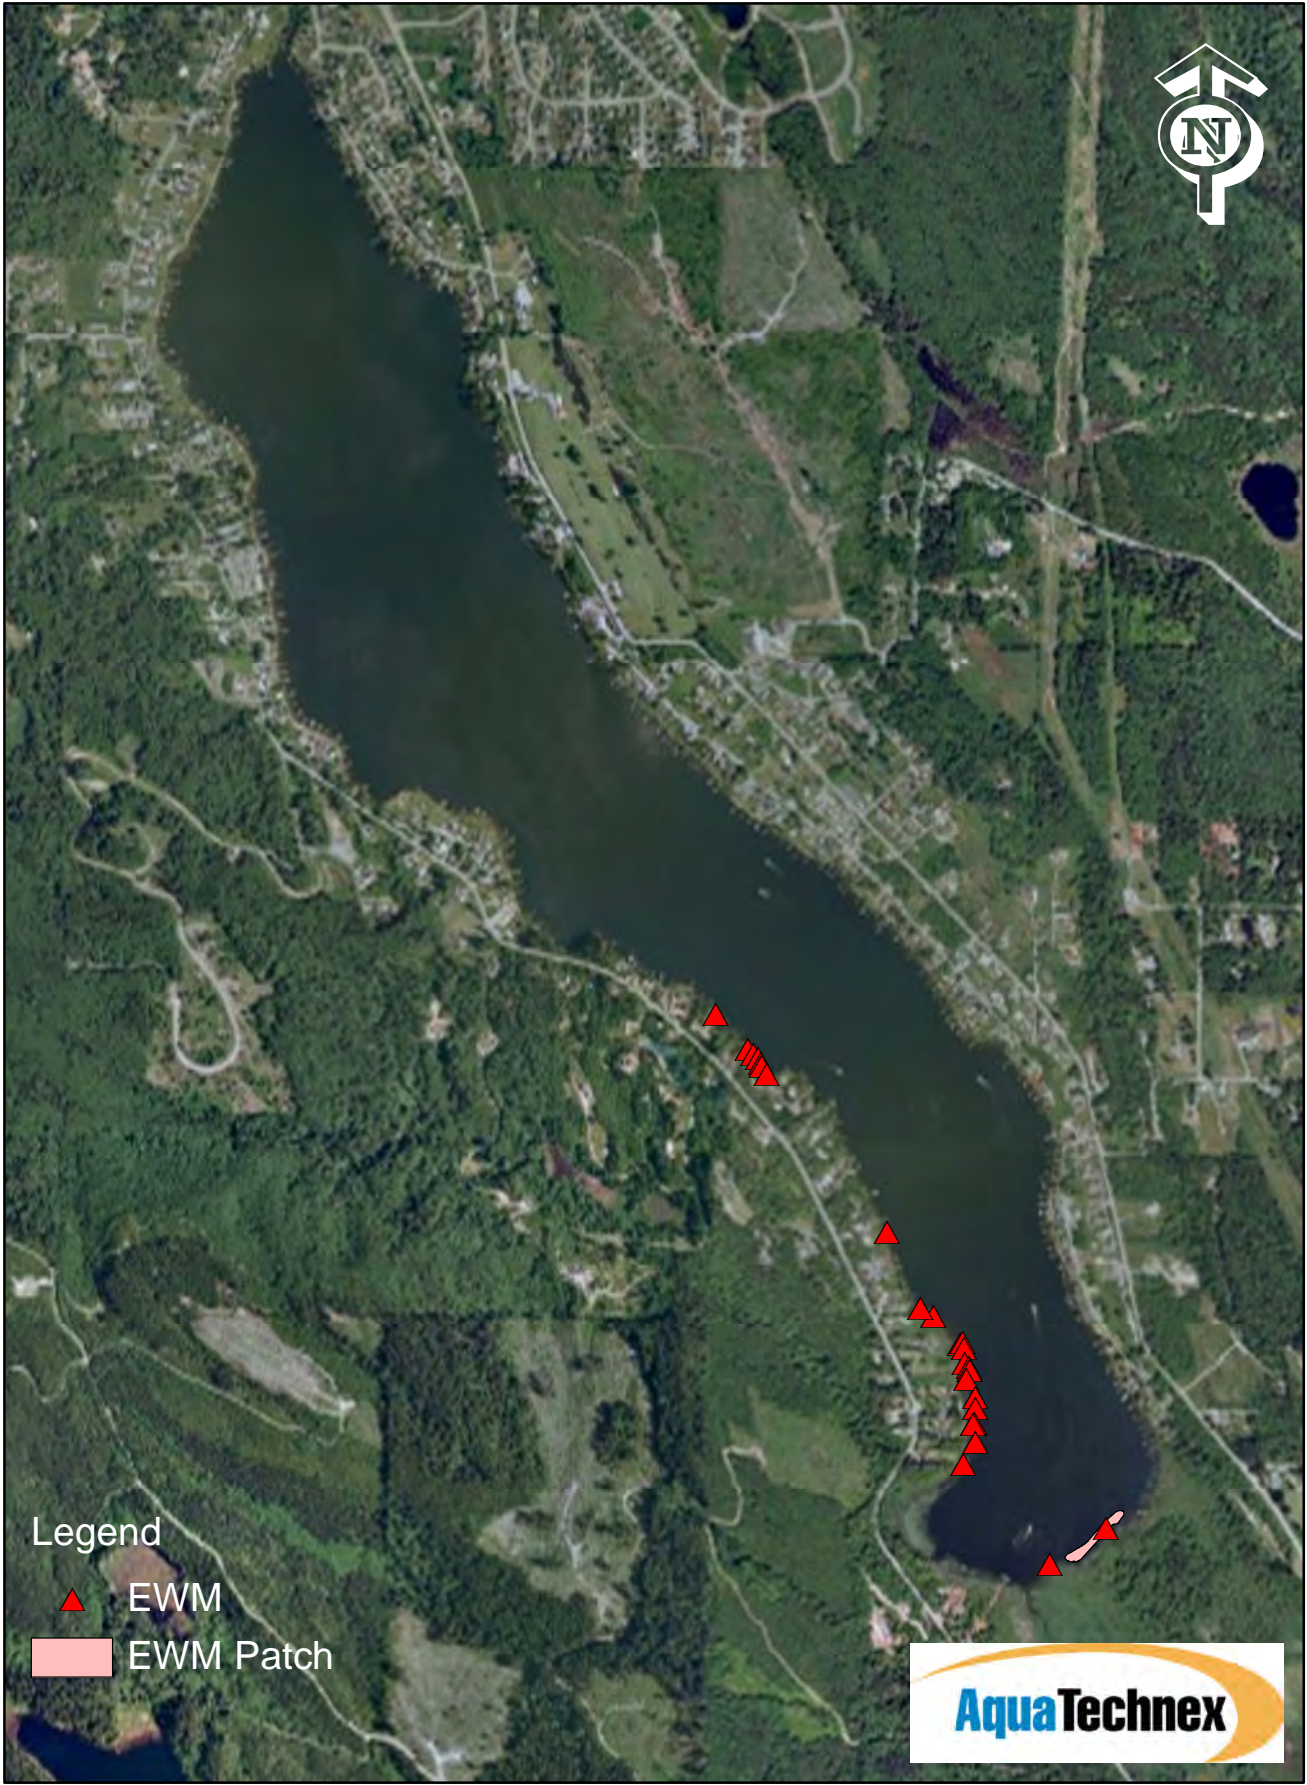
Big Lake Milfoil 2011

- Eurasian Water Milfoil (*Myriophyllum spicatum*) was identified growing at the southern end of the lake and along the western shoreline.
- Native aquatic plant populations seem to be what could be considered “normal”.
- Fragrant Water Lily (*Nymphaea odorata*) populations appear to be increasing in some locations and continue to expand along the southern end of the lake.
- Dominant species include Elodea (*Elodea canadensis*), Large-leaf pondweed (*Potamogeton amplifolious*), Najas (*Najas sp.*), and Chara (plant-like macro algae).

Eurasian Milfoil has expanded quite a bit in Big Lake in 2011. Though the population at the south end seems to be kept in check, expansion along the western shoreline has continued. Plants were found about midway along the west shoreline, south of the Fish and Wildlife operated boat launch. Because the EWM plants were treated with a contact herbicide in 2011 it can be assumed that these plants will be able to regrow from their root crowns and will be present in 2012. It is our recommendation that the 2011 survey map be utilized to create treatment maps for an early season application of systemic herbicides to these plants. This aggressive approach has been used by our firm in other lakes with very good success. The annual survey can be completed a few weeks after this application to assess the treatment as well as identify other locations in the lake which may require treatment.

with specific attention given to those locations where the milfoil was found growing in dense native growth. It was recommended that the milfoil location at the south end be treated with a granular systemic herbicide – Renovate OTF. This product is designed to impact the entire plant root and all, resulting in its complete death. The nuisance zones are to be treated with a contact herbicide – diquat dibromide. There were several locations along the western shoreline where both dense native growth and Eurasian milfoil were present together. Our recommendation was to treat with a contact herbicide only in these situations. In order to control both the EWM and nuisance plants, the choice to use contact herbicides only was made in an effort to provide clearing of the plants from the area because an application made for milfoil only would not affect the native plants, and using both would have possibly diminished the results from any systemic applications.

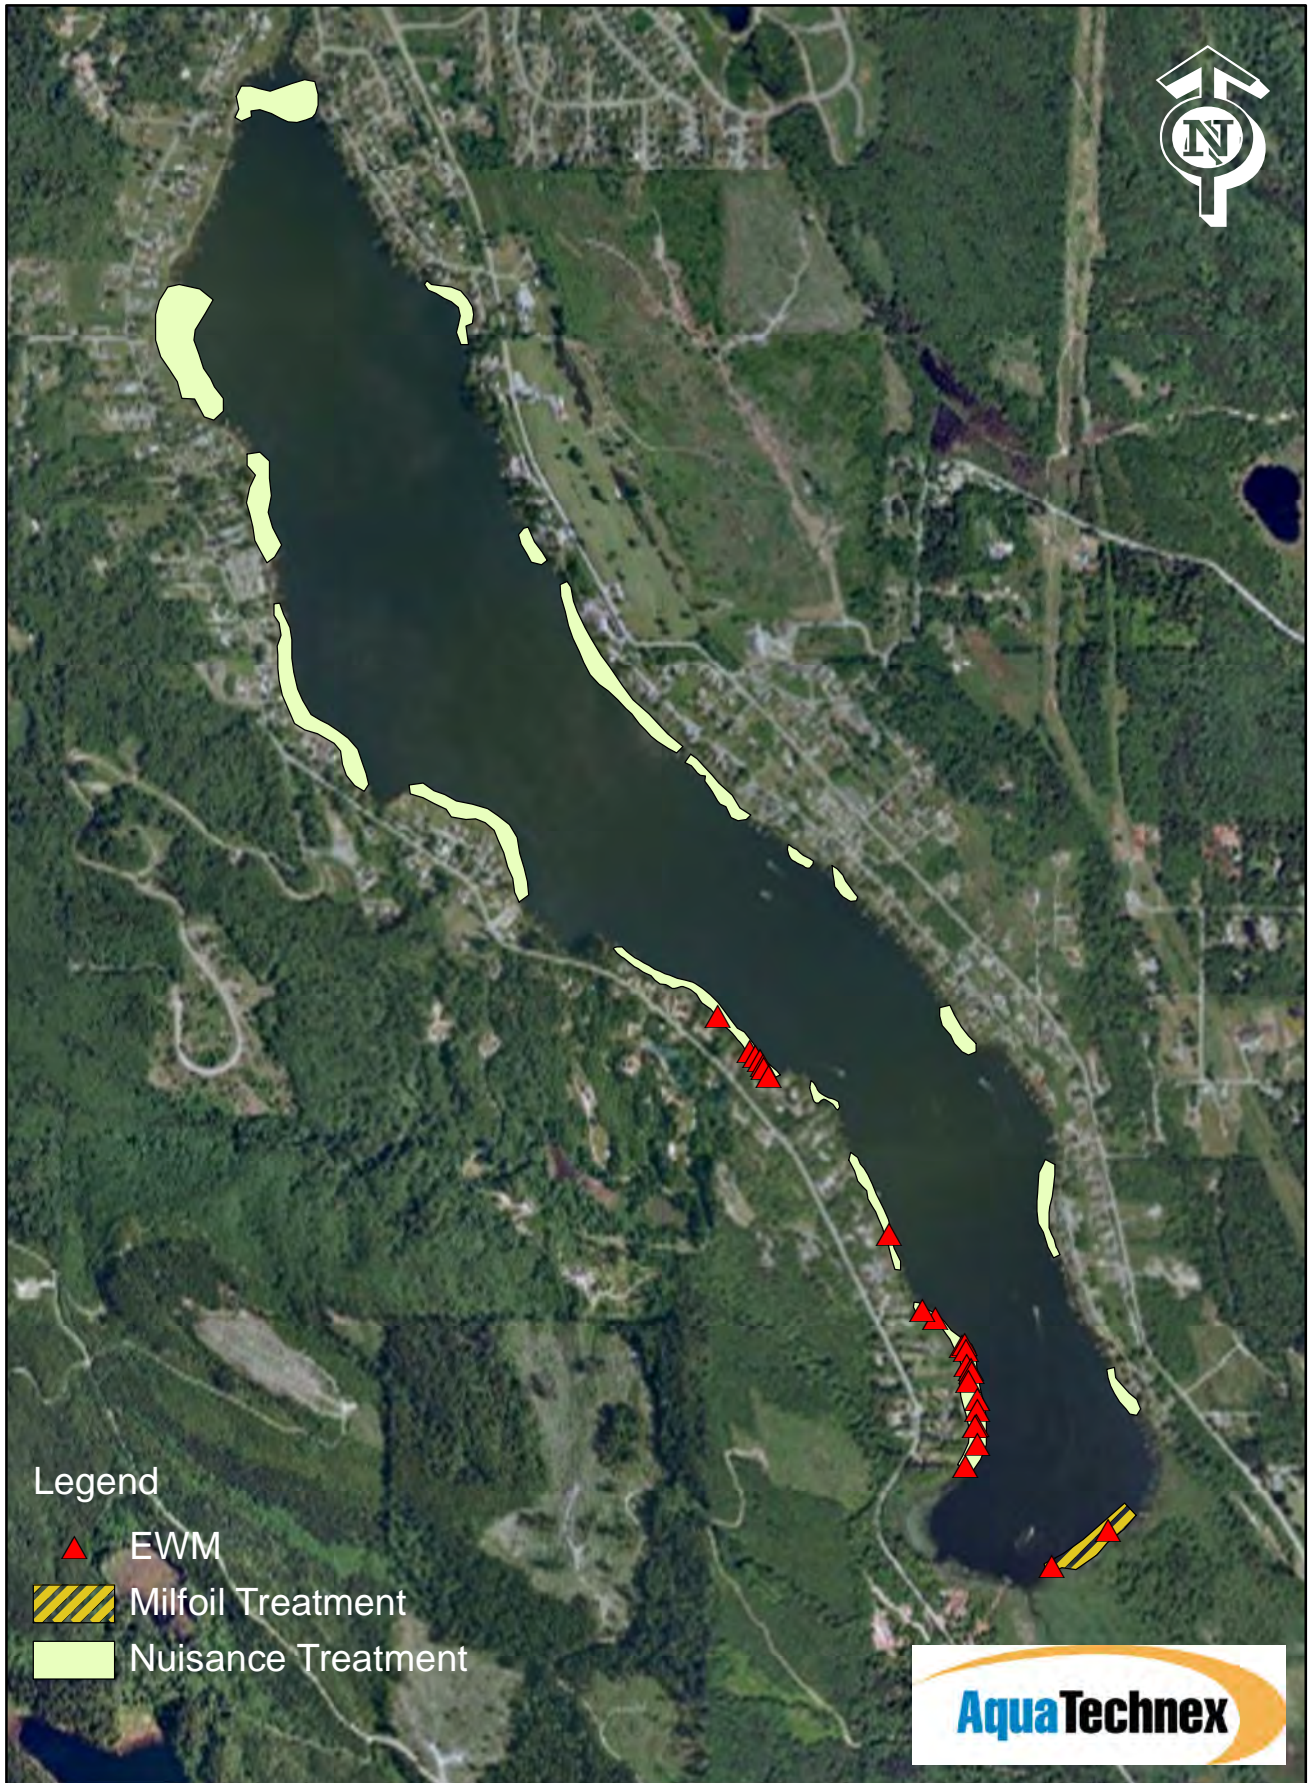
Big Lake Treatments 2011

The 2011 season was more “normal” in terms of the weather patterns experienced. Nuisance native plant growth seemed to be slightly less when compared to previous years. The Eurasian milfoil populations seemed to have expanded quite a bit from 2010. The locations of the milfoil in the lake fell into two basic situations – growing in a more “monoculture” situation with no direct homeowner impact and in a dense, mixed plant community along a heavily populated shoreline (west side). In addition to the nuisance plant treatments, all of the locations which were identified as containing EWM were slotted for treatment.

The outflow on the north end of the lake was protected with a buffer zone extending outward which was not included in the treatment areas.

A boat-mounted liquid injection system with weighted drop hoses was used to navigate the lake and treat the pondweeds on Big Lake. An eductor system was utilized to apply the granular herbicide to treat the Eurasian Milfoil at the south end.
