## BOULDER TV Repeater's REPEATER

## November, 2018

Jim Andrews, KH6HTV, editor - kh6htv@arrl.net

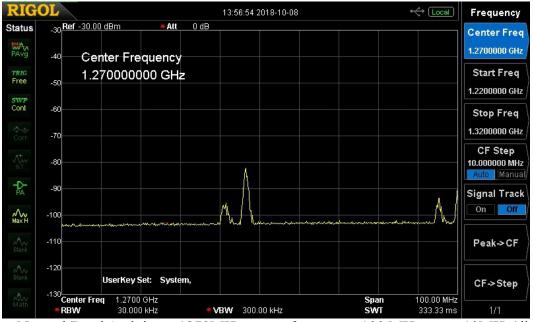
23cm Normal Band Activity -- 1270MHz center frequency, 100 MHz span, 10MHz/div data acquired in max. hold for 10 minutes. The only signals seen are government radars.

**70cm vs. 23cm BAND ACTIVITY:** From my QTH with my Rigol spectrum analyzer, I have monitored the relative activity on both the 70cm and 23cm bands. Dramatic differences ! The screen shots shown below were taken under the same analyzer settings on both bands. The analyzer was set to the Peak Hold mode to capture everything which occurred in the 10 minute acquisition interval. The measurements were made on a weekday in the middle of the day. On 70cm, the span of 50 MHz includes the government band 410-420MHz (bottom 2 divisions) and the commercial / FRS band 450-460MHz (top 2 divisions). A lot of amateur, 70cm, FM repeater outputs are noted in the 445-450 MHz portion. Also a lot of unlicensed activity is seen in the 434 MHz region. On 23cm, the span of 100 MHz includes government

bands below 1240 and above 1300MHz. Absolutely the only activity detected were the govt. radars in the vicinity of 1265MHz and 1318MHz. 23cm monitoring over extended 1/2 day periods also showed essentially an empty, quiet band, except for the radar signals.

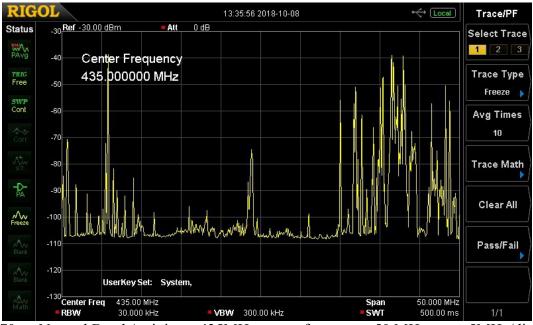
70cm Normal Band Activity -- 435MHz center frequency, 50 MHz span, 5MHz/div data acquired in max. hold for 10 minutes

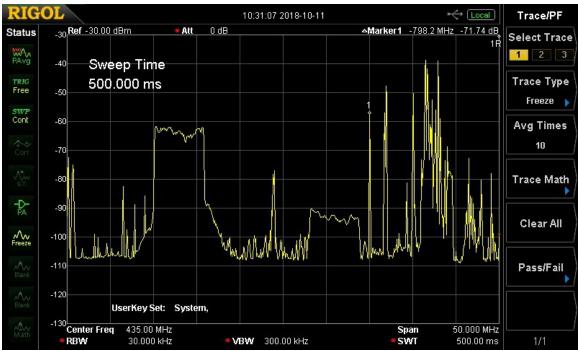
70cm Band Activity with ham DTV signals. TV repeater at 423 MHz & another ham's signal at 441 MHz -- 435 MHz center frequency, 50 MHz span data acquired in max. hold for 1 minute

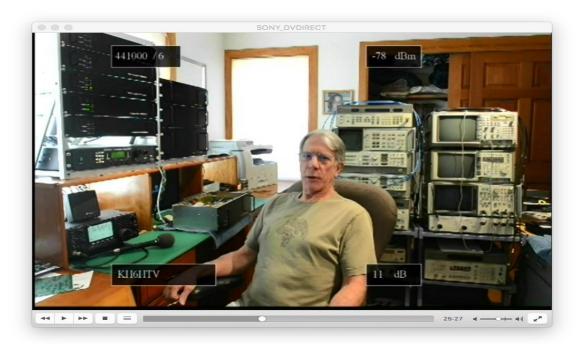
Steve, WA0TQG finally makes it thru the TV repeater !!!

The two photos here were taken from the TV repeater's output. Steve's signal first went on 441 MHz to Jim's QTH where it was received and then relayed on 1243 MHz up to the TV repeater where it was then broadcast all over the Front Range on 423 MHz. The on-screen-display (OSD) seen was superimposed by Jim's Hi-Des HV-110 receiver showing the received signal strength (upper right corner) and signal/noise ratio (lower right corner). The received power needs to be corrected by 11dB for Jim's preamp (18dB gain) and a 1:4 signal splitter (-7dB). Thus -78dBm was actually -89dBm coming in from the antenna. The S/N was seen to vary from 7 to 11dB.

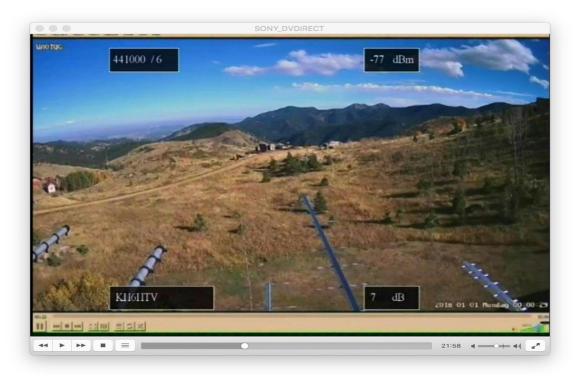
TV camera view from the top of Steve's tower looking to the SE towards the repeater. The repeater is hidden behind the tall peak in the center.

MISSION IMPOSSIBLE ! ! -- We were actually able to see Steve, WA0TQG's smiling face on the TV repeater on the Thursday net, Oct. 4th. Steve lives on the flank of Sugarloaf mountain in the western part of the county. He has a great view from his OTH out onto the plains of eastern Colorado. However, he is shielded from the TV repeater by the Flatiron mountains. Radio Mobile computer rf path predictions say the path from Steve to the repeater is impossible with a -77dB margin. Steve however is just barely able to receive a picture from the TV repeater. So some kind of funky path Steve is transmitting DVB-T with QPSK on 70cm with 6 watts of power. He is exists. however unable to get into the repeater directly. Using KH6HTV's remote 70cm/23cm receive site, on Thursday, Oct. 4th, Steve was finally able to get into the repeater. Jim's QTH is further east out on the prairie and has a good view back into the mountains in the western part of the county. Radio Mobile predicted that the path from Steve would actually be worse at -95dB margin. But it worked ! So much for computer predictions ! They usually work, but for really weird paths with many possible reflections from other mountains, etc. all bets are off. The moral of the story is, even if everyone says it is impossible, try it anyway.

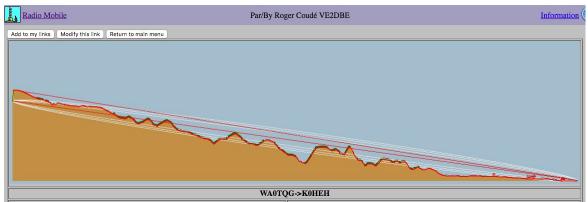
Radio Mobile predicted path from Steve to Jack's QTH - 84dB margin

relaying Steve's picture on to the repeater. The plot below shows the path from Steve to Jack. Radio Mobile predicts the signal strength, receive margin at Jack's QTH to be better, but still horrible at -84 dB. Hopefully, Jack will continue to be Steve's relay repeater in the future.
