Brent M. Wilson  
Amsted Rail  
February 12, 2010

# What does Amsted Rail do??

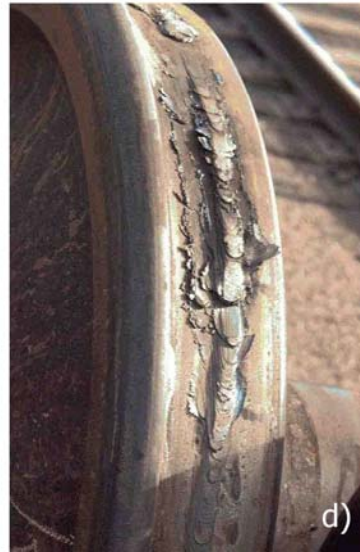
a) Wheel flat b) Shell / Spall  
c) Shattered rim d) Built-up-tread

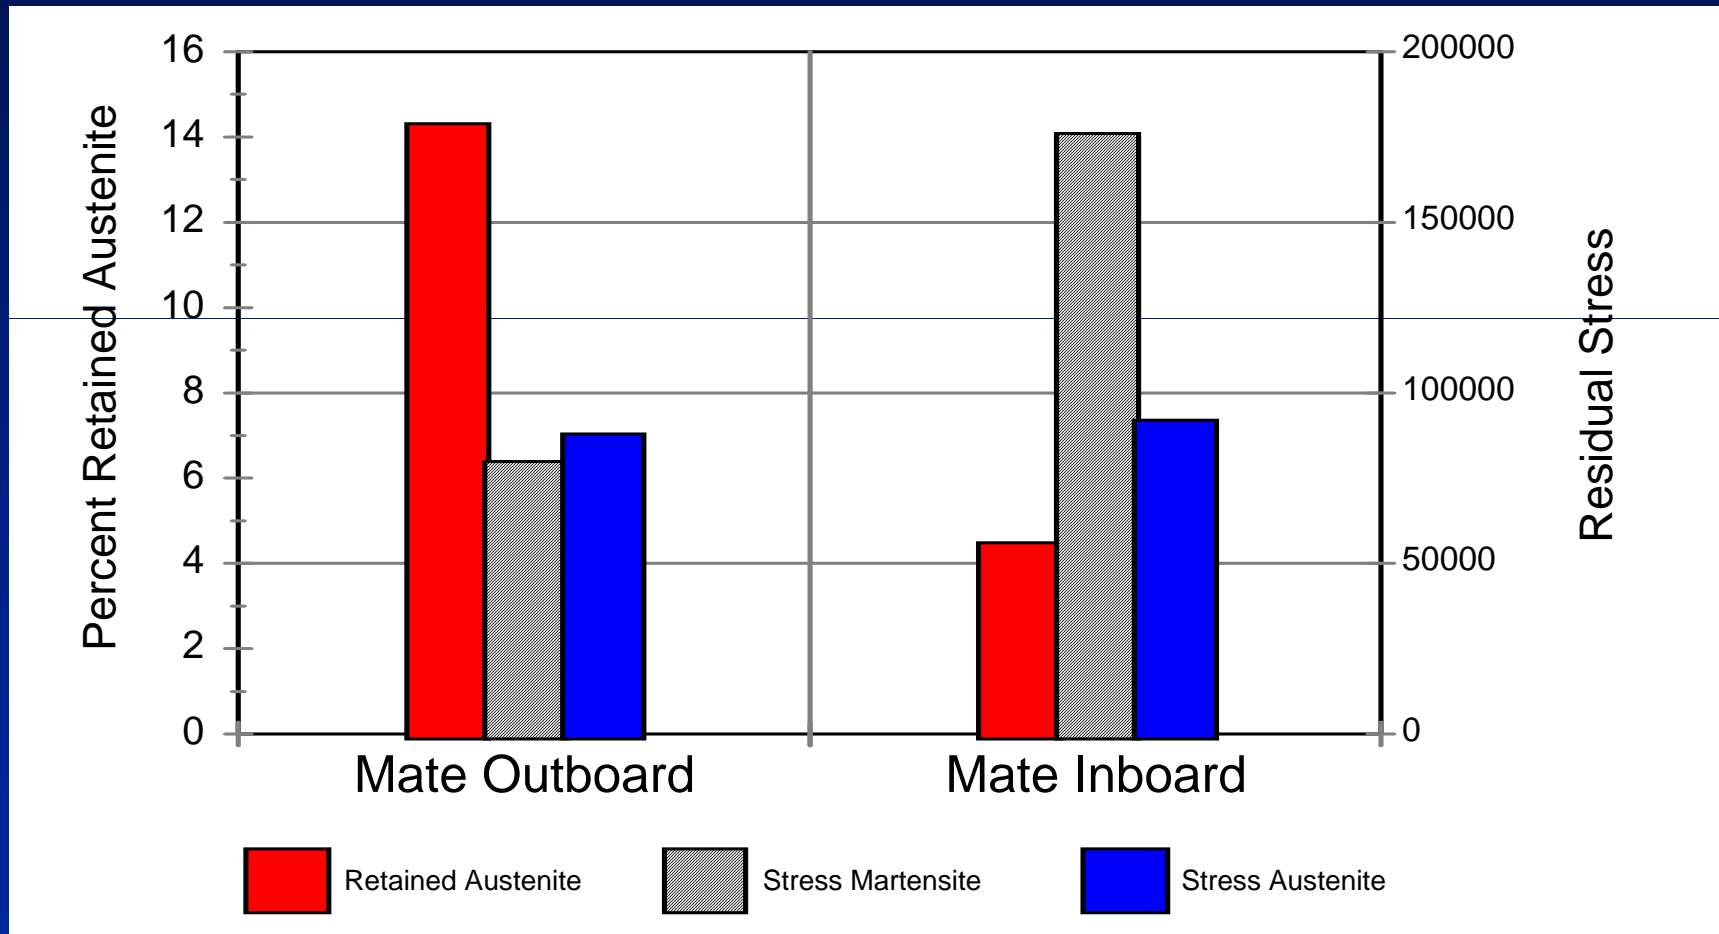
## Residual stress and retained austenite reflect the service history

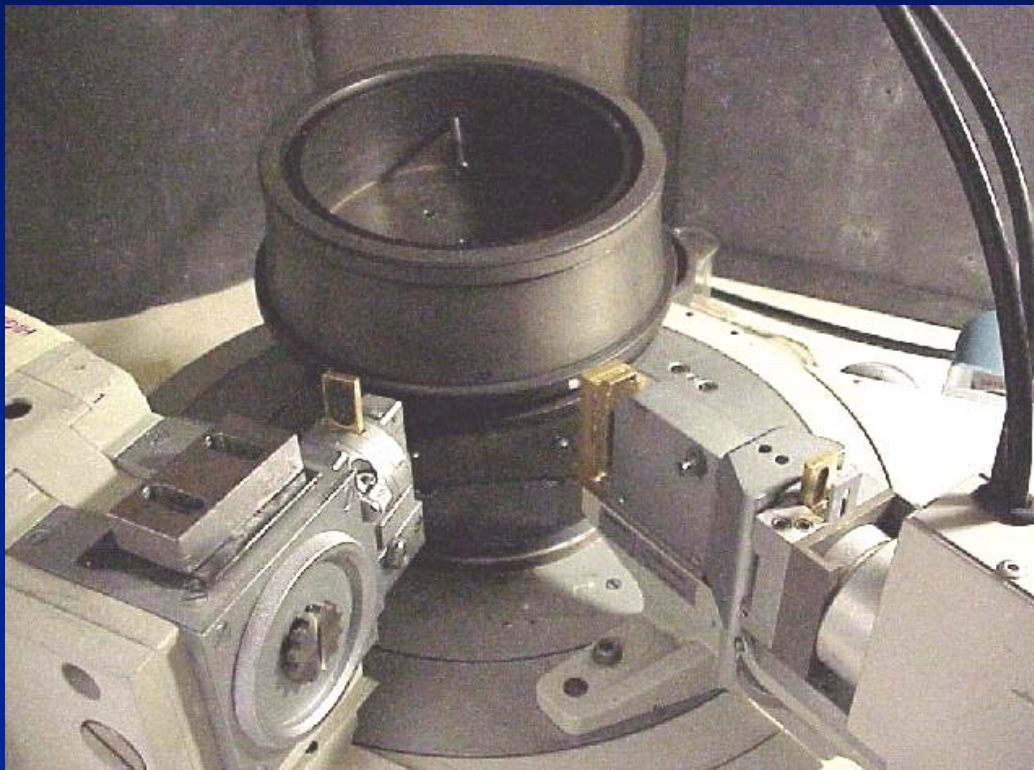
## Service Load Factor (SLF) :

Absolute residual stress (martensite) / %RA  
Normalized to new cones ( $42.5/22.5 = 1.88$ )

Serviced Load Factor
New Product 0 lbs 0 miles	1.00
Typical Bench Test 34,500 lbs 250,000 miles	2.38
Typical Field Test 34,500 lbs 300,000 - 600,000	2.56
Failure Criterion 140ksi / 10% RA	7.50
Severe Overload	15.10

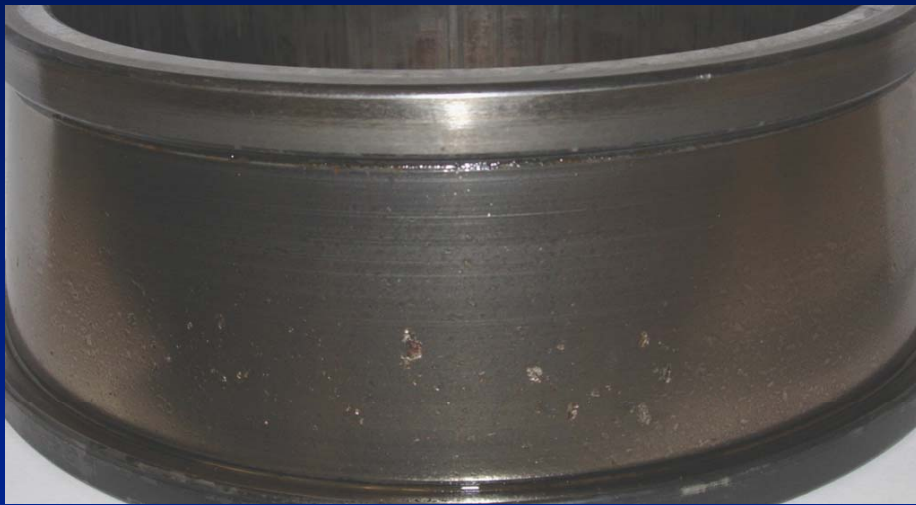
Serviced Load Factor
1 million mile 66 OB *	6.56
1 million mile 66 IB	3.23
1 million mile 67 OB	3.40
1 million mile 67 IB	5.93
Failure Criterion 140ksi / 10% RA	7.50

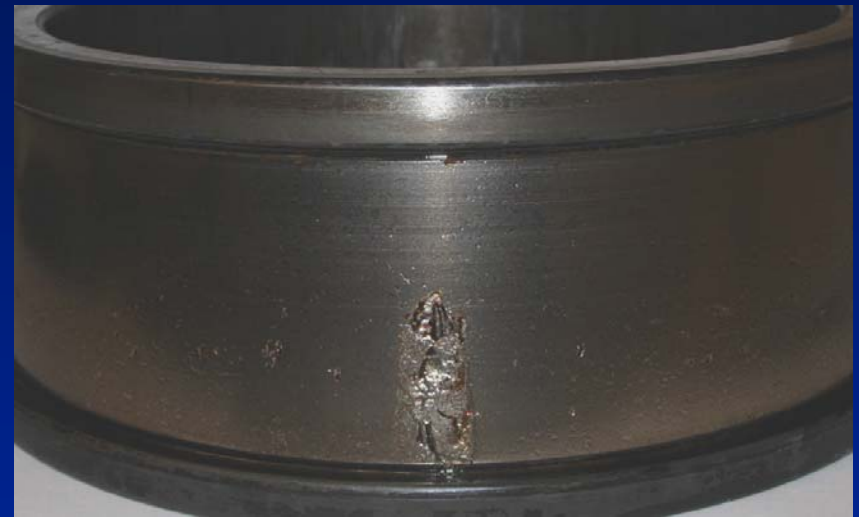
1.2 million

Serviced Load Factor
1 million mile 66 OB	10.67
1 million mile 66 IB	3.45
Failure Criterion 140ksi / 10% RA	7.50

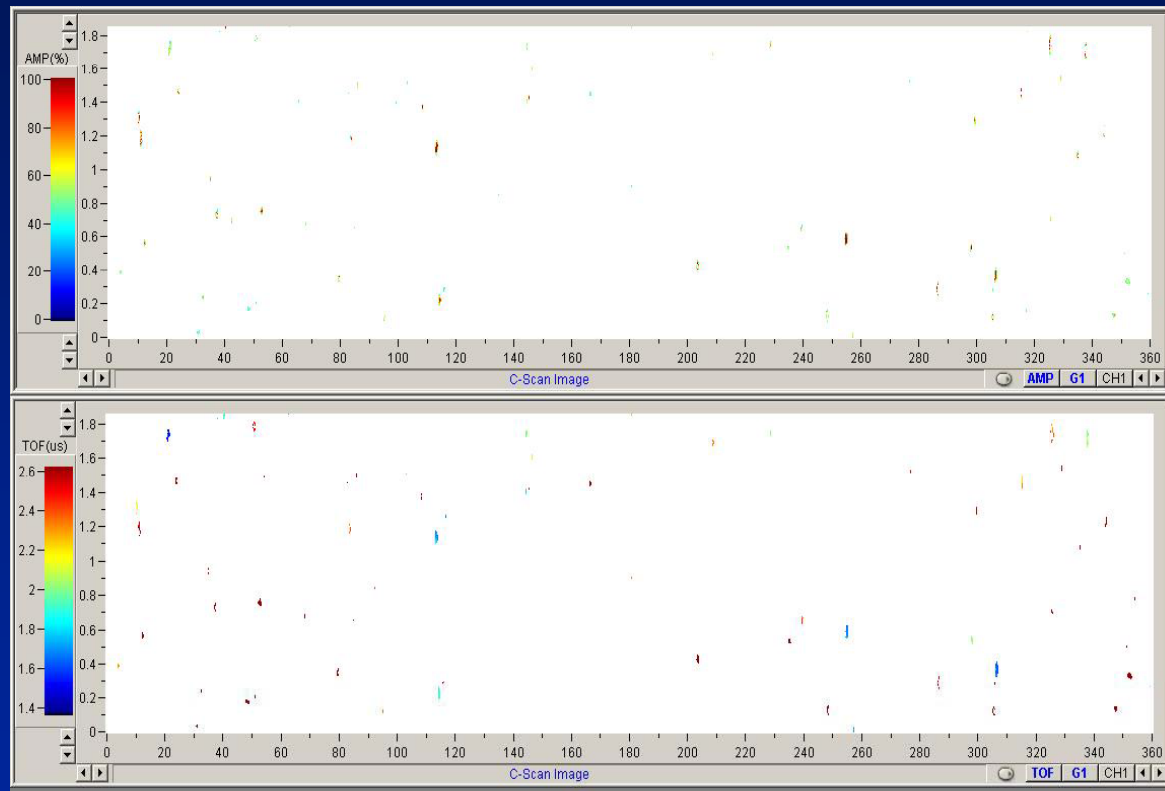
## C-scan (top) and TOF (bottom) for South European steel

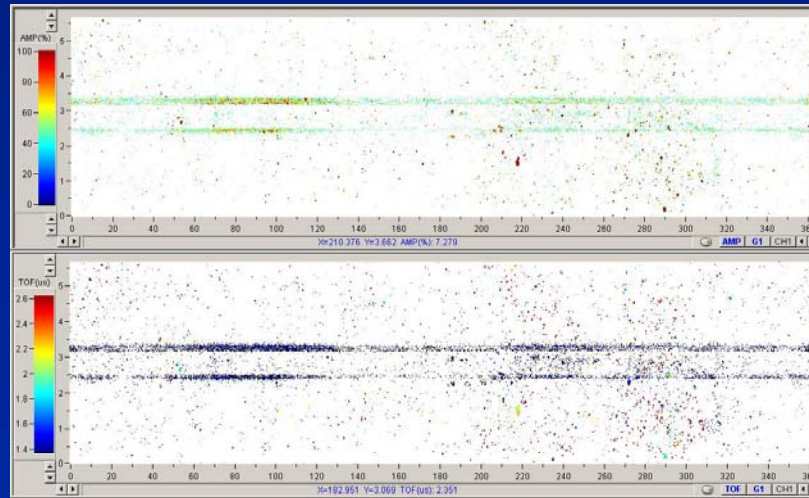
# C-scan (top) and TOF (bottom) for ABD setouts

Sept 98

Aug 02

Mar 99

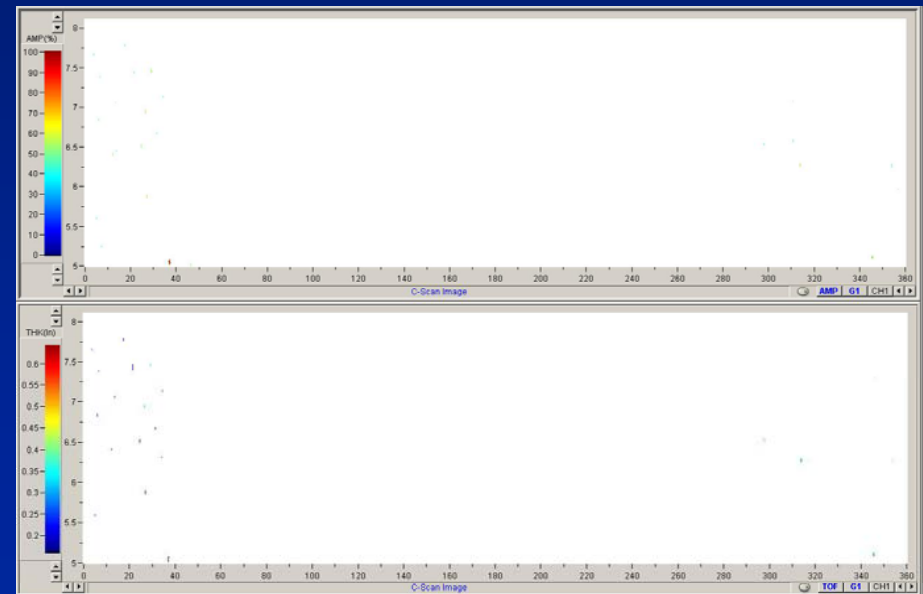
# Korean vs. USA

Total Scan Area –  $7.1 \times 10^4 \text{ mm}^2$ ,  
Total Inclusion Area = 4,047  $\text{mm}^2$

Total Scan Area =  $7.1 \times 10^4 \text{ mm}^2$ ,  
Total Inclusion Area = 44.5  $\text{mm}^2$
