ACTIVITIES REPORT FOR THE CRUISE GOM2-10-MC118 ABOARD THE *R/V
PELICAN*

MISSISSIPPI CANYON FEDERAL LEASE BLOCK 118
NORTHERN GULF OF MEXICO

**OPERATIONS REPORT AND EVENT LOG OF AT-SEA ENGINEERING TESTS OF
THE STATION SERVICE DEVICE, SURVEYING EFFORTS AT THE SEAFLOOR
OBSERVATORY SITE AT MC118, DEPLOYMENT OF THE INTEGRATED DATA
POWER UNIT, AND PUSH-CORE SAMPLE COLLECTION**

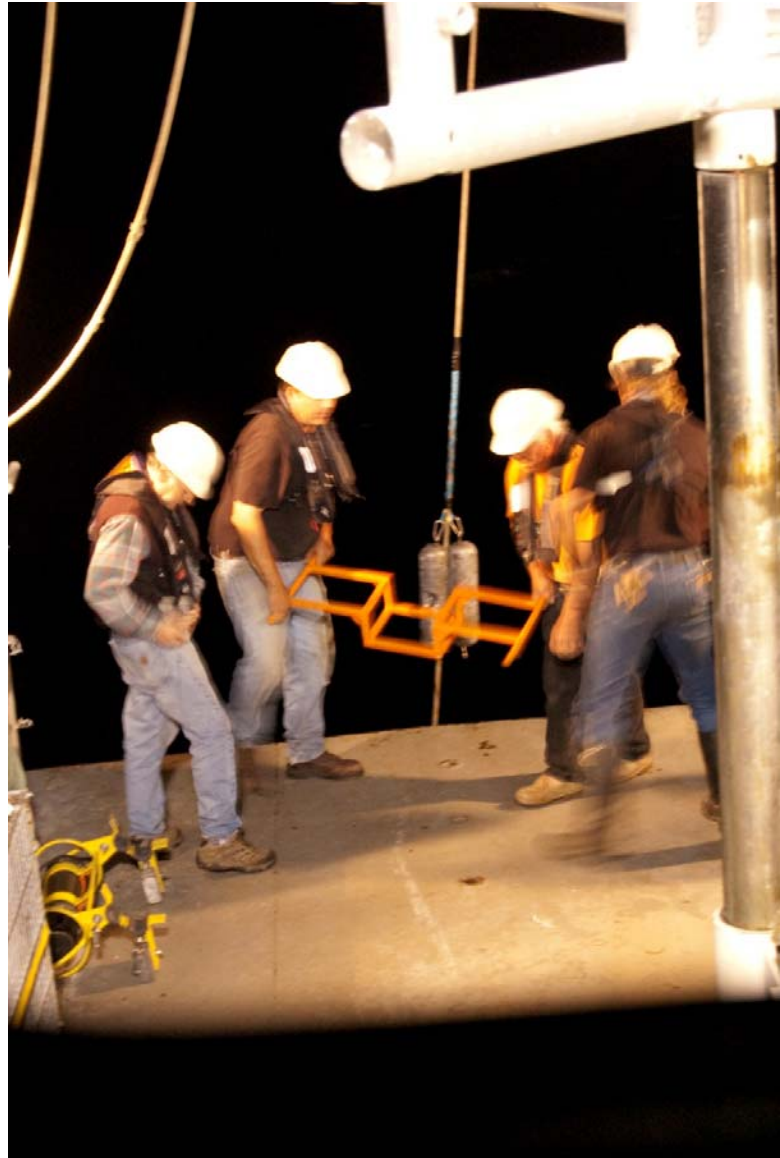
After the SSD is off the back deck, a USBL transducer is attached to the cable for precise location of the vehicle during deployment and operations. Floats are then attached to the cable to keep it clear of the vehicle during seafloor operations. Then, a series of lead weights is attached to the cable to give it stability, a form of mid-water “anchor” that isolates the vehicle from the ship’s movement. In this photograph, the MMRI team has just attached one member of this series to the cable.

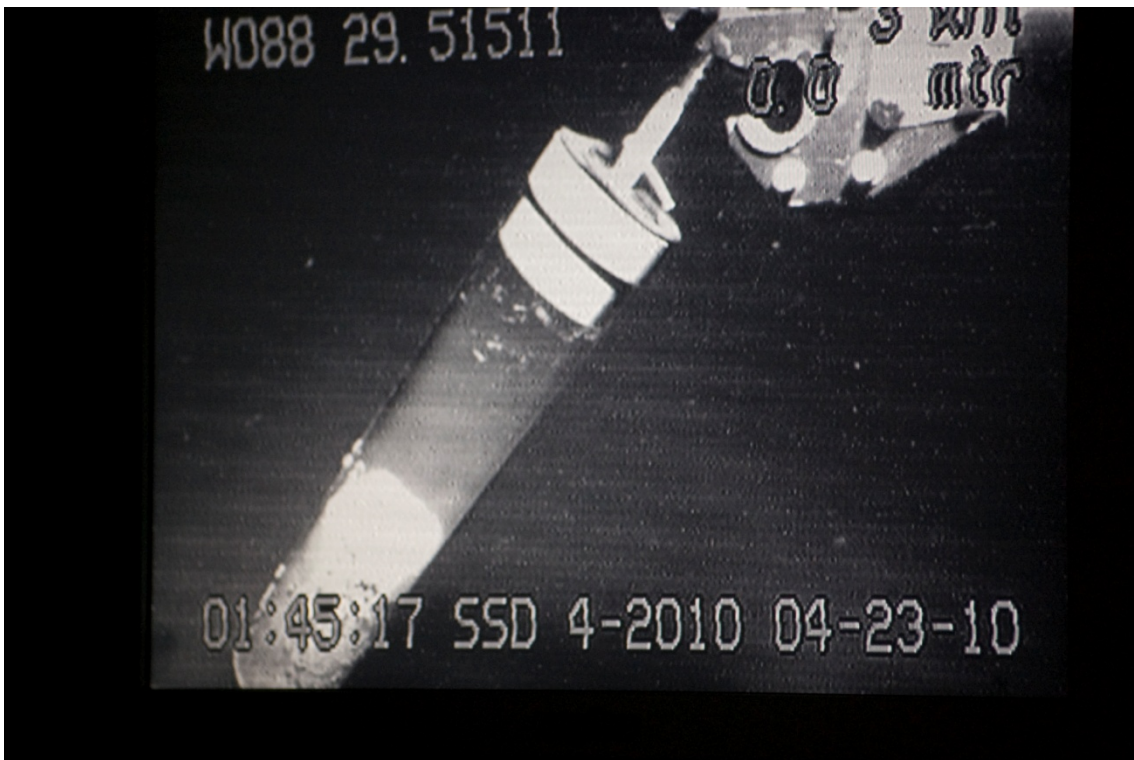
SSD recovering a push-core from the seafloor at MC118, ~870m water depth.

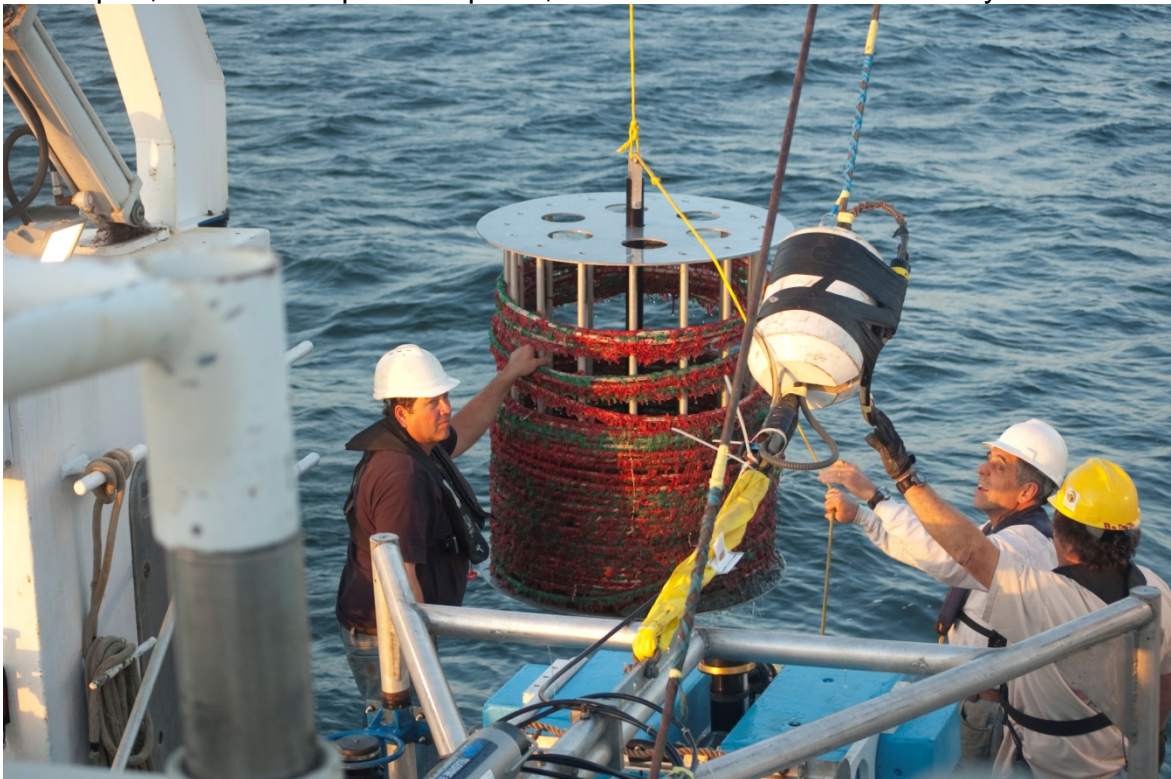
The mock-up horizontal array, being recovered, following its shallow-water deployment.

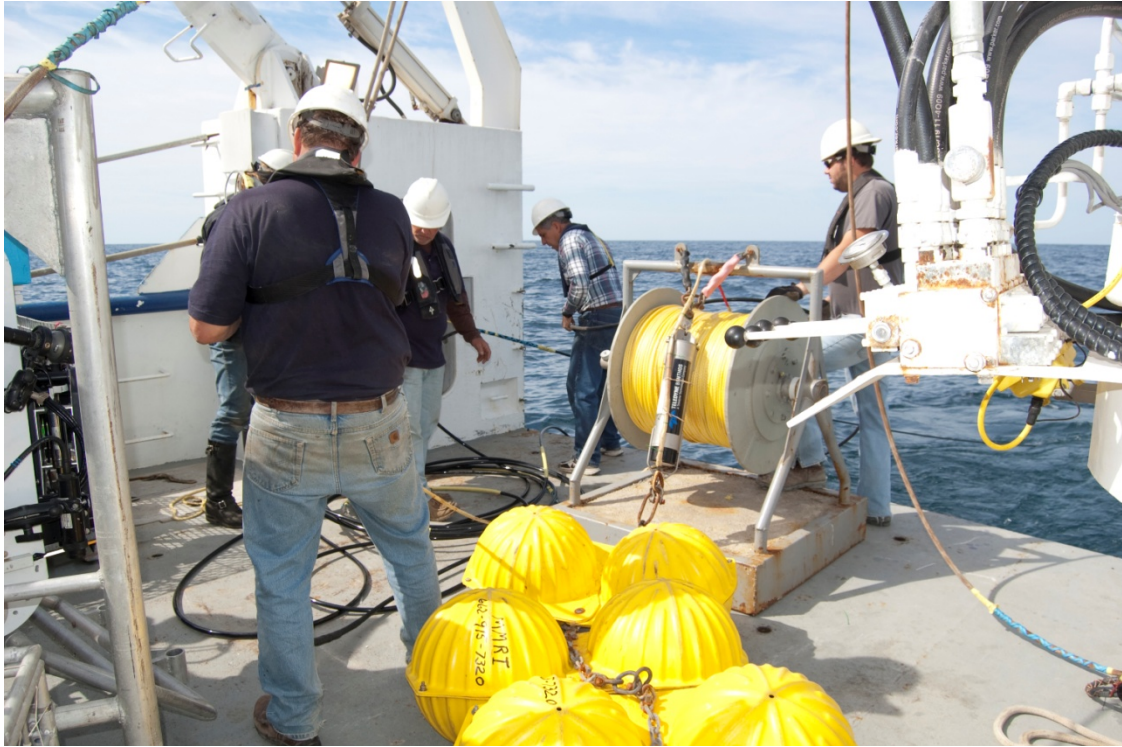
The pop-up-buoy, part of the data recovery system for the observatory, rigged for deployment about 3km distant from the IDP. The arrangement allows a surface vessel to “pop” the connection to the data-logger and down-load data without risking entanglement in the observatory instruments.

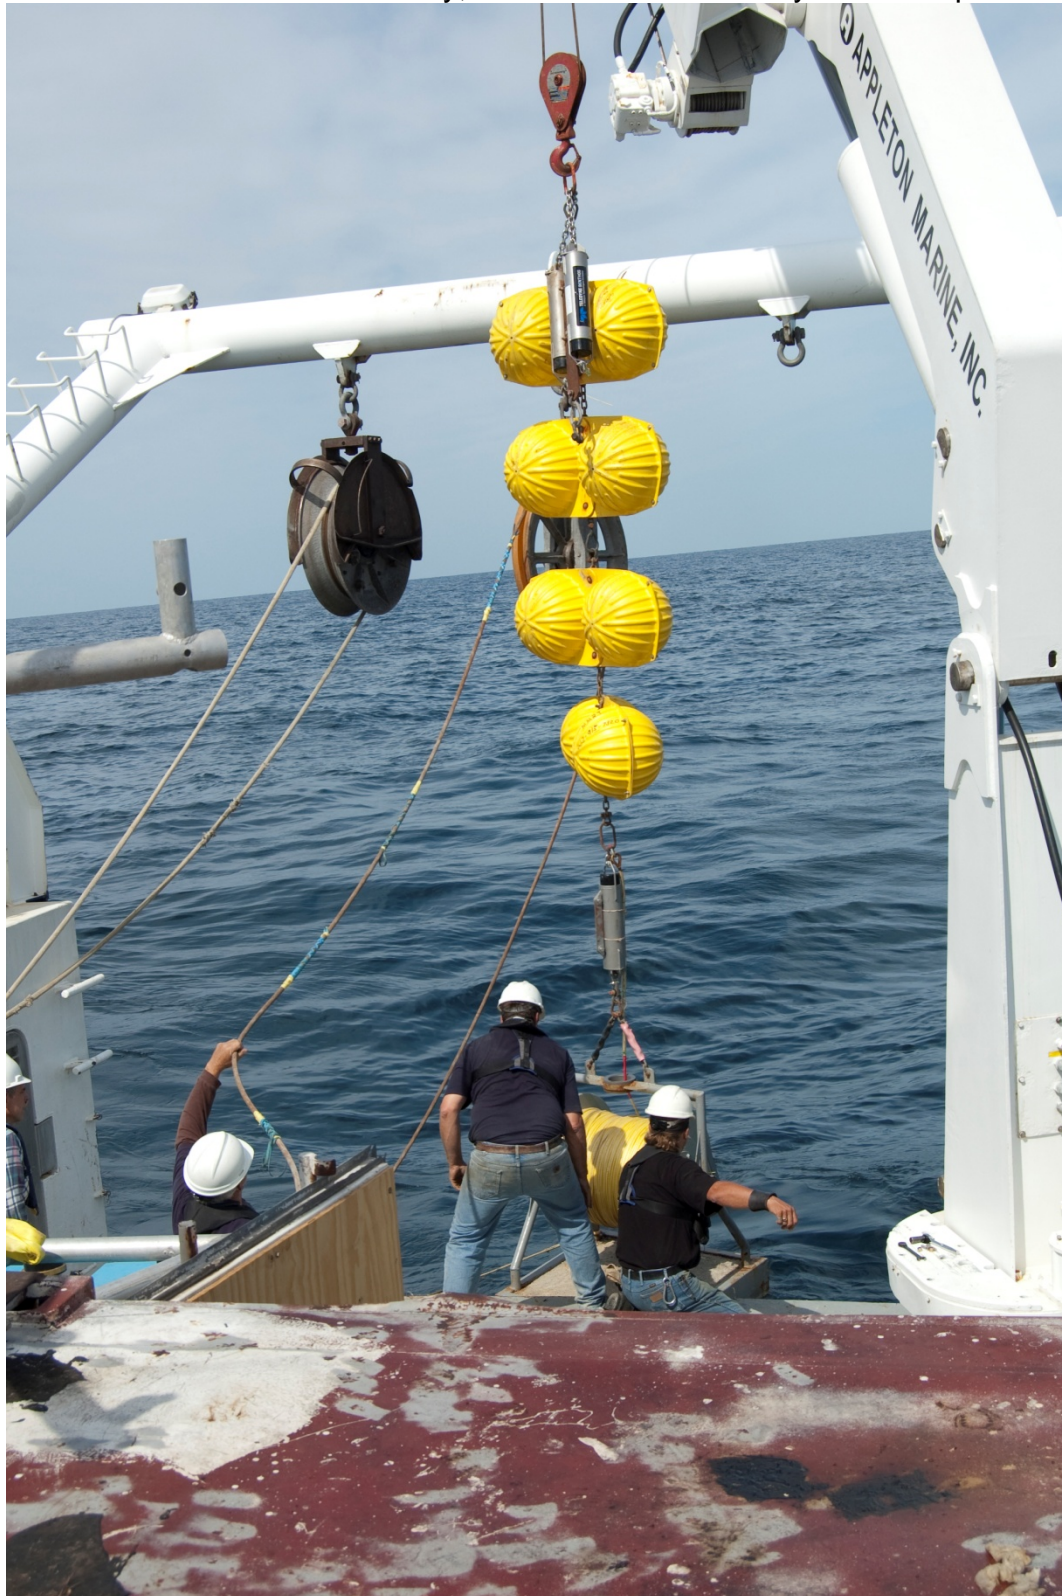
The pop-up buoy was deployed near the northern border of the Consortium's research reserve at MC18, the only one in the Gulf of Mexico.
