# Cessna Single Engine Safety Initiative

# Single Engine Safety Initiative

- Cessna has developed a structural inspection program to assure the continued safe operation of single engine airplanes
- Visual inspection techniques are utilized to detect
  - Corrosion
  - Cracks caused by metal fatigue

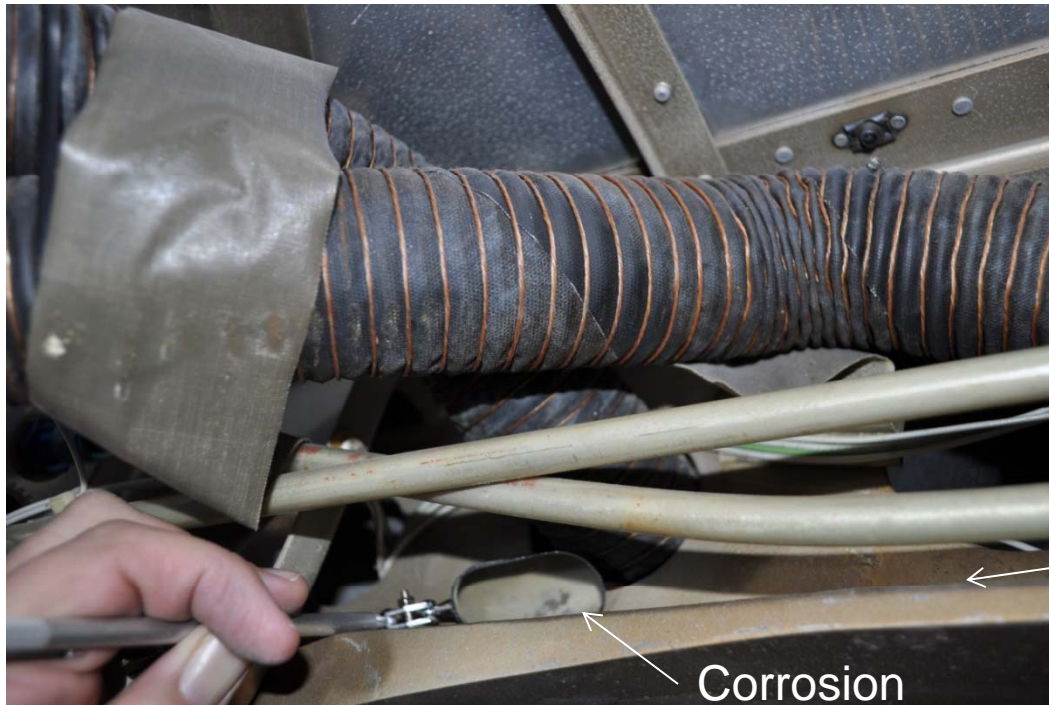
# Models 177/210 Cantilever Carry-Thru

- Provides the primary means of carrying wing loads across the fuselage
- Made of 2014-T6 material
  - High strength material but is very susceptible to corrosion
- Corrosion occurs when
  - Ducting contacts lightening holes in beam, or
  - Moisture accumulates on I-beam surface
- Limited repairability

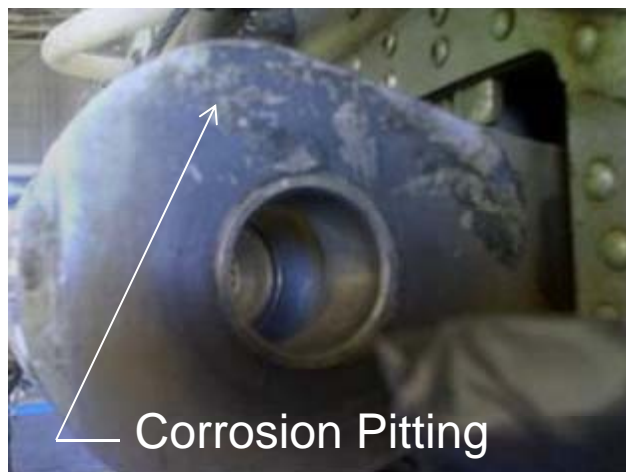
Carry-Thru Spar Lug

- Primary load carrying member
- Corrosion is common on the carry-thru lugs and the wing attach fittings
  - Tight fitting faces act as a moisture trap
- Made of 2014-T6 material
  - High strength material but very susceptible to corrosion

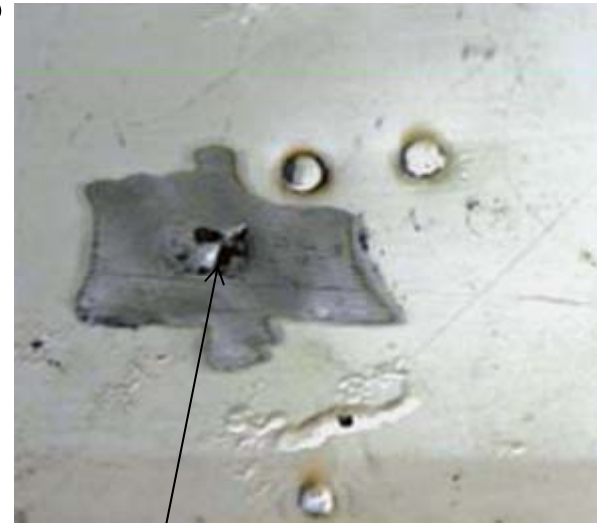
# Model 200 Series Elevators

- Foam filled trim tab and foam filled trailing edge
  - Absorbs moisture
    - Results in corrosion
    - Changes elevator balance
  - When trim tab skin thins due to corrosion, the actuator can pull the fasteners through skin and disconnect
  - Not repairable
  - Inspect for pinholes, surface roughness, bubbling
  - FAA SAIB CE-05-27R1 recommends replacement of tab and trailing edges with non foam filled parts

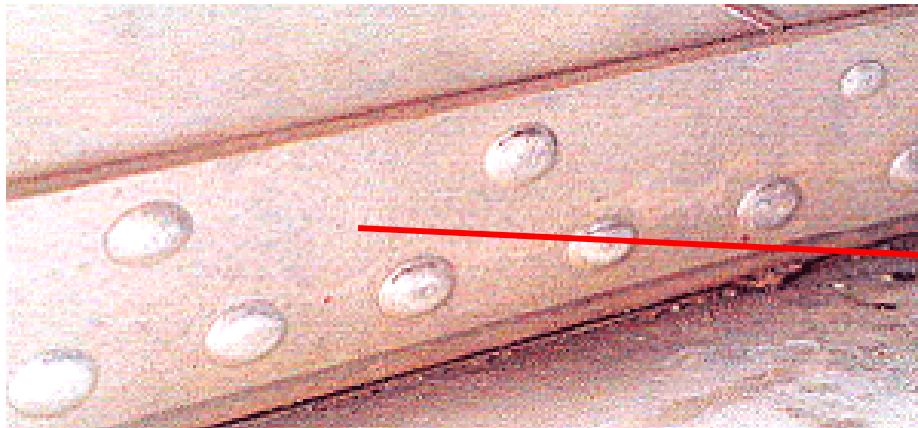
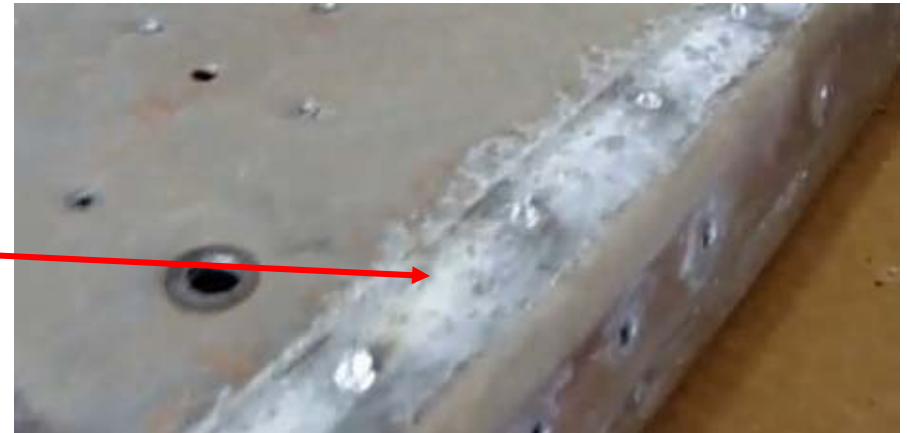
# Strut Braced Wing Front Spar

- Corrosion is often indicated by the discovery of a missing rivet
  - If rivet is missing, corrosion is likely to be severe
- Australia asks owners to remove leading edge after 15 years, inspect and reassemble with primer

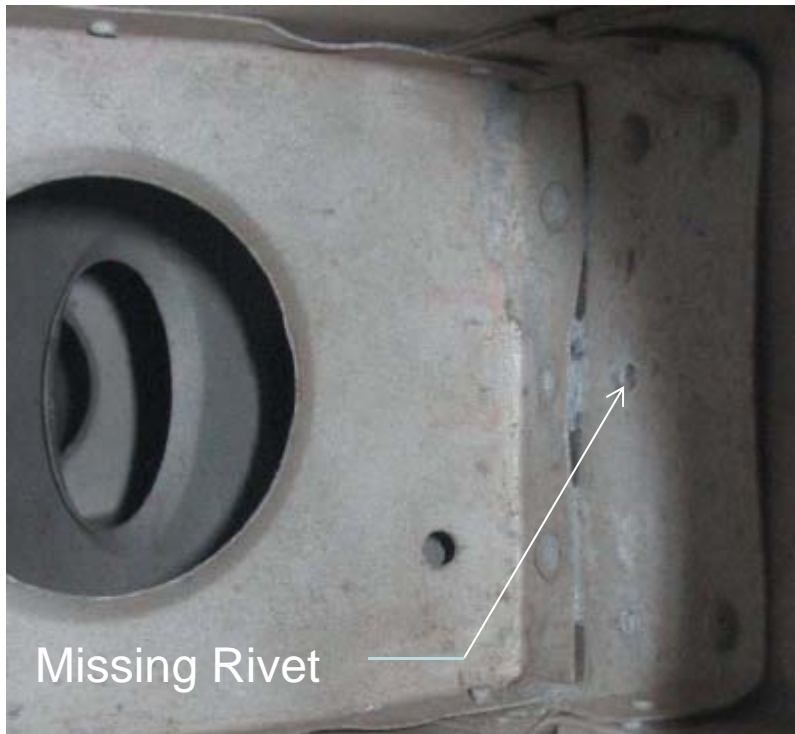
# Airframe Ribs

“A repair station found severe corrosion in the front and rear wing to fuselage attachments. There was so much corrosion (many of the rivets had broken off the wing’s rear attachment), and when the corrosion was removed many more rivets fell out. The vertical stabilizer was opened up and more significant corrosion was found.”

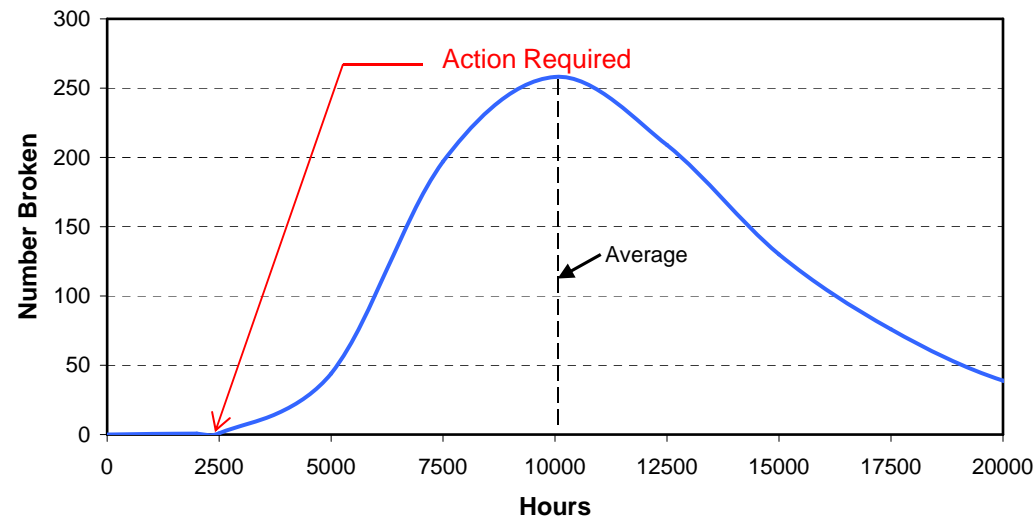
- When will it crack?
  - Suppose 1000 identical wing spars were fatigue tested with the same loads
  - Assume the average wing spar breaks at 10,000 hrs
  - They won't all break at the same time

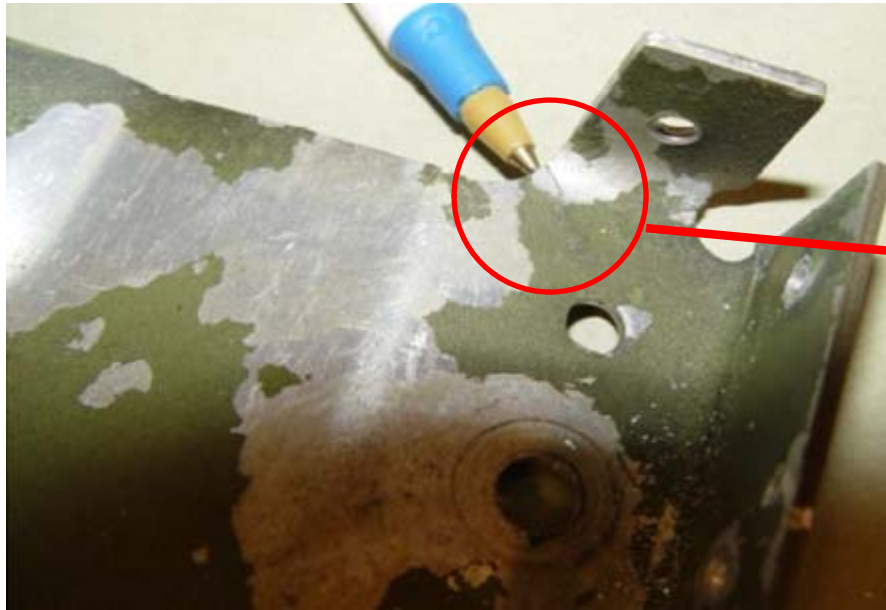
# 200 Series Aft Bulkhead

Source: FAA Maintenance Alert 43-16A, May 2011
