# Challenging Inspections of Offshore Pipelines by Intelligent Pig

Subsea Expo  
Integrity Management & Repair  
2<sup>nd</sup> February 2017

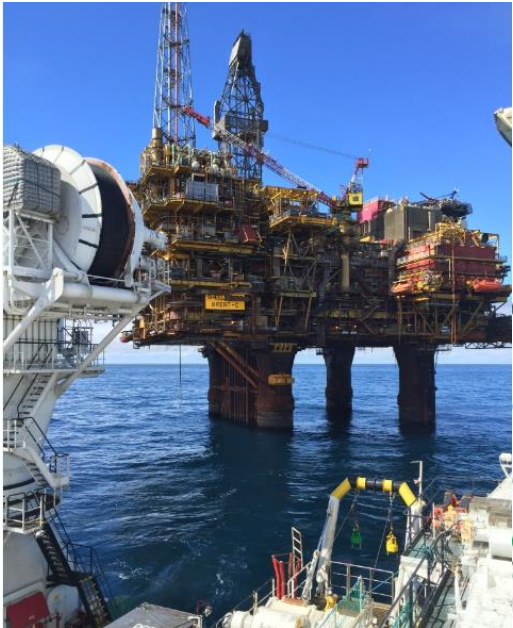
# Penguins to Brent C Field Layout

Penguins Data				
Property	DC2-DC3	DC3-DC4	DC4-DC5	DC5-BRENT C
Nominal Diameter	10"	16"	16"	16"
Length	3.6	5.7	4.8	52.1
Service	Multiphase Oil

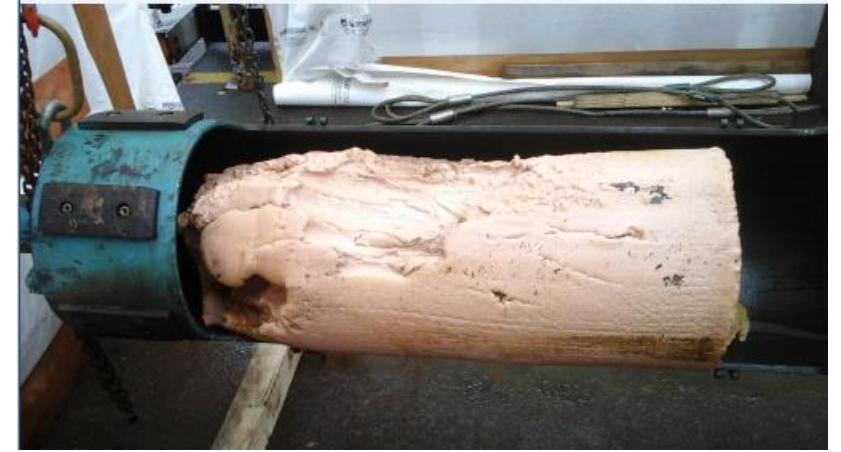
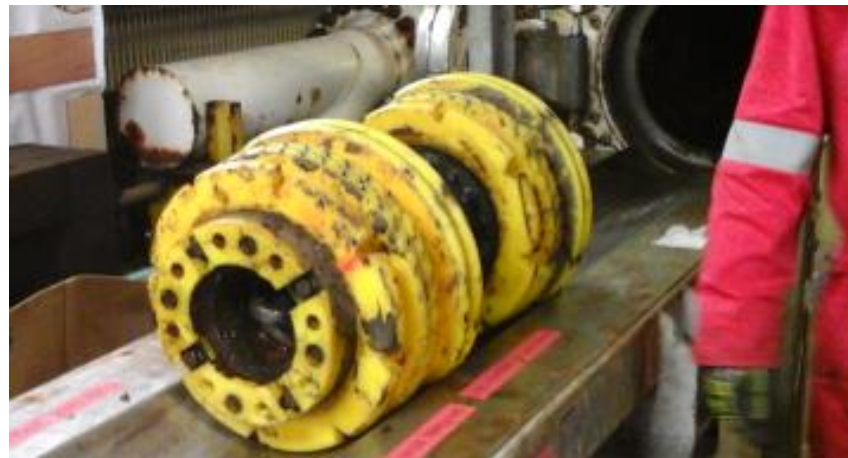
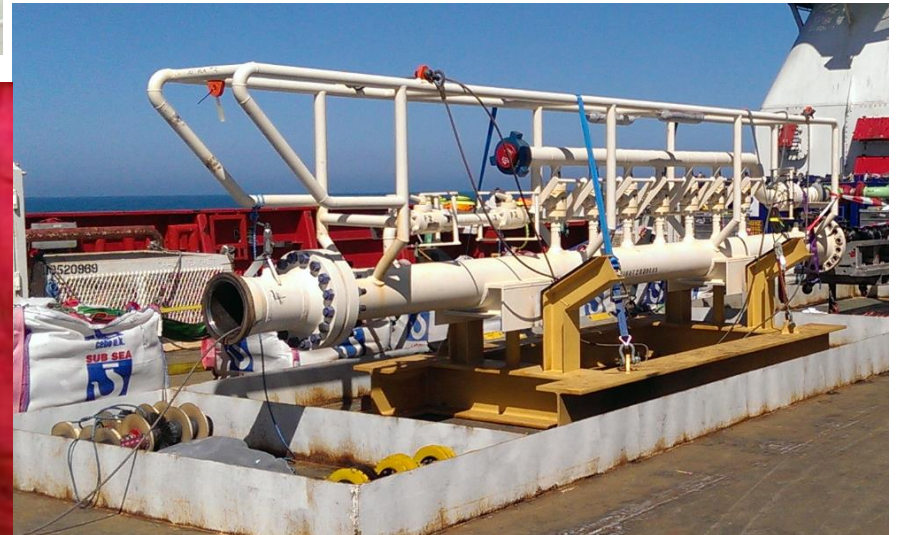
# De-oiling and Cleaning

- De-oil 10" into 16" using 10" pathfinder pigs
- De-oil 16" to Brent C process using gel pigs
- Switch to temporary debris handling package
- Run debris pick up gel
- Load chemical soak train
- Clean 10" & Inspect 10"
- Run 16" pathfinders
- Clean 16" & Inspect 16"

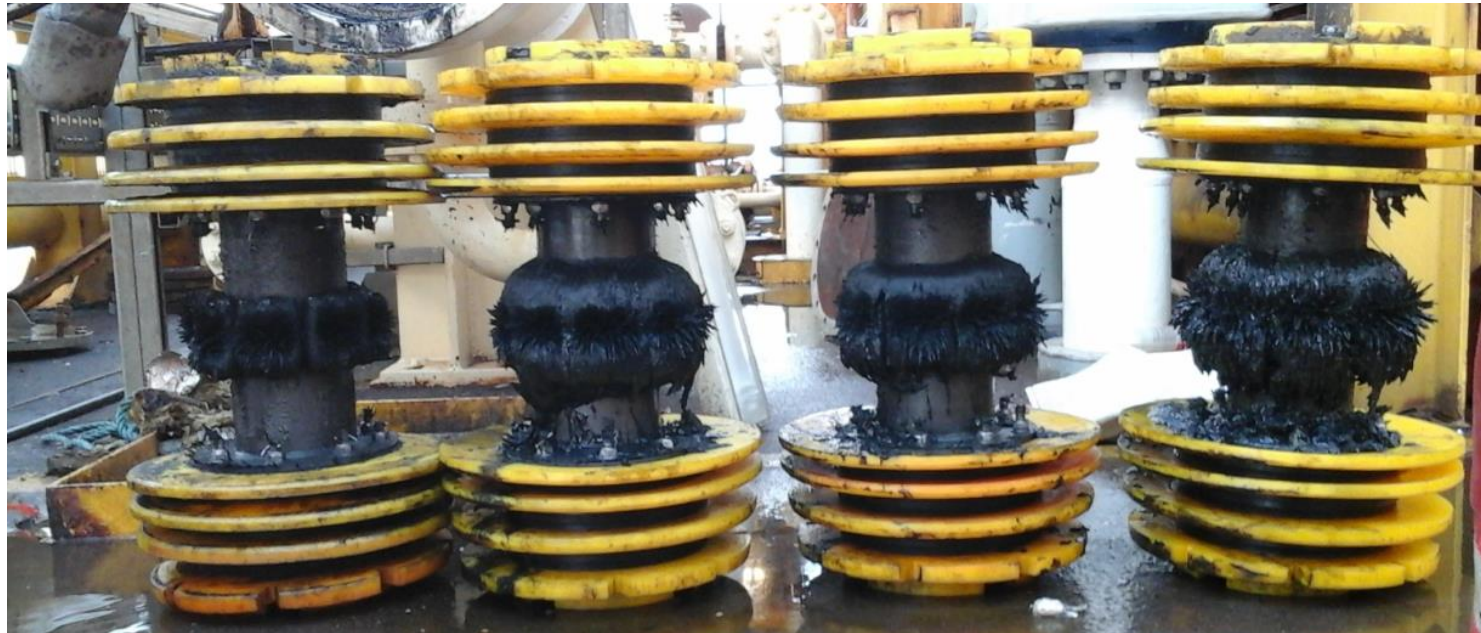
- 10" dewatering completed with MEG/Water mix supplied from the DSV.
- 16" dewatering completed with a pig train left in pipeline.
- Platform successfully re-started the Penguins Field following completion of the turnaround.
