# Composite Structure Fatigue and Damage Tolerance Experience

Boeing Commercial Airplane  
17 September 2015

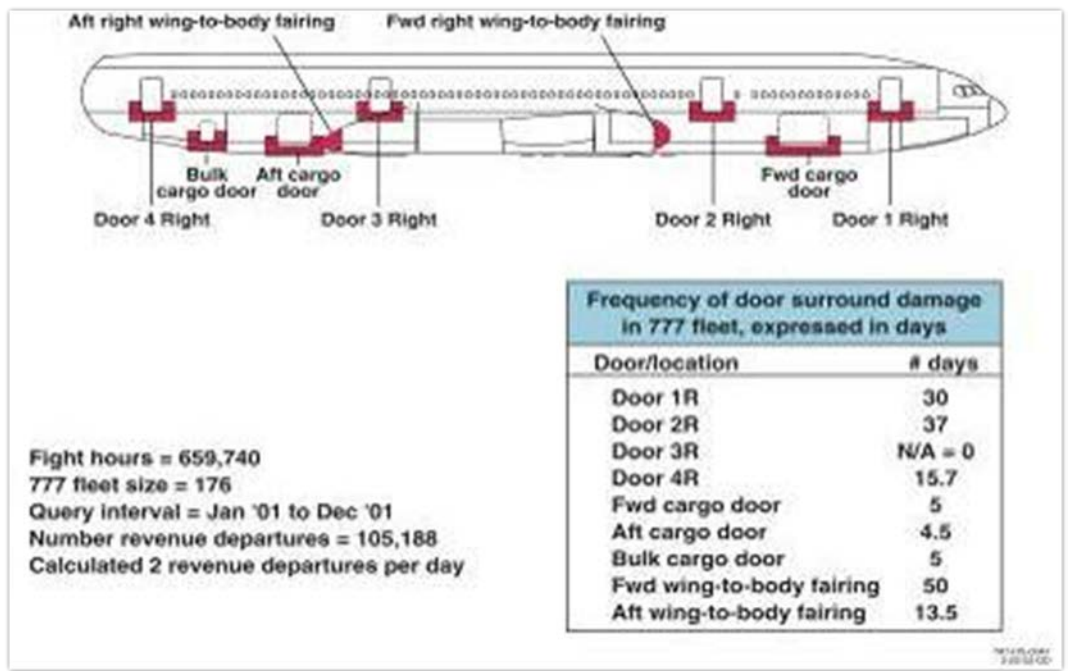
# In-Service Example – Lightning Strike

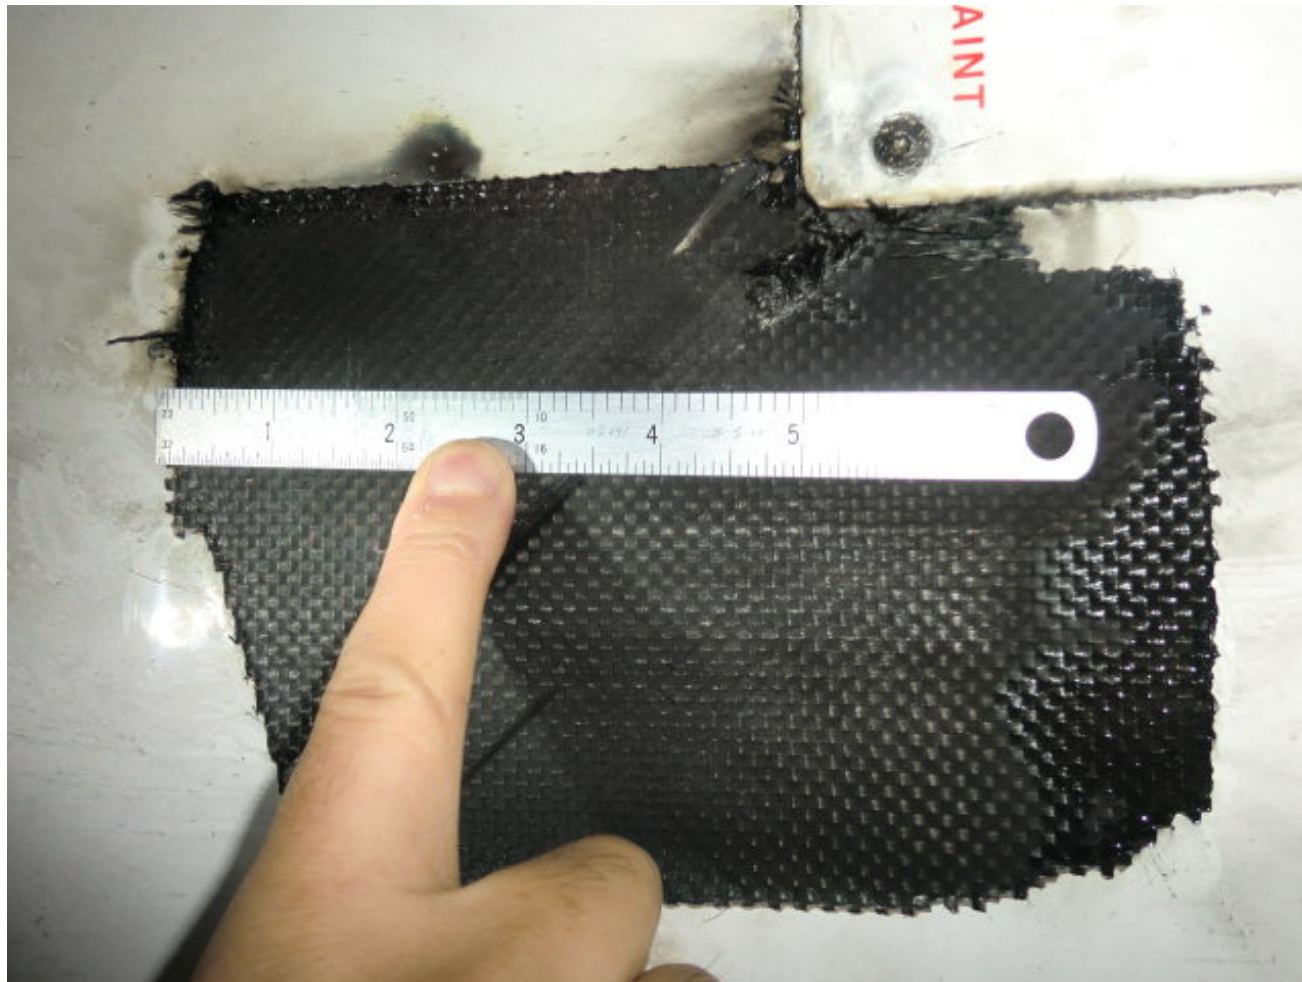
# In-Service Examples – Damage Resistance – Servicing Vehicle Impact

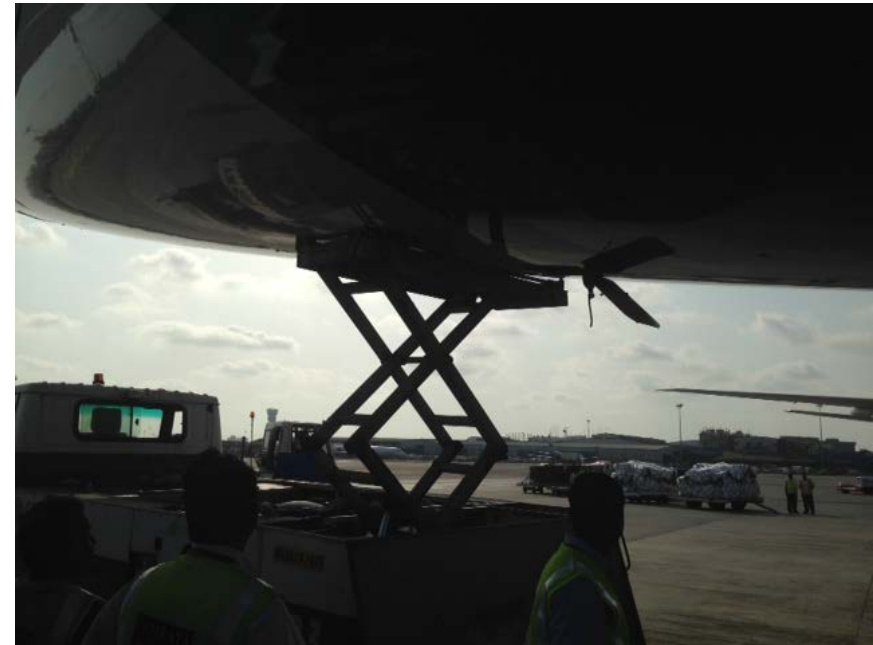
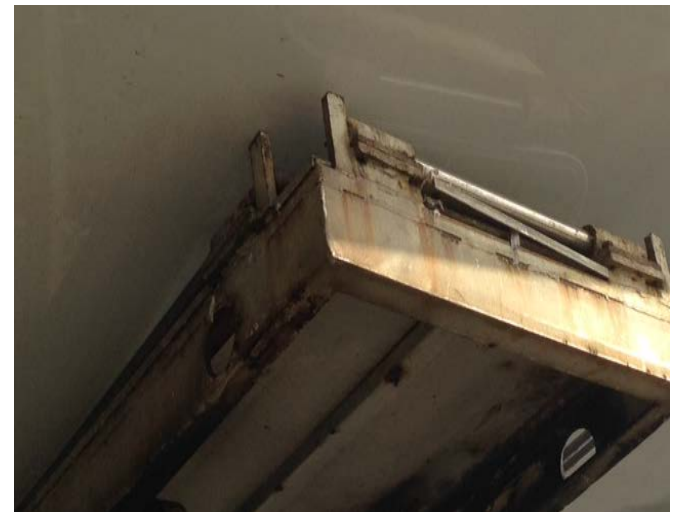
# In-Service Examples – Damage Resistance – Food Service Truck Impact

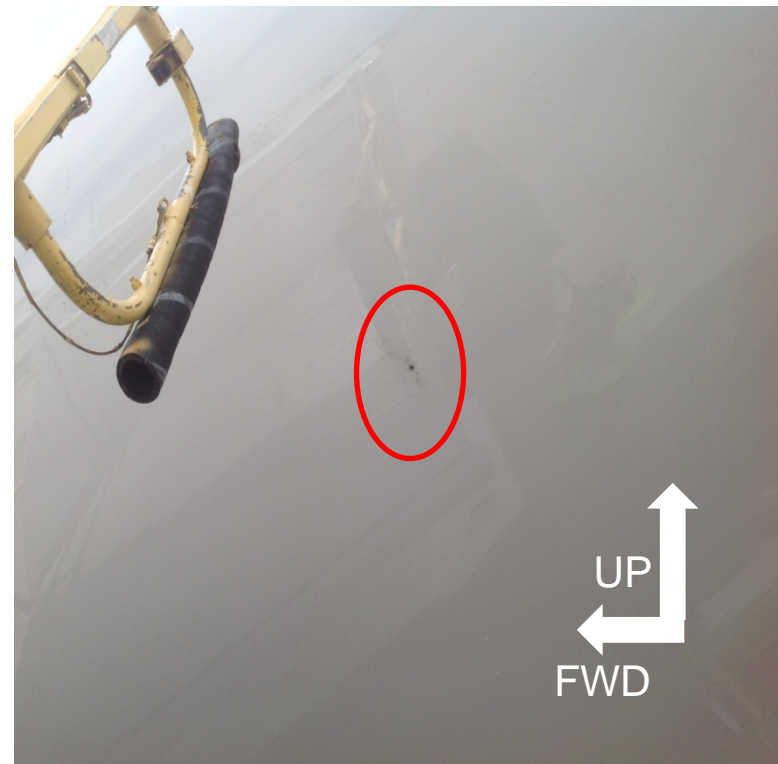
*787 Structure is proven to be robust and damage tolerant*

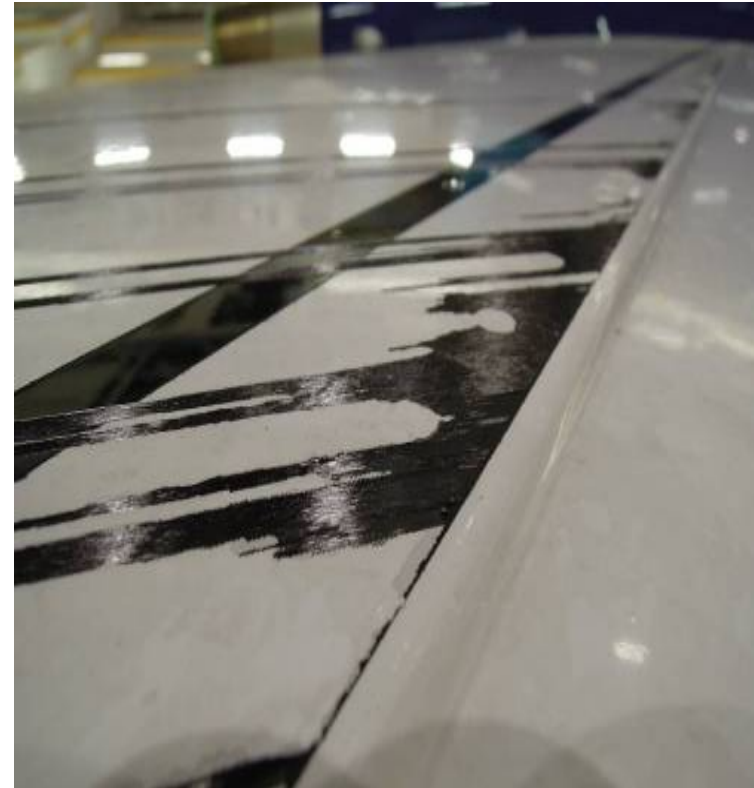
# Damage Categories – AC20-107

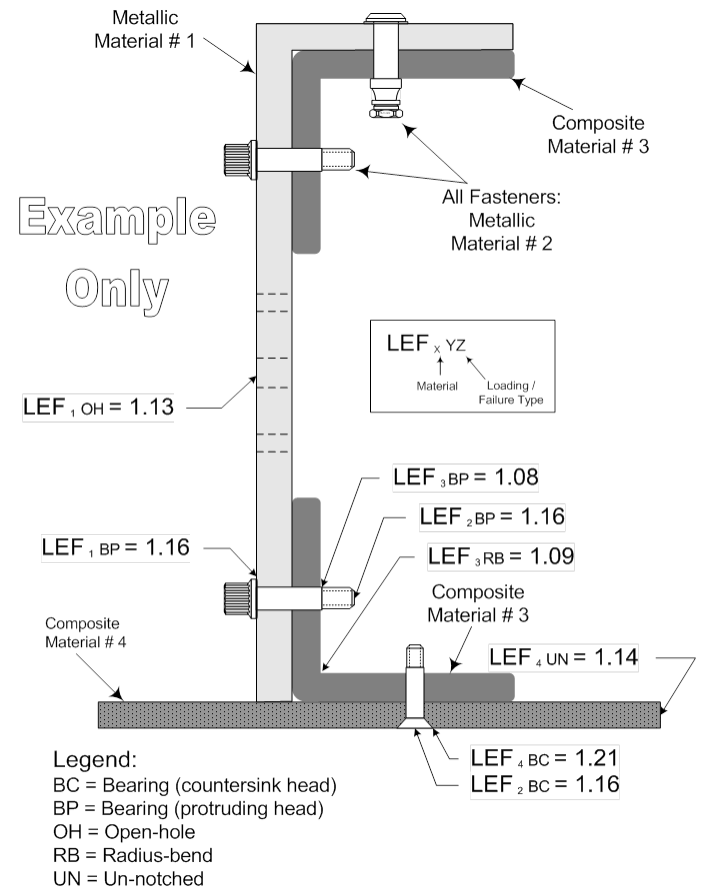
# Flight with Known Damage
