Corporate Report on the 8 July 2015 Tornado of Mira (VE), Italy

Time tornado on ground:	17:25 to 17:45 local time (CEST), 15:25 to 15:45 UTC
Affected communities:	Baluello (Pianiga) Arino (Dolo), Pianiga (Cazzago), Cazzago, Dolo (San Bruson), Mira, Porto Menai (Mira), Piazza Vecchia
Length of damage path:	11 km
Mean width of damage path:	700 m
Maximum width:	1000 m
Maximum intensity:	F4, violent
Number of fatalities:	1 (person was forced to stop car because of electric mast blocking the road, then car was picked up by the tornado)
Number of injuries:	72
Damage:	about 100,000,000 EUR
Accompanying hail:	5 to 7 cm

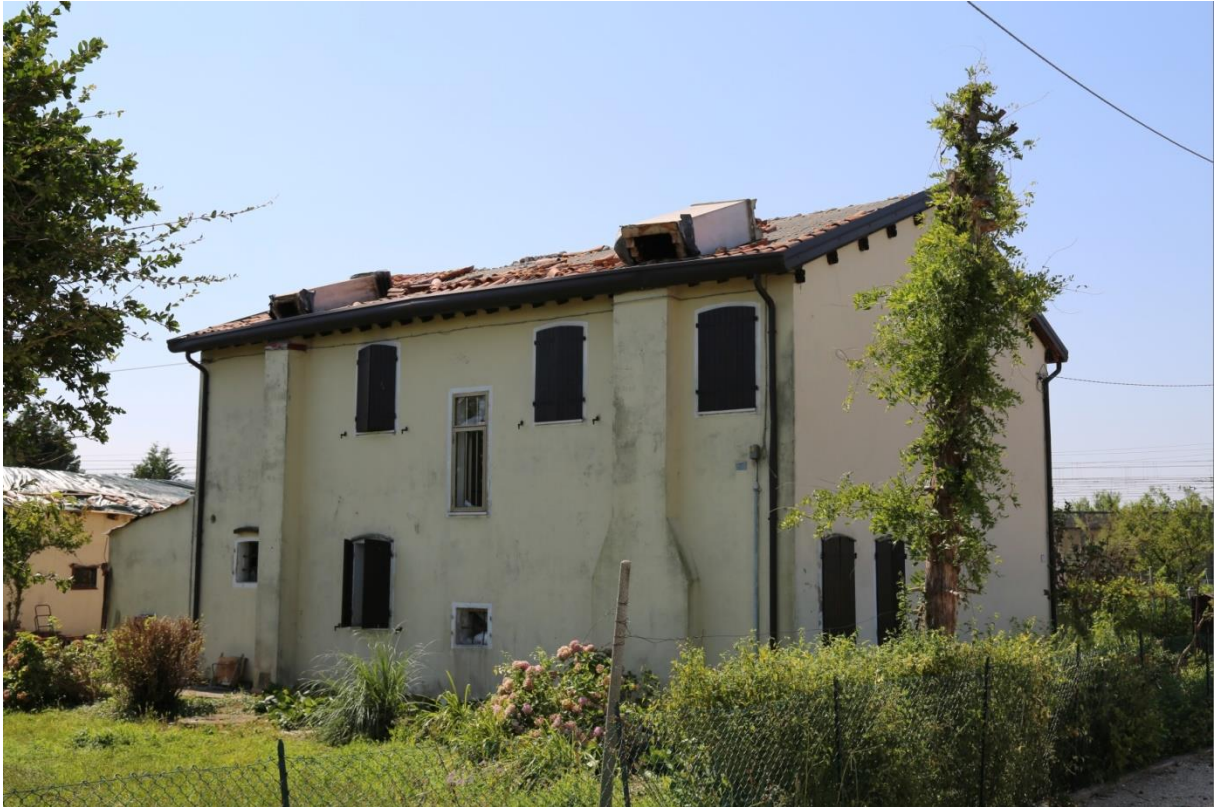
Image 1: Significant roof damage on a strong brick building (F2) in Pianiga (photo: Rainer Kaltenberger)

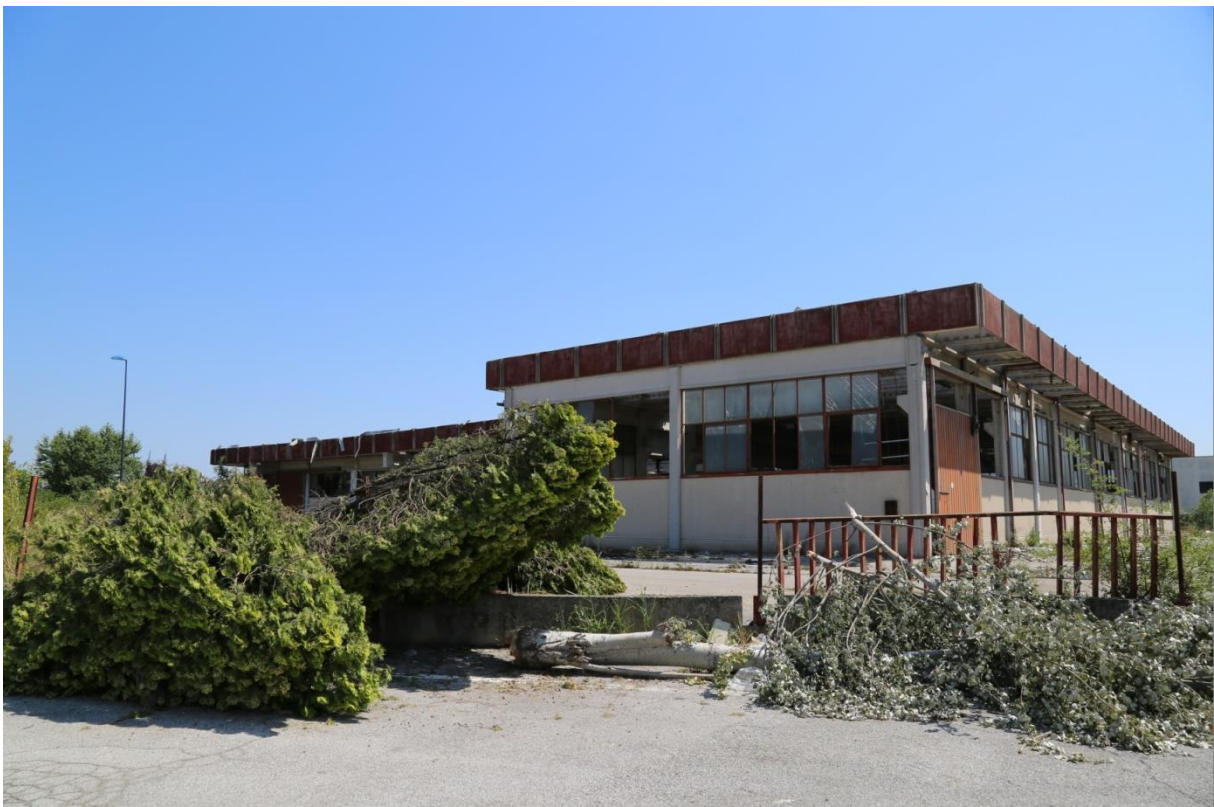
Image 2: F2 damage in Cazzago industrial zone (photo: Rainer Kaltenberger)

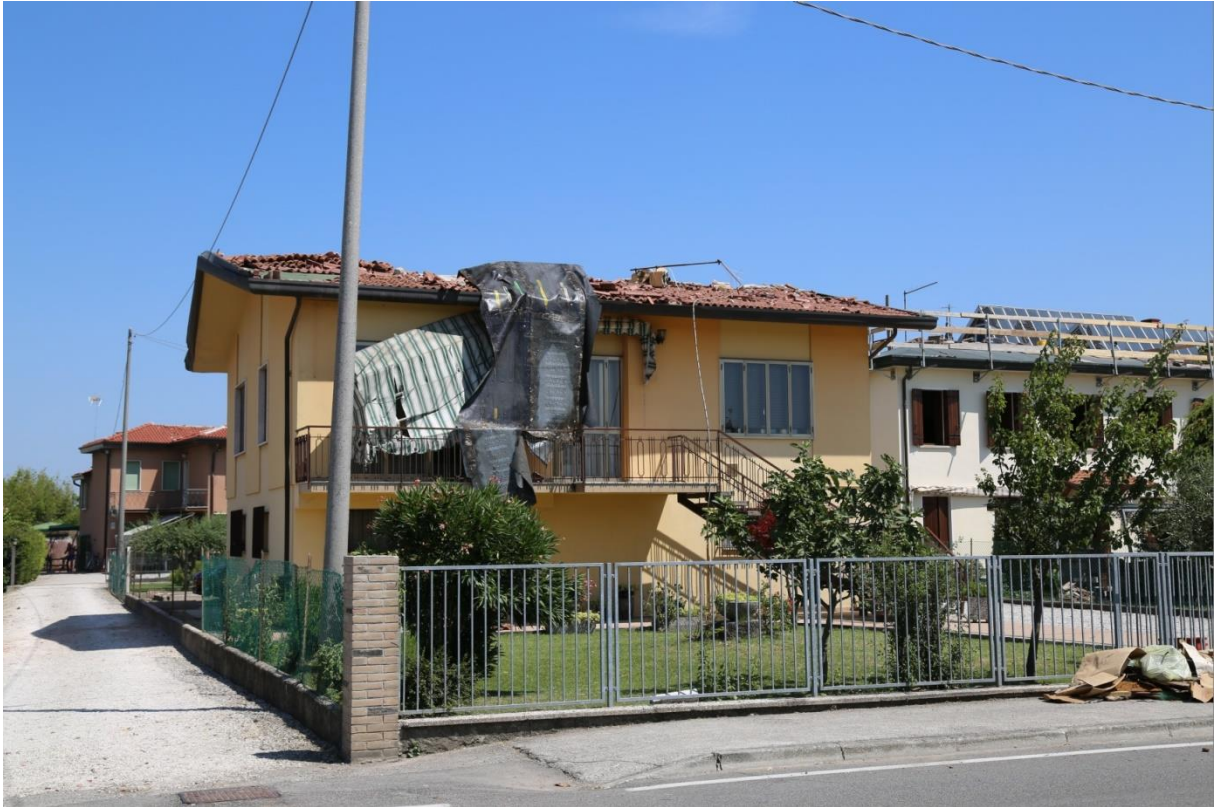
Image 3: F2 damage (significant roof damage to strong brick structure) in Cazzago (photo: Rainer Kaltenberger)

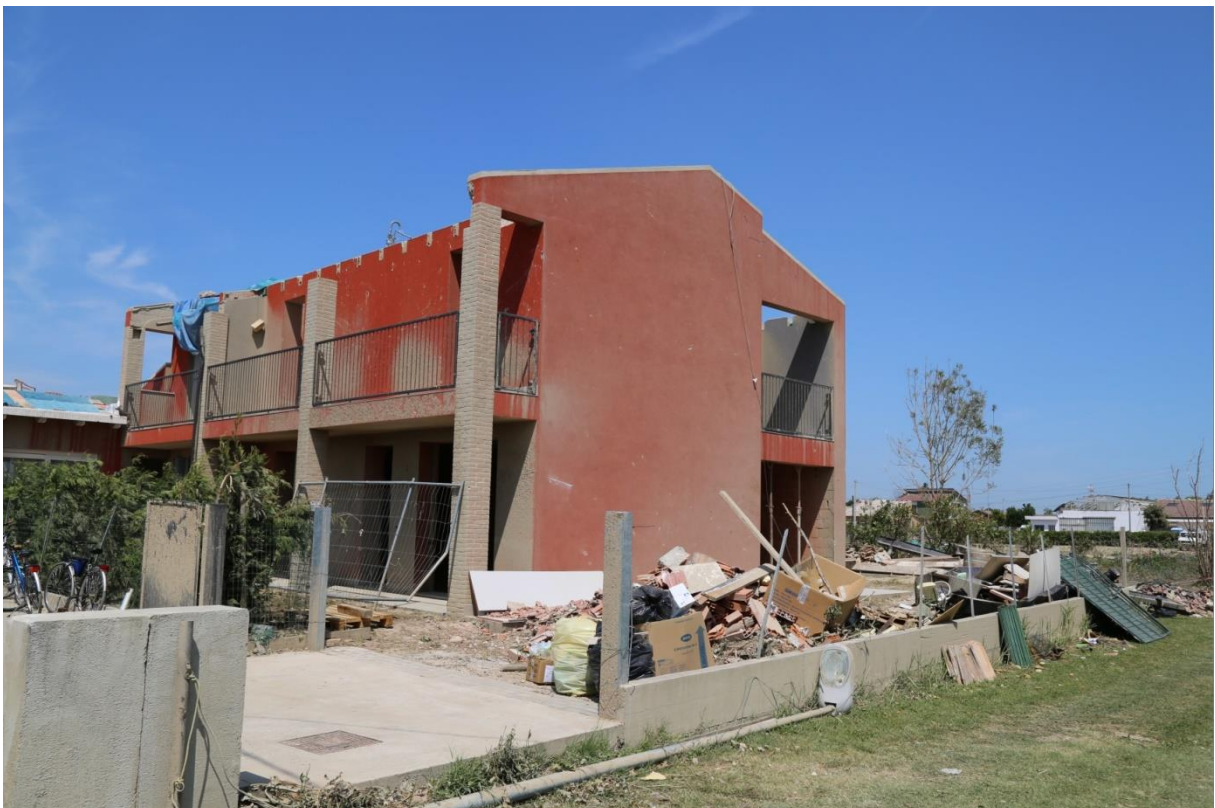
In the eastern neighborhoods of Dolo F3 intensity was typical close to the tornado center and many houses were badly damaged.

Image 4: F3 damage (strong brick structure, roof gone) to a house in eastern Dolo (photo: Rainer Kaltenberger)

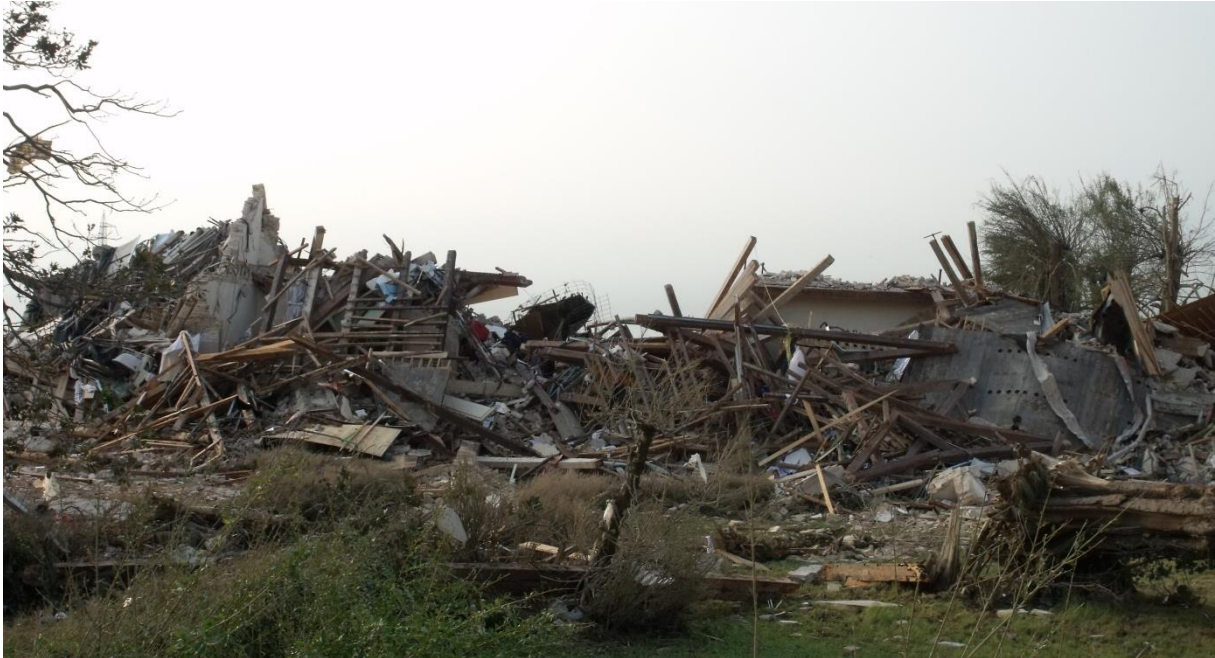
The western neighborhoods of Mira experienced the worst tornado impact. A few buildings were rated F4, including the historical Villa Fini. This villa was assumed to be a “weak brick building” damage indicator because of the very aged and crumbly mortar in between the bricks. This building totally collapsed.

Image 5: Remnants of Villa Fini (F4, collapsed weak brick structure) in western Mira (photo: Alberto Gobbi)

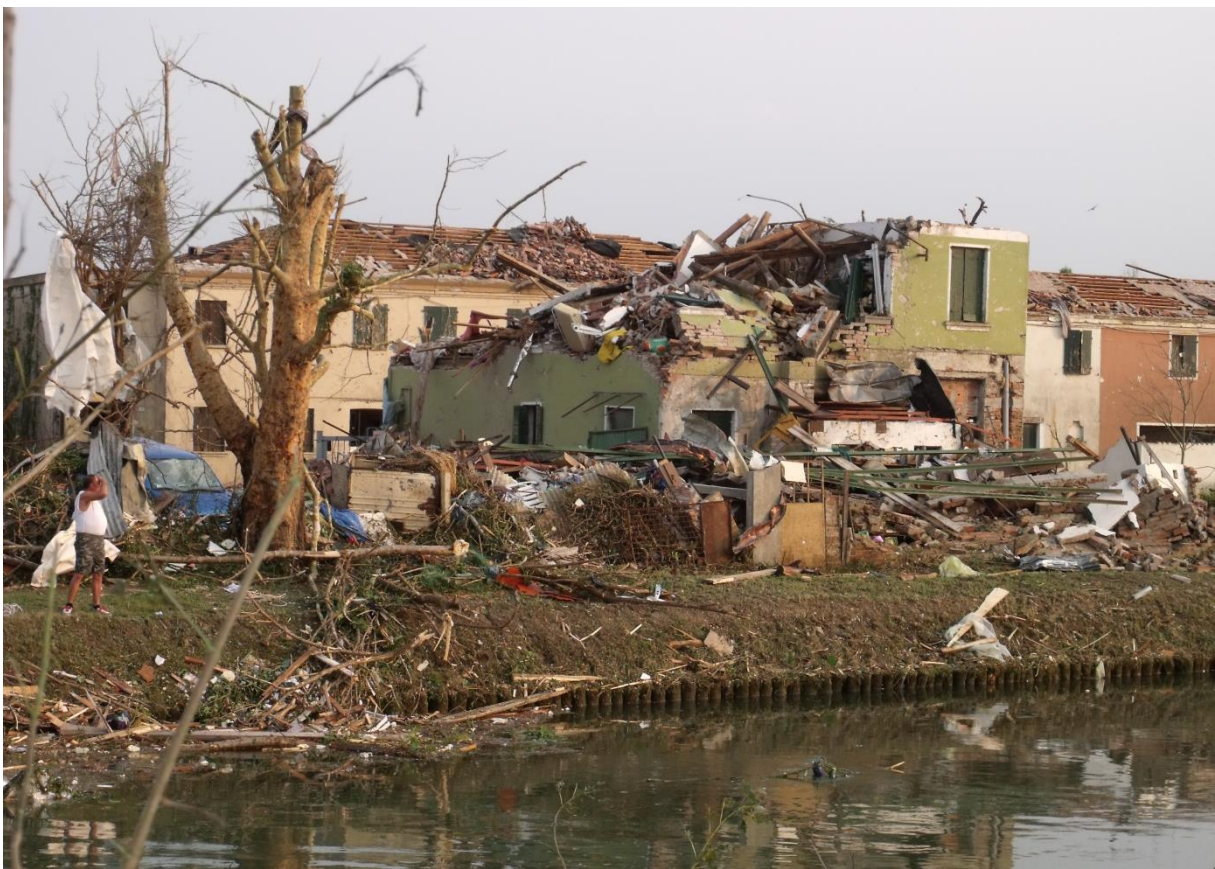
Image 6: F4 damage (strong brick structure, walls partly collapsed) in western Mira close to the Villa Fini, on the other side of the streamer (photo: Alberto Gobbi)

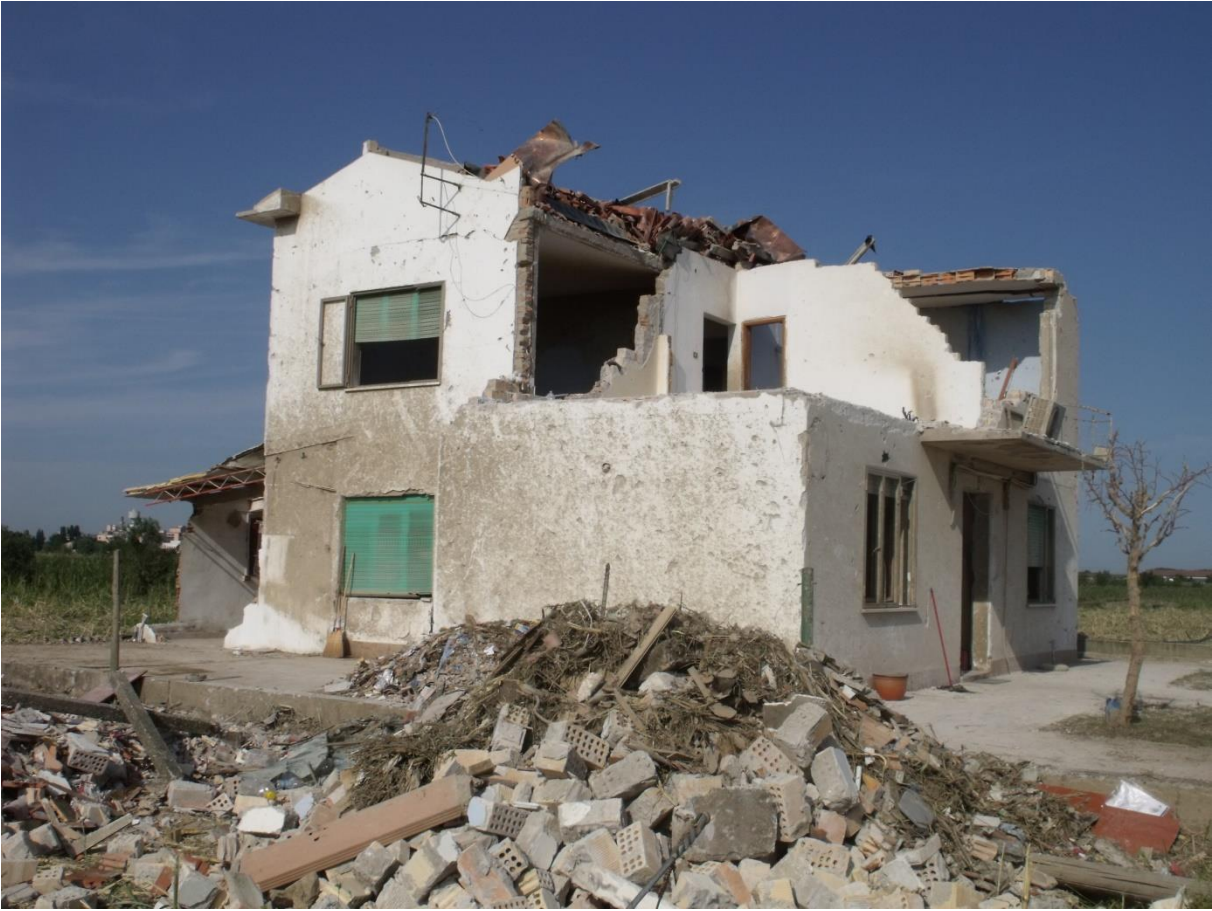
South of the Naviglio del Brenta the tornado still maintained an intensity of F4 or upper F3 for some time. A high voltage electric power pole was twisted and collapsed. Then the tornado reached open fields and then the southern settlements of Mira – still with F2 intensity south of Piazza Vecchia.

Image 7: South Mira F3+ damage (weak brick structure, walls partly collapsed, photo: Alberto Gobbi)

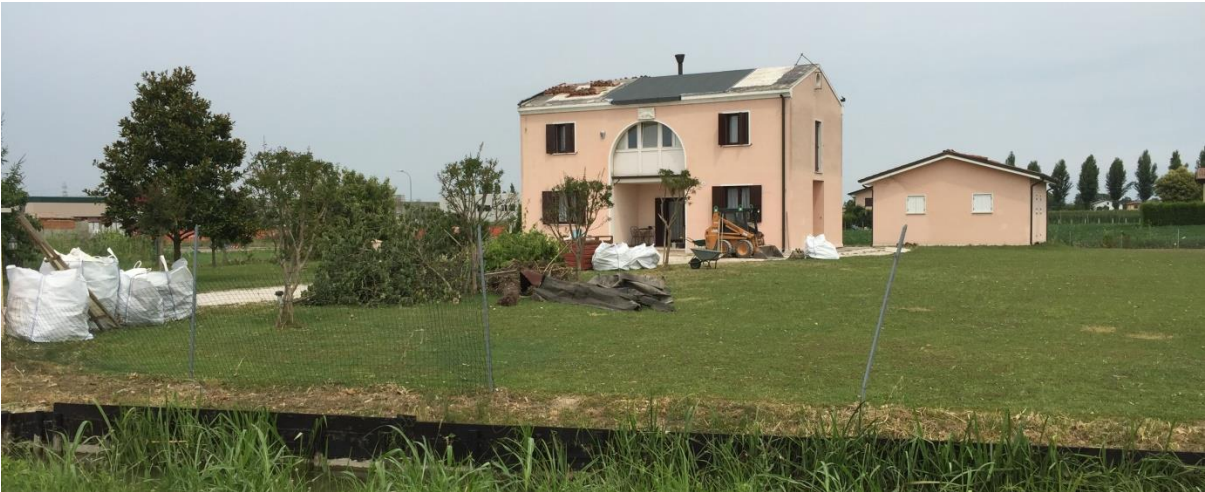
Image 8: F2 damage (strong brick structure, significant roof damage) in Piazza Vecchia (photo: Alois M. Holzer)
