Defects, their source and detection in wire drawn products

C. Mapelli, S. Barella, A. Gruttadauria, D. Mombelli, A. F. Ciuffini, M. Cusolito

KEYWORDS: WIRE DRAWING – DEFECTS – LIQUID STEEL – CASTING

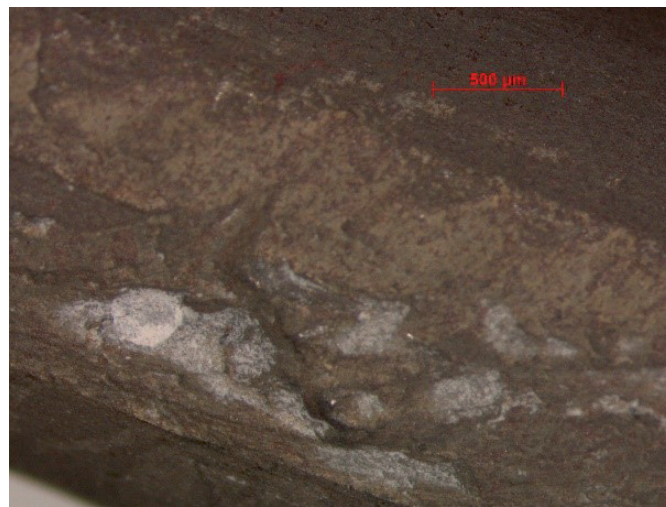
On several wire rods, after the first pass of drawing, some defects were detected after visual examination. These defects appear like slivers (Figure 1).

Fig. 1 – Slivers detected on the wire after the drawing

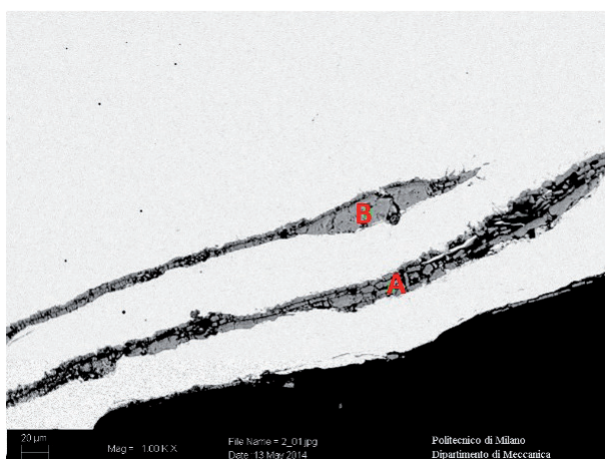
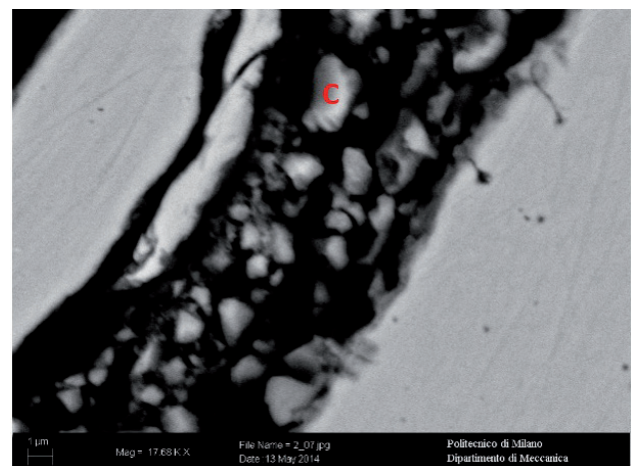
Fig. 2 – SEM-EDS analysis on the metallographic sample: (a) at low magnification and (b) at higher magnification. In A, B and C chemical analysis was performed (Table 1).

Figure 2 shows long inclusions under the surface of the wire. The inclusions, using the BSE probe, appear oxidized. The EDS analysis suggest that this defect is mainly iron oxide but, in some points, a high concentration of copper was detected. This flaw is due to a hot shortness phenomenon: the high concentration of copper creates a liquid film between the grain and some cracks are formed. The defect origin is probably related to the deformation processes prior to the wire drawing (i.e. hot

rolling) as a consequence of the high oxidation level featuring the observed crack.

Tab. 1 – Chemical composition in A, B and C in Figure 2

% by weight	C	O	Ca	Mn	Fe	Cu
Fig.2 A	30,68	20,50	0,52	-	45,44	2,86
Fig.2 B	8,04	13,86	-	-	78,10	-
Fig.2 C	12,78	15,31	0,71	-	69,74	1,47

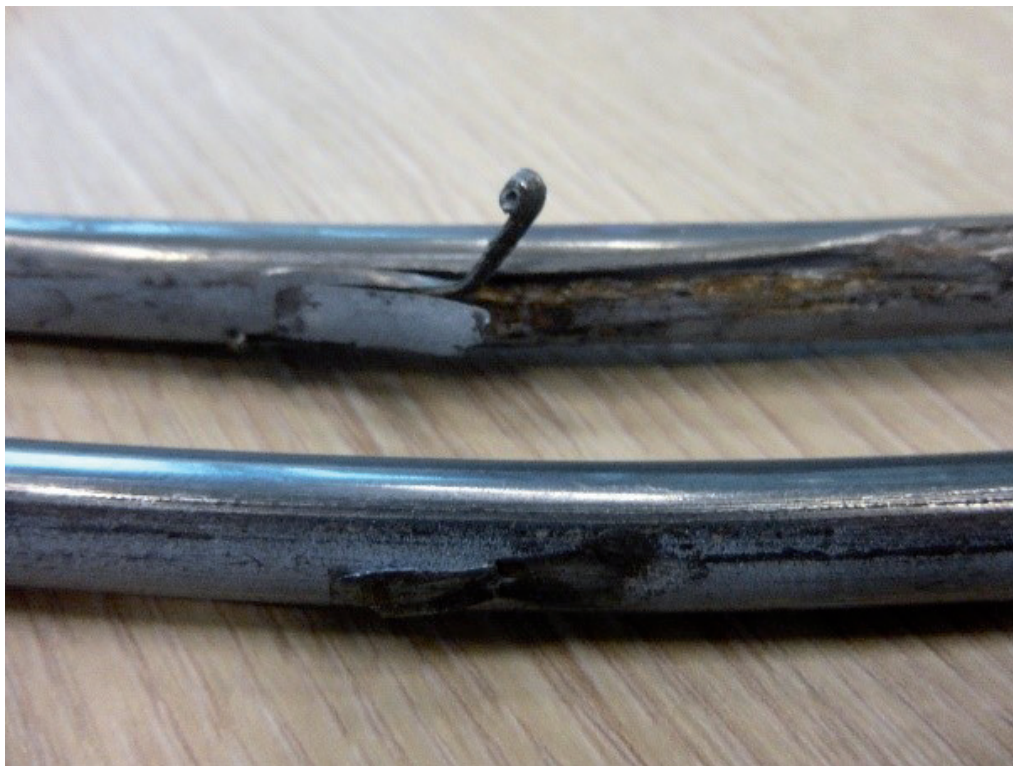
On several wire rods, at the end of the drawing process, some defects were detected after visual examination. These defects appear like laminations (Figure 3) pointing out the typical shape similar to the tool chipping.

Fig. 3 – Laminations on wire drawn products (diameter 7mm).

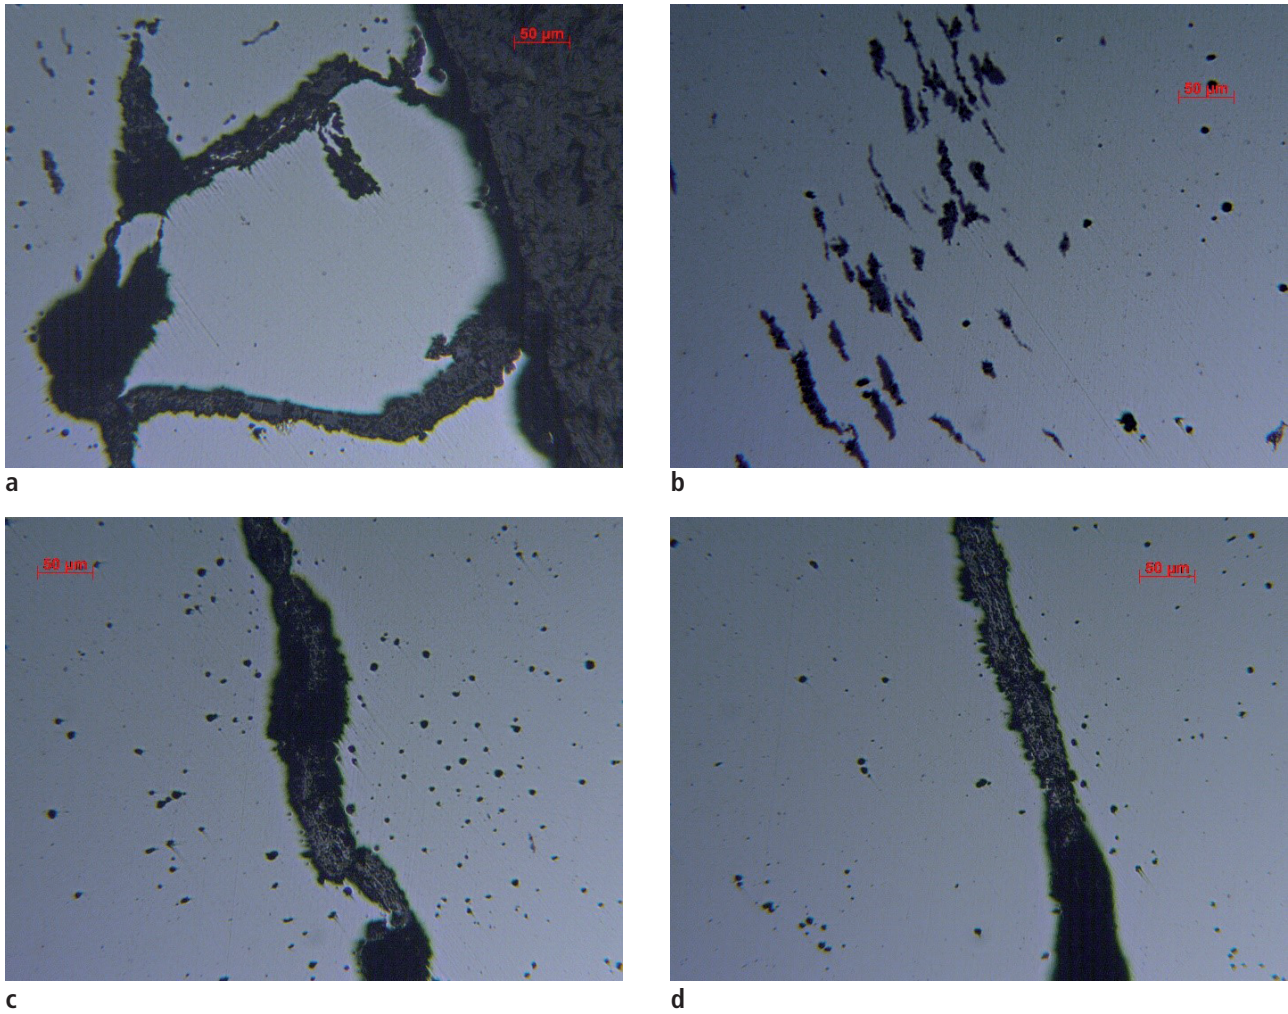
Fig. 4 – OM of the defects

Figure 4 shows many flaws in the sub-cortical zone of the sample: there are some cracks (Fig.4-a), some non-metallic inclusions (b) and a huge number of porosities proximal to the cracks. All these factors could have given a contribute to the lamination formation. Sub-superficial cracks are often oxidized and, during the drawing process, they tend to open. Moreover,

deformable inclusions tend to align and because of their poor ductility (if compared to the matrix) they tend to break under the high stress and strain generated by the process.

The SEM-EDS analyses shows a relevant cracks oxidation and the chemical composition of the nonmetallic inclusions (Table 2).

These inclusions can be originated by the re-oxidation of the steel in the tundish or in the mold during the continuous casting process. This phenomenon creates the Si and Mn oxides and promotes the gas formation inside the molten metal.
Example 3

Tab. 2 – Non-metallic inclusion chemical composition (Fig.4-b)

% by weight	O	Si	Ca	Mn	Fe
Inclusion (fig. 4-b)	20,83	29,33	2,04	44,24	3,56

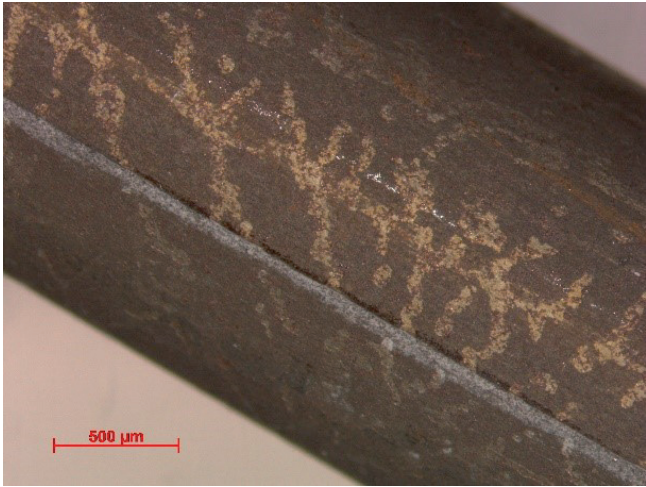
On several wire rods, at the beginning of the drawing process, some defects were detected after visual examination. This defects can lead to failure or scarp at the endo of the drawing. These defects appear like seams (Figure 5).

Fig. 5 – Seams on a wire before the wire drawing

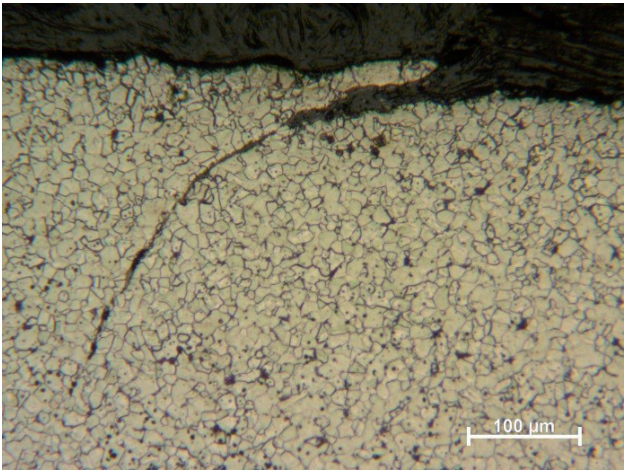
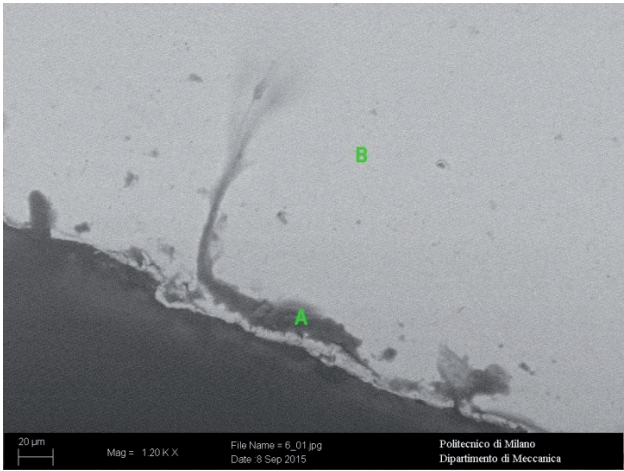
Fig. 6 – Micrographic investigation on transversal section of the wire in Figure 5: (a) optical microscopy and (b) SEM-EDS analysis.

Figure 6-a shows some non-metallic inclusions featured by a particular curvature. This "hook" is peculiar of lubricant entrapment due to pronounced oscillation marks arisen during

the continuous casting. SEM-EDS supports this hypothesis because of the detected chemical composition (Table 3).

As a matter of fact, this chemical composition is typical of the powder used in the mold during the continuous casting. The lubricant viscosity, the oscillation frequency and the mold stroke have to be taken into account for the formation of such a defect [9].

Tab. 3 – Local chemical composition: figure 6-b point A

% by weight	O	Na	Al	Si	Cl	K	Ca	Fe	Mo
Fig.6 A	35,64	12,15	2,81	15,58	12,78	5,09	1,91	8,99	5,05
