Design and Testing of a High Voltage Feedthrough for Extending IEC Operations to 300 Kilovolts

University of Wisconsin–Madison, Fusion Technology Institute

16th US-Japan Workshop on Fusion Neutron
Sources for Nuclear Assay and Alternate Applications
University of Wisconsin | Madison, WI | Sep. 1 – Oct. 2, 2014

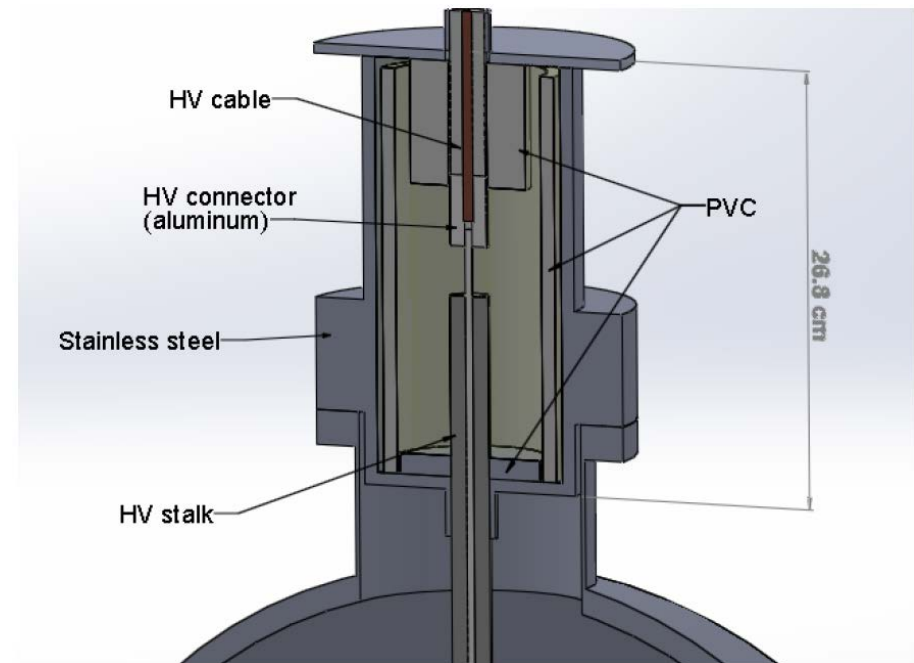
Old HELIOS HV Feedthrough Design

- 200 kV design
- 200 kV cable coupled to molybdenum stalk conductor via banana-style connector
- Stalk held by Swagelok-style, nylon ferrule compression fitting
- Vegetable based oil filled, PVC jacket increase voltage standoff

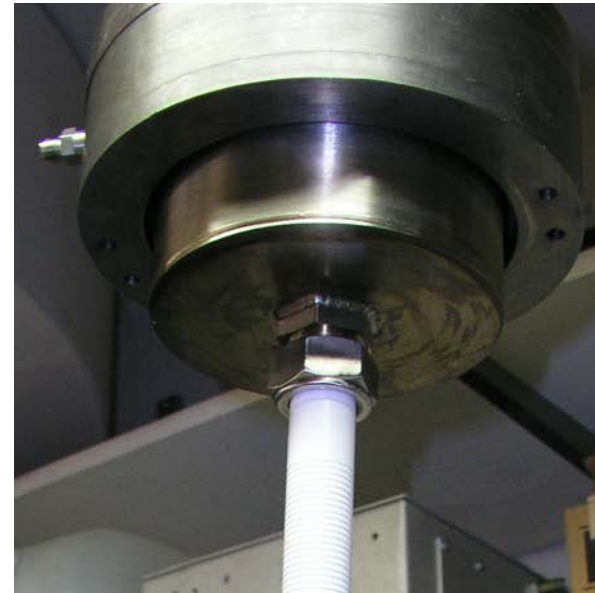
Swagelok style oil to vacuum seal

- Most common failures:
 - Pin-hole type failure near vacuum sealing compression nut
 - Over tightening of ferrule can fracture boron nitride (BN) stalk
 - Oil leak if ferrule is not tight enough

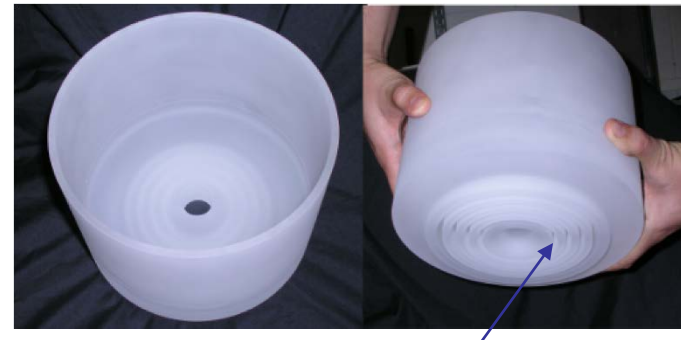
Grooves increase path length to ground

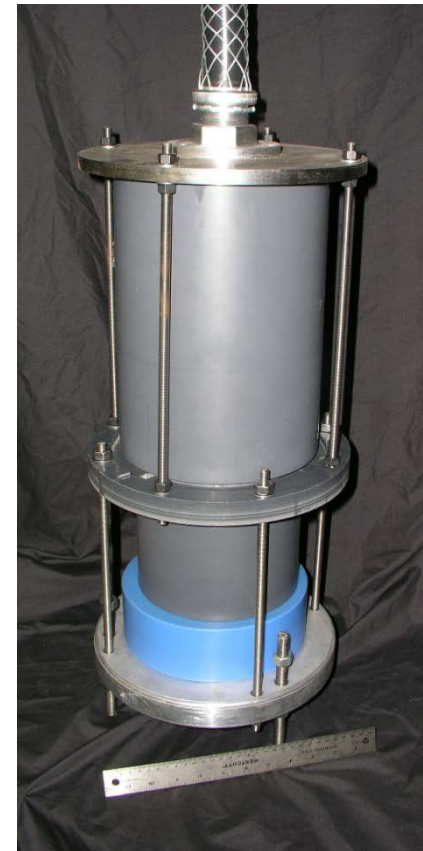
- MC901 cast unfilled nylon 6 (blue nylon) base replaces quartz bowl
- Features good mechanical and dielectric strength (2MV/m), vacuum compatible, excellent wear resistance
- Double o-ring fitting for radial sealing against stalk

Fully assembled blue nylon base HV feedthrough

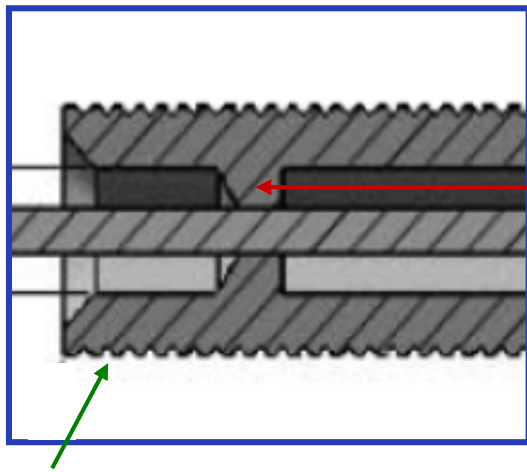
BN collar shields moly rod from fast ion bombardment

PYRE-ML coating prevents oil permeation

Grooves add:

- Increased path length to ground
- Maintains breaks in metal surface coating from sputtering

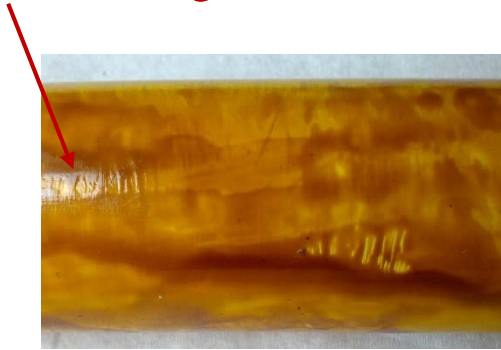
- Helium testing showed leaks at o-ring to PYRE-ML seal due to **poor surface coating**

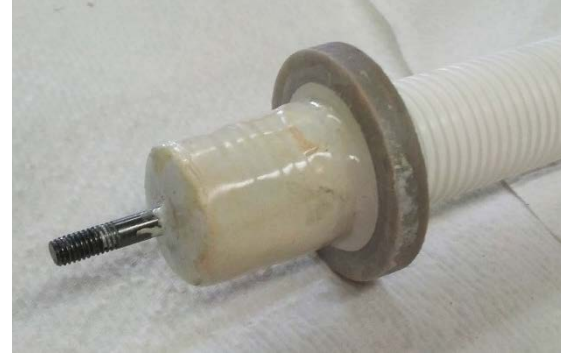
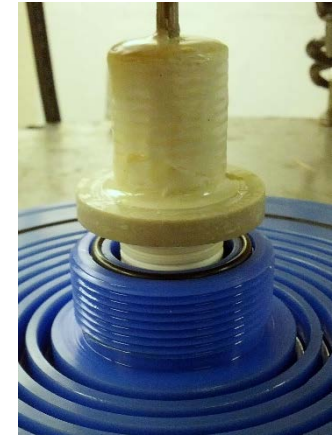
- Top of stalk coated and sealed to macor plate using vacuum epoxy eliminates oil permeation
- Face seal o-ring provides oil to vacuum barrier

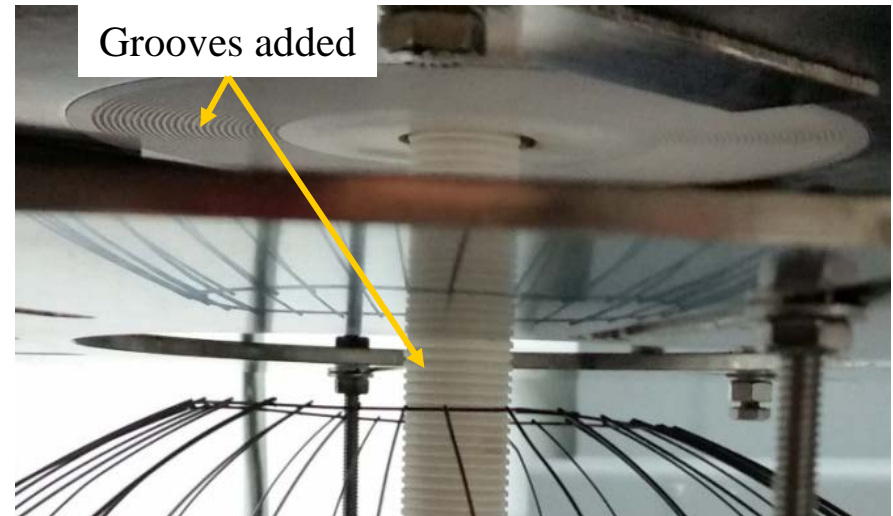
- Stalk grooves: 0.075 inch deep, 0.050 inch wide
- Grooves added to ceramic shield plate
- Increased lifetime of stalk at higher power runs

Improved HV feedthrough performance from 110 kV to 165 kV thus far...
