DETERMINING THE SPATIAL VARIABILITY OF NITRATE REMOVAL IN A WOODCHIP BIOREACTOR THROUGH HIGH FREQUENCY MONITORING AT MULTIPLE LOCATIONS

**Aldrin Rivas^{1*}, Greg Barkle², Bryan Maxwell³, Brian Moorhead¹, Roland Stenger¹,
Louis Schipper⁴, François Birgand³, Juliet Clague¹**

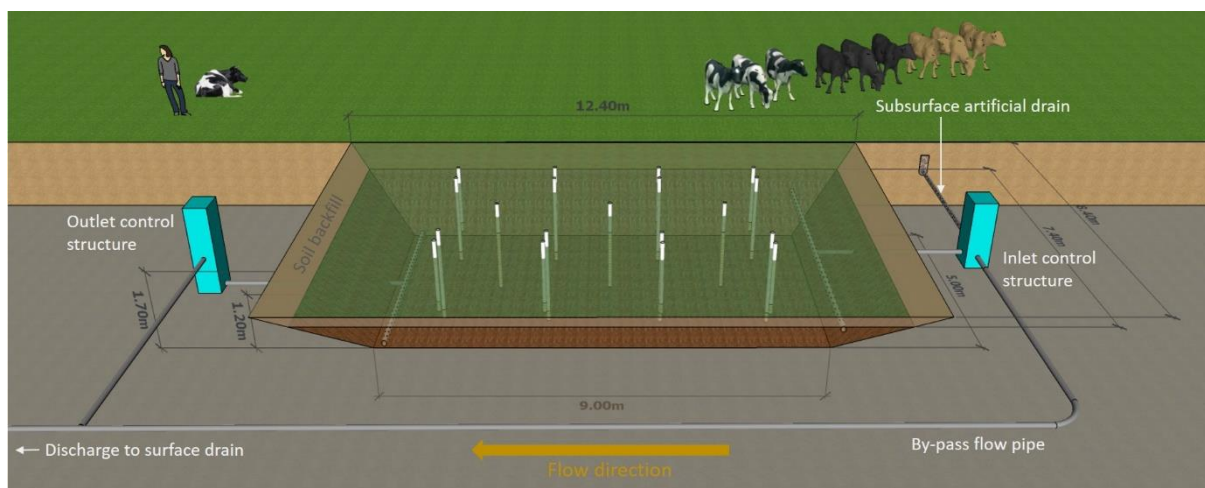
Figure 1 Schematic of the Tātuanui woodchip bioreactor showing the main components of the bioreactor and the monitoring wells from which water was drawn for high-frequency measurements of nitrate. Flow direction is from right to left.

We monitored the nitrate concentrations in a woodchip bioreactor constructed in 2017 on a dairy farm near Tātuanui in the Hauraki Plains, Waikato, New Zealand (Figure 1). The lined bioreactor, which is trapezoidal in shape, has an effective volume of 56 m³ and intercepts drainage water from an artificial subsurface drain with a drainage area of approximately 0.65 ha. More information on the bioreactor and its performance have been published previously (Rivas *et al.* 2019; Rivas *et al.* 2020).

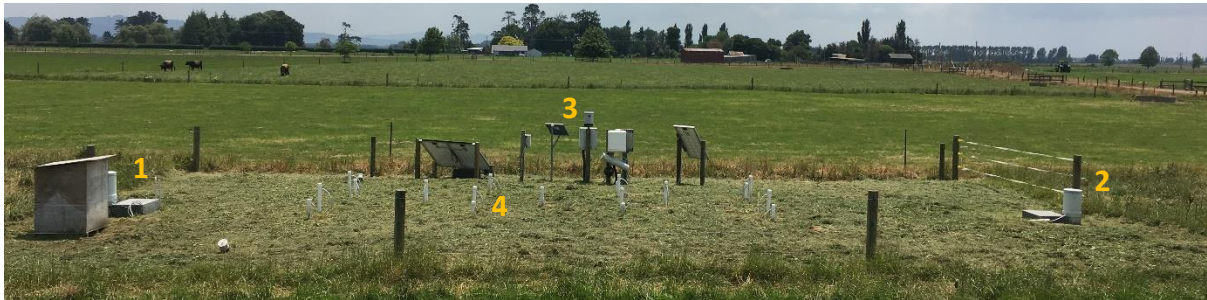
Figure 2 Photo of the completed installation of the woodchip bioreactor showing the main components: (1) inlet control structure with auto sampler and stilling well, (2) outlet control structure with auto sampler and stilling well, (3) multiplex sampling system and optical sensor, rain gauge, solar panel, and control panels for the instruments, and (4) monitoring wells. Flow direction is from left to right.

Nitrate concentrations were monitored using a multiplexer sampling system by pumping water from the inlet, outlet, and 19 wells installed in the bioreactor to the optical nitrate sensor (Figure 2). In 2018, high-frequency monitoring was conducted in the later part of the drainage season,

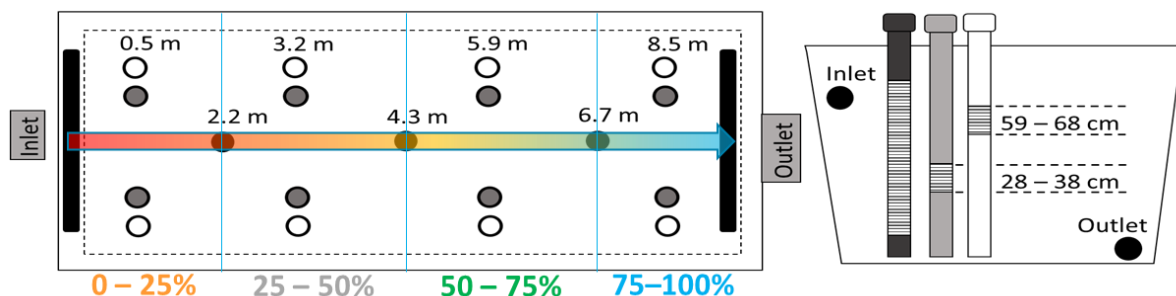
Figure 3 Plan and section diagram of the bioreactor showing the locations and depth of screen, respectively, of the monitoring wells. The arrow across the bioreactor shows the flow direction. Modified from (Maxwell 2019).

While nitrate concentrations were monitored at the two control structures and 19 monitoring wells inside the bioreactor, this paper presents only the results from the control structures and the three fully-screened wells located along the centre line. The changes in nitrate concentrations and thus removal are analysed in quarter sections corresponding to the locations of the centre line wells as shown in Figure 3.

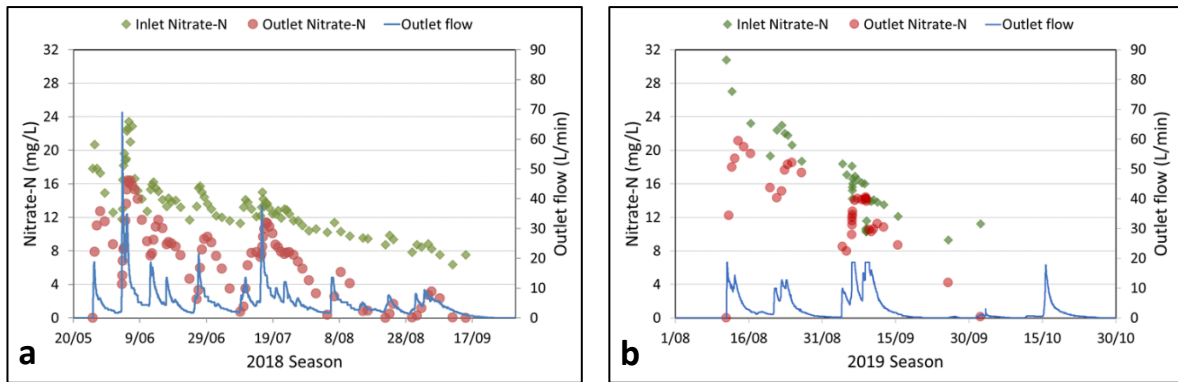
Figure 6 Nitrate-N concentrations at the inlet and outlet at the Tatuani bioreactor in (a) 2018 and (b) 2019.

As expected, nitrate-N concentrations at the outlet were consistently lower than concentrations at the inlet, indicating nitrate removal in the bioreactor during the 2018 and 2019 seasons (Figure 6). Maximum nitrate-N concentrations at the inlet were approx. 24 mg/L in 2018 and up to 32 mg/L in 2019. A decreasing trend in inlet nitrate-N concentrations is apparent in both years, indicating the gradual depletion of the nitrate pool stored in the soil profile during the drainage season. However, short-duration nitrate peaks were observed throughout the season, reflecting the flushing out of nitrate from the soil zone during high-flow events.

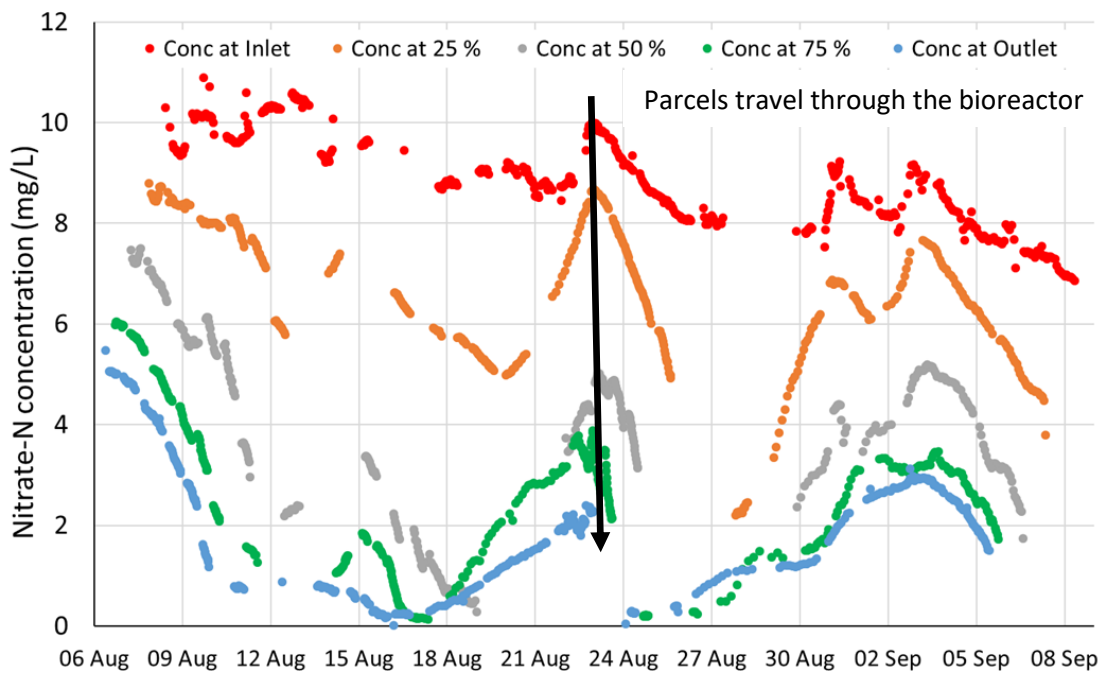
Figure 8 Nitrate-N concentrations at the inlet and outlet plus three centre line wells at the Tatanui bioreactor measured in 2018 and adjusted to match the time of a parcel of water when it entered and exited each section of the bioreactor.

Hourly measurements of nitrate at the inlet, outlet and the three centre line wells during 8 Aug – 8 Sep 2018 showed the change in concentrations over the length of the bioreactor (Figure 7). A substantial decrease in nitrate-N concentrations from the inlet through the centre line wells to the outlet was evident. The peak concentrations in nitrate-N occurring at different times for the different time series shown reflects the travel time required from one sampling location to the next. Taking this travel time into account allows the nitrate-N concentration peaks to be matched (Figure 8). Two-hourly measurements in 2019 show the same time-lag characteristics (Figures 9 and 10).

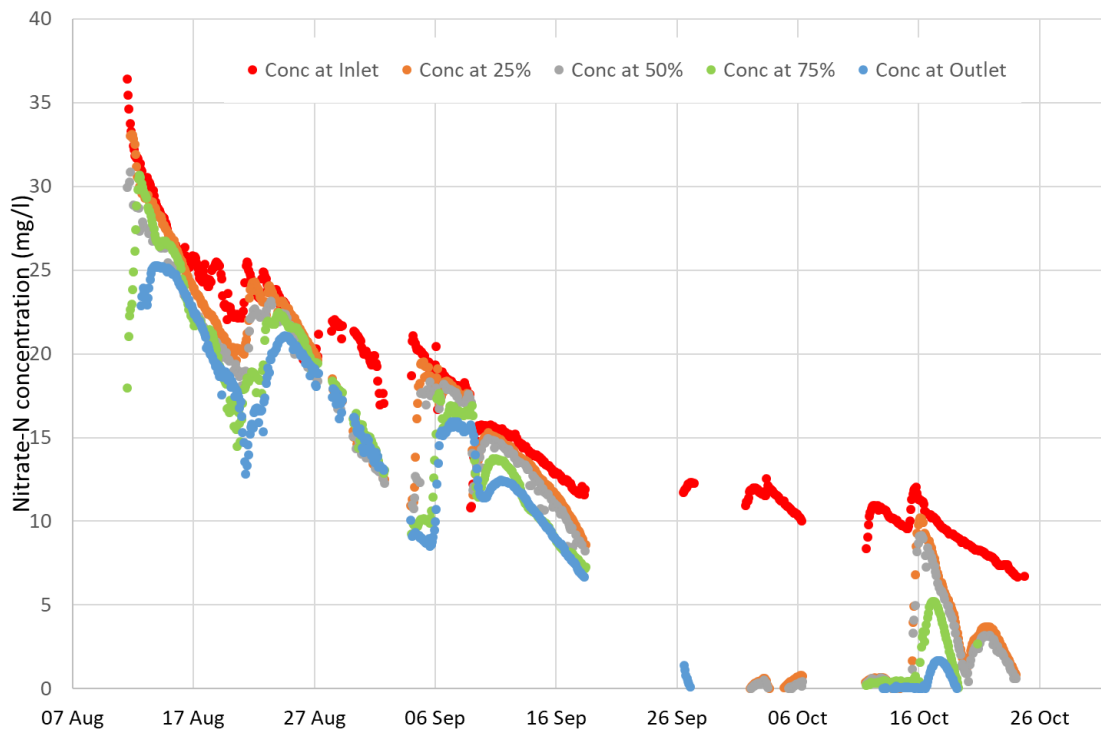
Figure 9 Nitrate-N concentrations at the inlet and outlet plus three centre line wells at the Tatanui bioreactor measured in real-time at high frequency in 2019.

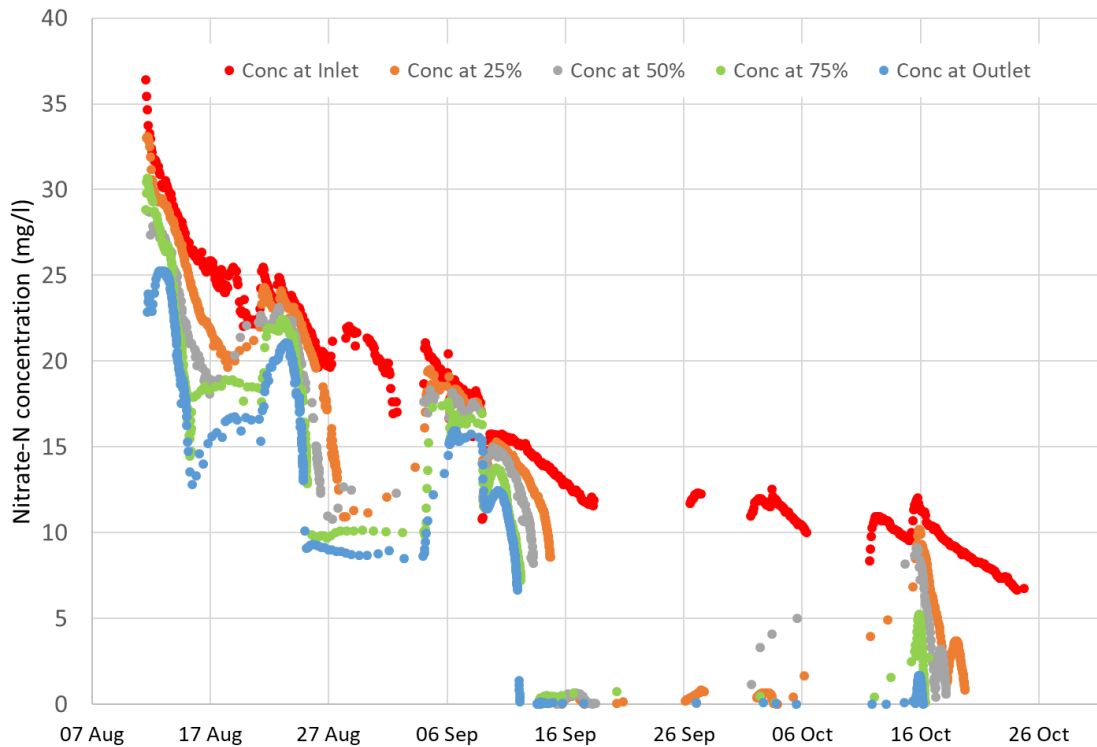
Figure 10 Nitrate concentrations at the inlet and outlet plus three centre line wells at the Tatuani bioreactor measured in 2019 and adjusted to match the time of a parcel of water when it entered and exited each section of the bioreactor.
