**Principal Investigator** Gene Roberson  
**Region Director** R.M. Seeley  
**Date of Report** 4/15/2011  
**Subject** Failure Investigation Report – Texas Gas Transmission Internal Corrosion

## **Failure Investigation Report – Texas Gas Transmission Internal Corrosion**

8/4/2009 and 11/4/2009

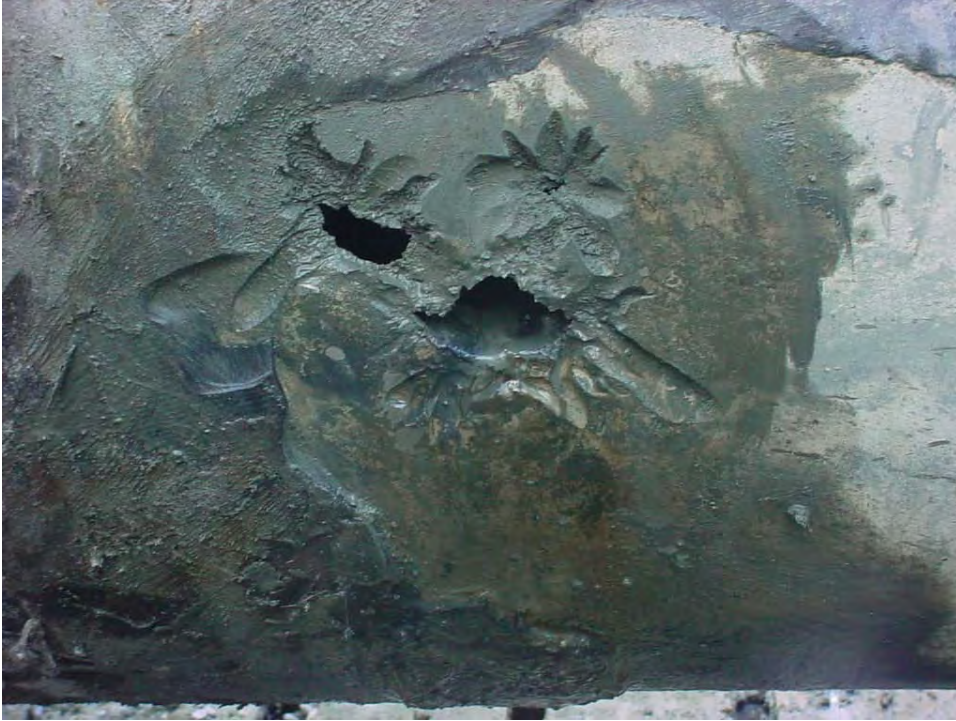
The operator indicated that prior to shutting in this pipeline, corrosion inhibitor was injected and internal corrosion monitoring was accomplished by monitoring ER Probes and weight loss coupons. However, upon isolating the system, there was no flow, and the pipeline was no longer injected with inhibitor nor monitored. The operator further determined that the internal corrosion was a result of microbiologically influenced corrosion (MIC).

**Figure 1** Photo of leak at MP 28.

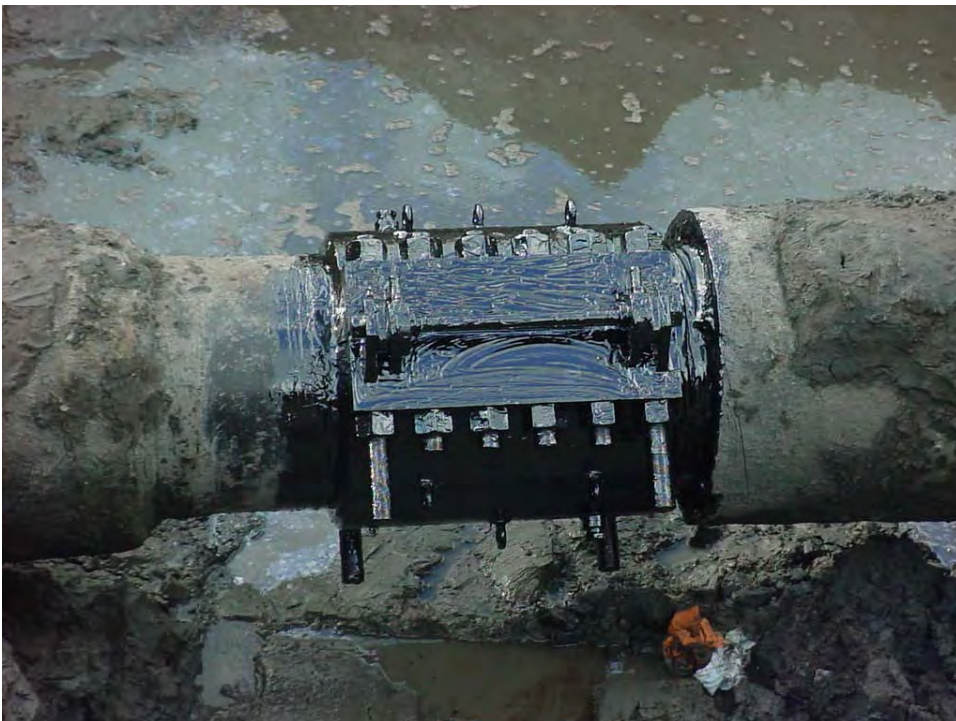
**Figure 2** Installed PLIDCO sleeve at leak site MP 28

Upon excavation of the failure, Texas Gas identified internal corrosion as the cause of the failure and installed a PLIDCO split sleeve over the leaking area of pipe on August 24 through 26, 2009 (See Appendix C).
