REPORT NO.  
UCB/EERC-80/04  
FEBRUARY 1980

EARTHQUAKE ENGINEERING RESEARCH CENTER

# EFFECTS OF AMOUNT AND ARRANGEMENT OF WALL-PANEL REINFORCEMENT ON HYSTERETIC BEHAVIOR OF REINFORCED CONCRETE WALLS

RAMZI ILIYA  
VITELMO V. BERTERO

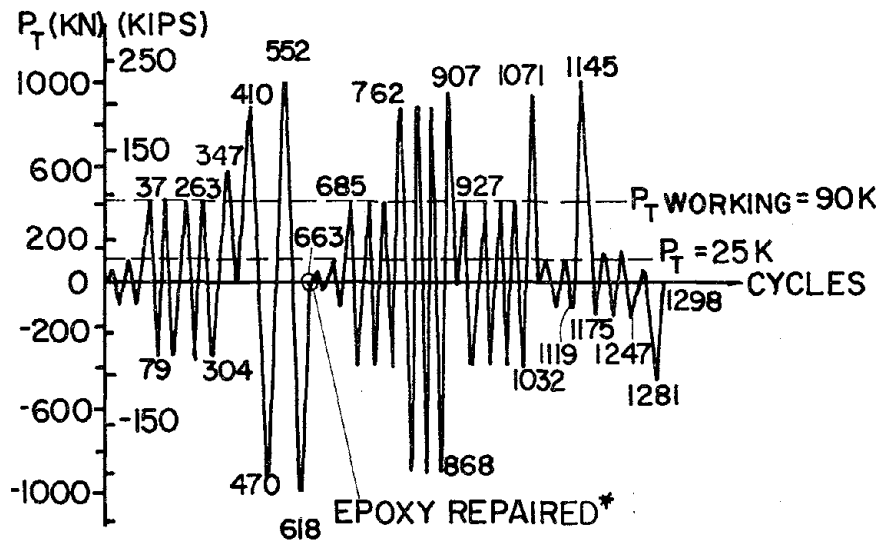
FIG. 4.1(a) LOADING HISTORY--SPECIMENS SW7 VIRGIN + SW7 EPOXY-REPAIRED\*

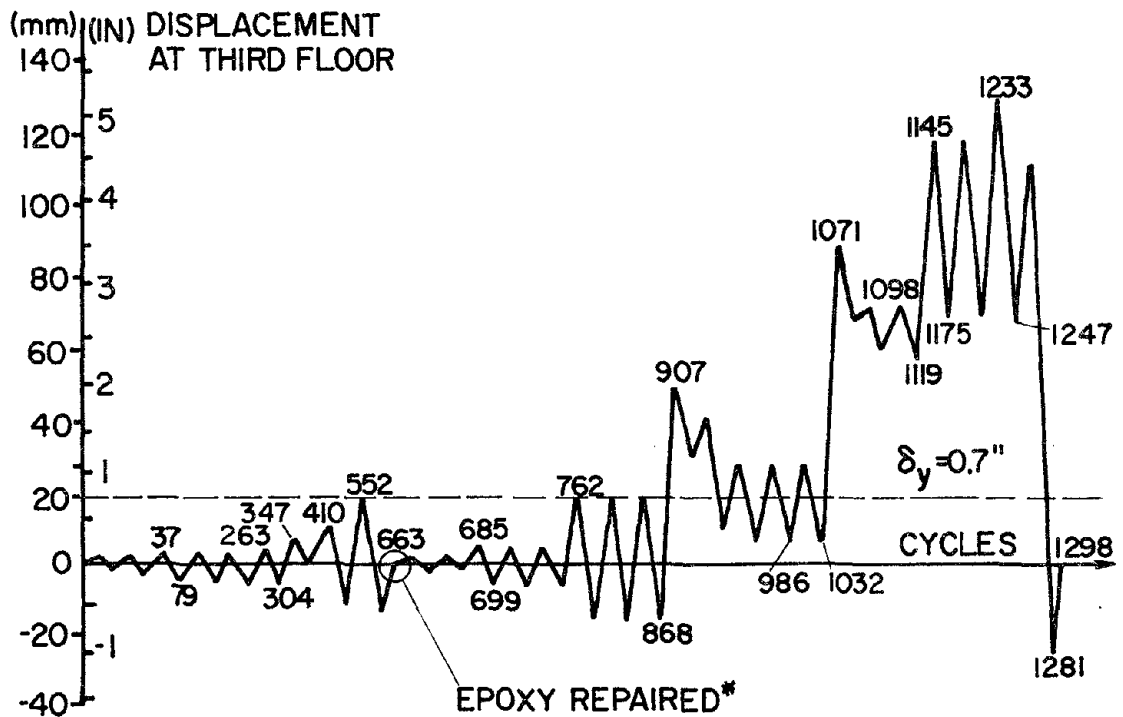
FIG. 4.1(b) DISPLACEMENT HISTORY--SPECIMEN SW7 VIRGIN + SW7 EPOXY-REPAIRED\*

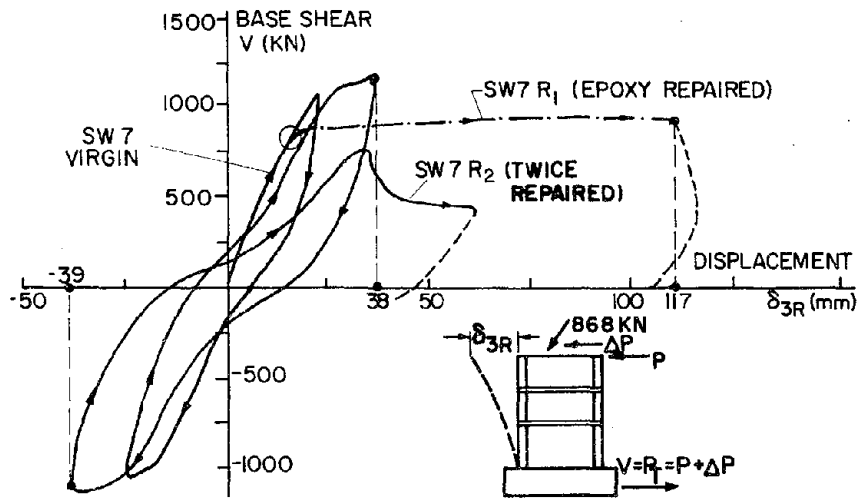
FIG. 4.3 TOTAL LATERAL LOAD,  $V$ , VS. THIRD-STORY DISPLACEMENT ENVELOPE --SPECIMEN SW7: VIRGIN, EPOXY-REPAIRED, TWICE-REPAIRED

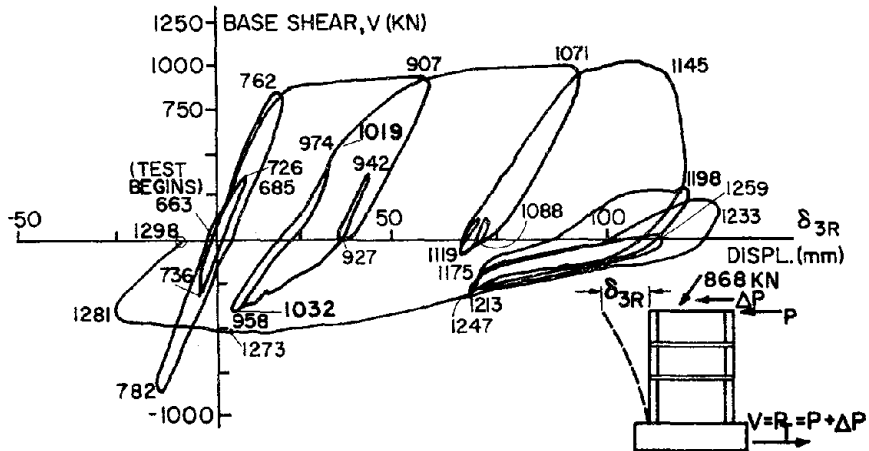
FIG. 4.4(b) TOTAL LATERAL LOAD,  $V$ , VS. THIRD-FLOOR RELATIVE DISPLACEMENT DIAGRAM,  $\delta_{3R}$  --SPECIMEN SW7 R<sub>1</sub>, EPOXY-REPAIRED

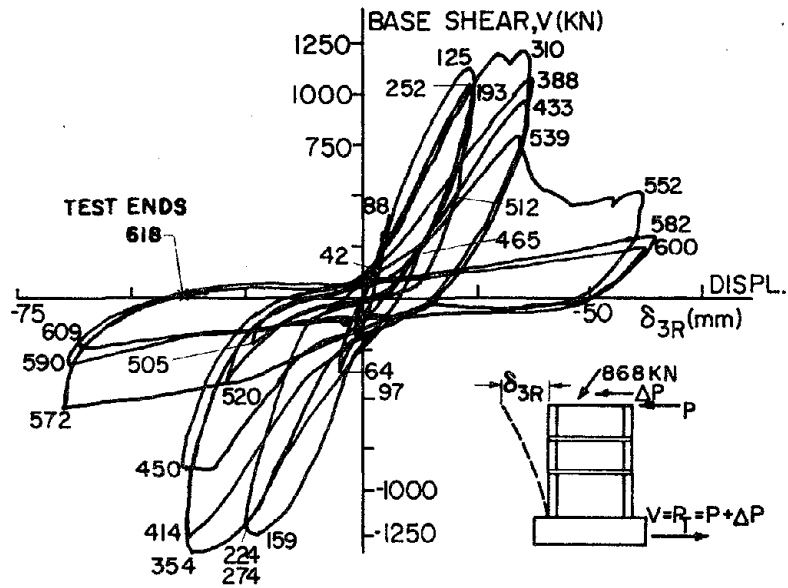
FIG. 4.7 TOTAL LATERAL LOAD, V, VS. THIRD-FLOOR LATERAL DISPLACEMENT DIAGRAM,  $\delta_{3R}$ --SPECIMEN SW7 R<sub>2</sub>

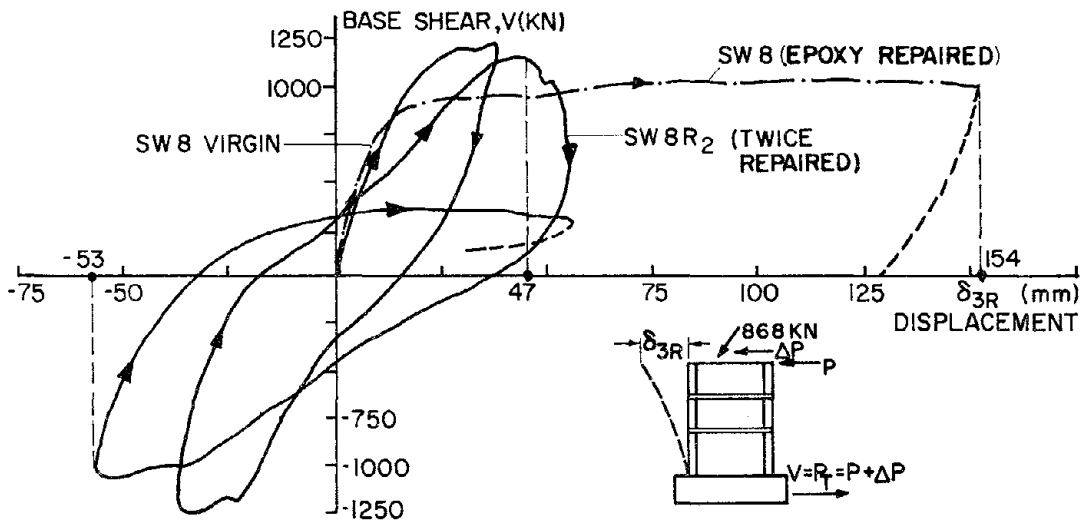
FIG. 4.18 TOTAL LATERAL LOAD,  $V$ , VS. THIRD-FLOOR RELATIVE DISPLACEMENT ENVELOPE,  $\delta_{3R}$ —SPECIMEN SW8: VIRGIN, EPOXY-REPAIRED, TWICE-REPAIRED

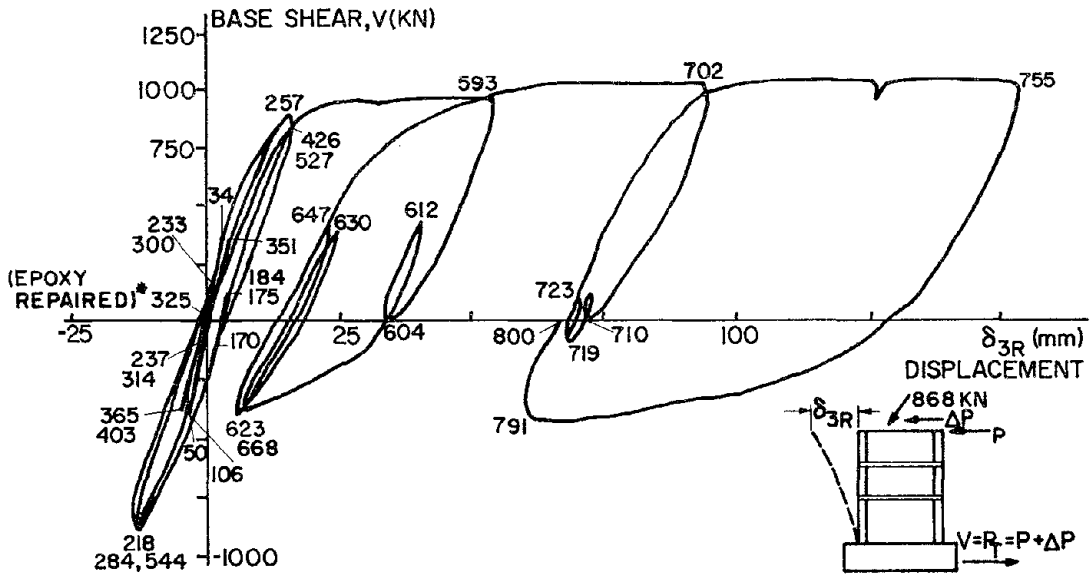
FIG. 4.19 TOTAL LATERAL LOAD,  $V$ , VS. THIRD-FLOOR RELATIVE DISPLACEMENT,  $\delta_{3R}$ —SPECIMEN SW8: VIRGIN + EPOXY-REPAIRED\*

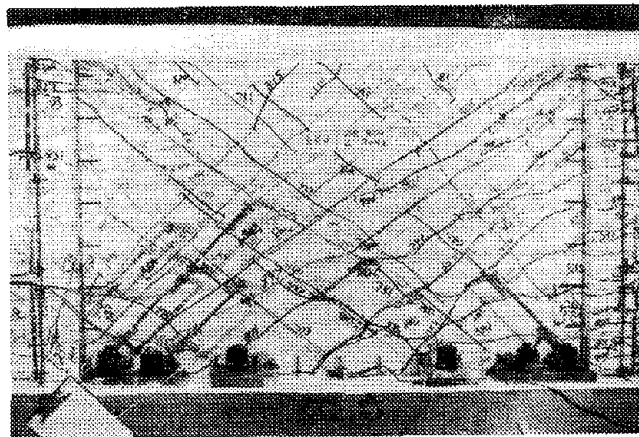
FIG. 4.49 EXCESSIVE CRACKING AT FIRST-STORY LEVEL OF SPECIMEN SW7 EPOXY-REPAIRED. LP 904,  $\mu_{\delta} = 3$

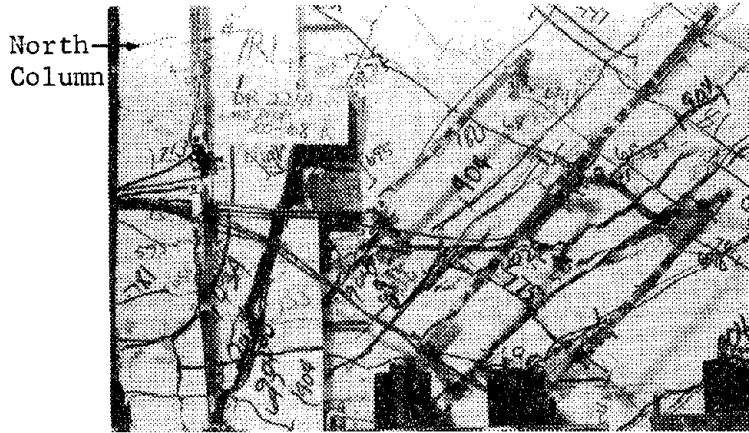
FIG. 4.50 CRUSHING OF CONCRETE IN THE NORTH CORNER OF FIRST-STORY WALL PANEL OF SPECIMEN SW7 EPOXY-REPAIRED. LP 1145,  $\mu_{\delta} = 6.4$

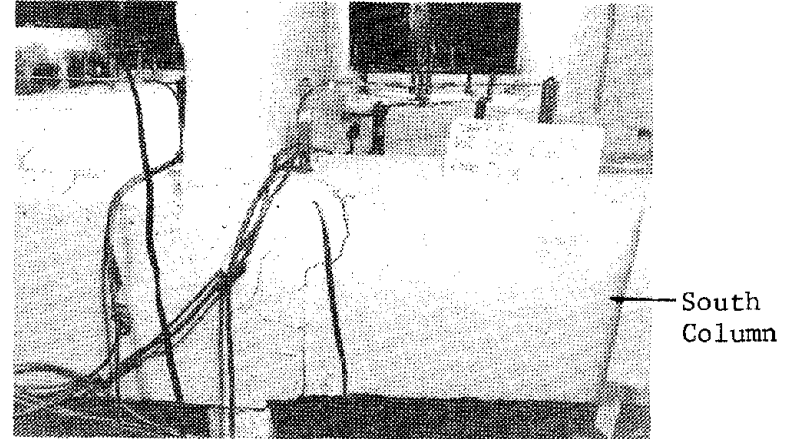
FIG. 4.51 CRACK AT BASE OF SECOND-STORY SOUTH COLUMN OF SPECIMEN SW7 R<sub>2</sub>. LP 125,  $\delta_{3R} = 1''$

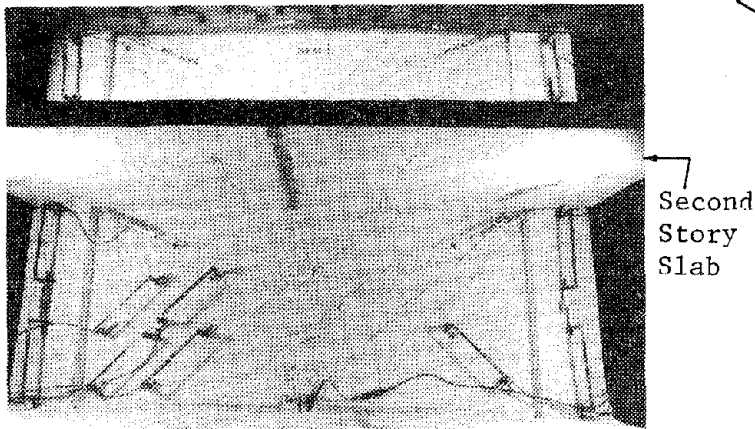
FIG. 4.52 DIAGONAL CRACKS IN SECOND-STORY WALL PANEL OF SPECIMEN SW7 R<sub>2</sub>. LP 125,  $\delta_{3R} = 1''$

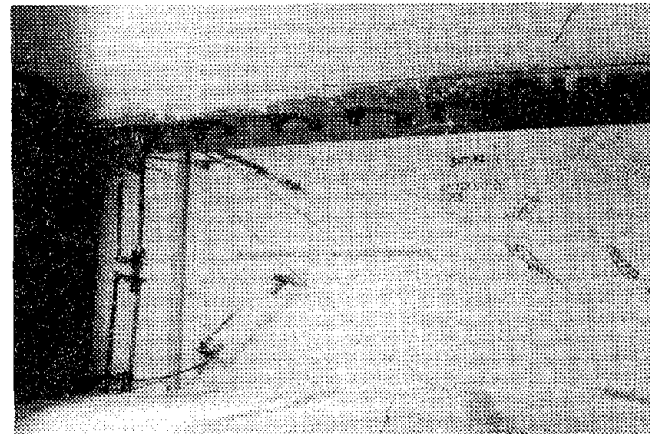
FIG. 4.53 DIAGONAL CRACKING AND LOCALIZED CONCRETE CRUSHING OF THIRD-STORY WALL PANEL OF SPECIMEN SW7 R<sub>2</sub>. LP 159,  $\delta_{3R} = 1''$

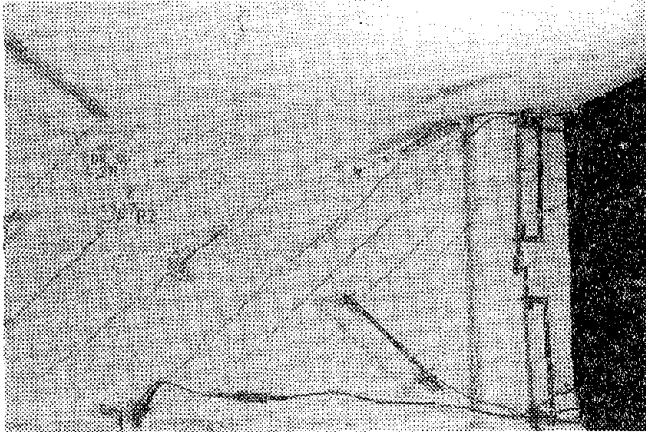
FIG. 4.54 DIAGONAL CRACKING AND LOCALIZED CONCRETE CRUSHING OF SECOND-STORY WALL PANEL OF SPECIMEN SW7 R<sub>2</sub>. LP 310,  $\delta_{3R} = 1\ 1/2"$ ,  $\mu_{\delta} = 2$ .

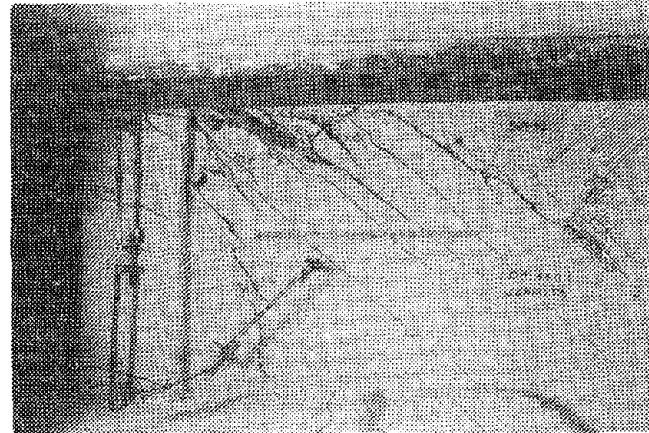
FIG. 4.55 CRACKS EXTENDING FROM UPPER NORTH CORNER OF THIRD-STORY WALL PANEL TO FACE OF SECOND-STORY SLAB OF SPECIMEN SW7 R<sub>2</sub>. LP 450.

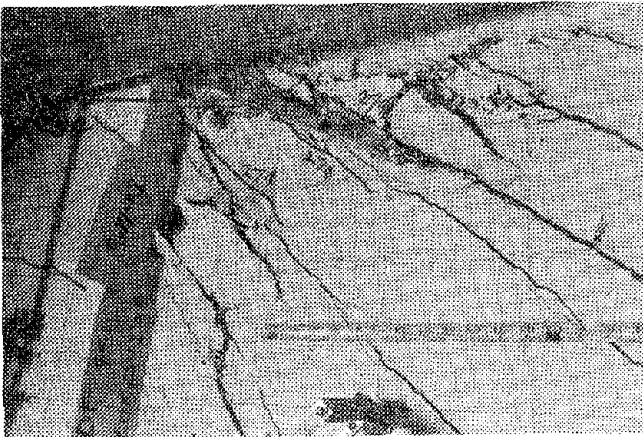
FIG. 4.56 SPALLING OF CRUSHED CONCRETE IN UPPER NORTH CORNER OF THIRD-STORY WALL PANEL OF SPECIMEN SW7 R<sub>2</sub>. LP 450.

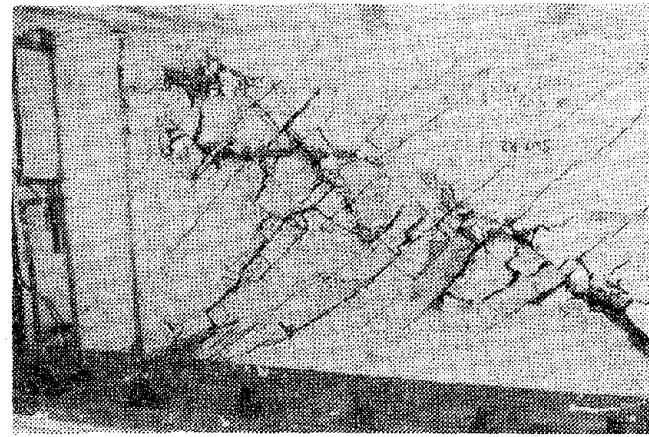
FIG. 4.57 FAILURE ZONE: THIRD-STORY WALL PANEL OF SPECIMEN SW7 R<sub>2</sub>. EXCESSIVE CRUSHING OF CONCRETE AND BUCKLING OF PANEL REINFORCEMENT. LP 547,  $\mu_{\delta} = 3$ .

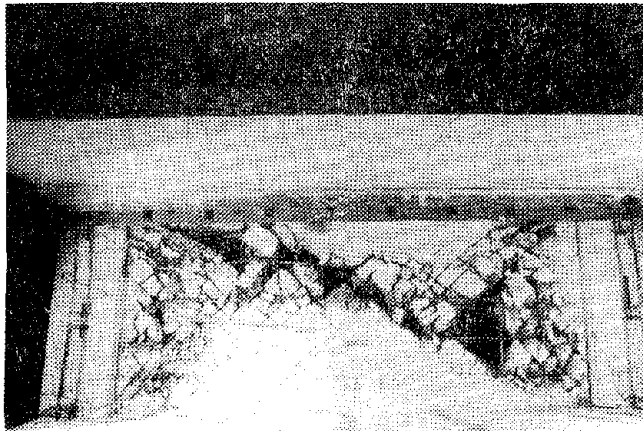
FIG. 4.58 FAILURE ZONE: THIRD-STORY WALL PANEL OF SPECIMEN SW7 R<sub>2</sub>. EXPOSED AND BUCKLED PANEL REINFORCEMENT. END OF TEST.

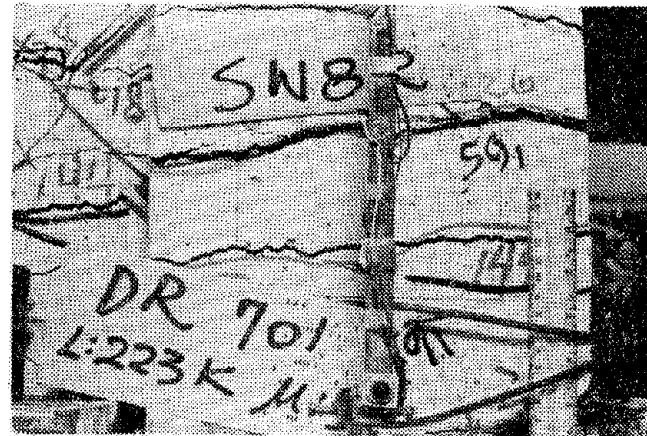
FIG. 4.59 WIDE CRACKS IN THE FIRST-STORY LEVEL OF THE SOUTH COLUMN OF SPECIMEN SW8 R<sub>1</sub>. LP 701,  $\delta_{3R} = 3.7''$ ,  $\mu_{\delta} = 5.9$ .

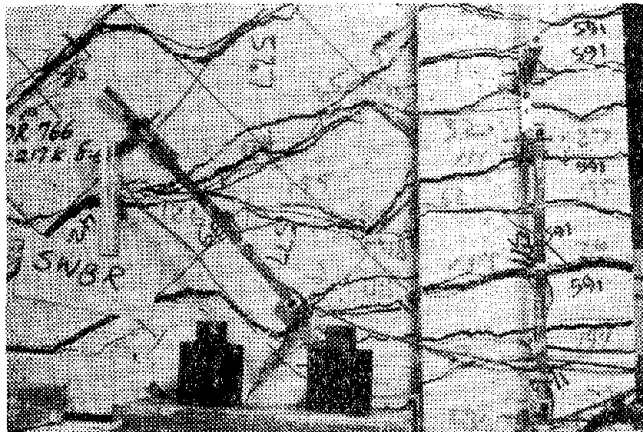
FIG. 4.60 FURTHER WIDENING OF CRACKS IN FIRST-STORY LEVEL OF SOUTH COLUMN OF SPECIMEN SW8 R<sub>1</sub>. PROPAGATION OF CRACKS INTO WALL PANEL. LP 766,  $\delta_{3R} = 6''$ ,  $\mu_{\delta} = 9.75$ .

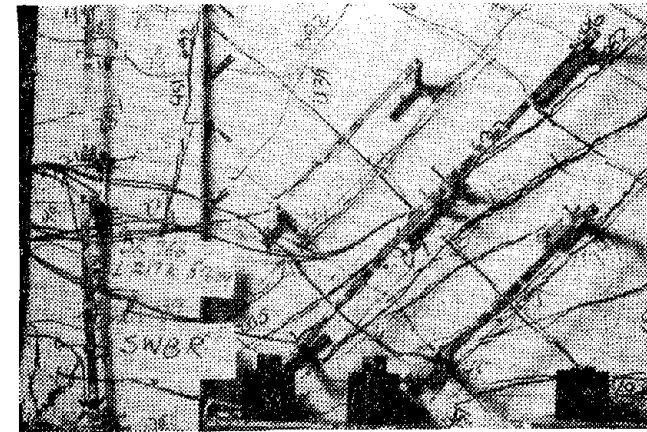
FIG. 4.61 CRUSHING OF CONCRETE AT BASE OF FIRST-STORY NORTH COLUMN OF SPECIMEN SW8 R<sub>1</sub>. LP 766,  $\delta = 6''$ ,  $\mu_{\delta} = 9.75$ .

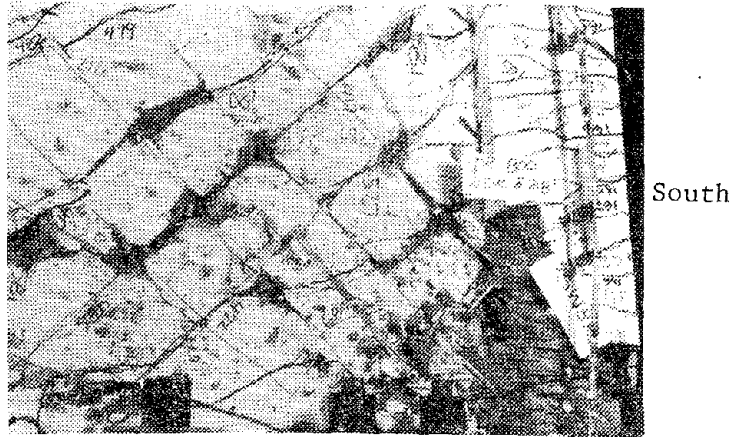
FIG. 4.62 LOADING TO THE SOUTH AFTER FAILURE OF SPECIMEN SW8 R<sub>1</sub>. CRUSHING OF CONCRETE COVER AT BASE OF FIRST-STORY SOUTH COLUMN. BUCKLING OF WALL-PANEL REINFORCEMENT AND FRACTURE OF SPIRAL. LP 800. END OF EXPERIMENT.

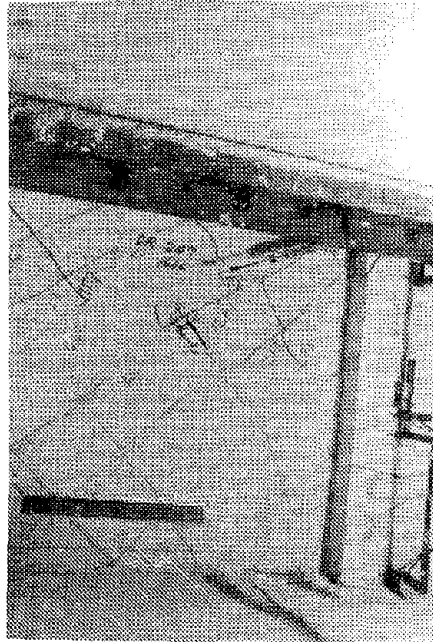
FIG. 4.65 LOCALIZED CRUSHING OF CONCRETE AND BUCKLING OF REINFORCEMENT IN THIRD-STORY WALL PANEL OF SPECIMEN SW8 R<sub>2</sub>. LP 247,  $\mu_{\delta} = 2$ .

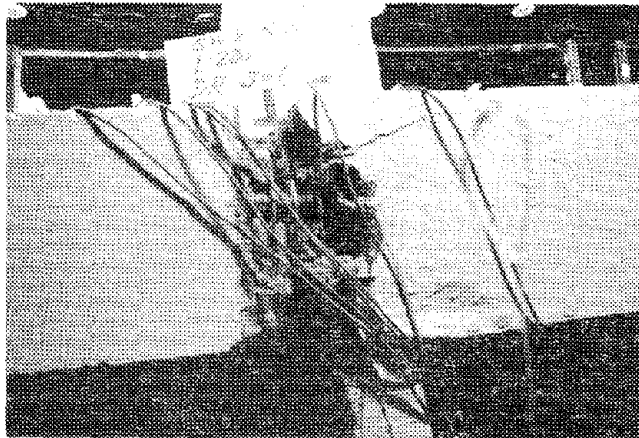
FIG. 4.66 FAILURE OF CONCRETE COVER AT TOP OF FIRST-STORY SOUTH COLUMN OF SPECIMEN SW8 R<sub>2</sub>. LP 361.

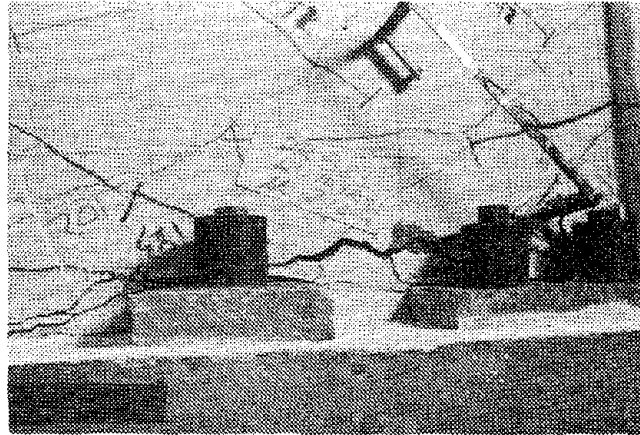
FIG. 4.67 SPECIMEN SW8 R<sub>2</sub>. LP 383,  $\mu_{\delta} = 2.18$ .

(b) Propagation of Crack into First-Story Wall Panel Adjacent to Foundation

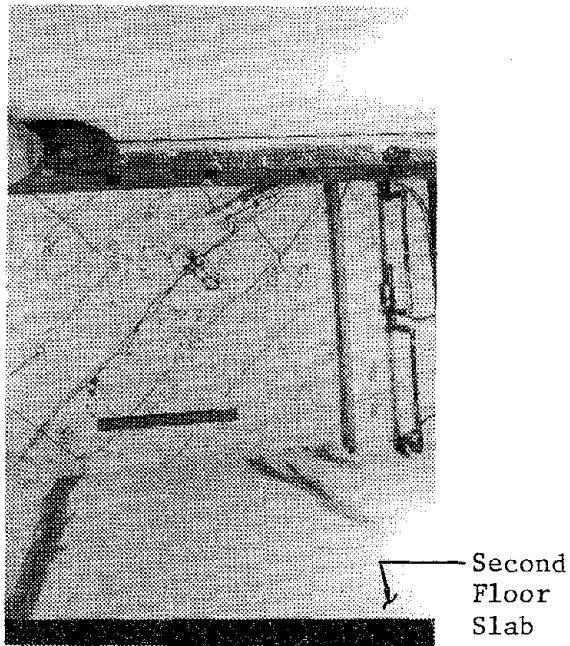
FIG. 4.68 INCREASED LOCALIZED CRUSHING OF CONCRETE IN THIRD-STORY WALL PANEL, ACCOMPANIED BY BUCKLING OF WALL-PANEL REINFORCEMENT OF SPECIMEN SW8 R<sub>2</sub>. LP 383,  $\mu_{\delta} = 2.18$ .

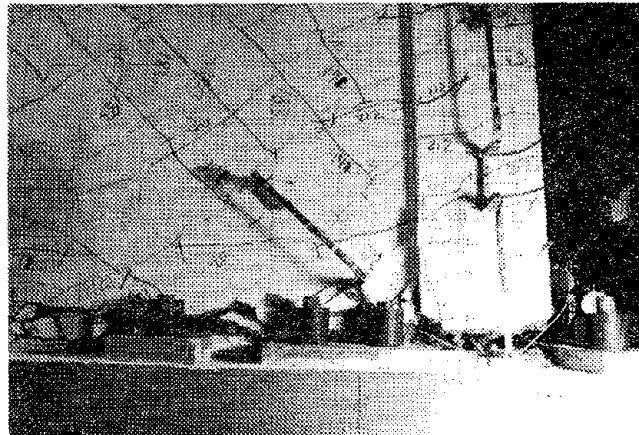
FIG. 4.69 SPECIMEN SW8 R<sub>2</sub> AFTER FAILURE, LP 558. FAILURE OF LONGITUDINAL REINFORCEMENT AT BASE OF FIRST-STORY SOUTH COLUMN AS WELL AS FAILURE OF FIRST-STORY WALL-PANEL REINFORCEMENT.

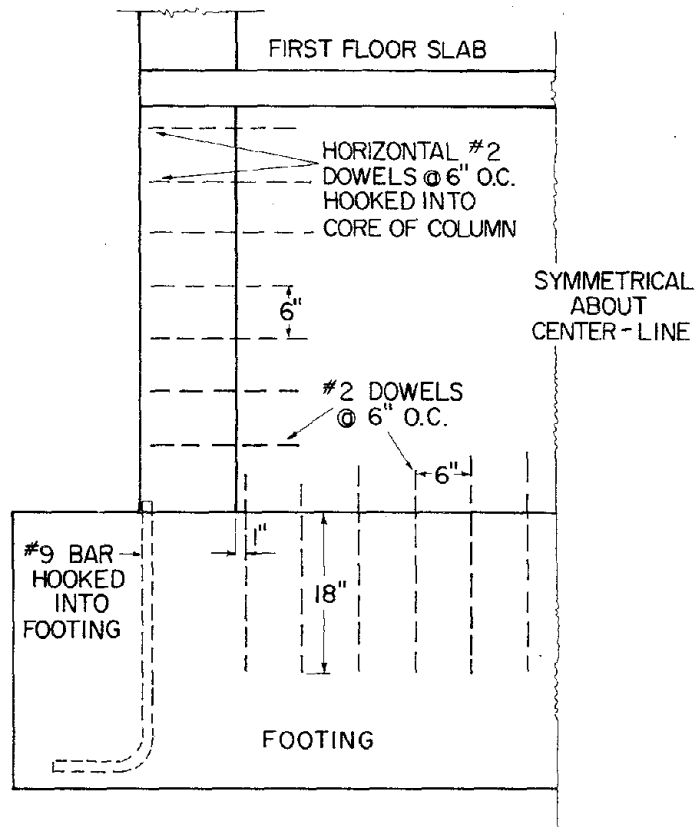
FIG. 5.1 DOWELS ORIGINALLY PLACED AT FIRST-STORY LEVEL TO FACILITATE STRENGTHENING OF SPECIMEN SW7

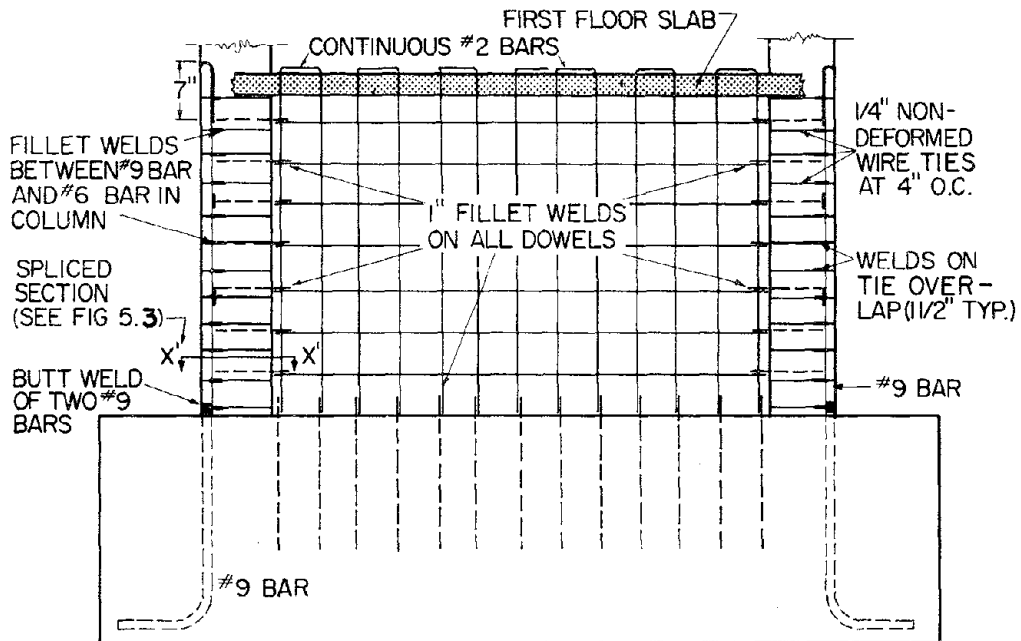
FIG. 5.2 FIRST-STORY REPAIRS ON SPECIMEN SW7 AFTER FAILURE OF SPECIMEN SW7 EPOXY-REPAIRED.

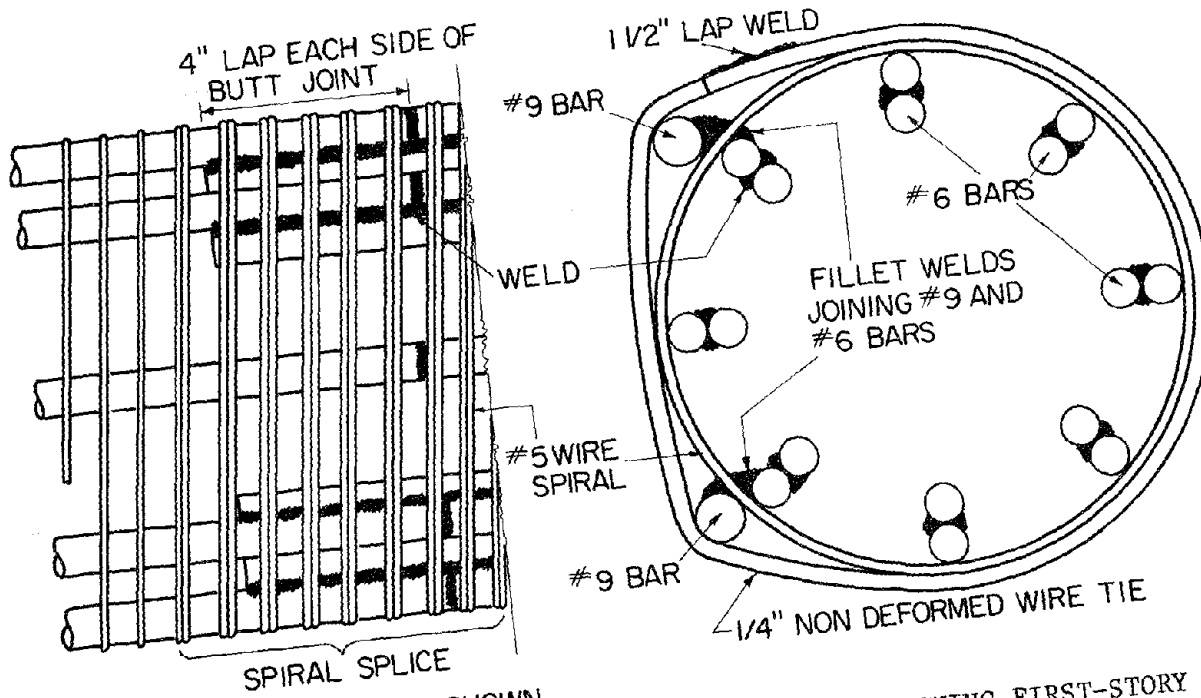
#9 BAR AND STIRRUP NOT SHOWN  
 FIG. 5.3 SECTION X'-X (FIG. 5.2)--SPlice DETAIL SHOWING FIRST-STORY COLUMN REPAIRS ON SPECIMEN SW7 AFTER FAILURE OF SPECIMEN SW7 EPOXY-REPAIRED

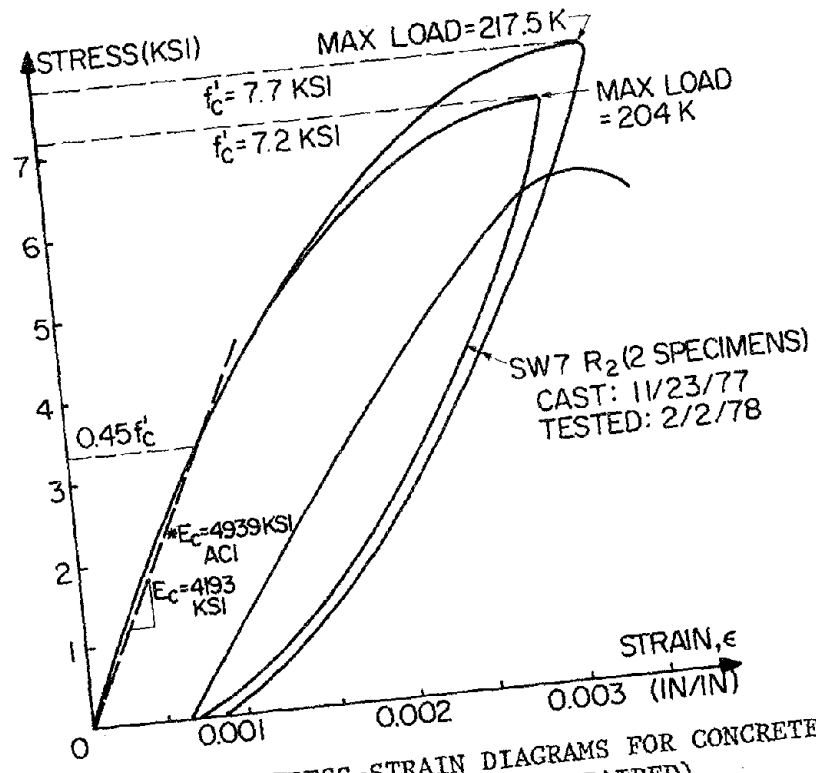
FIG. 5.4 STRESS-STRAIN DIAGRAMS FOR CONCRETE SPECIMENS--SPECIMEN SW7 R<sub>2</sub> (REPAIRED)

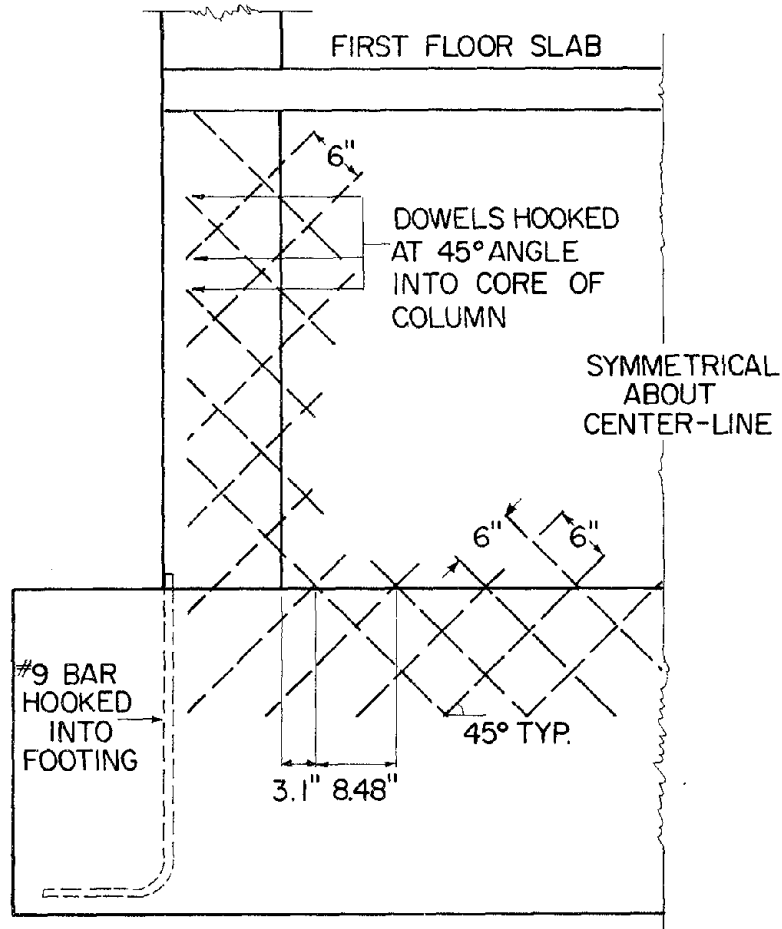
FIG. 5.5 VIEW SHOWING PLACEMENT OF REPAIR STEEL AT FIRST-STORY LEVEL--SPECIMEN SW8 VIRGIN

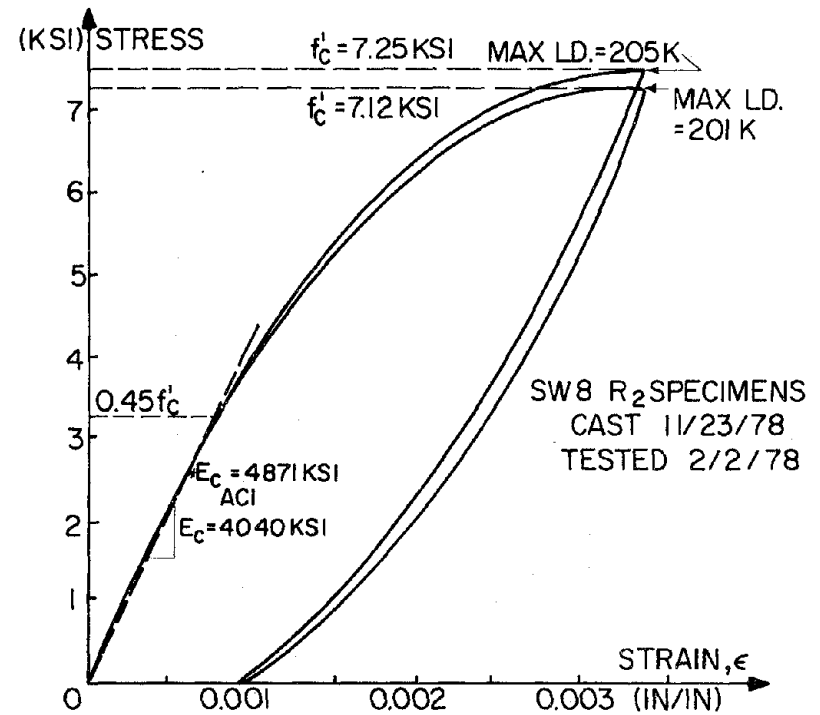
FIG. 5.6 STRESS-STRAIN DIAGRAMS FOR CONCRETE SPECIMENS--SPECIMEN SW8 R<sub>2</sub> (REPAIRED)

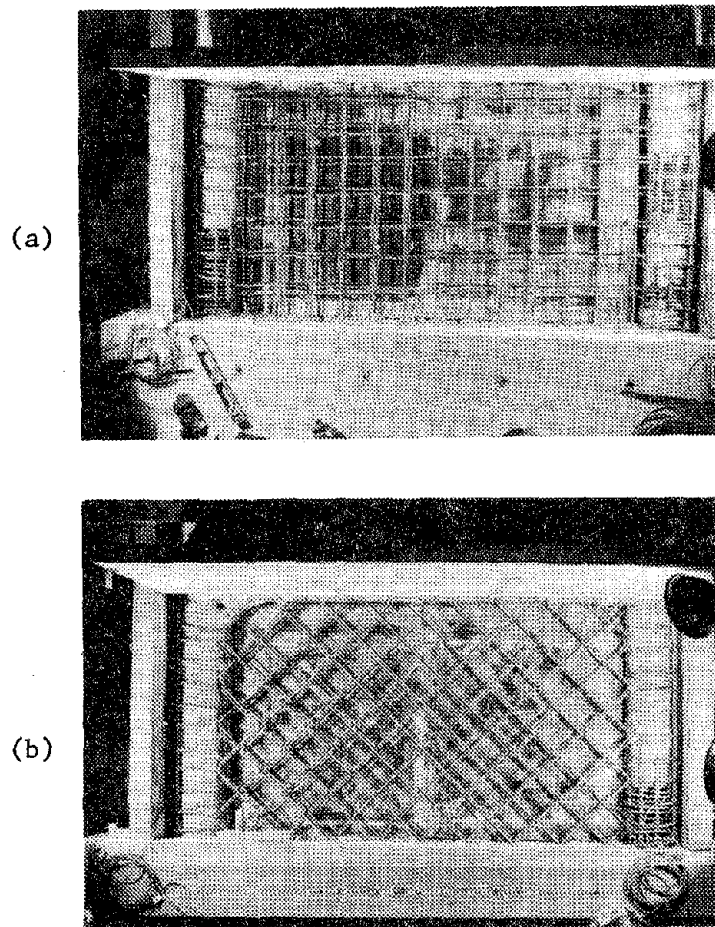
FIG. 5.7 REPAIRING AND STRENGTHENING TECHNIQUES FOR FIRST STORIES OF SPECIMENS SW7  $R_1$  AND SW8  $R_1$ .\*

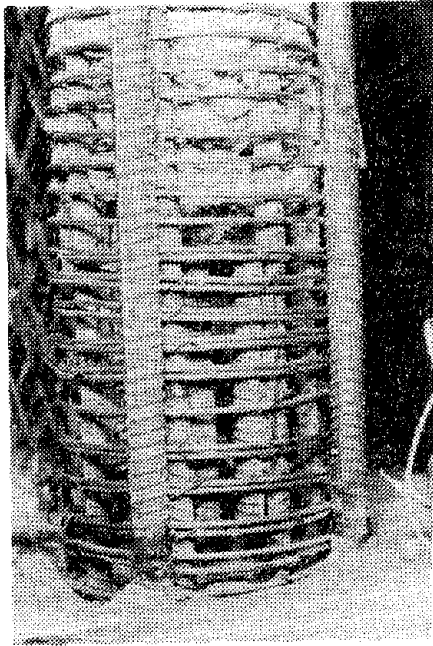
FIG. 5.9 REPAIRING AND STRENGTHENING TECHNIQUES FOR SPECIMENS SW7 AND SW8. (TWO NO. 9 BARS BUTT WELDED ON OUTER EDGES AT BASE OF FIRST-STORY COLUMNS; BARS EXTEND TO FIRST-FLOOR SLAB)

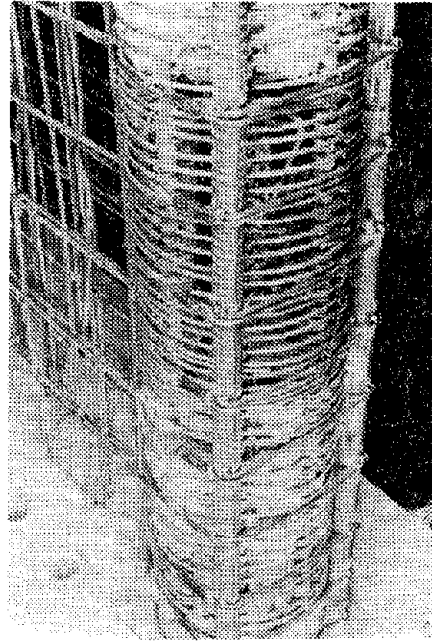
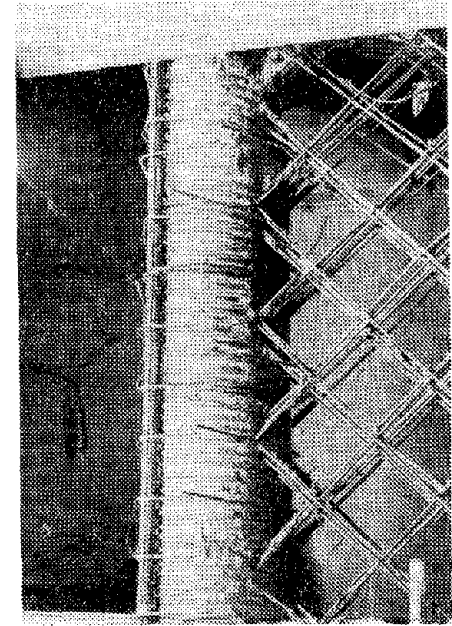
FIG. 5.10 REPAIRING AND STRENGTHENING TECHNIQUES FOR SPECIMENS SW7 AND SW8. NOTE: ADDED OUTER MATS OF WALL-PANEL REINFORCEMENT; WELDED STIRRUPS AT 6" O.C. AROUND NO. 9 BARS AND ORIGINAL COLUMNS.

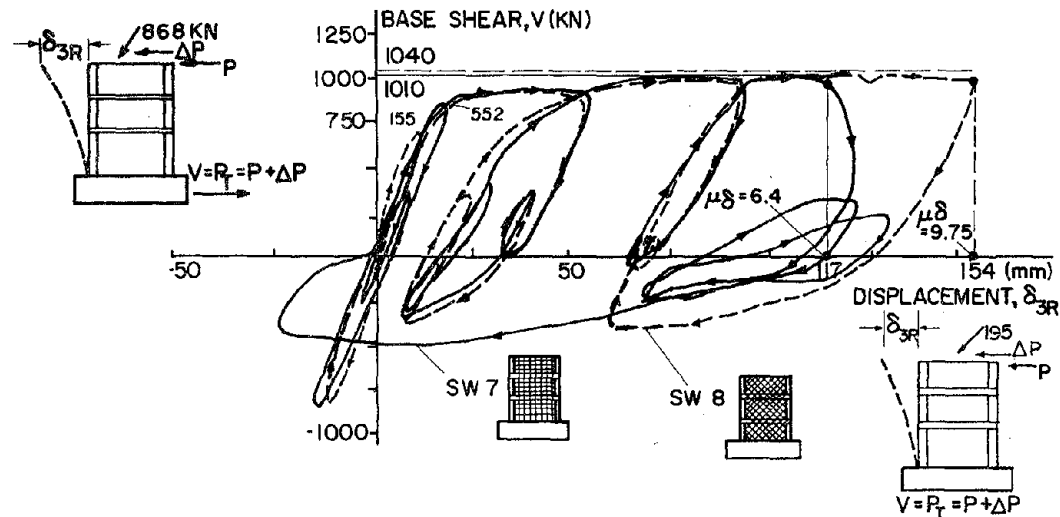
FIG. 6.1 EFFECT OF ARRANGEMENT OF WALL REINFORCEMENT ON THE LOAD-DISPLACEMENT RELATIONSHIP--MONOTONIC LOADING. SPECIMENS SW7 AND SW8 EPOXY-REPAIRED.

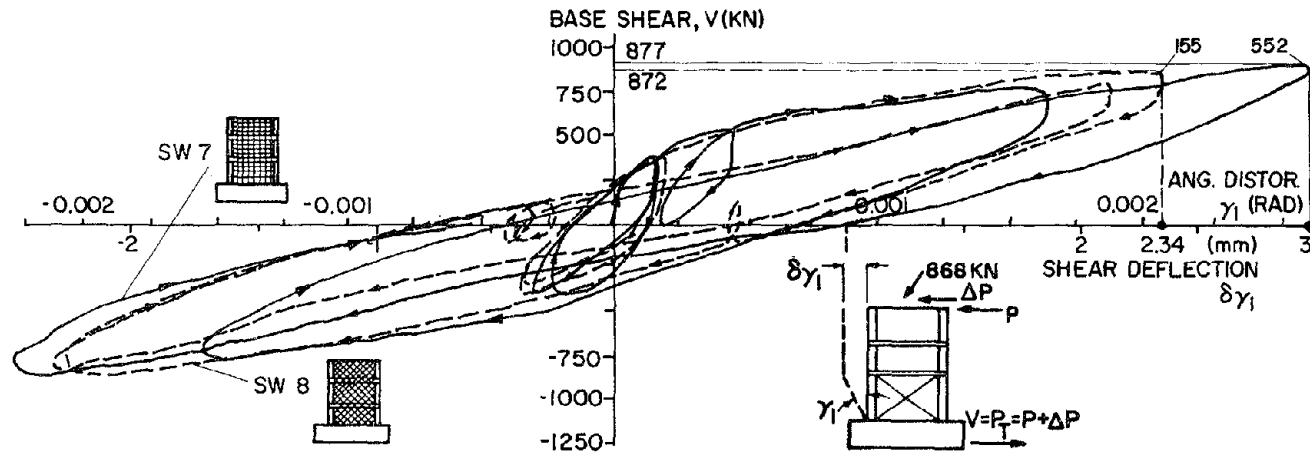
FIG. 6.2 EFFECT OF ARRANGEMENT OF REINFORCEMENT ON AMOUNT OF FIRST-STORY SHEAR DISTORTION. SPECIMENS SW7 AND SW8 VIRGIN. (SEE FIGS. 4.12(a) AND 4.25)
