## Efficiency of two wastewater treatment plants situated in Zomba, Malawi

Sandra Lundgren

## **Abstract**

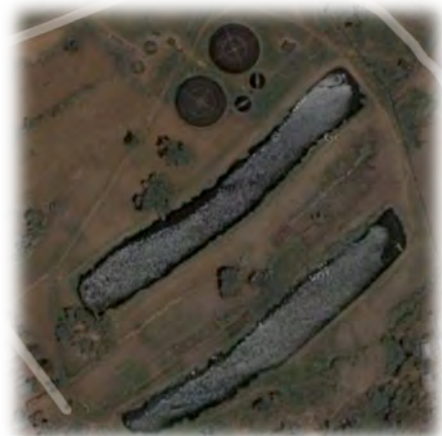
Figure 3: View of Zomba WWTP. The two maturation ponds shown in the picture are about 150 m long (Google Map Maker, 2012).

The municipal wastewater treatment plant consists of both biological filter plants and maturation ponds. The wastewater will first pass through two screens, which cleans the water from the largest particles. After filtration the water is separated and stored in two identical settling ponds, so particles can settle and later on be removed. The water then runs into biological ponds where the water is sprinkled on rocks where bacteria, living on the rocks, degrade the organic matter. Finally, the water flows down into two, one after the other, maturation ponds where there is an uptake of nutrients in water lettuce (*Pistia stratiotes*) before releasing the water into Likangala River.

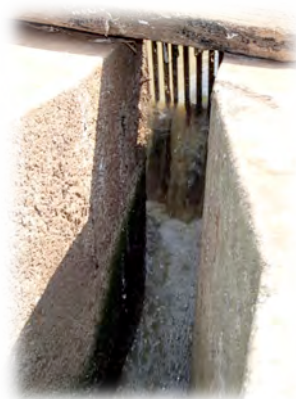
Figure 4: Screening at the municipally WWTP.

The first step in the wastewater treatment is called screening, where steel bars work as screens, removing large floating objects and big mineral particles. Screening is mainly to prevent damage of the equipment, but also to prevent objects from accumulating on the surface of the stabilization ponds later on in the process (Mara, 2003).

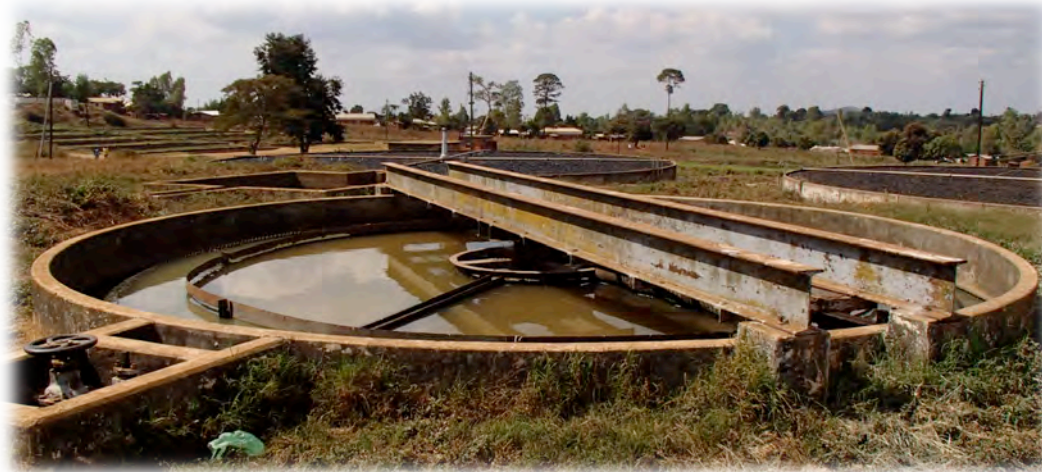
**Figure 5: One out of two sedimentation tanks at the municipal WWTP.**

When the largest particles have been removed in the screening process, water runs into two sedimentation tanks. The sedimentation tanks are over 15 m deep and cone shaped, the dimensions of the tanks makes the water flow very slowly, which enables the largest particles to settle by gravity (AWWA Staff, 2010).

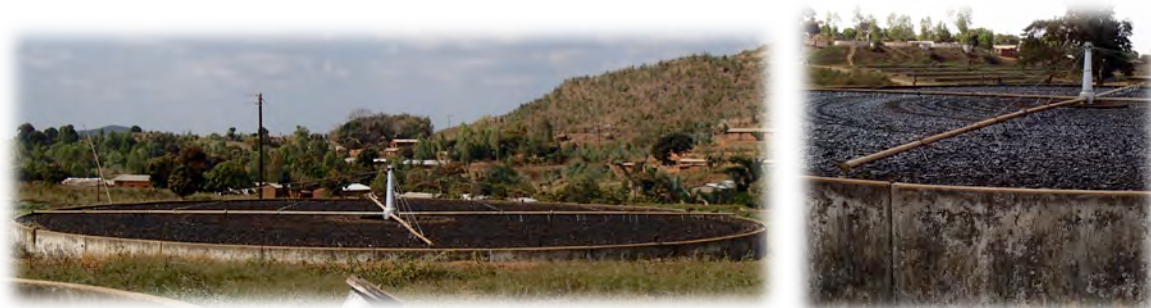
**Figure 6: Biofiltration at the municipal WWTP.**

When the sewage water has passed through the sedimentation tanks it runs into a biofiltration tank that consists of a 2-3 m deep bed with rocks that are about 50-100mm large. The water that runs into these tanks are sprinkled mechanically over the rocks, percolating down through the rocks and flows in the bottom into drain pipes leading the water to the next step in the treatment process. At the surface of these rocks, a microbial film is formed where the bacteria in this film can oxidize organic material in the water. The film formed grows in thickness and is eventually peeled off by the water flow; in the next treatment process these solids are removed (Mara, 2003). An important process that takes place in the biofiltration is nitrification. Nitrification is a two-step aerobic process where ammonia is oxidized to nitrite and then nitrite is oxidized to nitrate, both steps are facilitated by the present of different type of bacteria (Gomes, 2009).

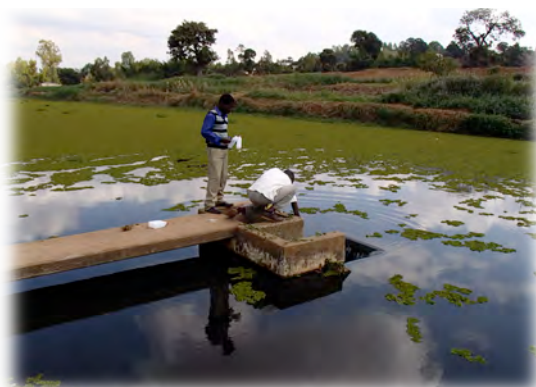
**Figure 7: Sampling at the final maturation pond at the municipal WWTP.**

In the last stage of the treatment there are two maturation ponds. The water surface in these ponds is covered with water lettuce (*Pistia stratiotes*) in order to reduce the number of algal suspended solids. By depriving the algae of sunlight the water lettuce inhibits the algae, which cannot

reproduce nor grow. The roots of the water lettuce will contribute in reducing nitrogen, phosphorous and metals in the water by absorption of these substances. One disadvantage with these ponds is that they can act as mosquito breeding ponds. To prevent this, fish that eat mosquito larvae can be introduced in the ponds. Only a couple of years ago the water in these ponds was so clean that there were fish living in the ponds. By the time of sampling, conditions were too poor for fish to survive (Sajidu, 2012, personal communication). Further explanation on the processes that occurs in maturation ponds follows in chapter 3.2 below.

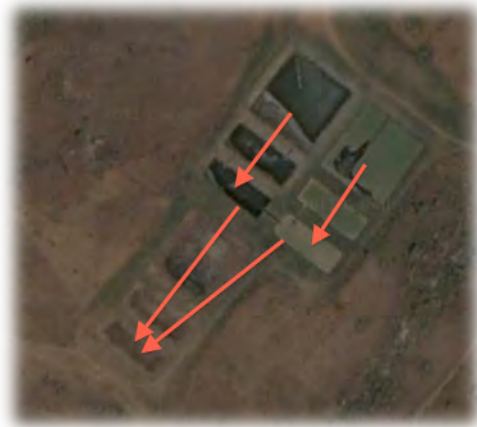
Figure 8: A view over Chancellor College WWTP. The process starts at the largest dark green pond, which is about 1600m<sup>2</sup>. By time of sampling only the last three ponds were working (Google Map Maker, 2012).

The Chancellor College wastewater treatment plant consists of so-called waste stabilization ponds where the water, in different stages, is purified from sewage. The water runs through six ponds, which runs in a series in sets of two. The first two ponds are anaerobic and runs in series. After the anaerobic treatment, the wastewater runs into two facultative ponds, the term facultative indicates that these ponds consists of both aerobic and anaerobic conditions, and lastly the water reaches its final stage in three maturation ponds. The first three ponds at Chancellor College WWTP are in duplicate and run parallel with each other, the water from the two last facultative ponds is then being emitted into a larger, joint, maturation pond. At the time of sampling, only the last three ponds were working. The water was led past the first three and directly into the fourth pond, which then acted as an anaerobic pond.

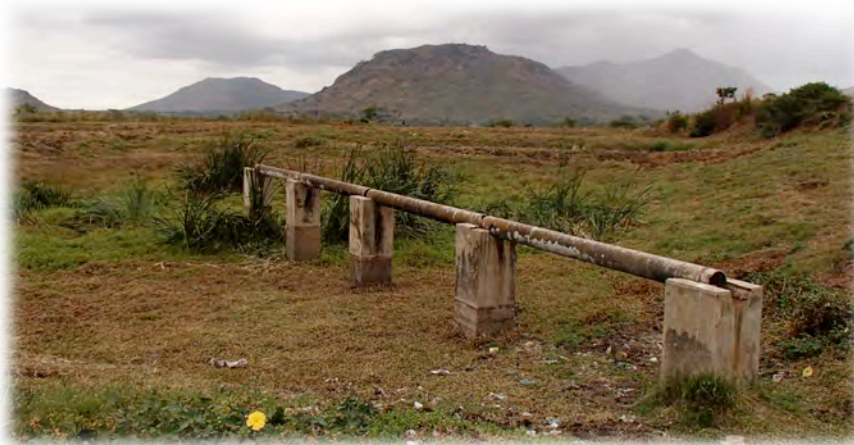
**Figure 9:** The inlet pipe to the first anaerobic pond at the Chancellor College WWTP. By time of sampling, this pond was not working and no water was stored there.

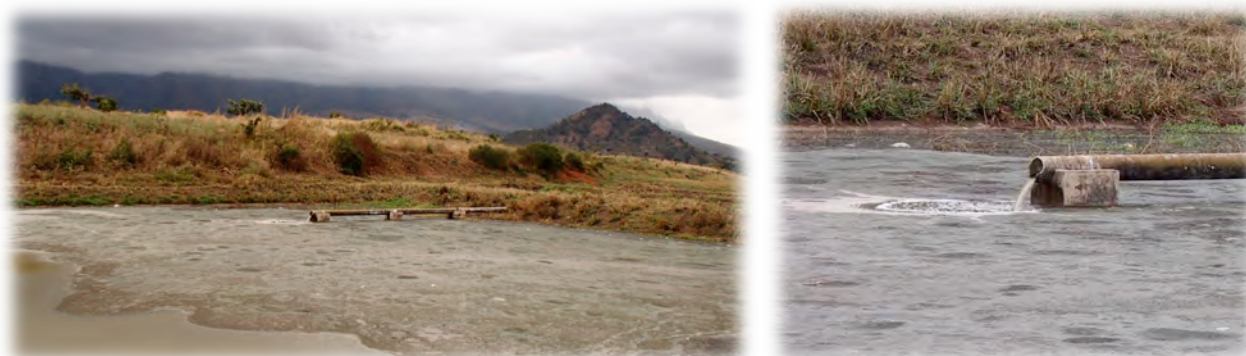
**Figure 11: Fourth pond normally working as a second facultative pond at the Chancellor College. By time of sampling, serving as anaerobic pond**

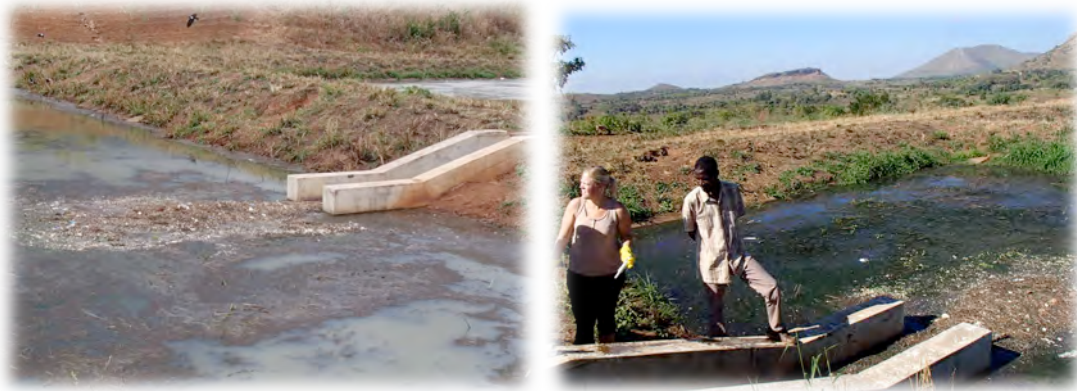
Figure 12: Fifth pond that should normally work as the first of two maturation ponds at the Chancellor College. By time of sampling the function of the pond was more similar to that of a facultative pond.

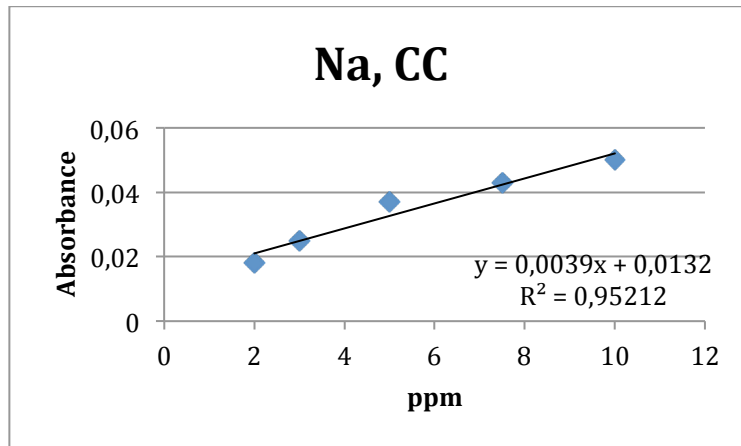
## Appendix 1

The sodium standard curve for Chancellor College was modified; two standards, 0,5 ppm and 1 ppm, were removed from the curve when these was considered inaccurate.
