Electromagnetic Compatibility

Vibration Sensor Test Set Model #

AT-2040

Test Report Number RV78081A-001

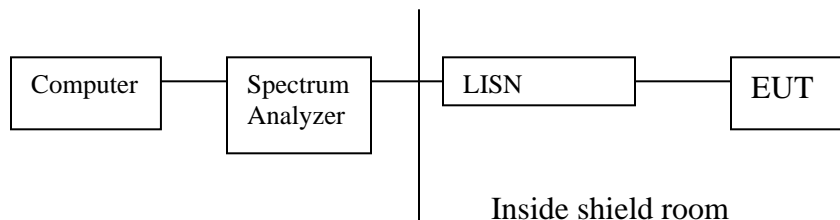
To measure conducted emissions, the EUT was set upon a wooden table in the shielded enclosure. AC power was fed into the EUT from the Artificial Mains Network (LISN). With the Artificial Mains Network connected to an HP 8568B Spectrum Analyzer, and using A Computer/Controller and the HP 85864B EMI Measurement Software, the spectrum was searched from 0.15 - 30 MHz for emissions emanating from the EUT. A list of the equipment used in this test is included in Appendix A. A photograph of this test set up is included in Appendix B.

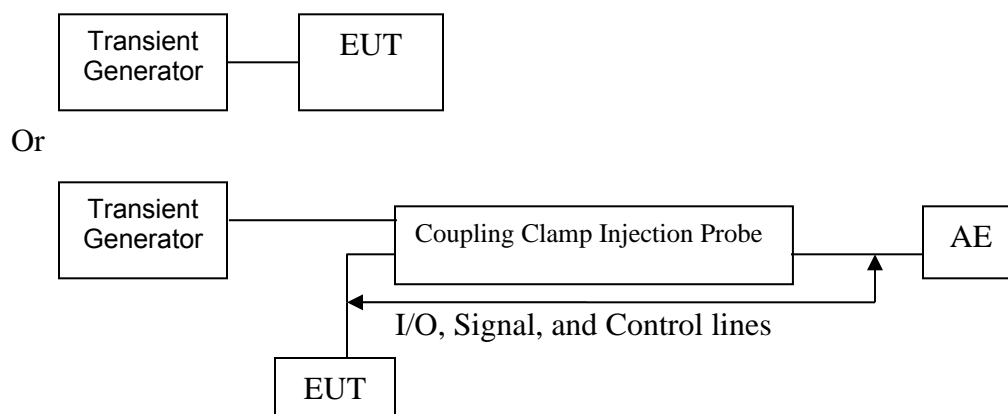
The Haefely 093 204.1 Transient Generator supplied the Electrical Fast Transient/Burst waveforms injected into the EUT. The pulses were capacitively injected onto the I/O, Signal, and Control lines using a Coupling Clamp injection probe. The pulses were directly injected into the power lines. A list of the equipment used in this test is included in Appendix A. Photographs of this test set up are included in Appendix B.

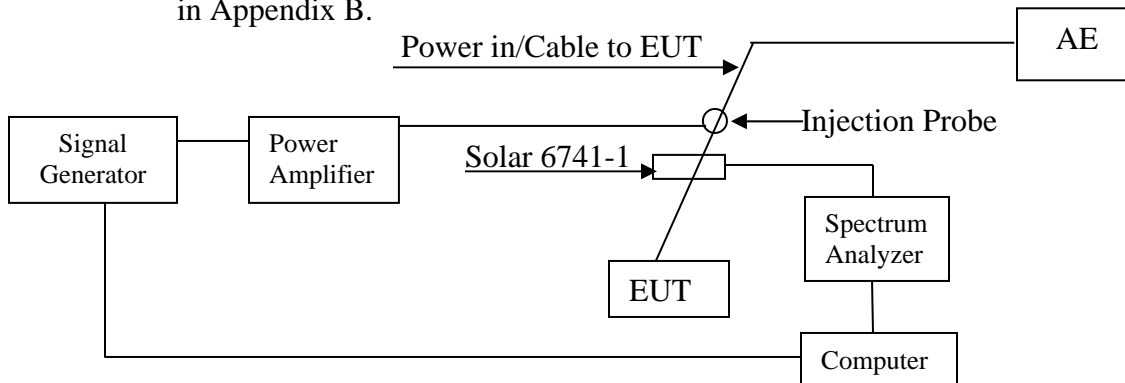
Conducted susceptibility signals were coupled into the input power leads and interconnecting cables using a current probe. Calibrated levels from 150 kHz to 80 MHz were injected while using a second probe to monitor the injected current. The radio frequency signal was supplied by a Marconi 2024 Signal Generator and a Kalmus 100 W Power Amplifier M/N 757LCB-CE. A Fischer Custom Communications Bulk Injection Probe M/N F-120-9B was used to inject the test level and a Solar 6741-1 was used to monitor the injected A list of the equipment used in this test is included in Appendix A. Photographs of this test set up appear in Appendix B.

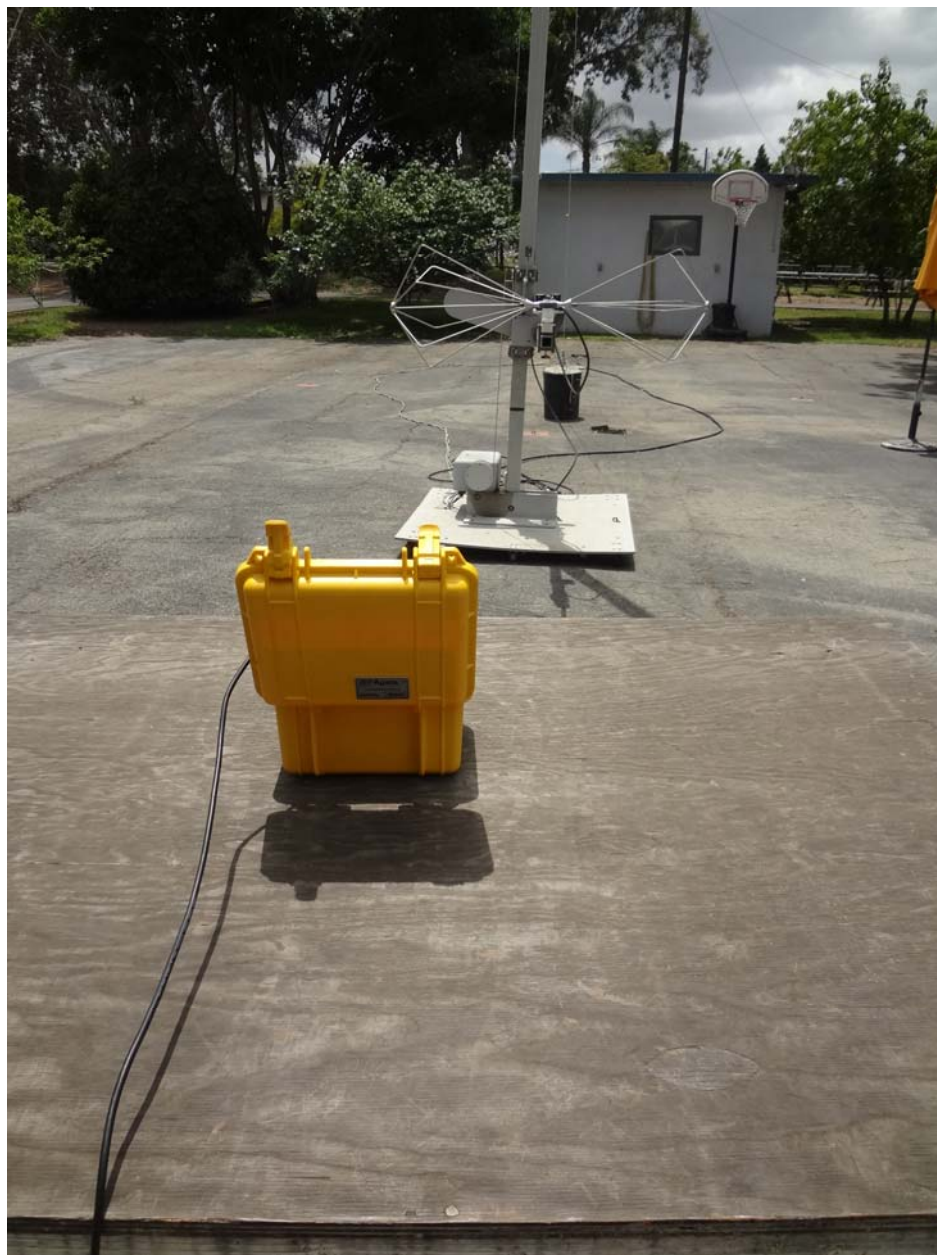
Radiated Emissions-Bicon

Notes: 30MHz – 200 MHz

To measure radiated emissions, the EUT was set up on the 3 or 10-meter open air test site. The EUT is placed on a wooden table, which rests on a wooden turntable. The top of the table is one meter above the ground, and the turntable can be rotated 360 degrees. For each frequency measured, the antenna is raised and lowered for both horizontal and vertical polarities to obtain the maximum reading on the analyzer. The turntable is also rotated throughout the 360 degrees in azimuth to determine the position of the maximum emissions. The applicable frequency range is searched using the antennas listed below. The respective antenna and preamplifier were connected to an HP 8568B Spectrum Analyzer. Preamplifiers were used for all ranges to achieve the needed dynamic range. A list of the equipment used in this test is included in Appendix A. Photographs of this test set up are included in Appendix B.

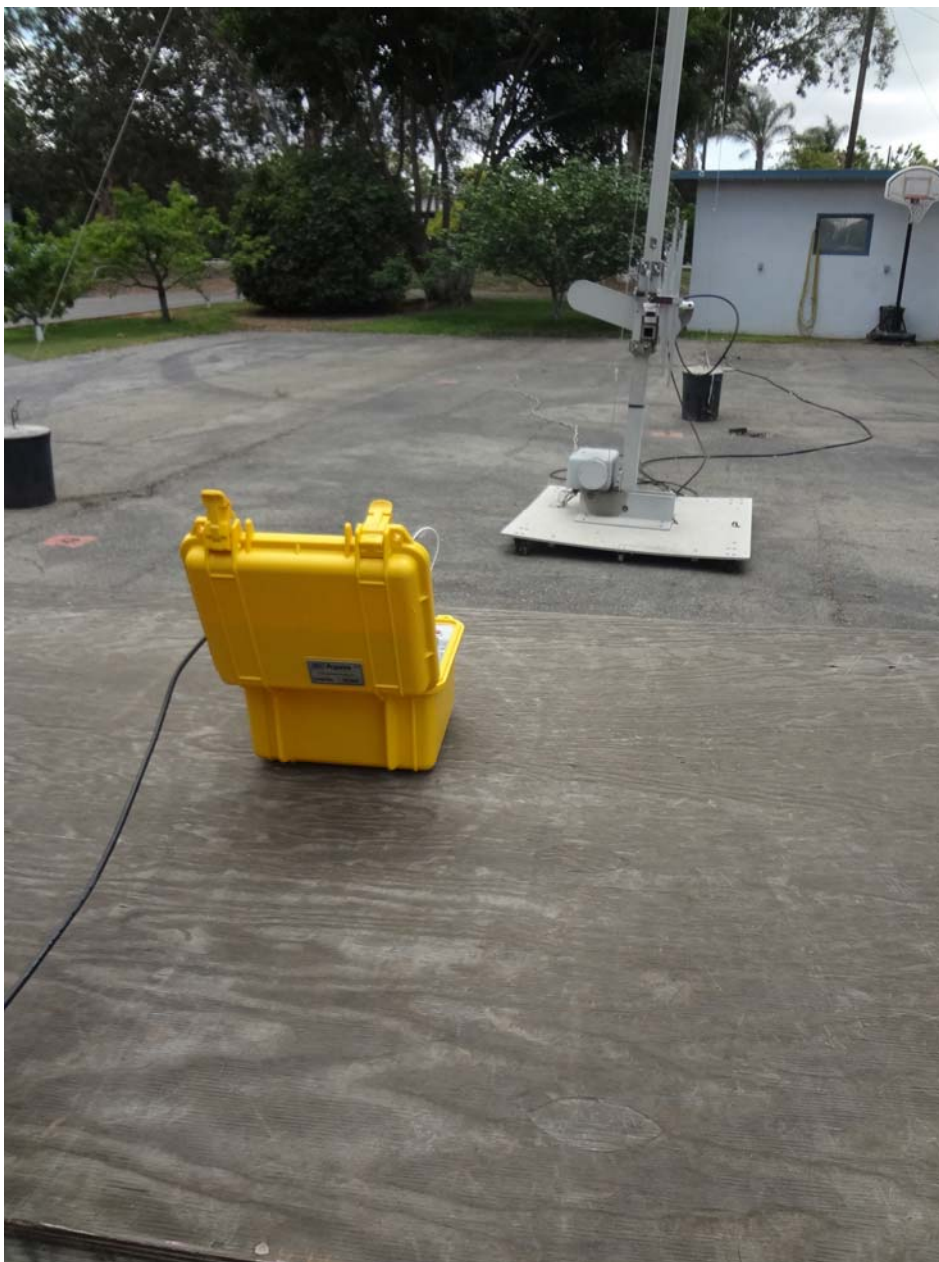
Radiated Emissions – Log Periodic

Notes: 200MHz – 1000MHz

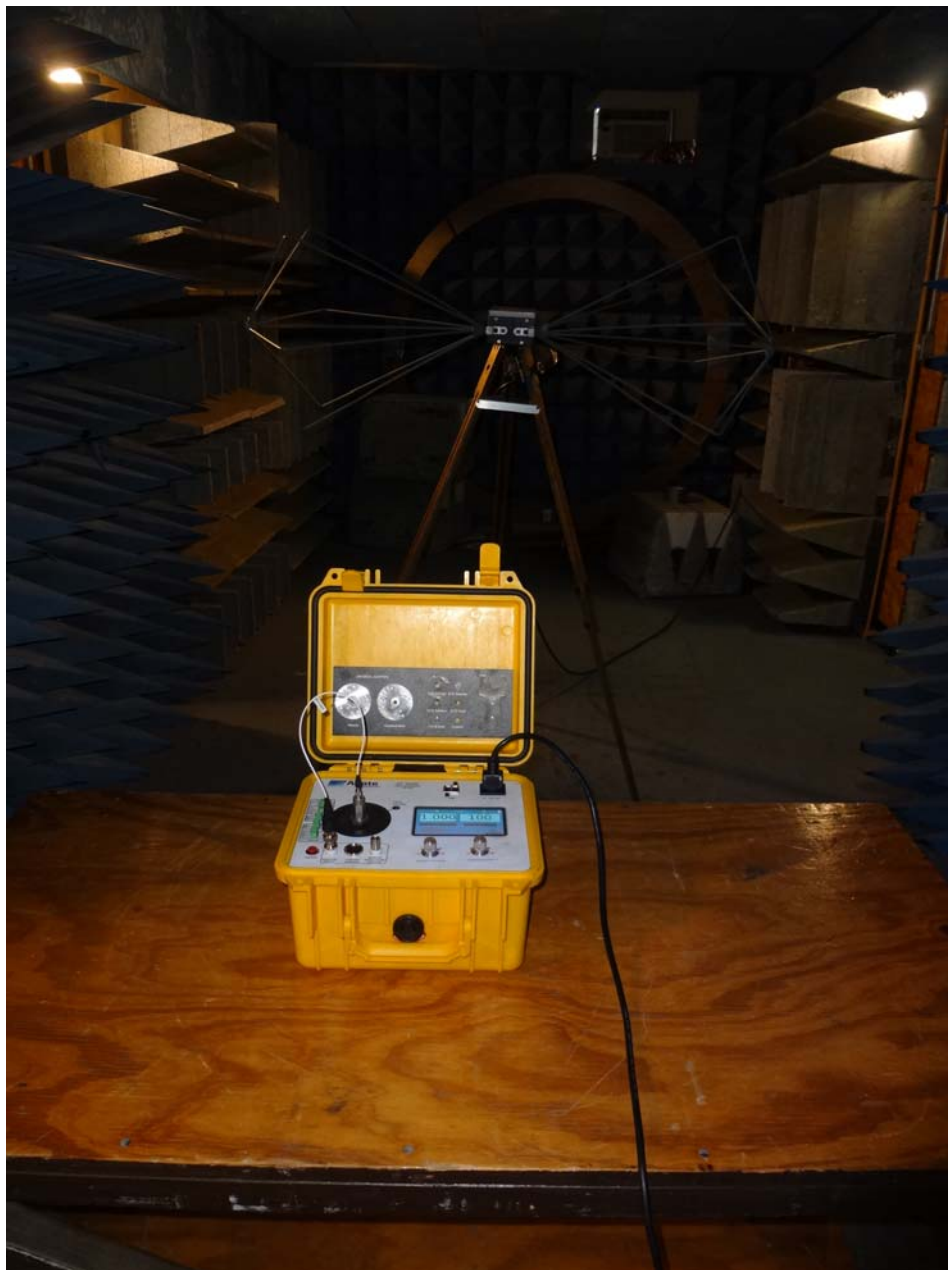
Radiated Susceptibility

Notes: 80MHz – 1000MHz

The EUT was subjected to a radiated E-field while being monitored for signs of susceptibility. To generate the required level of field strength in the appropriate frequency range a Power Amplifier and the appropriate antenna for the frequency range were used. The required field strength was monitored with Isotropic Field Probes along with an Isotropic Field Monitor. A list of the equipment used in this test is included in Appendix A.

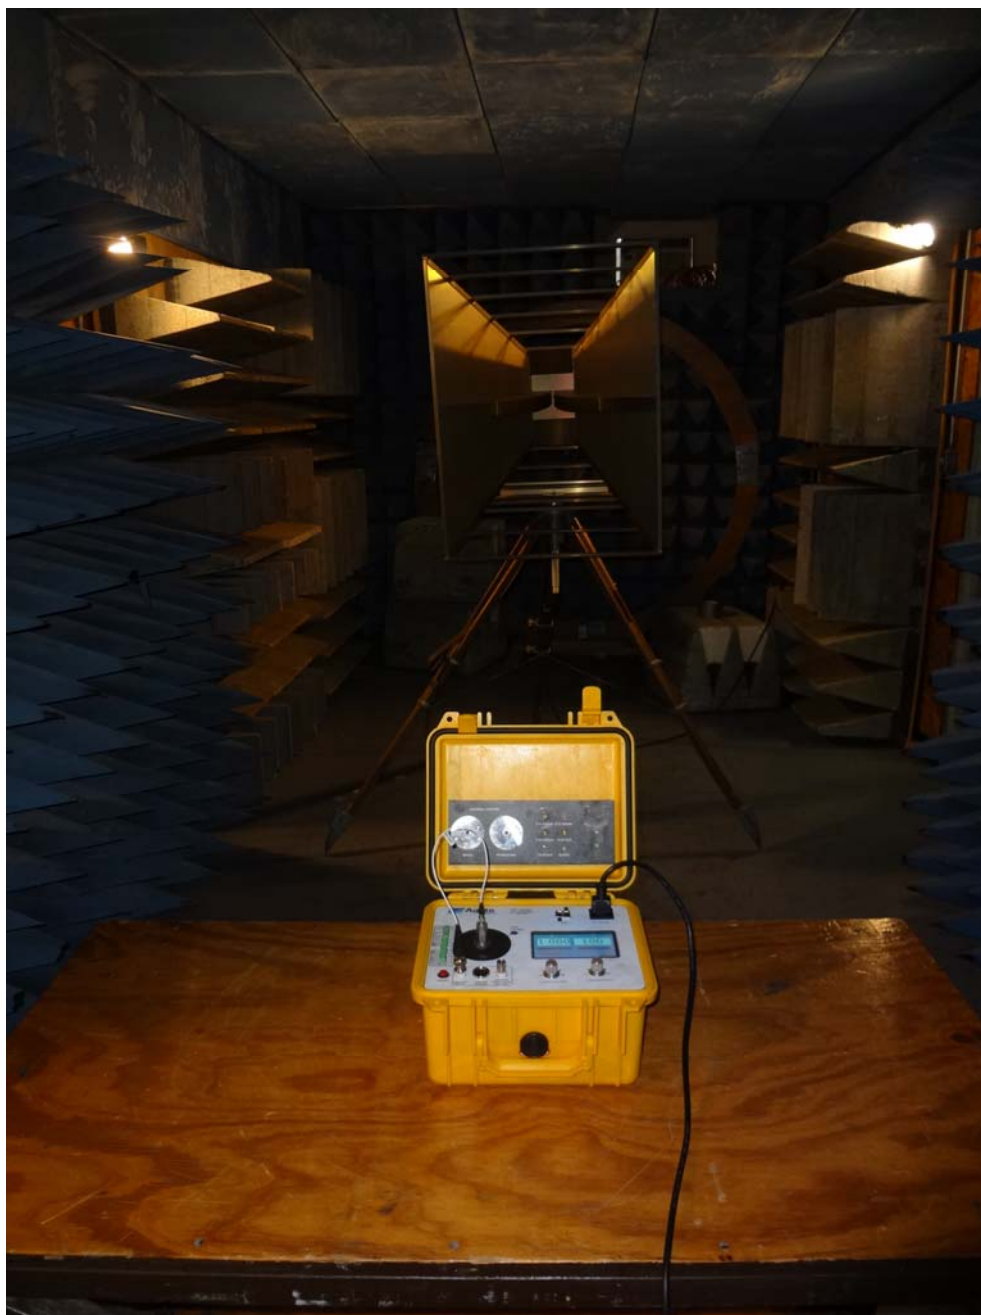
Radiated Susceptibility - DRG Horn

Notes: 160MHz – 1GHz

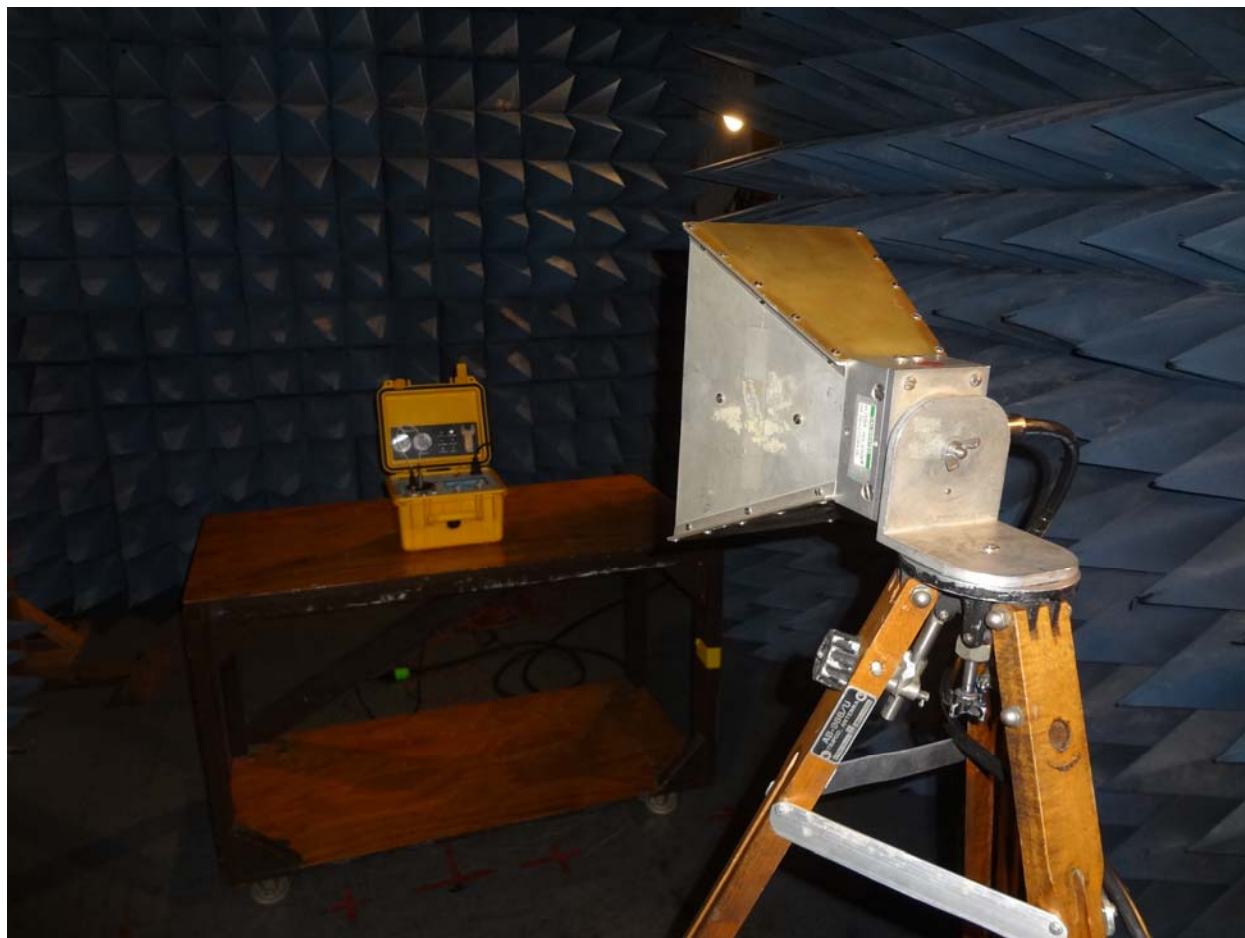
Radiated Susceptibility – DRG Horn

Notes: 1GHz – 2.7GHz

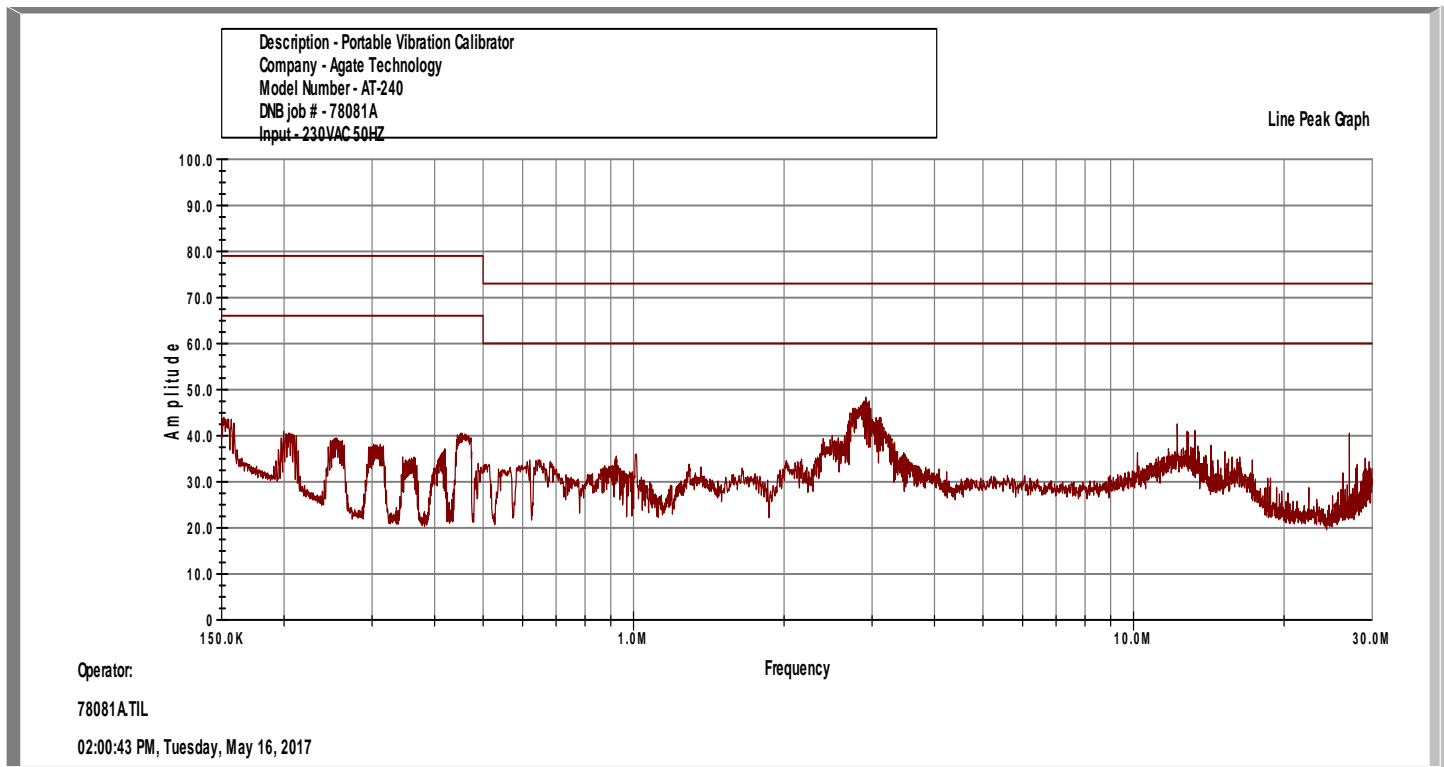
Conducted Emissions Datasheet

DNB Job Number:	RV78081A-001	Date:	16 May 2017	Specification EN55011 CLASS A [X] B [] GROUP 1
Customer:	Agate Technology			
Model Number:	AT-2040			
Description:	Vibration Sensor Test Set	S/N:	N/A	
Test Equipment: (See pg. 21)	Asset #'s: 844, 1109, 1242, 2180			
EUT performed within the requirements of the applicable Standard(s) YES <input checked="" type="checkbox"/> NO <input type="checkbox"/> SIGNED Mike Green

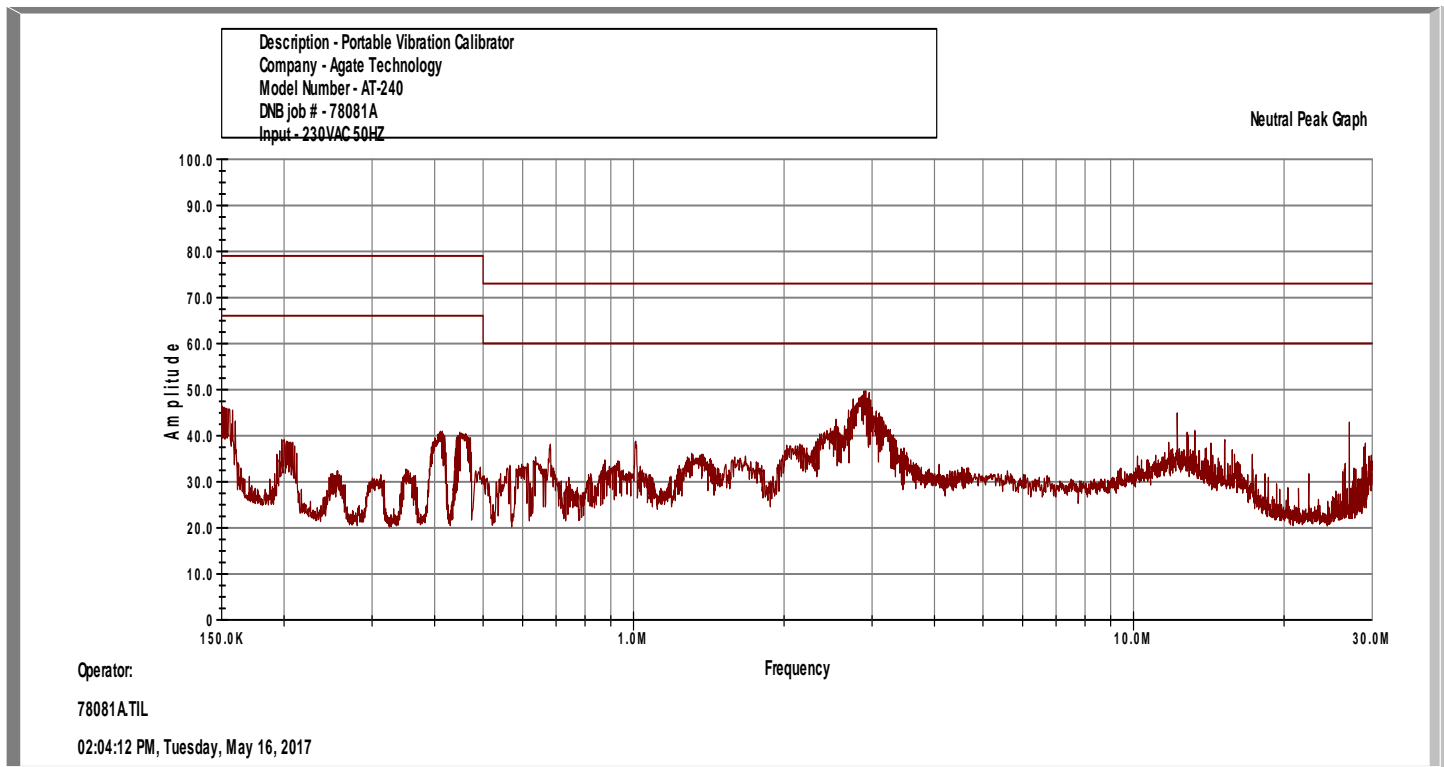
Conducted Emissions Datasheet

DNB Job Number:	RV78081A-001	Date:	16 May 2017	Specification EN55011 CLASS A [X] B [] GROUP 1
Customer:	Agate Technology			
Model Number:	AT-2040			
Description:	Vibration Sensor Test Set	S/N:	N/A	
Test Equipment: (See pg. 21)	Asset #'s: 844, 1109, 1242, 2180			
EUT performed within the requirements of the applicable Standard(s) YES <input checked="" type="checkbox"/> NO <input type="checkbox"/> SIGNED Mike Green

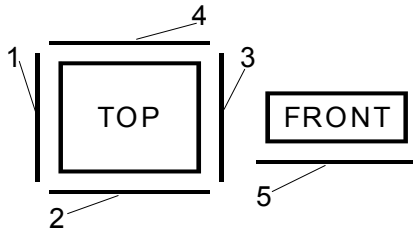
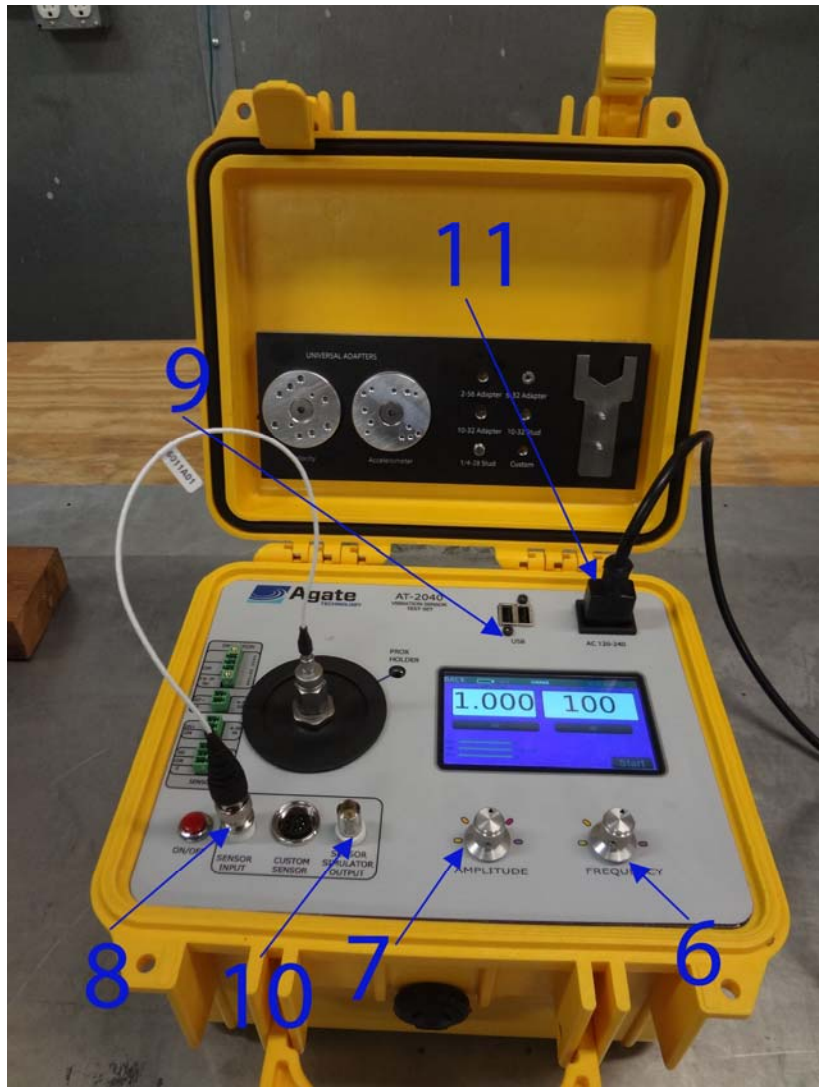
Location of injection points:

A minimum of ten discharges
 Per injection point is required.
