ENVIRONMENTAL IMPACT OF DEPOSITING DREDGE SPOILS IN AN AREA
BETWEEN FT. JAMES AND COVE BAY, ST. JOHN'S, ANTIGUA

August 25, 1987

Prepared for Ivor L. Jackson Associates, St. John's, Antigua

Environmental Impact of Depositing Dredge Spoils in an Area Between Ft. James and Cove Bay, St. John's, Antigua

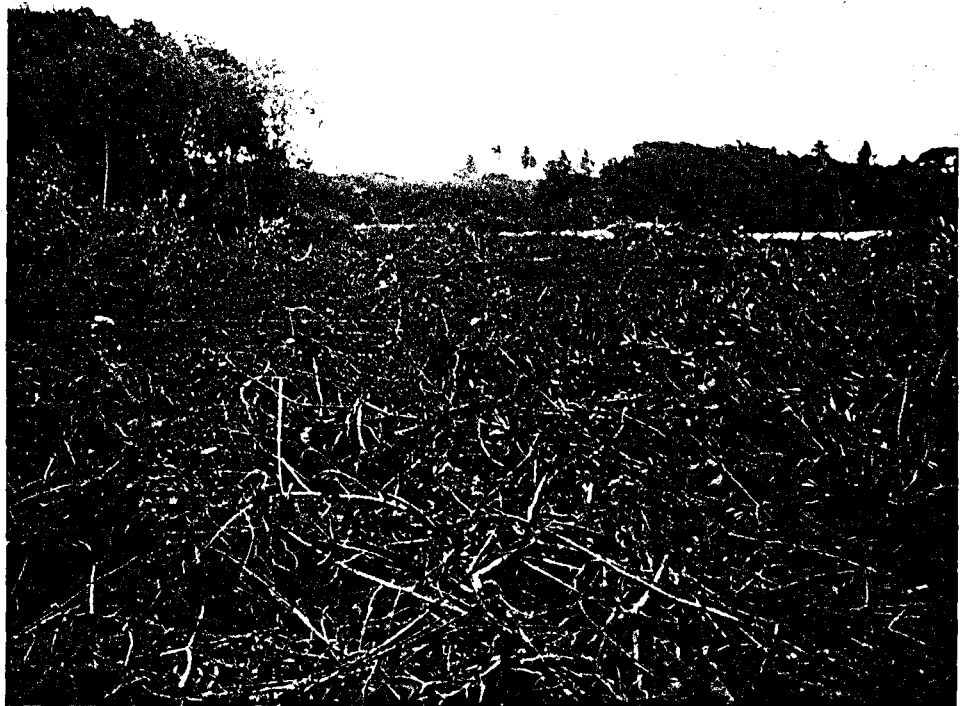
Area 1 shown in Figure 4 contains red and black mangroves that have been trampled by the dragline (Photographs 1 & 2). The construction of the containment dike is already in progress and is continuing to destroy valuable mangrove. On July 22, 1987, the dragline was located in area 2, Figure 4, where it was working on construction of the containment dike (Photograph 3).

Photograph 2. Mangrove destroyed by dragline (Area 1, Fig. 4) Inner cove lagoon and mangrove are in the background. Entire area is scheduled to be filled by dredge spoils.

1. all further destruction of the mangrove be halted;
2. no additional sediment be added to the lagoon;
3. the outfall from the containment dike be relocated to discharge into the outer cove and not into the lagoon;
4. a new plan for containment of dredge spoils be established that excludes and preserves existing mangroves;
5. the channel connecting the lagoon to outer harbour be kept open to allow for tidal flow of water in and out of the area;
6. a water quality monitoring plan be put into effect when dredging begins and
7. containment dike monitoring be included in the water quality monitoring plan.

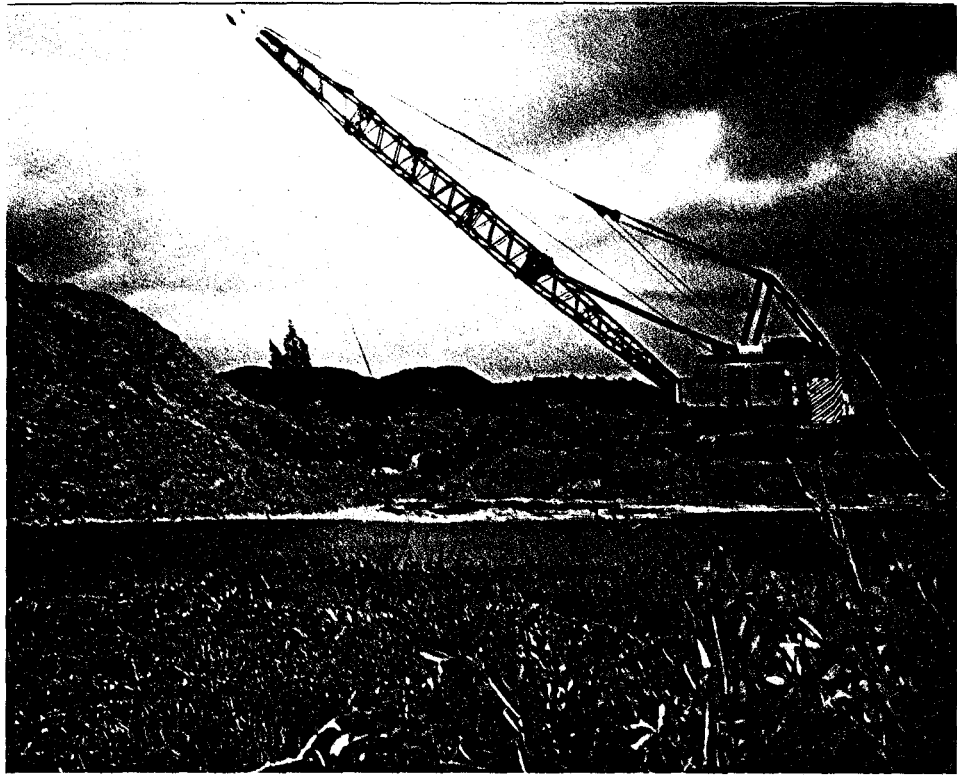
Photograph 3. Dragline building containment dike (Area 2, Fig. 4). Red and black mangroves of the area have already been destroyed.

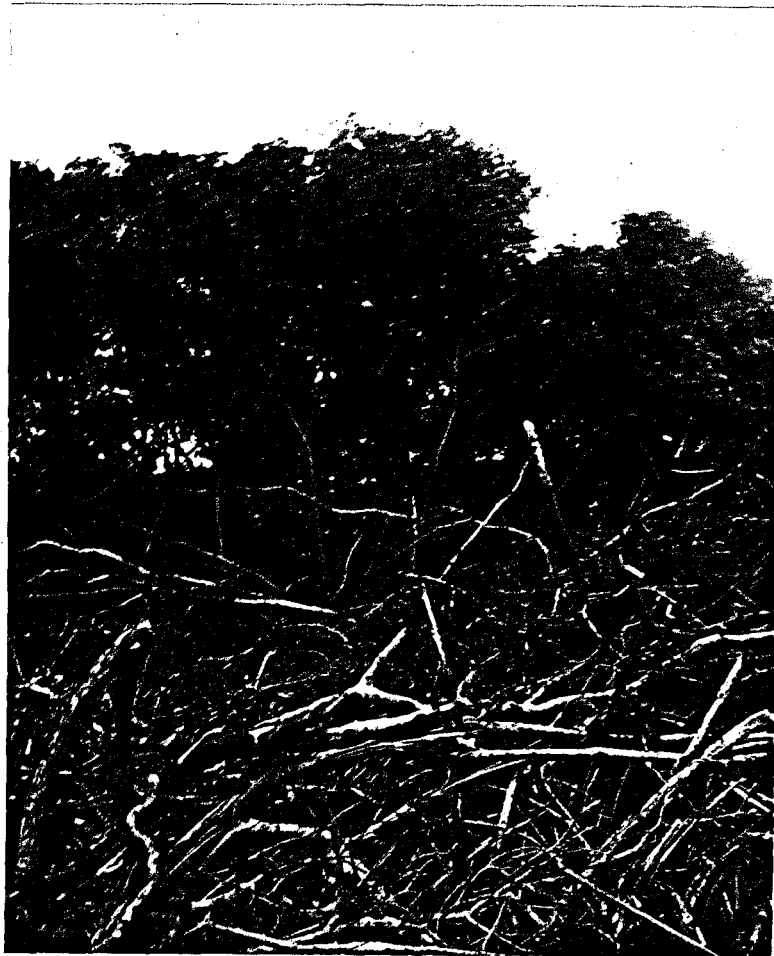
Photograph 4. Partially destroyed red mangrove area (Area 3, Fig. 4) rich in wildlife.

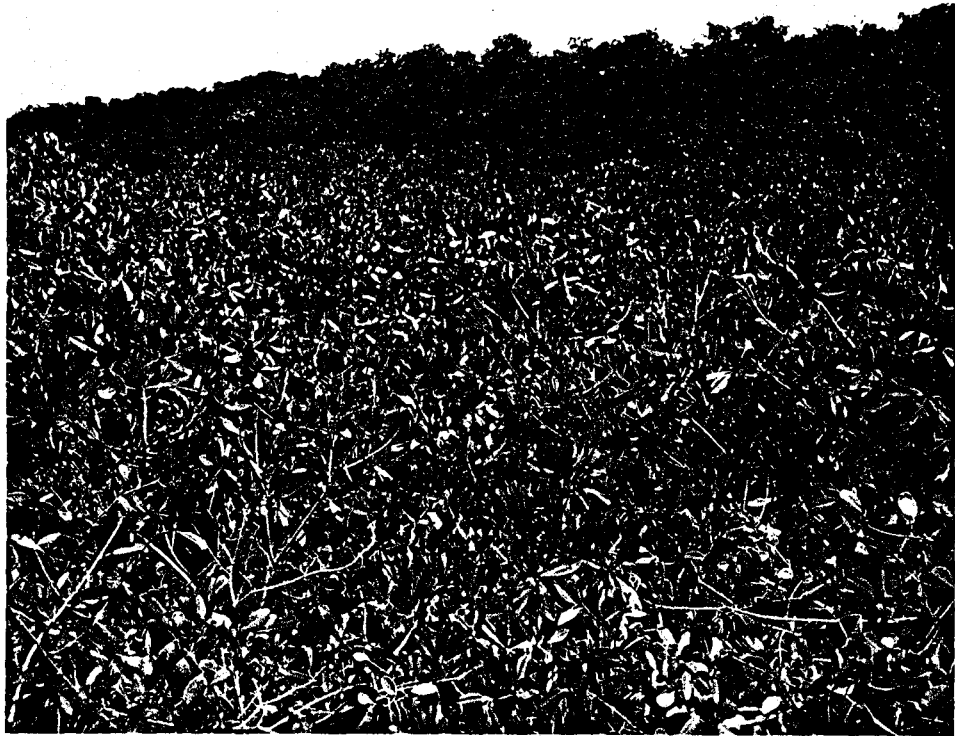
Area 4 in Figure 4, is an extensive and dense stand of small red mangroves (Photograph 5). This area will also be destroyed under the present plan. To the west of the area of small red mangroves is the salt pan which is

Photograph 5. Stand of red mangroves (Rhizophora mangle) located in Area 4, Fig. 4, destined to be destroyed if the present plan is used.

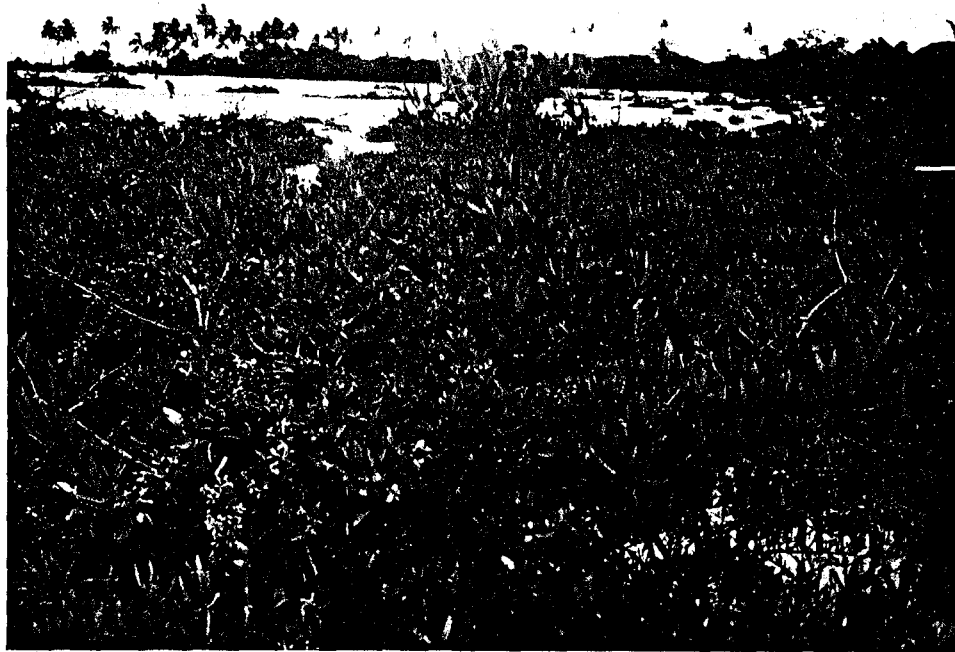
shown in Photograph 6. This is a more acceptable area for building containment dikes and dumping dredge spoils.

Photograph 6. Edge of the red mangrove and the beginning of the salt pan (Area 5, Fig. 4).

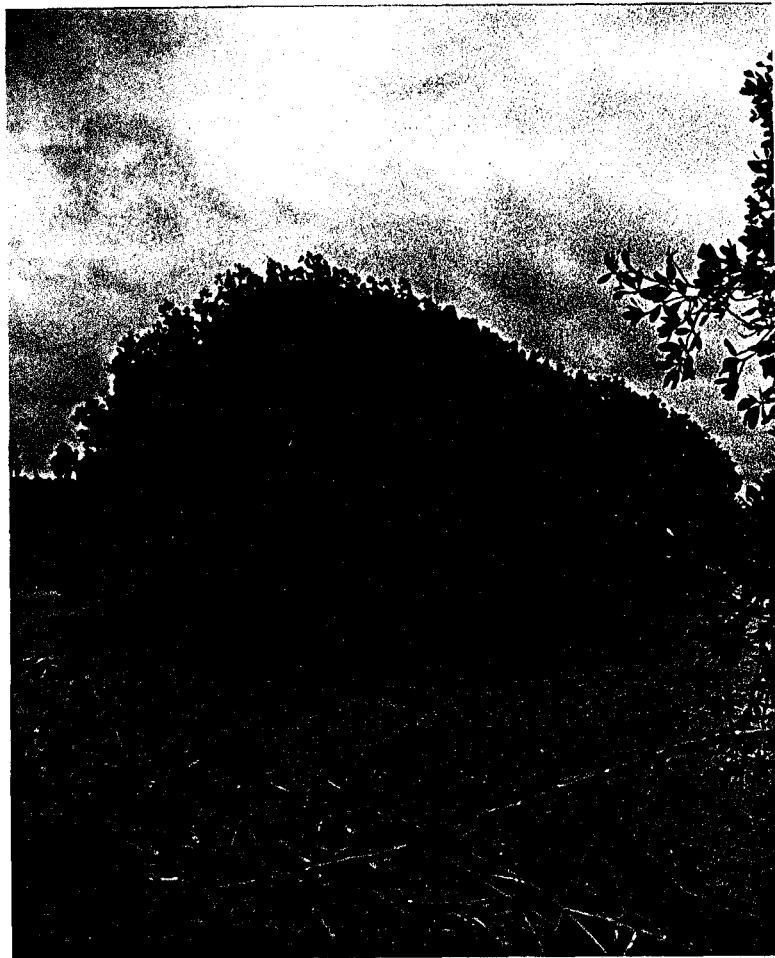
Photograph 7. Entrance to the inner cove lagoon showing luxurious red mangrove (Area 6, Fig. 5).

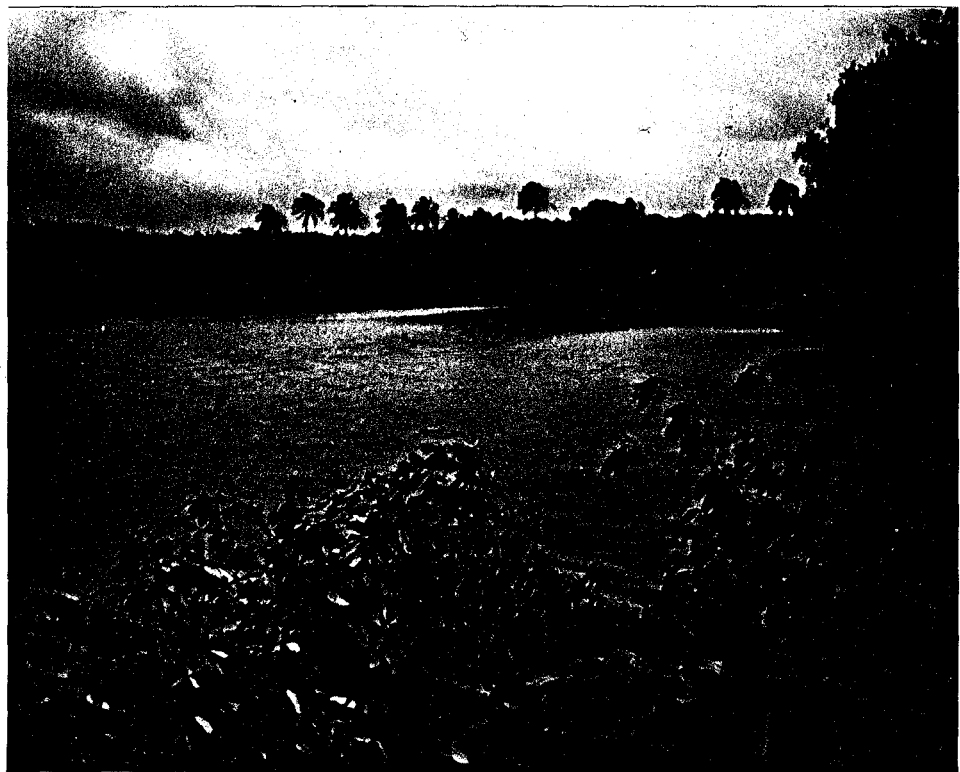
Mangrove habitats described and shown in Figure 4, including the waters of the inner cove, are destined to be destroyed under the present spoils containment plan. Both inner and outer coves of the lagoon are surrounded by lush and healthy red mangroves. The inner cove is especially luxuriant with the area entirely surrounded by red mangrove with many new plants becoming established. The entrance to the inner cove is shown in Photograph 7 (Area 6, Figure 4). Photographs 8 and 9 show the inner areas of the mangrove lagoon (Areas 7 and 8, Figure 4).

Photograph 8. Inner cove lagoon and mangrove. This area (Area 7, Fig 5) is slated to be filled with dredge spoils under the present plan.

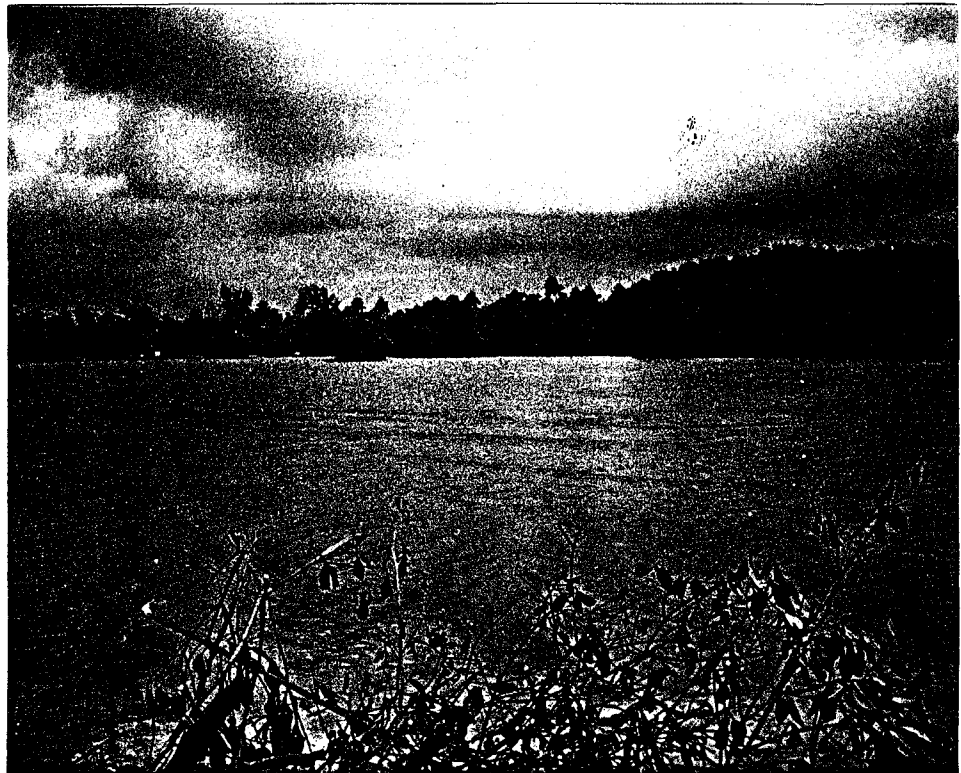
Photograph 9. Inner cove lagoon and mangrove. This area will be filled with dredge spoils if the present plan is not modified (Area 8, Fig. 5).

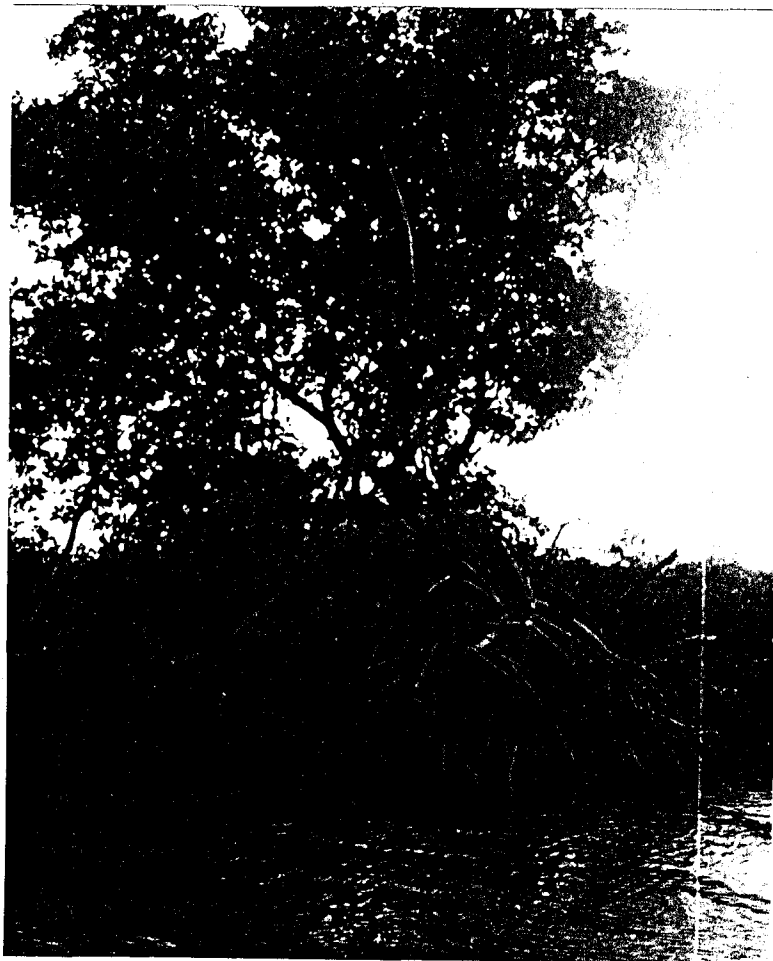
CHANNEL MANGROVE. Tall healthy red mangrove plants with deep prop roots line the channel. The waters of the channel were clear enough to observe marine life using a mask and snorkel. Many fish were seen, including bonefish (Albula vulpes), ballyhoo (Hemiramphus brasiliensis), barracuda (Sphyraena barracuda), mullet (Mugil sp.), grey and yellowtail snappers (Lutjanus griseus and Ocyurus chrysurus), blennies, butterfly fish, mojarras and many others.

Photograph 10. Cove entrance channel showing extensive red mangrove root system.

The channel opens naturally by tidal flow. However, it should be emphasized that it is very important for this channel to remain open. The daily tidal flushing provides an exchange with the outer harbour, keeping the temperature and salinity of the cove lagoon near that of the outside waters. Should the area be closed off there would be excessive evaporation causing a rise in salinity and temperature leading to adverse conditions for life. Closure should be avoided or a productive lagoon will soon become an unproductive, anoxic and very dead salt pond.

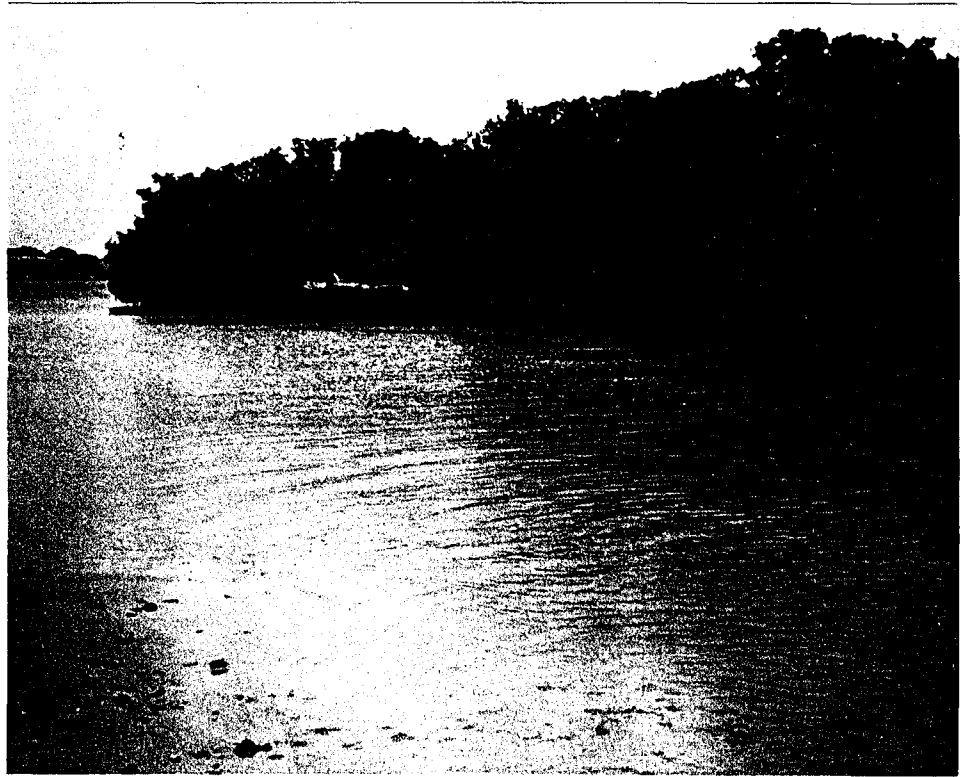
Photograph 11. Cove entrance channel lined by red mangroves.
