# EPBM Excavations of Prague Subway "Metro V.A."

The Metro V.A. extension included 4.8 km of twin tunnels bored by 2 Earth Pressure Balance Machines (EPBMs), and 1.3 km section including mined double track tunnel. The article focuses on the experience with EPBM excavations, and provides a brief description of the stations and mined tunnels.

**K. Rossler and D. Cyron**, Metrostav a.s., Czech Republic;  
**V. Vales**, Metroprojekt Praha a.s., Czech Republic

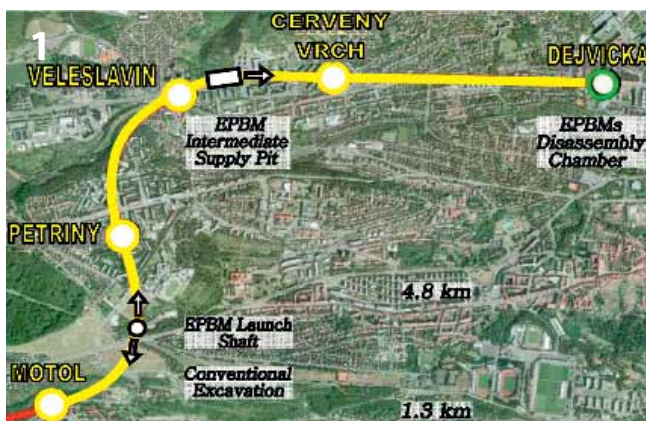
Metro V.A. will add to operation 4 new stations and 6.1 km of tunnels to the existing Prague subway

Hochtief CZ Company accounted for the 1.3 km double track tunnels including the open cut Motol Station, and the mined Cervený Vrch Station (Fig. 1).

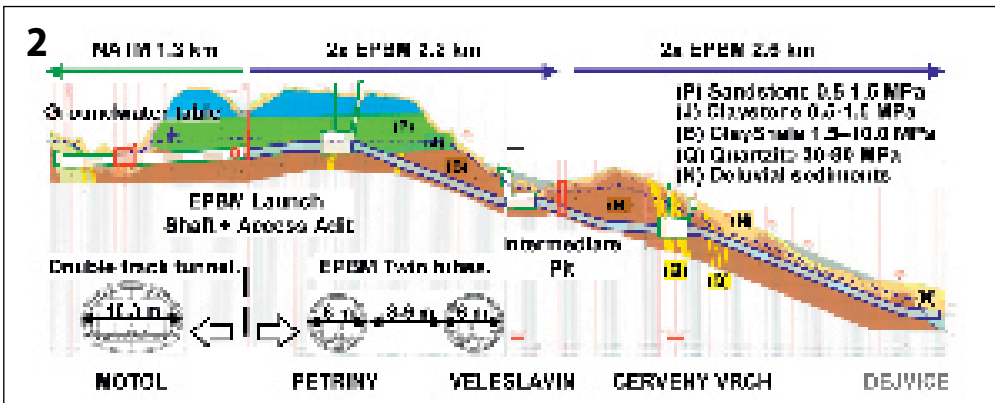
Major portion of the alignment was situated in the clayshale bedrock

Major portion of the alignment was situated in the clayshale bedrock (Fig. 2). At the launch shaft, about 0.7 km of the alignment was intersected by the water-bearing sandstone sealed by the

clayshale layer at the bottom. Shallow alignment portions were intersected by deluvial sediments and by weathered clayshale bedrock horizon classified usually as clayey sand or clayey gravel.

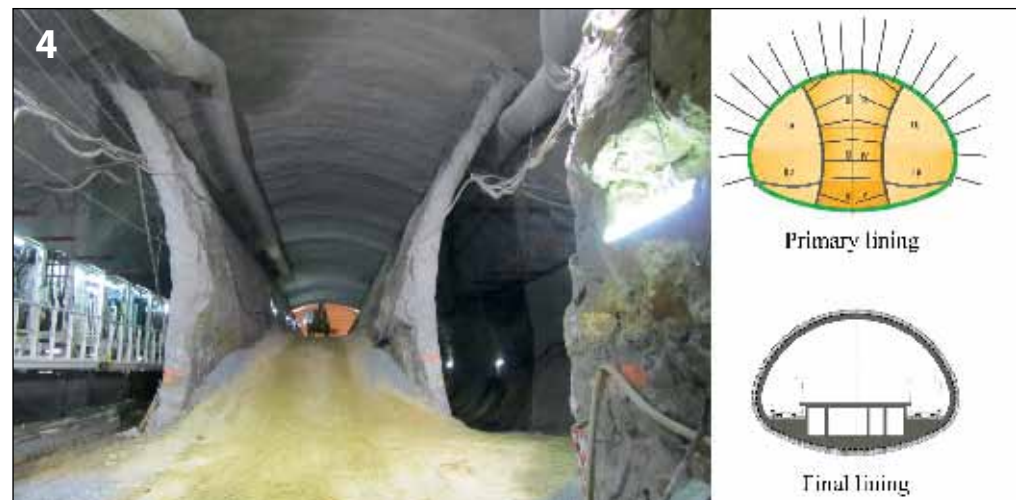
Station excavation implemented the twin side-wall drift method, which first built the side drifts to support the station arch. The left side drift shows the EPBM gantry

side-walls (Fig. 4). Under their protection the center drift excavation was completed and the invert was closed while the EPBM operations were still running in the side-drifts. After the EPBM logistics were relocated to the intermediate supply pit, the temporary side-walls were demolished from a gravel ramp.

By the time the 2 side-drifts were completed and the center drift was still under excavation the EPBMs arrived in the station and were walked through the side-drifts separated from the center drift by the temporary

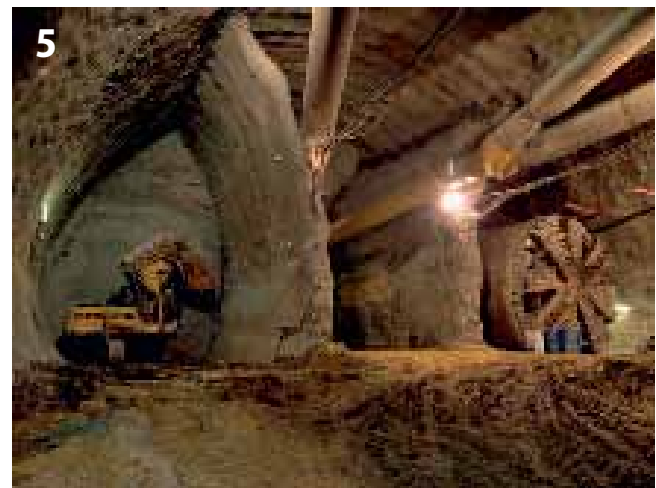
The side-drifts of Petrín Station were filled with light concrete to form a vertical wall for the EPBM breakthrough

10 m of the bifurcated adits were filled with the light concrete which at the same time formed a vertical wall for the EPBM breakthrough (Fig. 5).

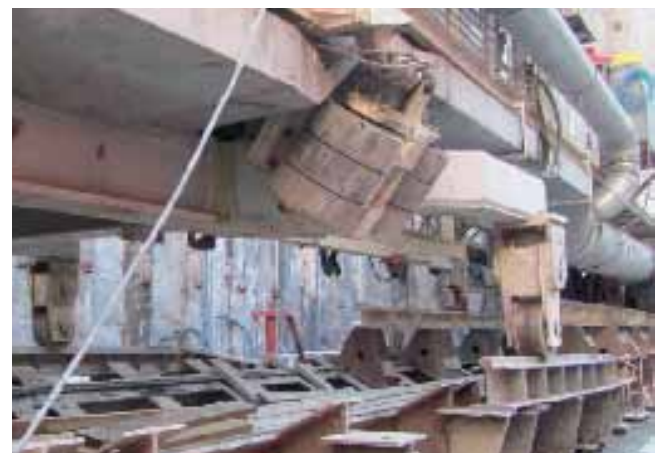
a) Steel cradle in a curve prepared for the shield in the intermediate shaft

The steel cradle was easy to adjust to required directions, and could be universally used to support both the 6 m diameter shield, and the wheeled gantries

b) The same cradle to support the gantries

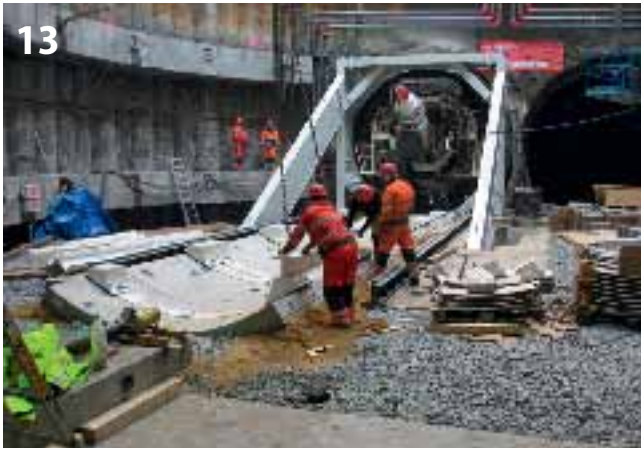
Massive bracing frame for EPBM start in the circular launch shaft

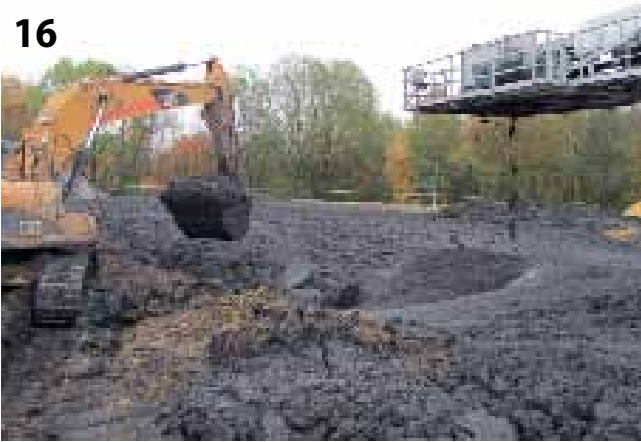
The clayshale rock was transformed into a mud by large quantities of water added to the cutterhead

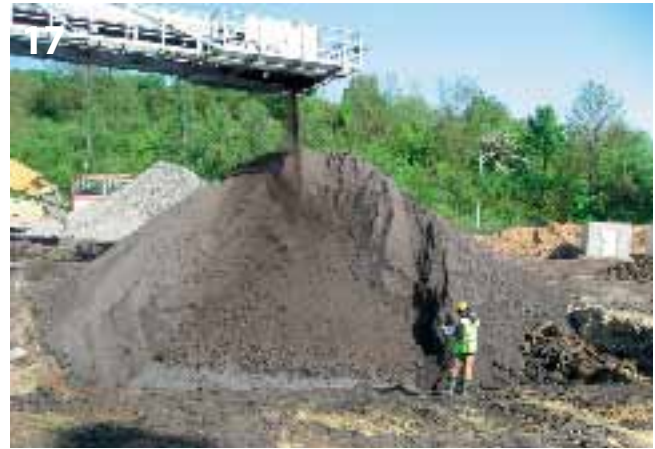
An initially good result of the “dry” muck production attempt, which failed after 75 m with the ingress of the groundwater and generation of sticky muck

without foams and without additional water, which would eliminate the problems with handling a depositing the sticky muck (Fig. 17). However that was possible only in the rock with none or minimum ground water seepage. The effort to keep the muck dry failed with the variable groundwater ingress. The crews had to fight either the stiff clayey chunks overloading the screw conveyor or the muck slurry, which poured from the belt on the tunnel floor after the cutterhead was filled with groundwater during a standstill. Besides the screw conveyor clogging the excavation was also stopped when in front of the cutterhead the sticky muck formed a stiff cake at the cutterhead center, which prevented cutters penetration into the rock. A full

stop to excavation took place when the muck finally plugged all the cutterhead openings, and no muck could be transported from the face. After 75 m of excavation it became clear that excavation in the “dry mode” was not possible in the given conditions. Therefore, the operators started to pump foams and additional water into the cutterhead.
