ESAIL D3.1.4

Tether Reeling Test Report

First Amendment

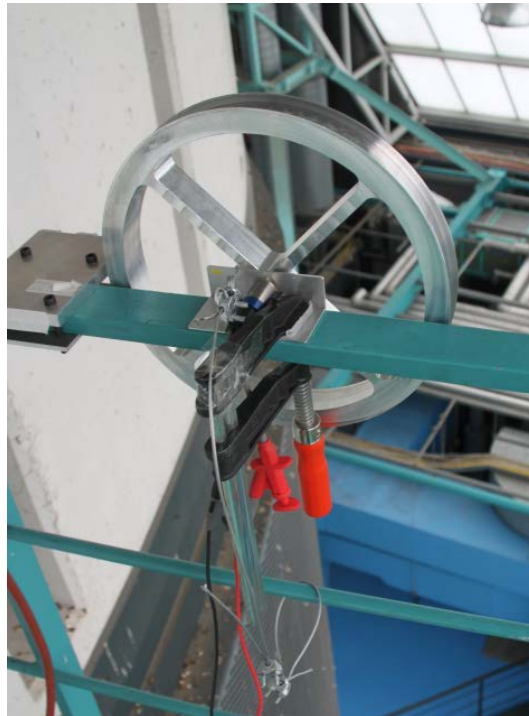
The PTA consists of a clamp, the e-motor and the tether reels (Figure 2). The clamp holds the e-motor and establishes the interface for mounting the PTA to the test facility. The e-motor is a Faulhaber DC-Micromotor, Series 1724 024 SR, connected to a Faulhaber planetary gear, Series 20/1, with a gear reduction of 415:1. [RD01].

Figure 2: The PTA mounted on the test facility

For the unreeling test two different types of a reel with a diameter of one coil is 280 mm and the tether running surface is 30 mm (also seen in Figure 2). The reels differ in one rounded edge on the tether running surface (Figure 3). A detailed reel description is written in [RD02]. A tether opening was not used.

The PTA was mounted on the outside of the handrail. It was fixed with a screw clamp and backed with a wire cable. The e-motor was connected with a power supply, where the voltage can be adjusted (Figure 2).
