ENGINEERED ARRESTING SYSTEMS CORPORATION

EMASMAX[™] Aircraft
Arresting Systems for
Runway Overrun
Protection"

ICAO - Global Runway Safety Symposium Montreal, 24 May 2011

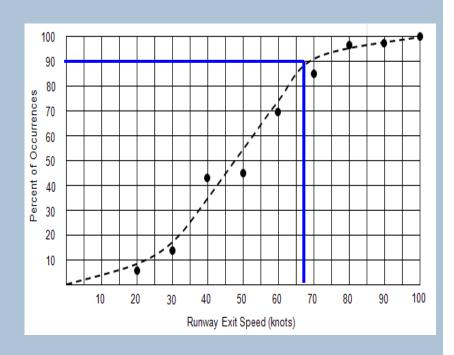
- FAA statistics show that for 90% of the overruns, the aircraft exits the runway at 70 Knots or less
 - Approximately 50% are at 50 Knots or less
- The FAA-required 1,000 foot (305 m) long Runway Safety Area is designed to provide space for 70 Knot braking
 - Good Weather and Surface Conditions
 - Good Aircraft Braking
- Vast majority of overruns are in poor weather conditions
- Clear weather overruns are typically due to aircraft malfunction

Source: FAA report "Soft Ground Arresting Systems for Airports" (DOT/FAA/CT-93/80)

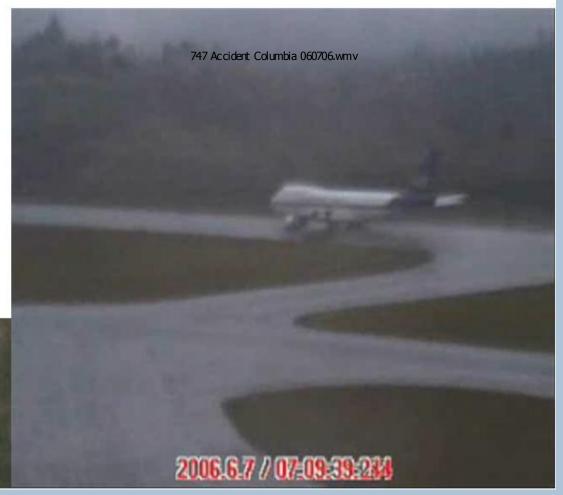
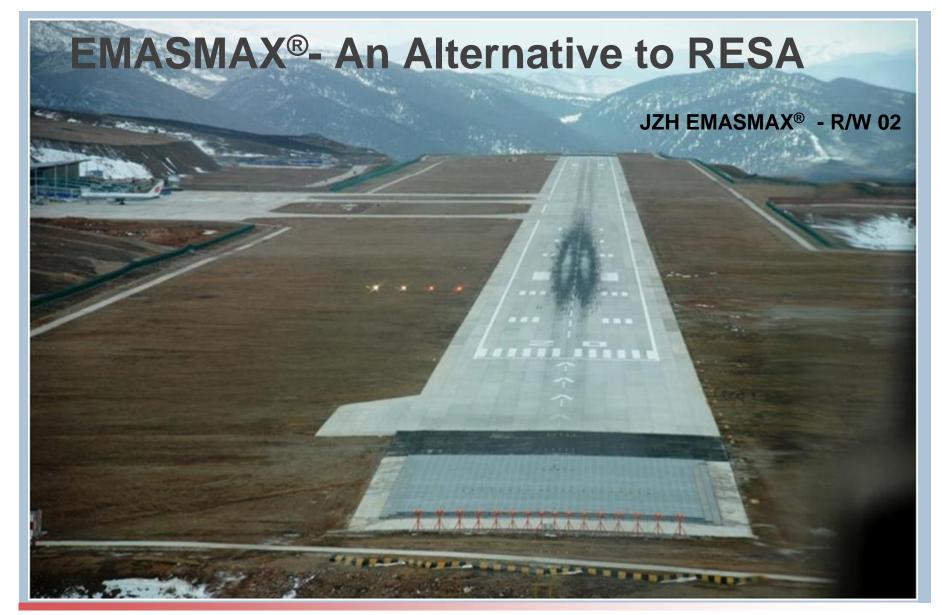
Medellin, Columbia (June 2006)

- ICAO Recommended RESA
 - 240 m beyond 60 m runway strip
- B747-200 Cargo Aircraft
 - Aborted Takeoff
 - Exits Runway at ~ 45Knots
- Aircraft Destroyed

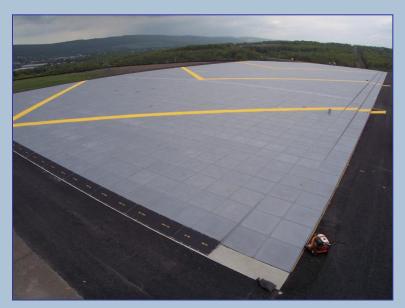
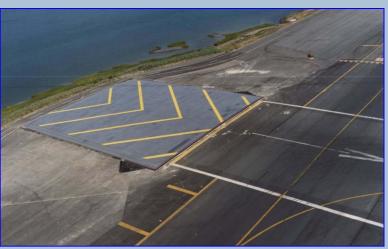
- A bed of cellular cement blocks encased in an environmental cover that is placed at the end of a runway to decelerate an overrunning aircraft in an emergency
- Passive system that will reliably and predictably crush under the weight of an aircraft, providing gentle, consistent deceleration

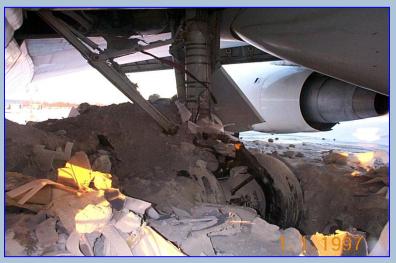
- Tire/material interface provides resistive loads to decelerate the aircraft
- Loads are placed on the aircraft landing gear and support structure
- ESCO's FAA-Approved computer model is used to determine final arrestor bed configuration

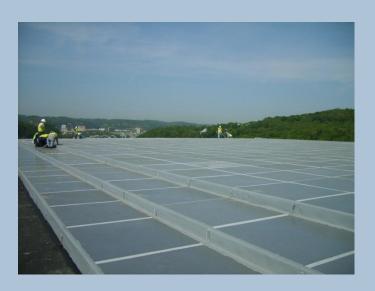
• Each EMAS is custom designed based on:

- The aircraft that operate on the runway
- The length and width of the runway
- The elevation of the runway
- The length of available RESA
- The slope of the RESA

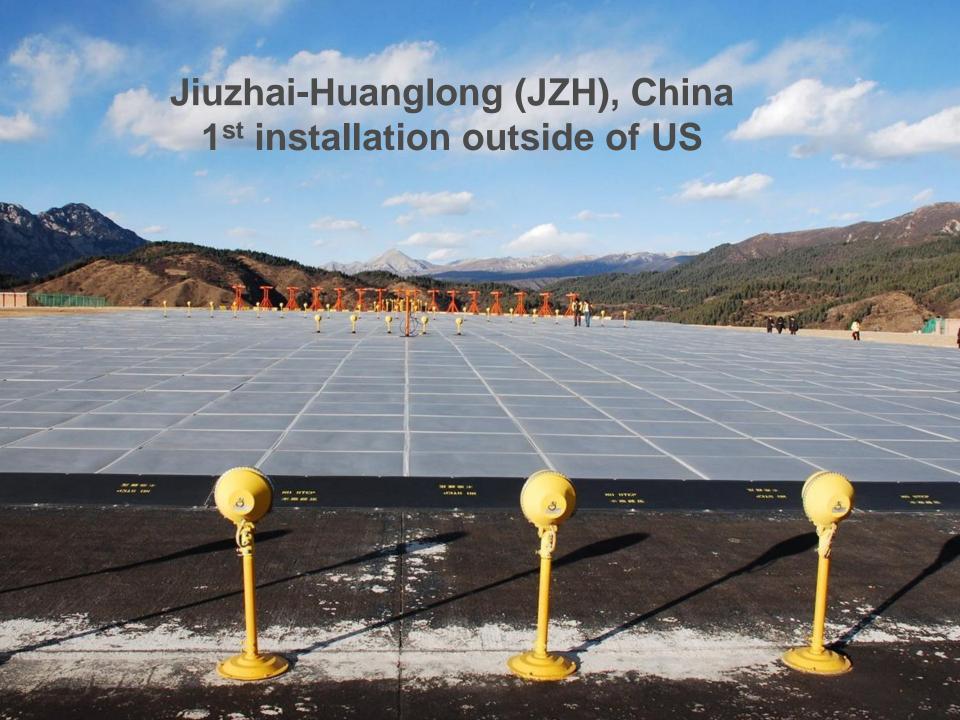
Performance is predicted based on:

- All critical aircraft (more than 500 annual operations)
- Aircraft at field-adjusted MTOW
- Aircraft at field-adjusted 80% MLW

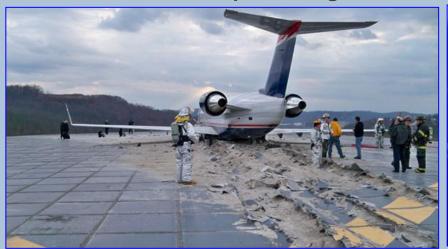
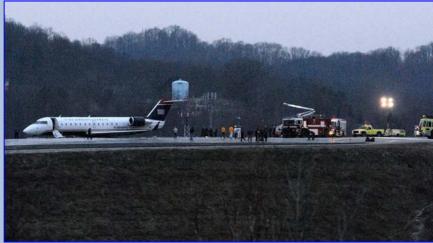
19 Jan. 2010: US Air Express, Flight 2495, CRJ-200 regional jet with 34 pax & crew

No injuries

Runway reopened within 5 hours

Aircraft returned to service (3 days)

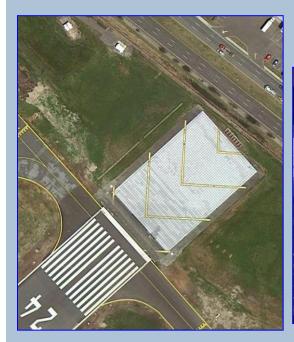
Teterboro, NJ Airport Runway 06 Departure

Prior to EMAS - Overrun February 2005

Arrestment October 2010

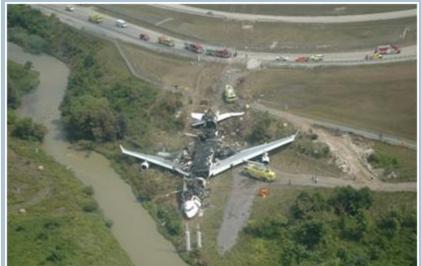
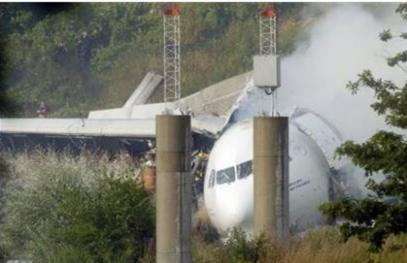
Toronto International Airport Accident, Aug 2005

TSB Final Accident Report
 12 Dec 2007

"The Board believes that all such runways could benefit from a RESA built in accordance with the ICAO Annex 14 recommended practice or the FAA's runway safety area (RSA) standard

The Board believes that there exists a requirement for an alternate means of compliance, such as the use of an engineered material arresting system to provide a level of safety that is equivalent to a 300 m RESA".
