# "Examples of Substantiation Testing and Documents to Support Large Areas of Composite Repair"

#### 2015 FAA/Bombardier/TCCA/EASA/Industry Composite Transport Damage Tolerance and Maintenance Workshop

Bombardier Aerospace, Montreal, Quebec, Canada, September 17, 2015

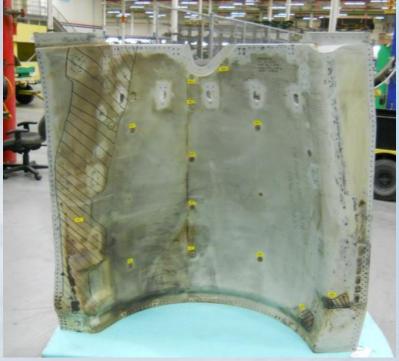
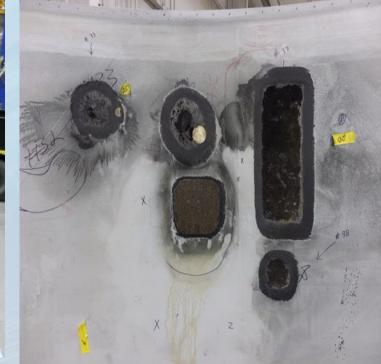
Damage is not always a result of an impact often times making the repair approach more intricate:

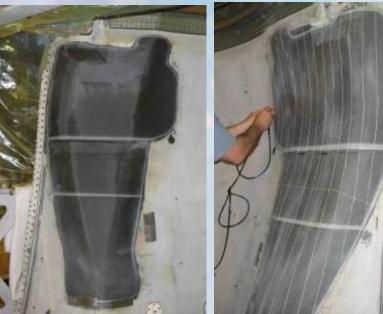
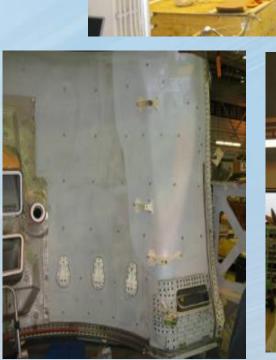
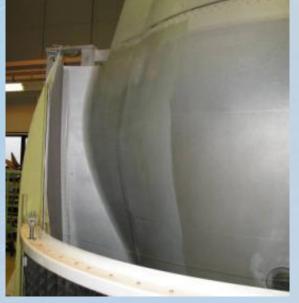
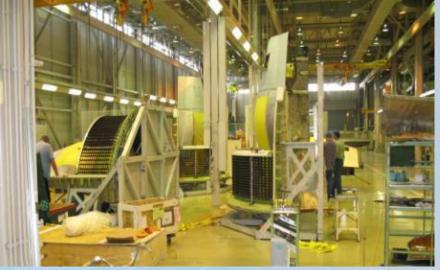
Large Area Repair for Inner Wall Compliance (72)

Necessary Tooling to get T/R into Repair Position

Repair Area = 33 and 35 sq ft (LH & RH) 28,000 cycles, 80,000 hrs, on the oldest repair Performed 6/9/2006 thru 4/2008

In 2005/2006 time frame, Spirit assisted Boeing by designing a repair kit to comply a condition that existed on 18 aircraft, 72 thrust reverser inner walls.

Service Bulletin 777-SB0078 was released, and 18 aircraft at 5 foreign carriers were identified to have an area between 35-36 square feet removed and replaced with structural materials of the same genre, for increased performance.

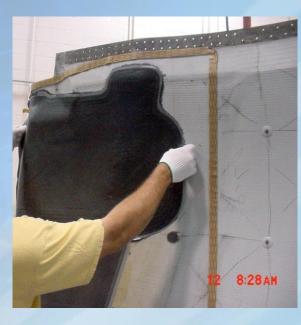
done out of autoclave

Placement of consolidated

Example of consolidated repair kit, onto structure

Note - Repair in "Sections" vs One Large Area

Lesson Learned: A well prepared kit drastically reduces repair time

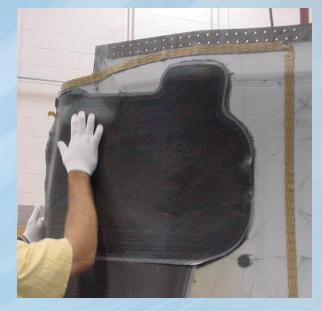
Smoothing kit into sanded recess, tool located and template aligned

Result – Kit is ready to bag and cure – total time involved in placement --7 mins

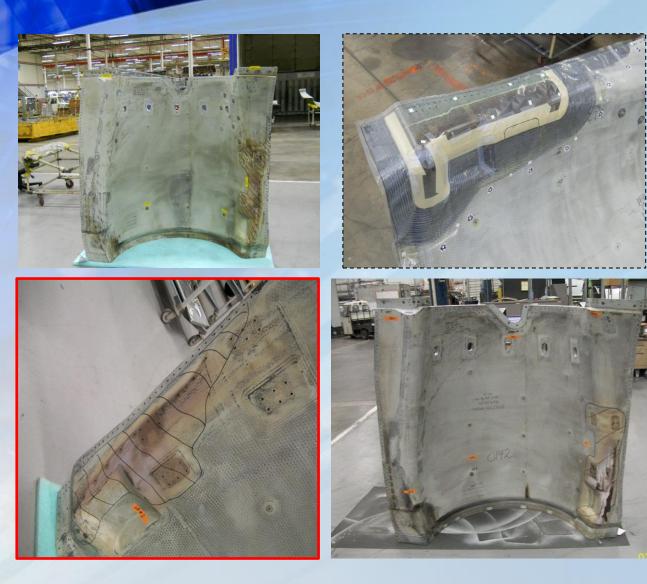
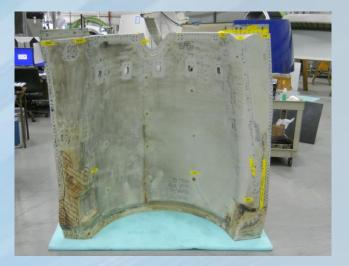
Compared Large Number of Damaged Inner walls: -Damage location was consistent -Damage area (size) was consistent -Found correlation between damage size and time on wing -From data, could categorize two basic geometry needs for a repair kit (Reviewed **more than 600 panels**)

Within a reasonable tolerance, learned we could categorize damage size - Repeatable Geometry has the opportunity for a designed repair kit

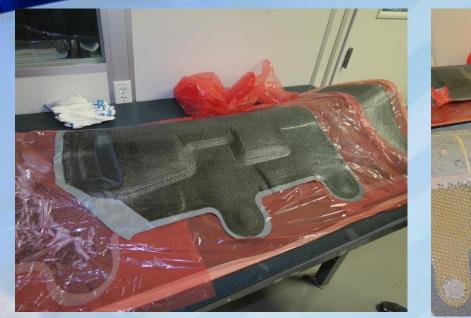
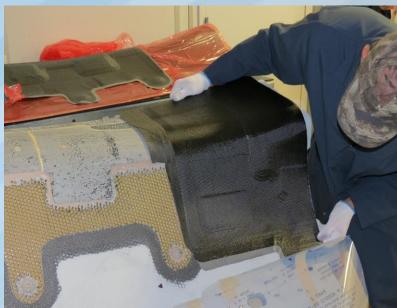
Repair Kit arrives on contoured Shipping fixture

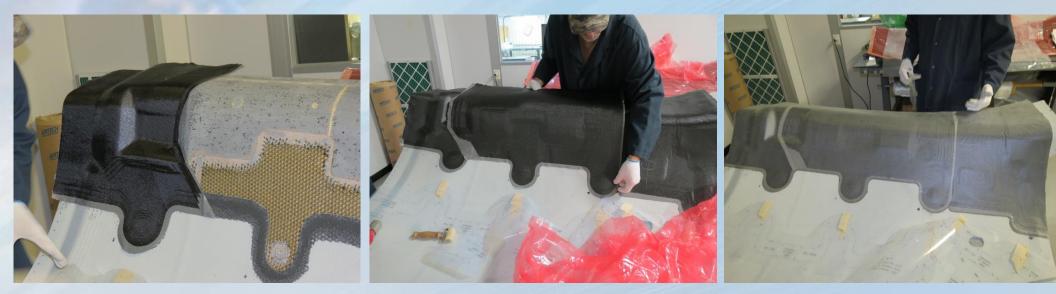
Forward Ply Kit

Aft Ply Kit

Middle Ply Kit

Kit Located – Ready for Cure

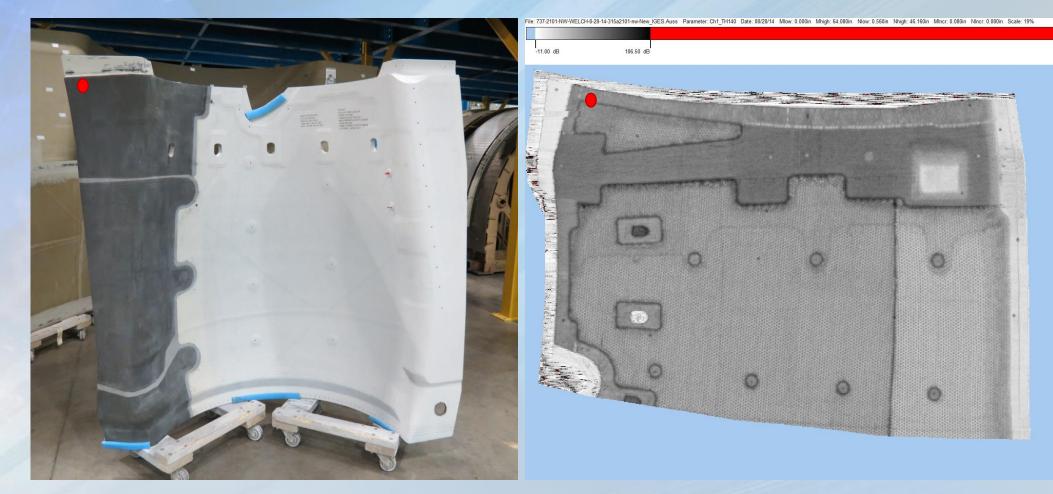
Finished Panel, after heat blanket cure

Clean NDI

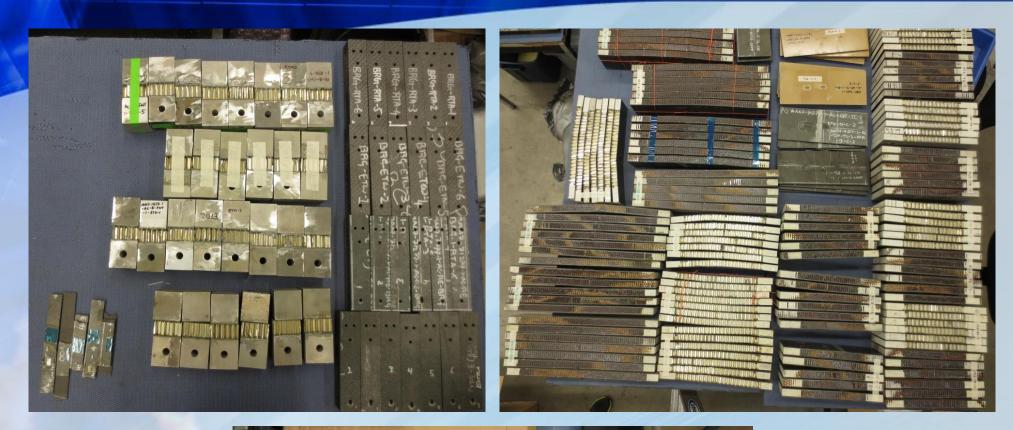
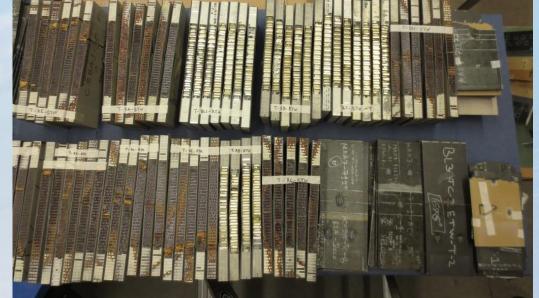
#### This is what Structural Substantiation Looks Like

Took about 1 year to fabricate, and test to failure, all coupons

Variables included in the test plan:

Spliced Heat Blankets One Side Heat Source Heat on both Sides Autoclave sub-strate Heat blanket cured sub-strate Baseline – Autoclave Cured Repaired – OoA Cured

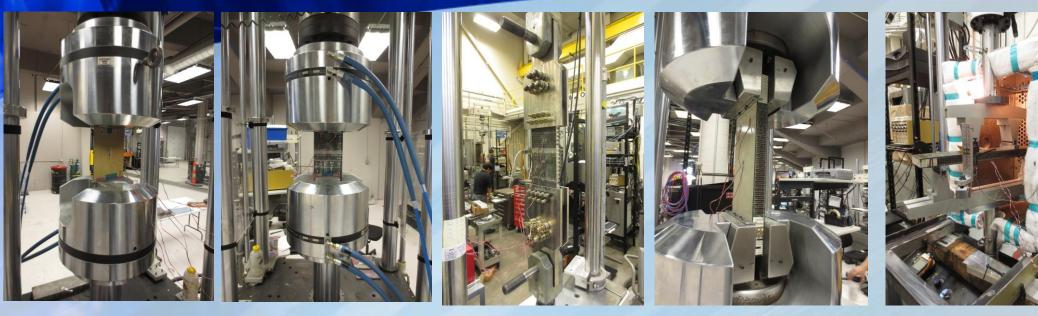
Tension - Laminate

Tension – Sandwich, Rpr

Tension – Sandwich, LD

Tension – Sandwich, HD

Flex – Sandwich, I

Flex – Sandwich, LD

Tension - Sandwich

**Pin Bearing**
