# Ferrari 328 A/C System Inspection, Leak Detection, Compressor Seal Replacement, & Recharge

*Carl Rose*

*November 2003/ revised June 2004*

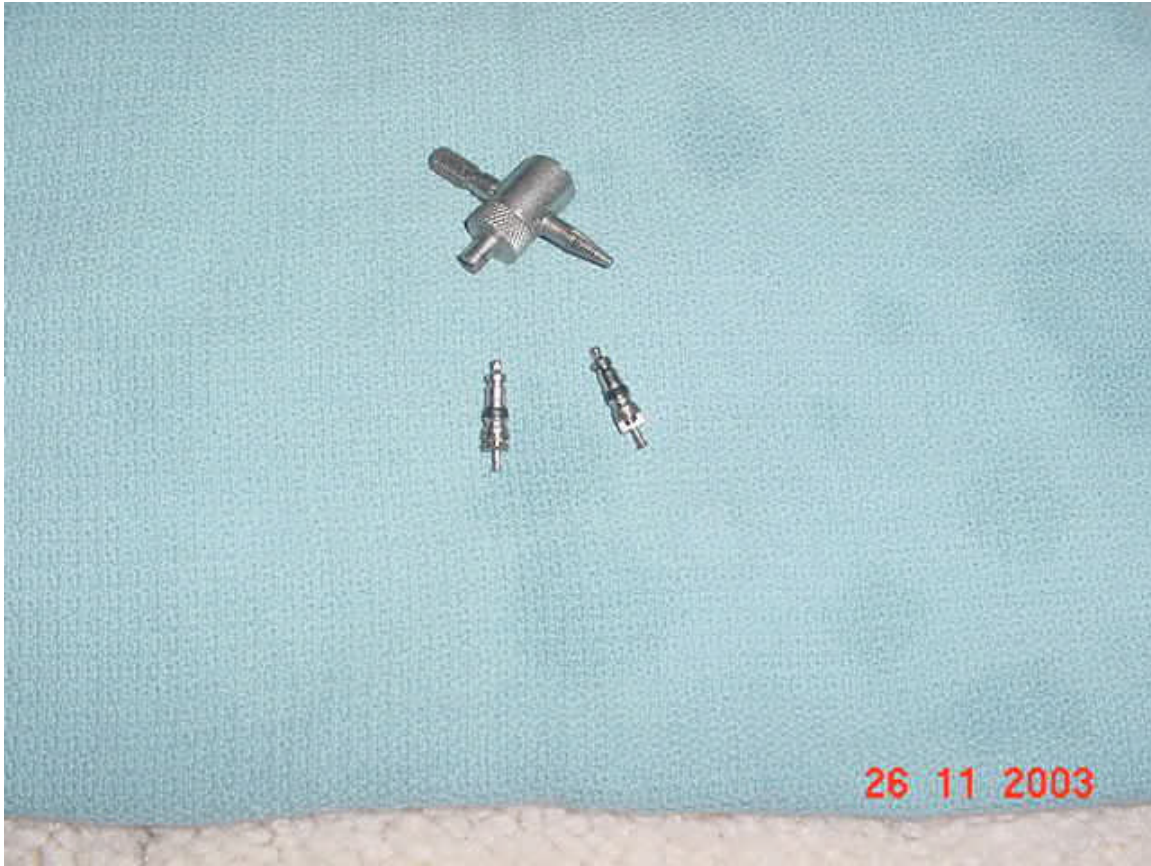
*Original Schrader valve cores & removal tool:*

- Schrader valve cores for compressor fittings (most recommend replacing at every major service; I did not as mine were only 12 months old). Will need installation tool (Craftsman tire valve removal tool works perfectly).

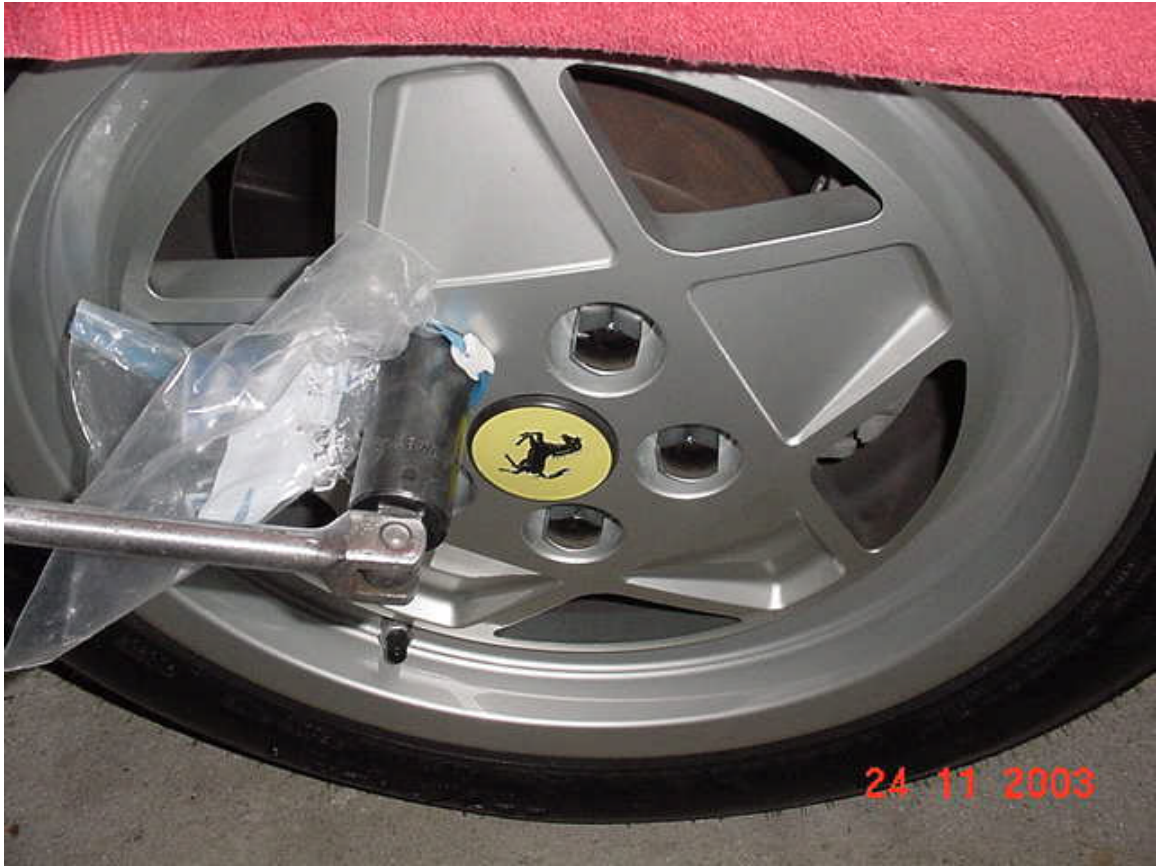
First, block front wheels & loosen right rear while car is still on ground. I use an aluminum-lined socket and plastic freezer baggie to avoid damaging the lug bolt:

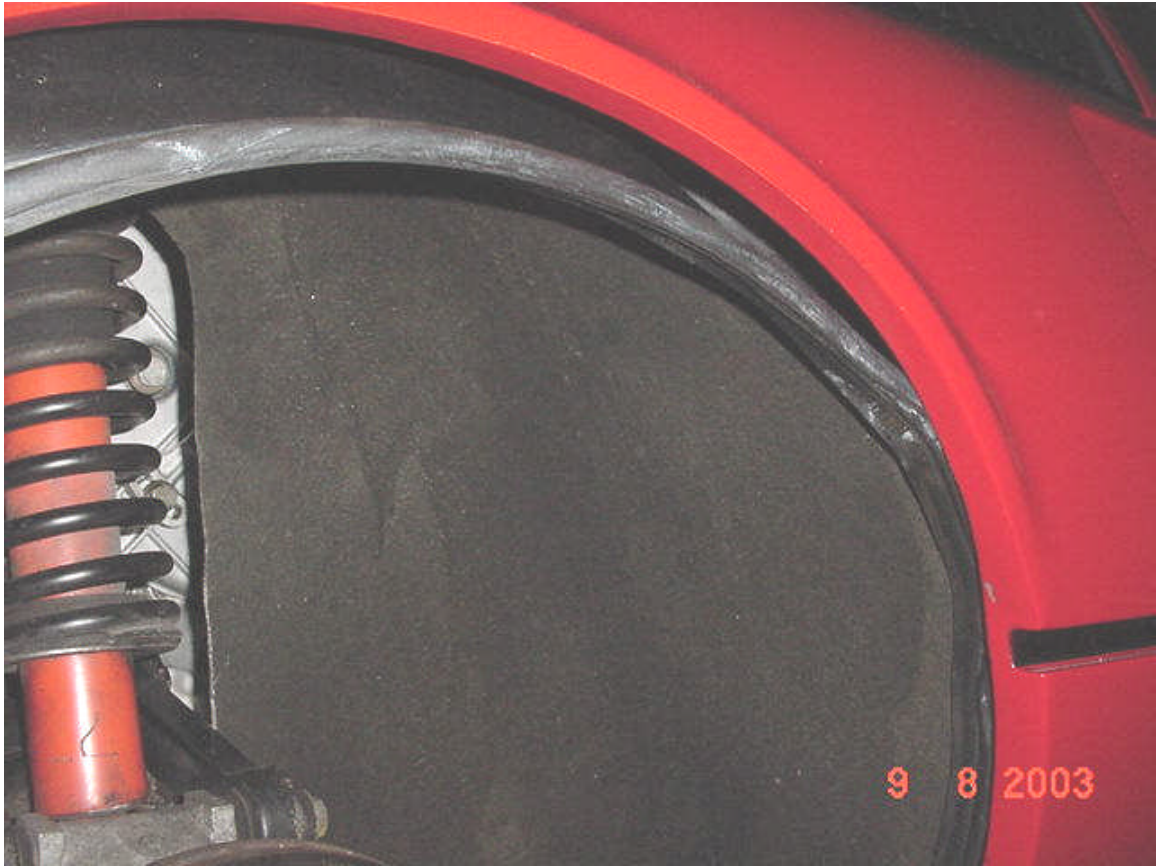
Remove wheel. Inner fiberglass well liner is held on with 7 screws – 3 hex, 4 Phillips. Maneuver liner out by rotating forward and clearing fender lip:

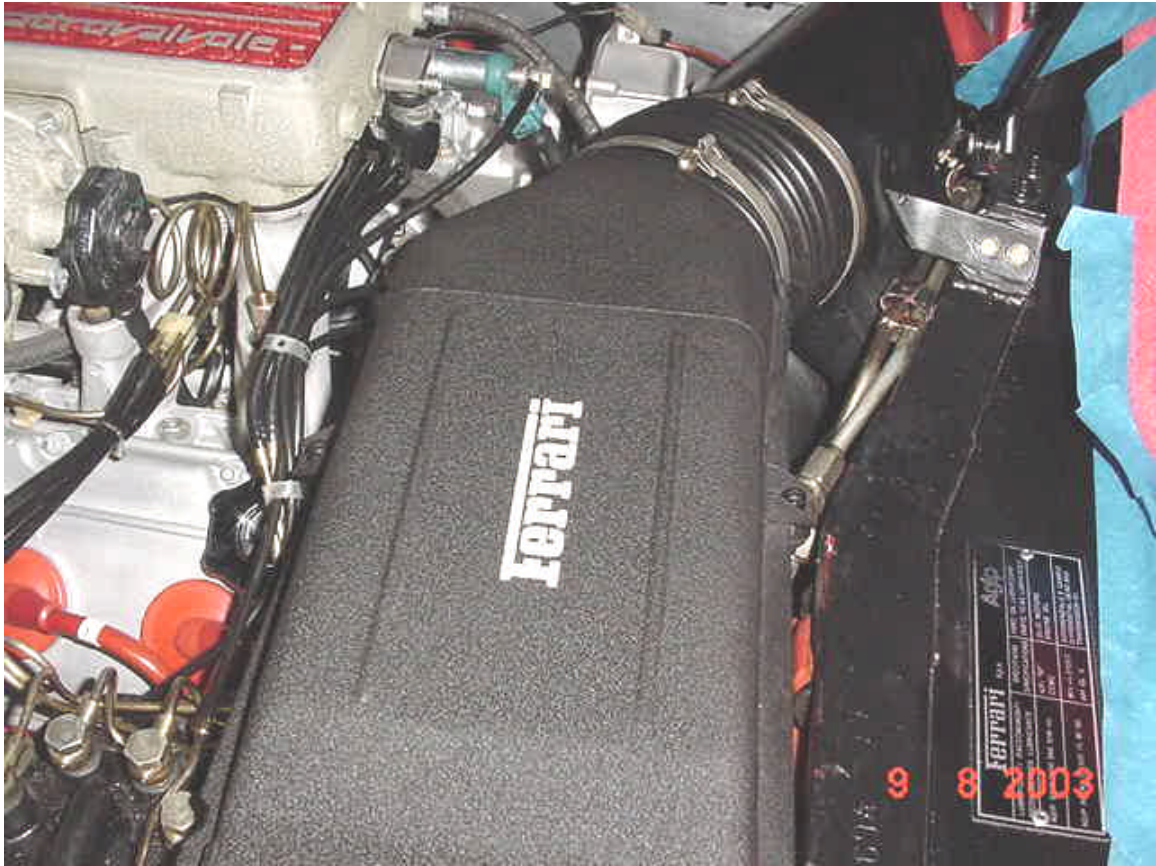
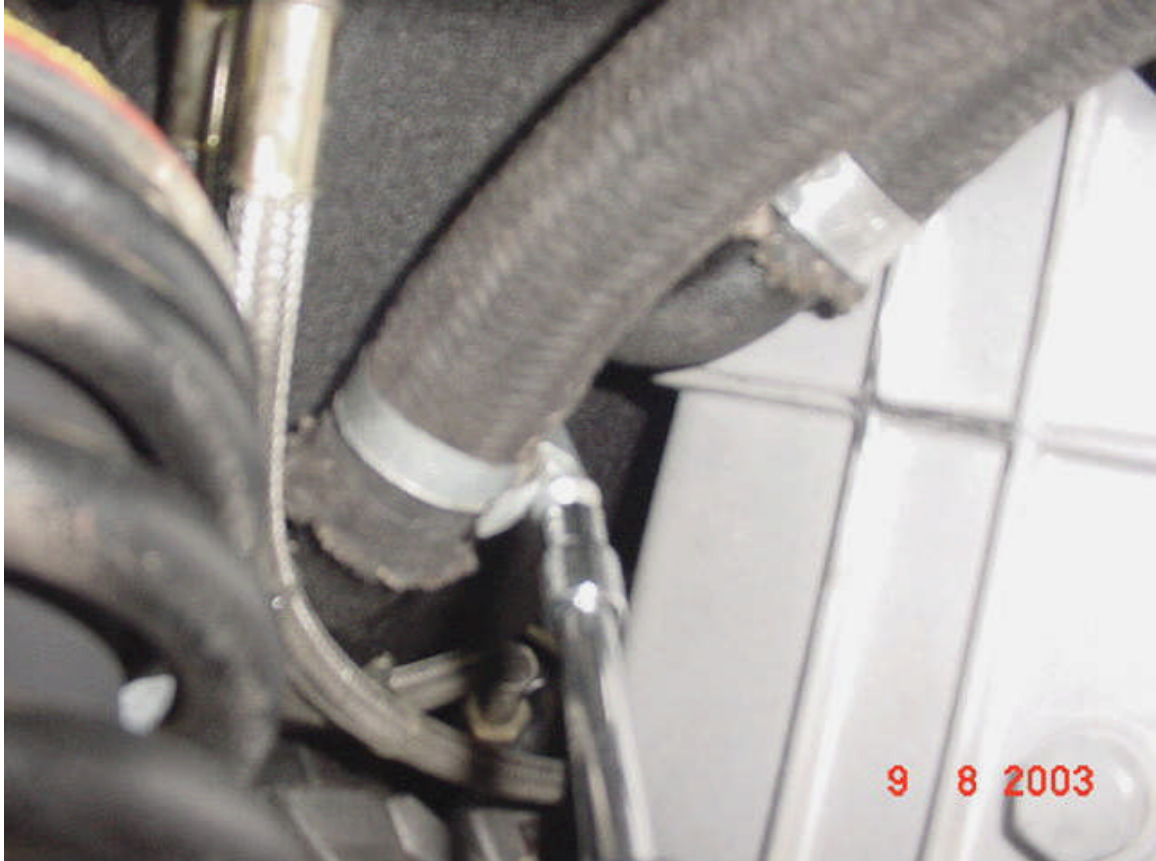
Compressor is now visible. Remove the airbox top cover 5mm hex screws and set aside. Remove the airbox lower section (held to CIS airflow unit with large hose clamp accessed from below fender with  $\frac{1}{4}$ " socket on universal; fortunately mine was only snug & I was able to wiggle off) and two hoses below:

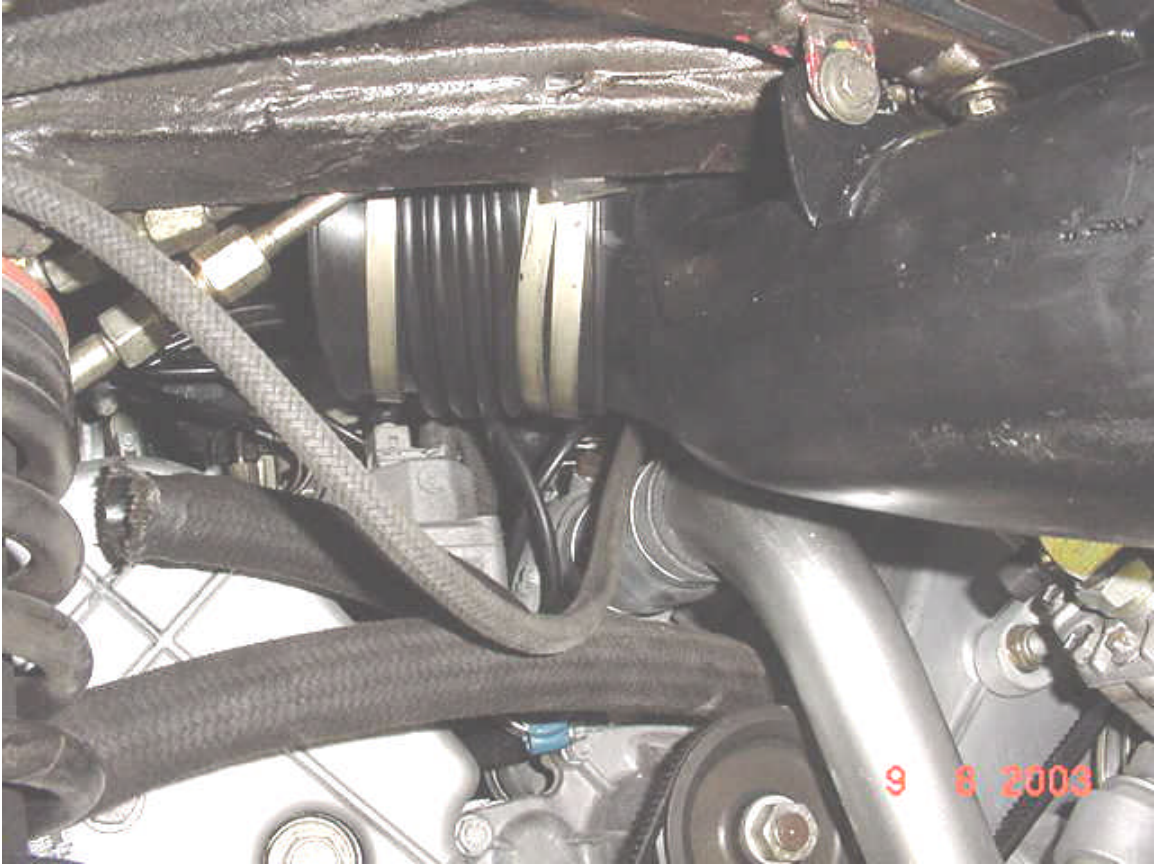
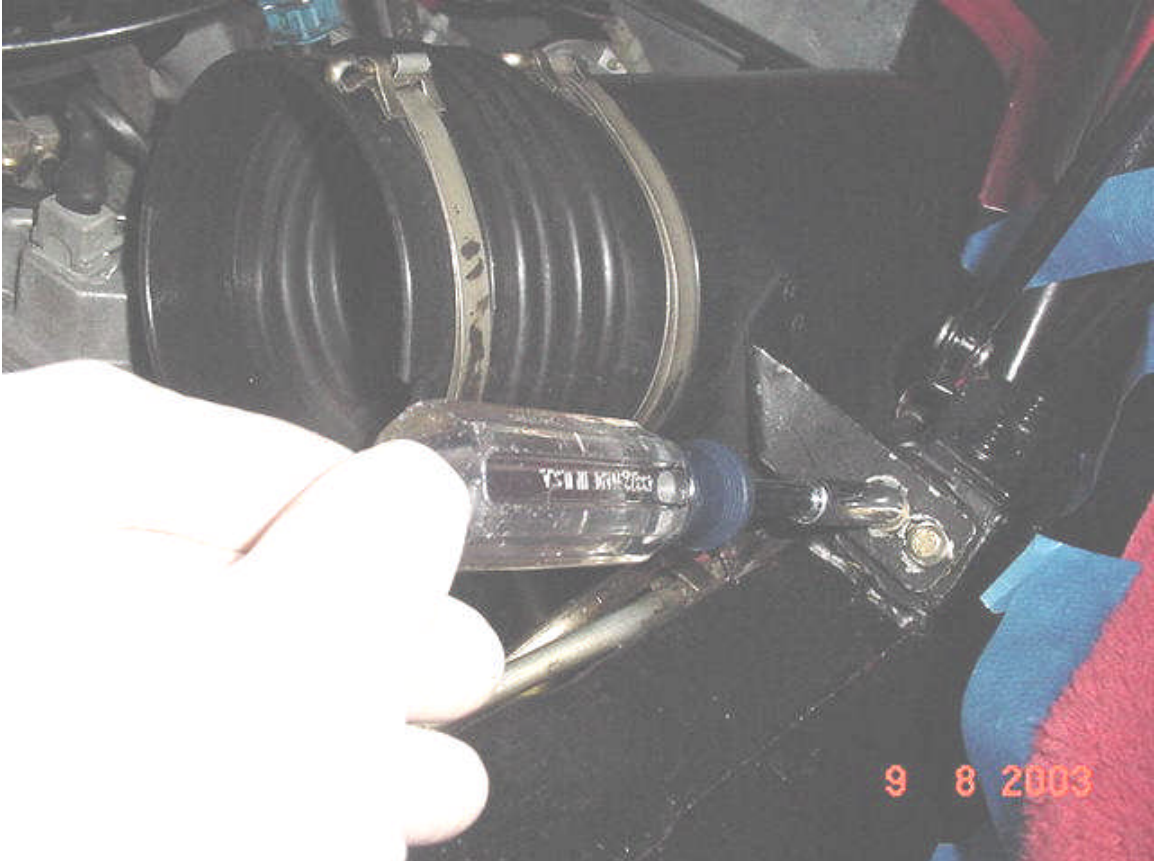
The “s-shaped” fiberglass intake duct is held in place by one small bolt in wheel well and two 8mm hex screws in engine compartment below decklid support strut:

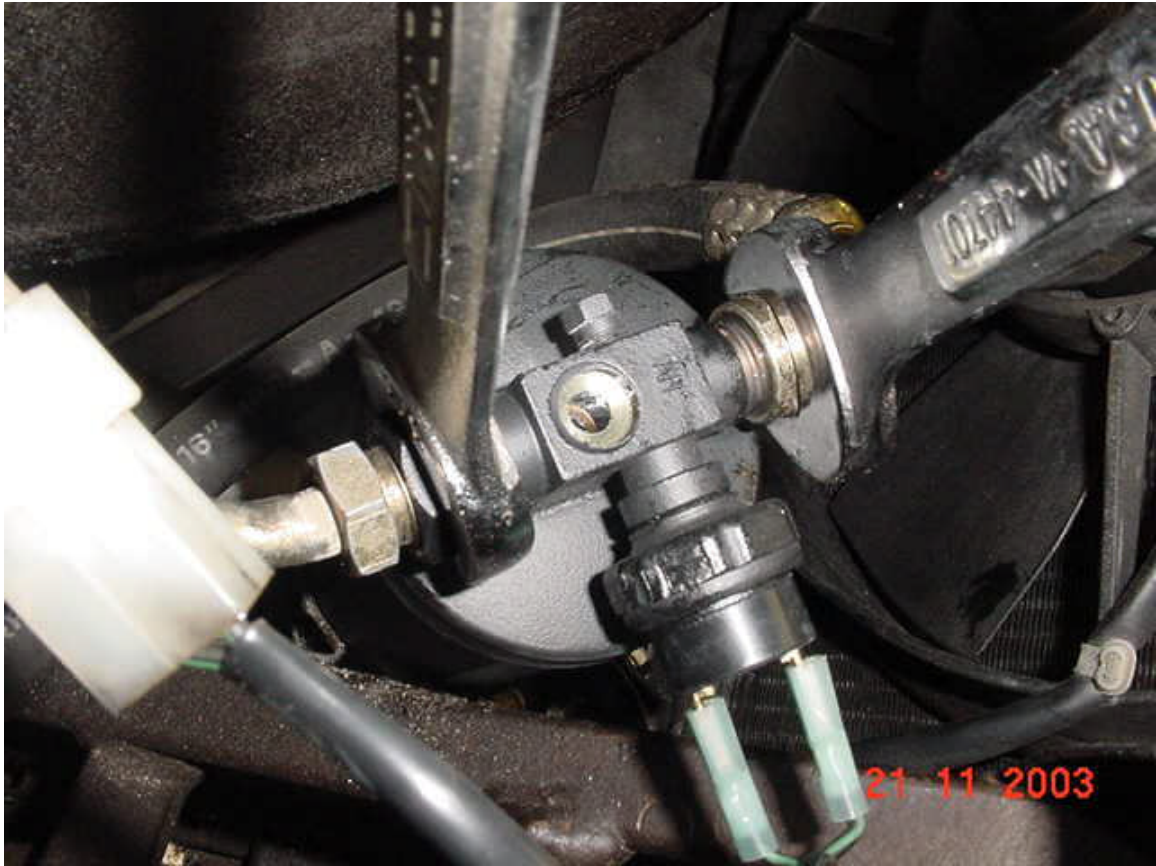
To remove, first confirm system is depressurized. Hold both fitting & top square part of filter-dryer and slowly loosen (normal RH threads):

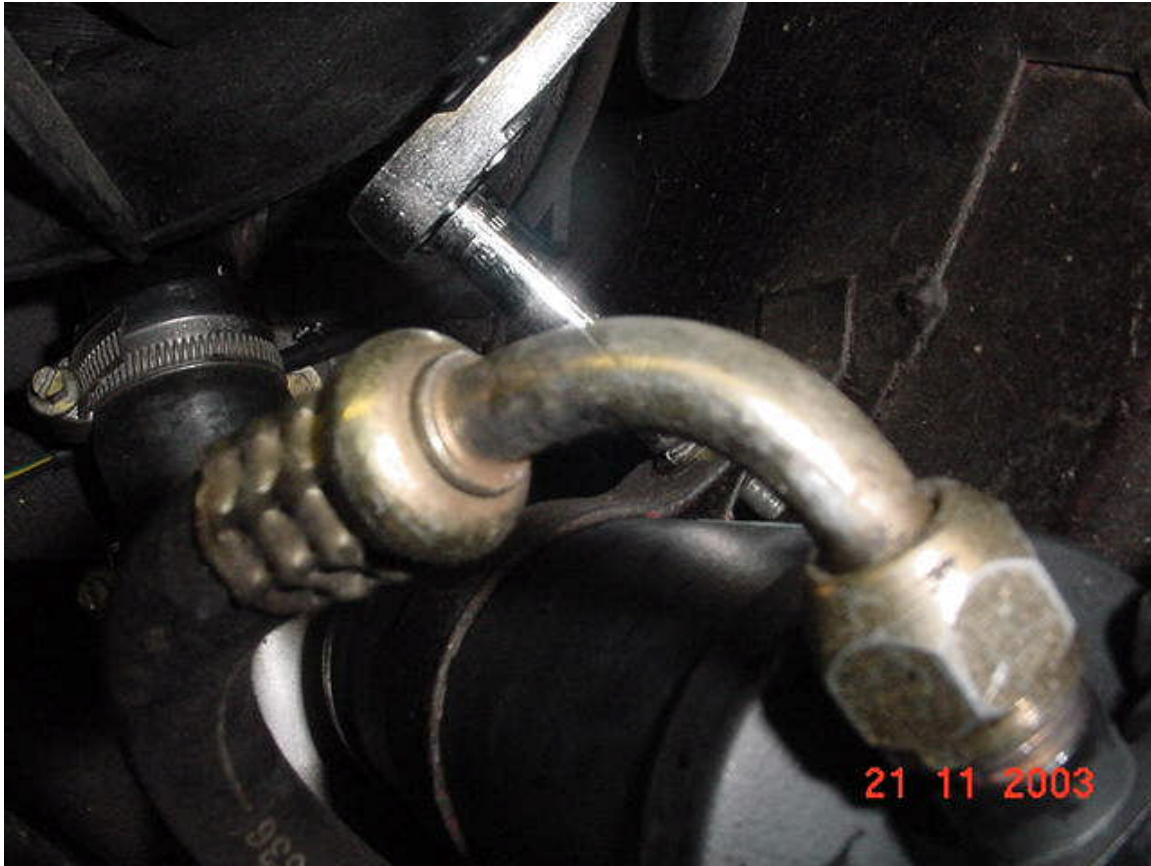
Note the o-ring on either hose – remove & cover both lines to prevent dirt in system. Disconnect the pressure switch wiring harness. Small 10mm bolt holds circumferential cylinder clamp in place:

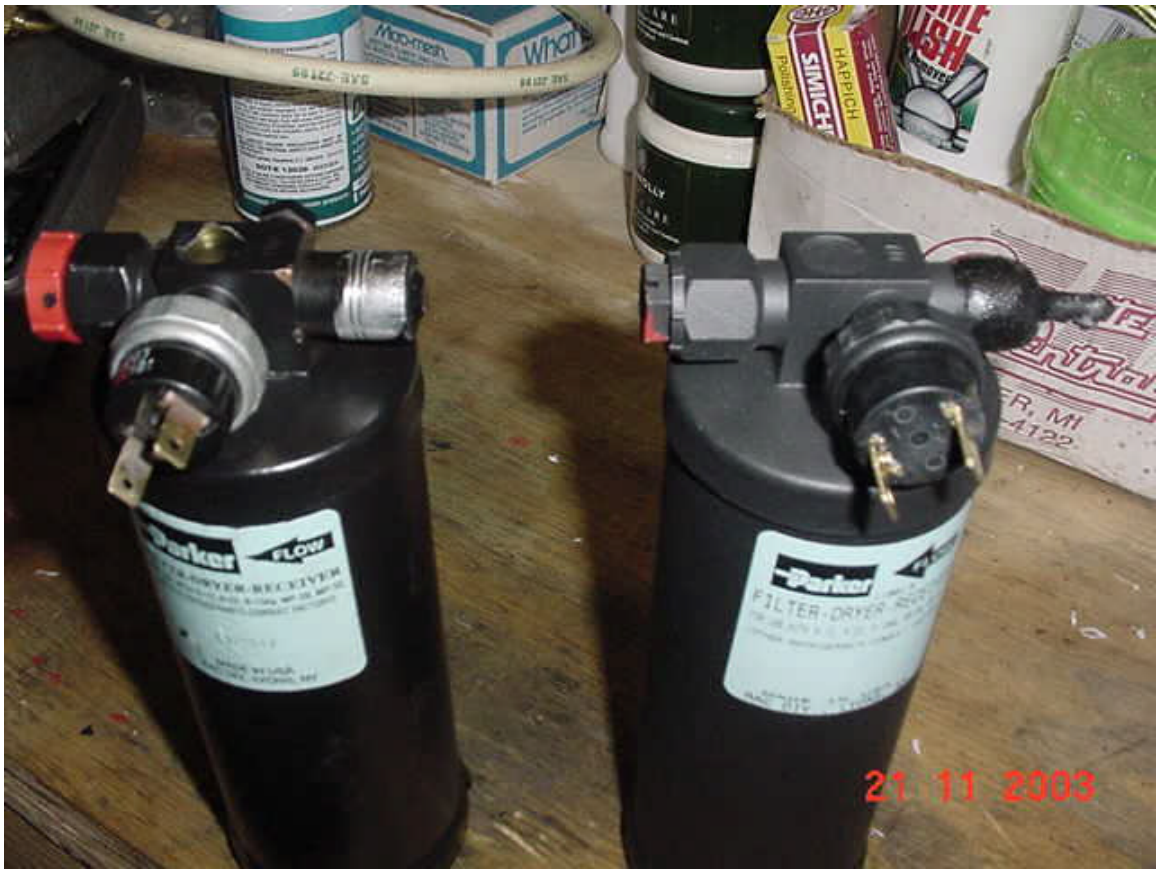
Remove and cap both input/discharge fittings on filter-dryer to prevent oil leaking out. The OEM unit on my car is a Parker #077942 that cross-references to Four Seasons #208625 available complete with canister & sensor from Carquest for \$63/NAPA \$58. Catalogs list as fitting 80-86 Saab with 8v engine; I have found online listings for \$31. OEM (left) and replacement (right) filter-dryers:

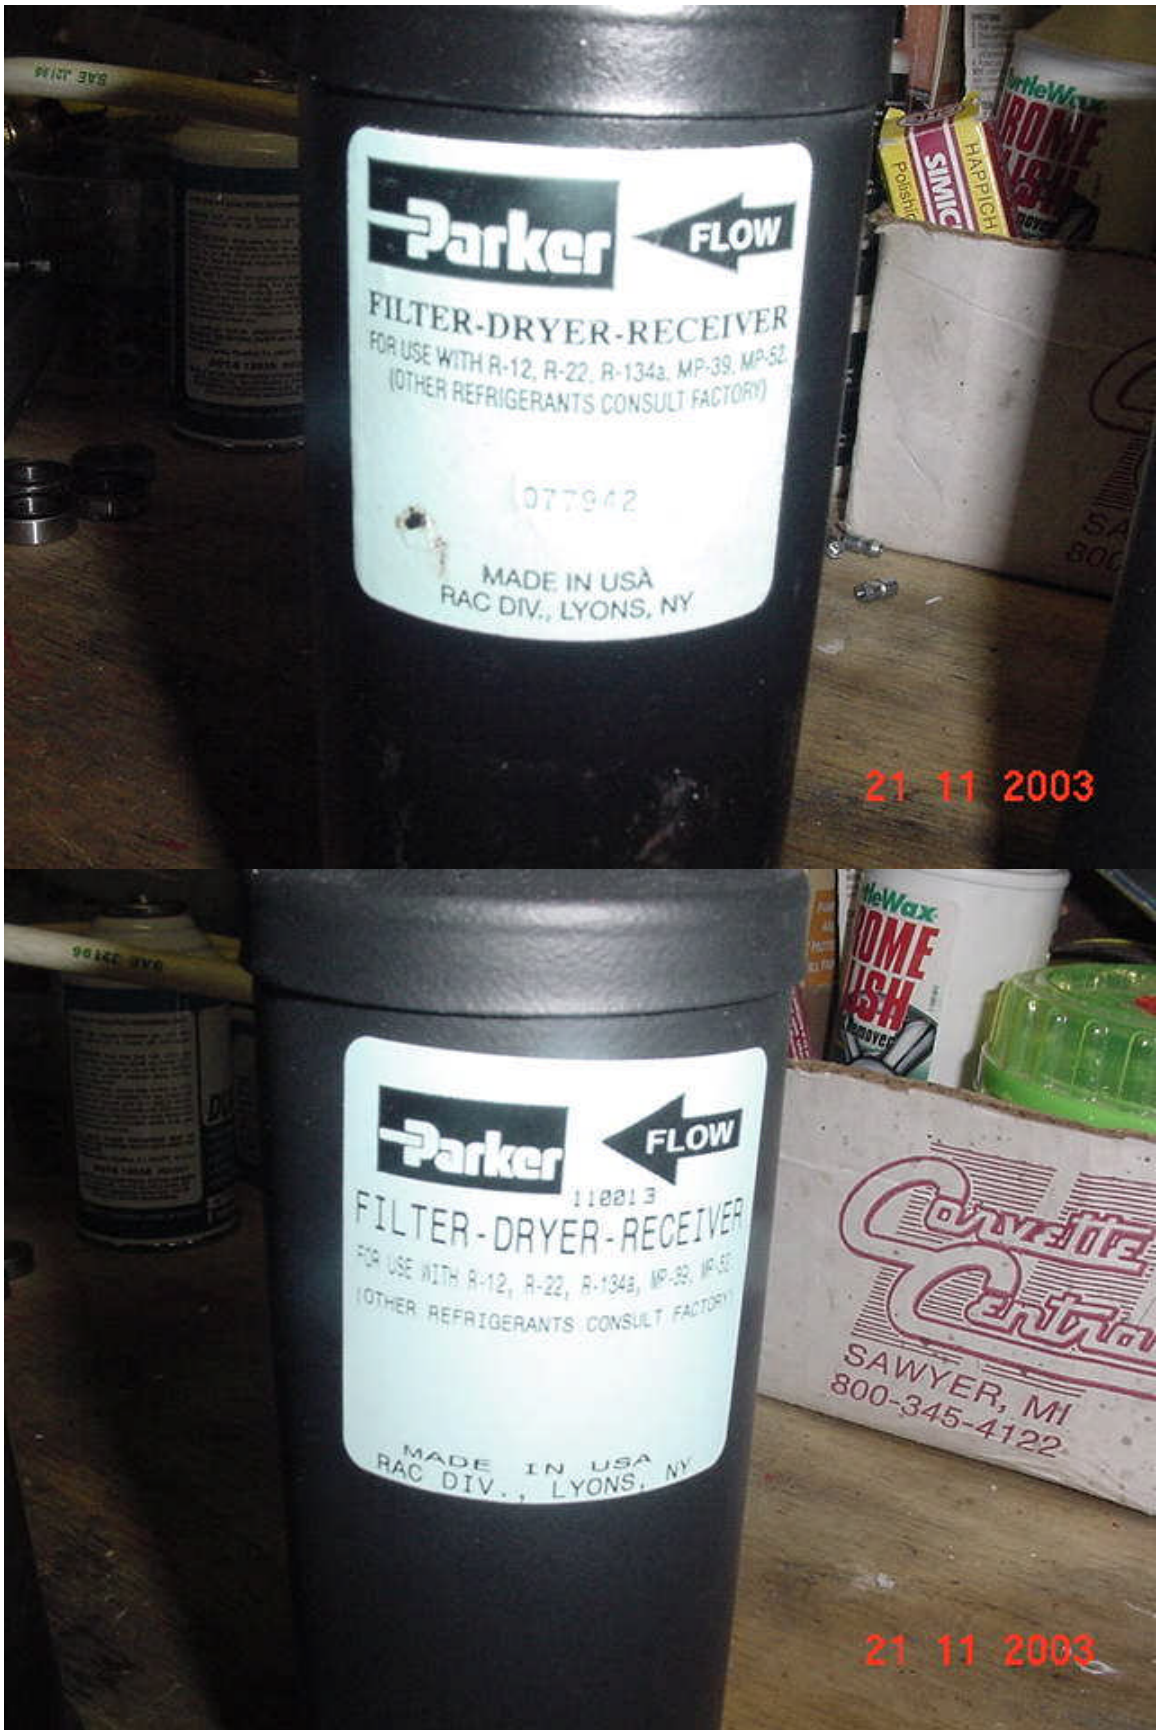
Close-up photos of Parker labels: OEM first then replacement:

**Parker** ← **FLOW**  
**FILTER-DRYER-RECEIVER**  
FOR USE WITH R-12, R-22, R-134a, MP-39, MP-52  
(OTHER REFRIGERANTS CONSULT FACTORY)  
077942  
MADE IN USA  
RAC DIV., LYONS, NY

**Parker** ← **FLOW**  
112213  
**FILTER-DRYER-RECEIVER**  
FOR USE WITH R-12, R-22, R-134a, MP-39, MP-52  
(OTHER REFRIGERANTS CONSULT FACTORY)  
MADE IN USA  
RAC DIV., LYONS, NY

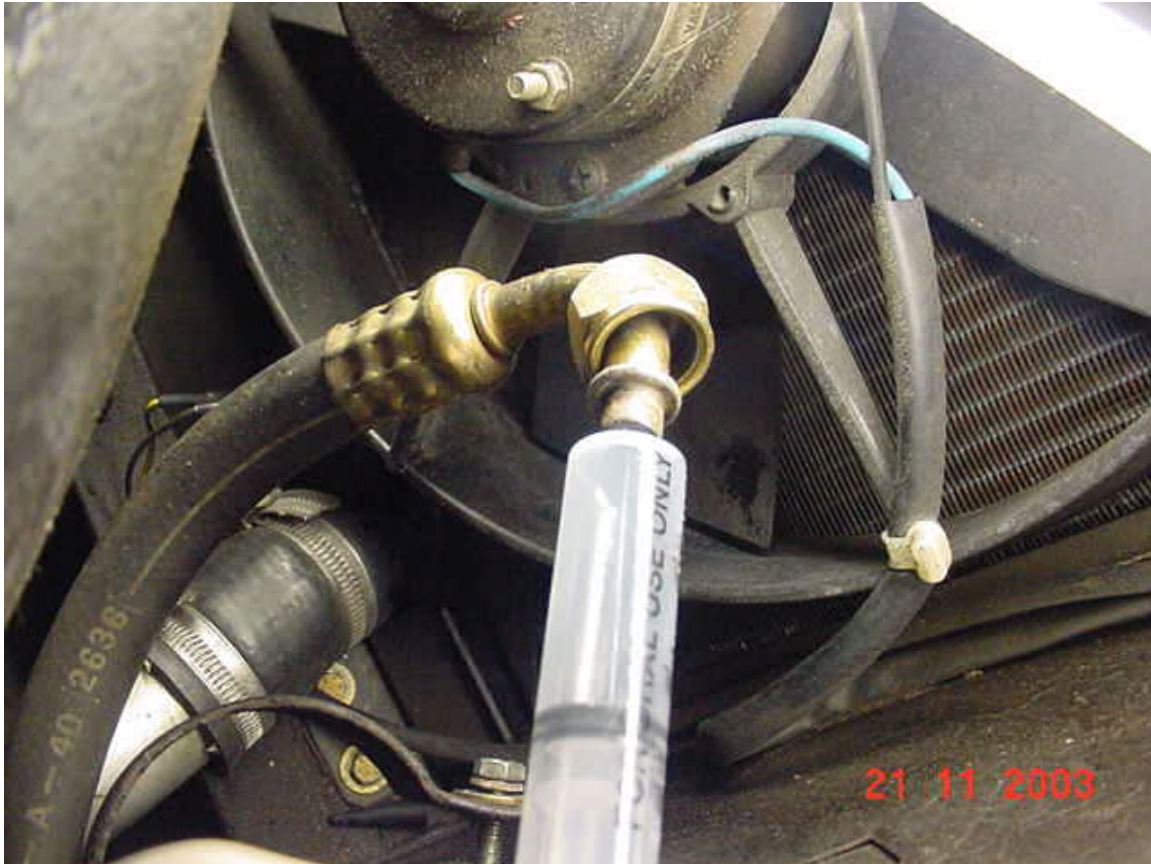
Remember to add 1oz of oil to the system (525 viscosity for R-12/HCFC blends or PAG for R-134a) when replacing. Can add either directly to new filter-dryer or into either line:

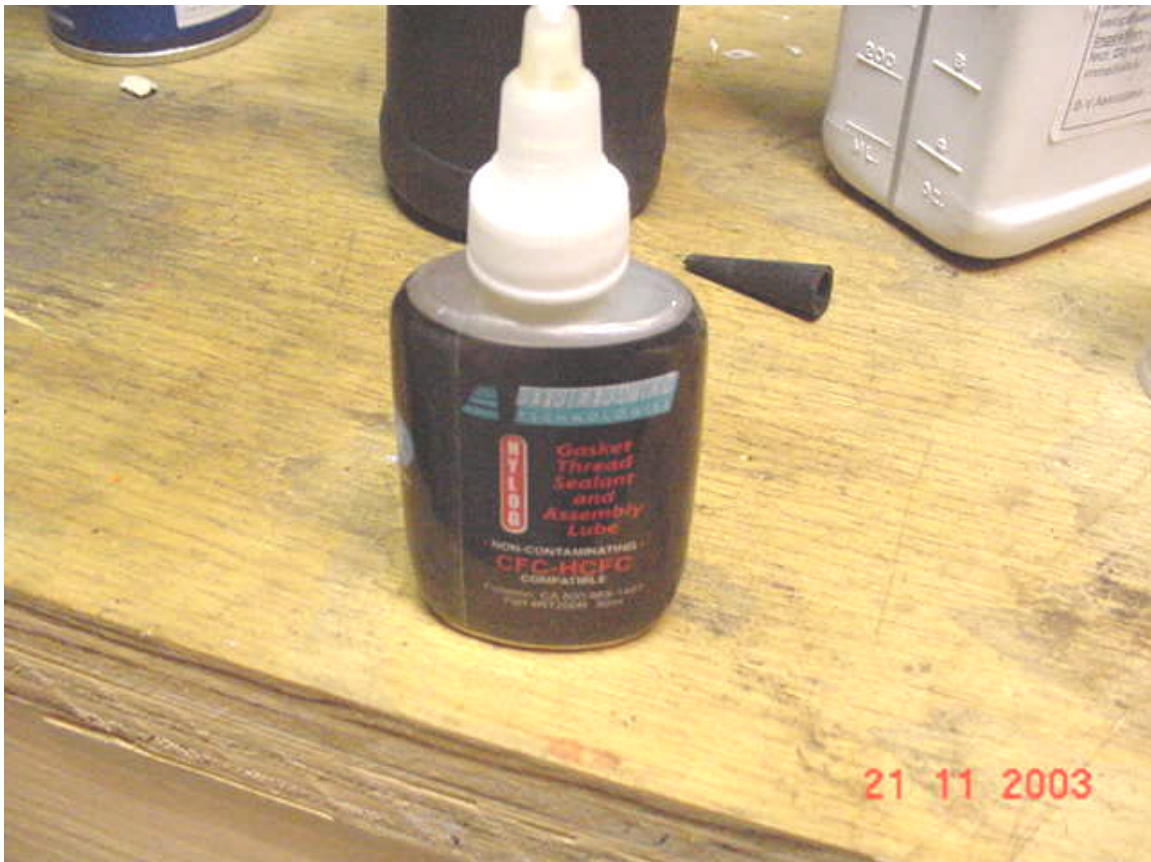
I used Nylog sealant on both O-rings:

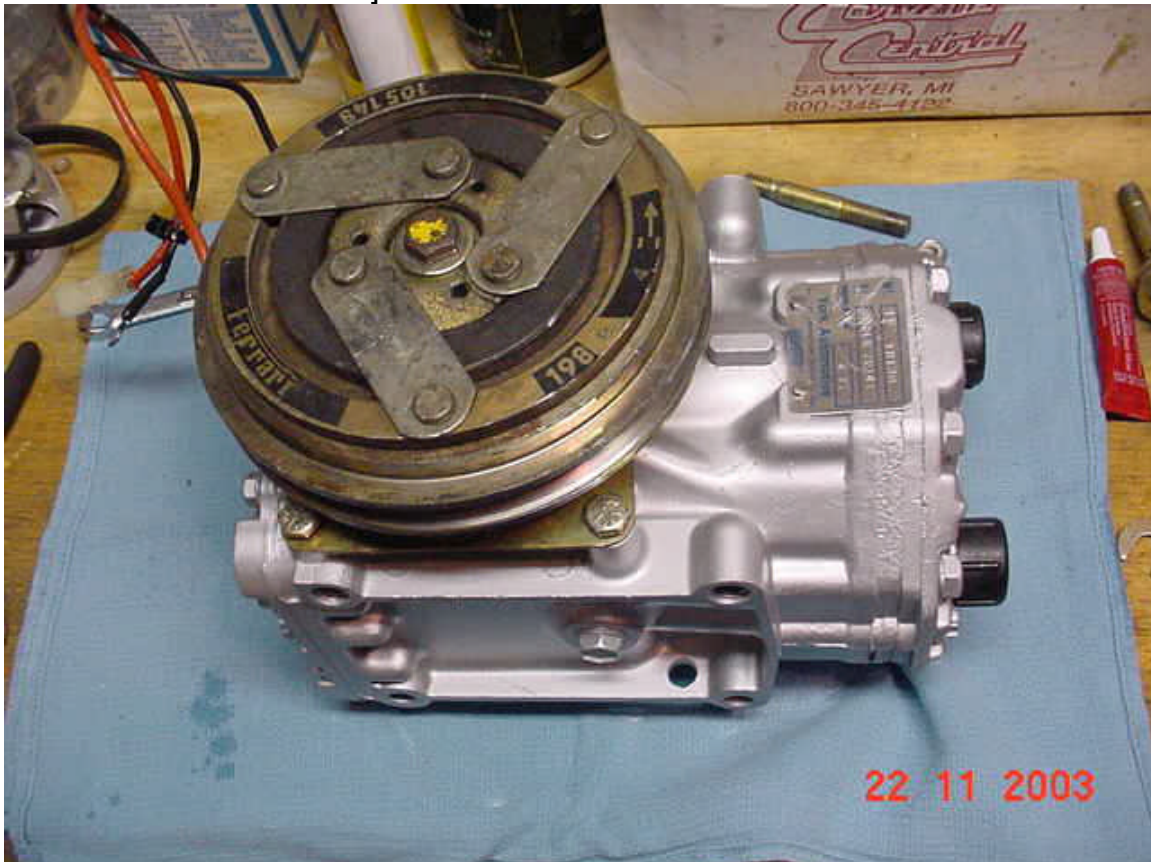
Set the compressor/clutch assembly on the workbench. Clean any major deposits of road debris. Note orientation of the magnetic clutch leads – ground wire attaches to top right magnetic coil bolt (with flat as opposed to star lock washer) and leads towards body of compressor [leads should run towards right in picture – I initially installed incorrectly but for some reason forgot to photograph after I realized & switched]:

Metal ID tag on compressor reads:

No 18130  
Pt 206R 20141  
Refrig 4 87

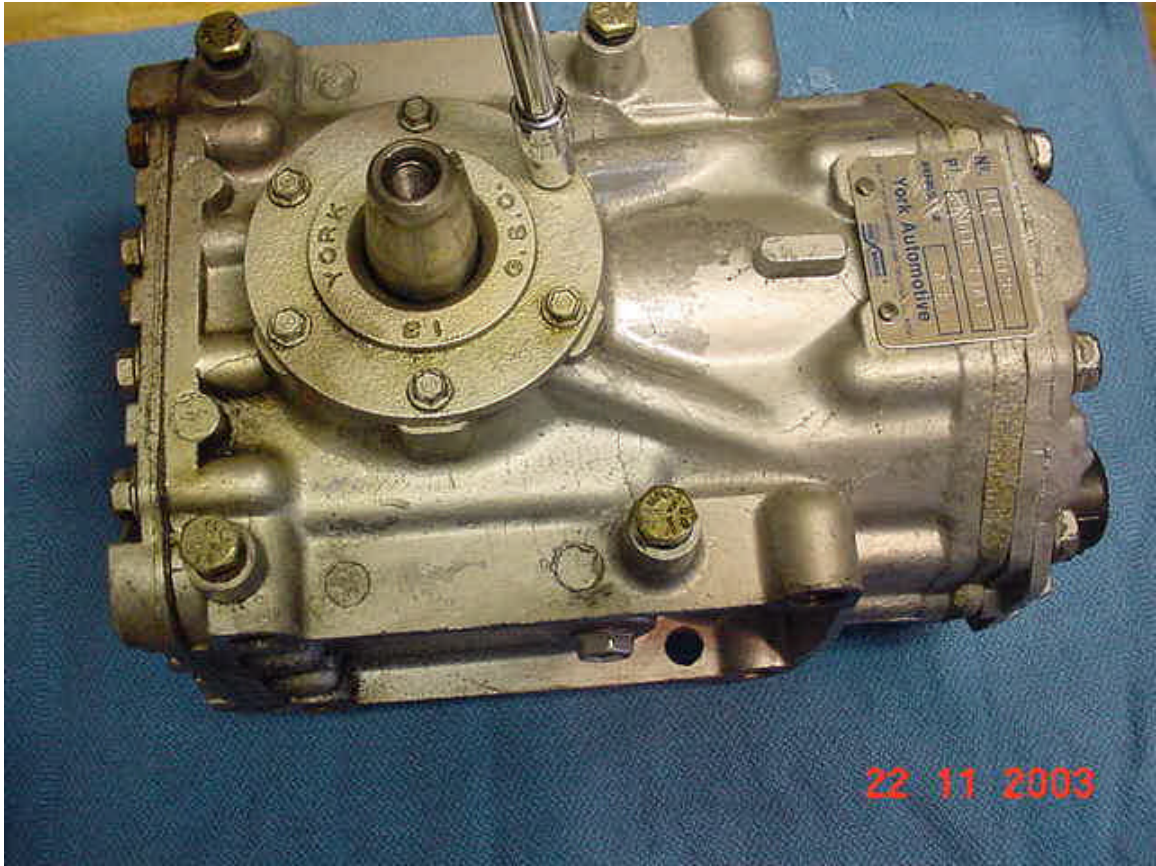
Compressor front seal was leaking. This is a York type 206 RH discharge compressor requiring seal kit for “6-bolt ¼” front plate” – NAPA part # 207243 or CCI # 488-25274. CCI kit is OEM with bolts & centering tool, NAPA kit has a few spare parts without bolts and unfortunately does not include instructions, so I installed new seal in manner old seal was removed (purchase CCI if you can find/order; both run about \$15-20). Front seal is spring-loaded, so apply gentle pressure with 7/8 deep socket [not illustrated] and loosen six perimeter ¼” bolts:

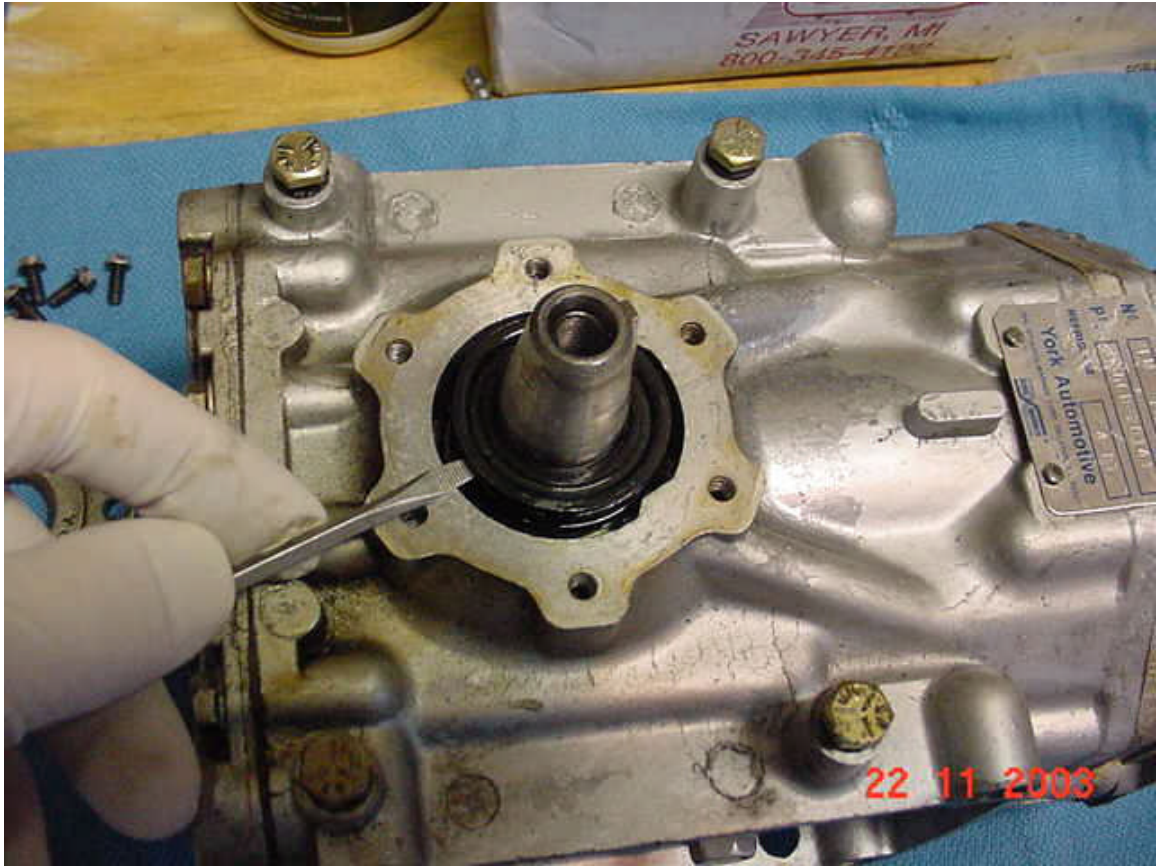
Next, carefully pry the seal components off the main shaft without scratching the shaft sealing surface:

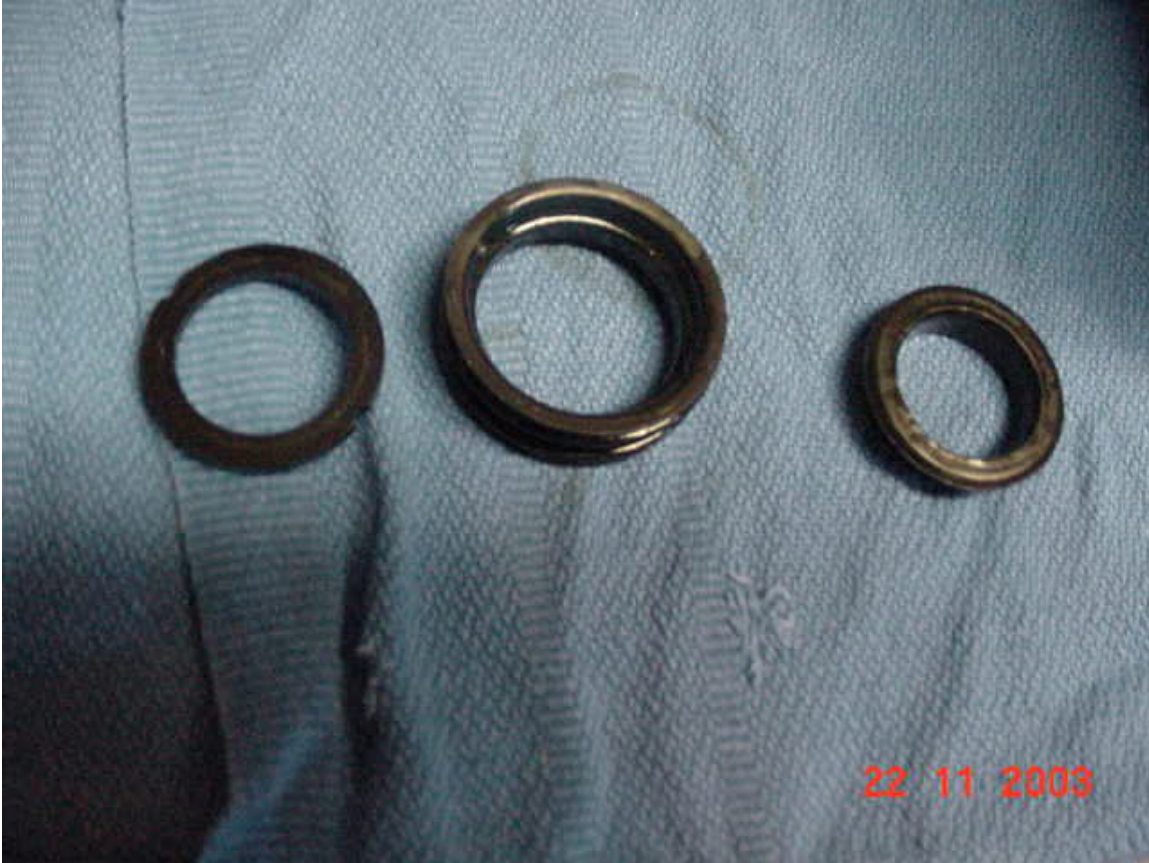
My car had a loud hissing sound in engine compartment when pulling initial vacuum but I could not localize. Partially charged with UV dye and then obviously leaking around magnetic clutch from front compressor seal (impossible to see once clutch installed).

My old seal came off in three pieces: a carbon washer, spring-assembly, and lower “hat-shaped” seal with encompassing thin metal ring:

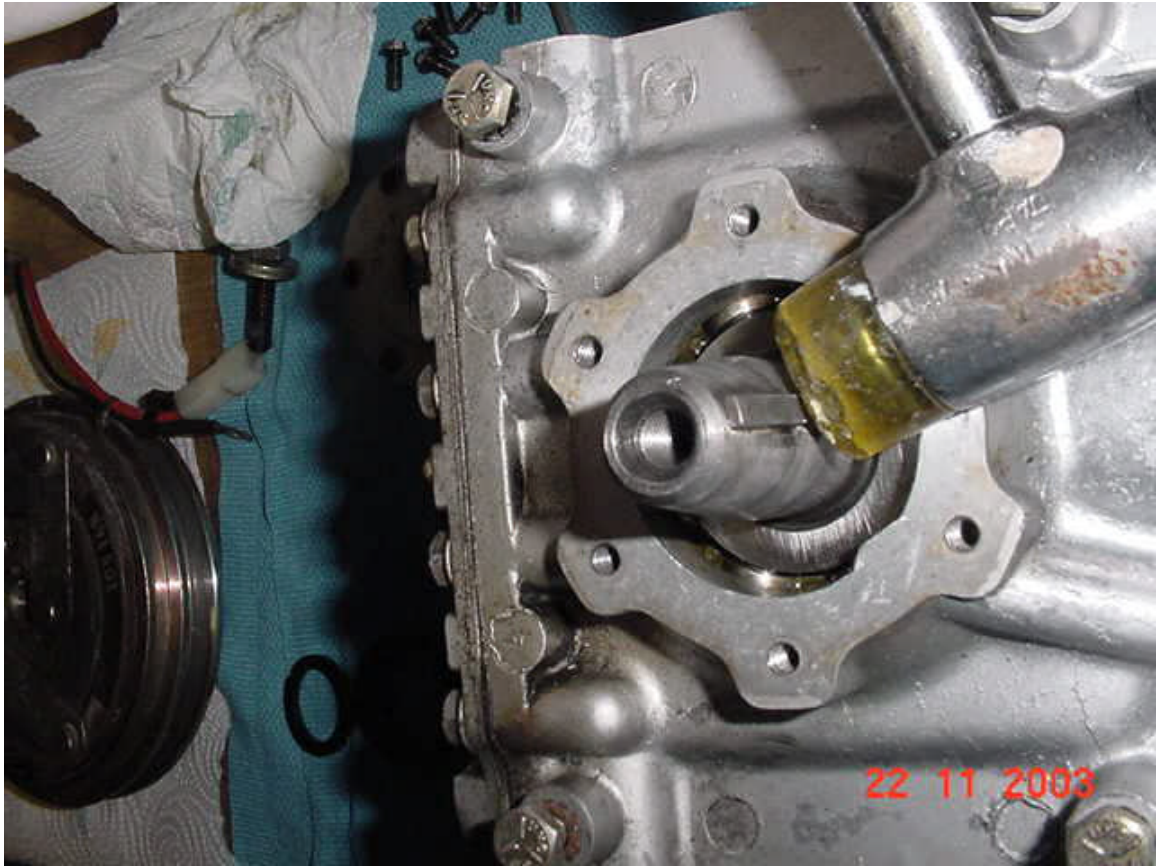
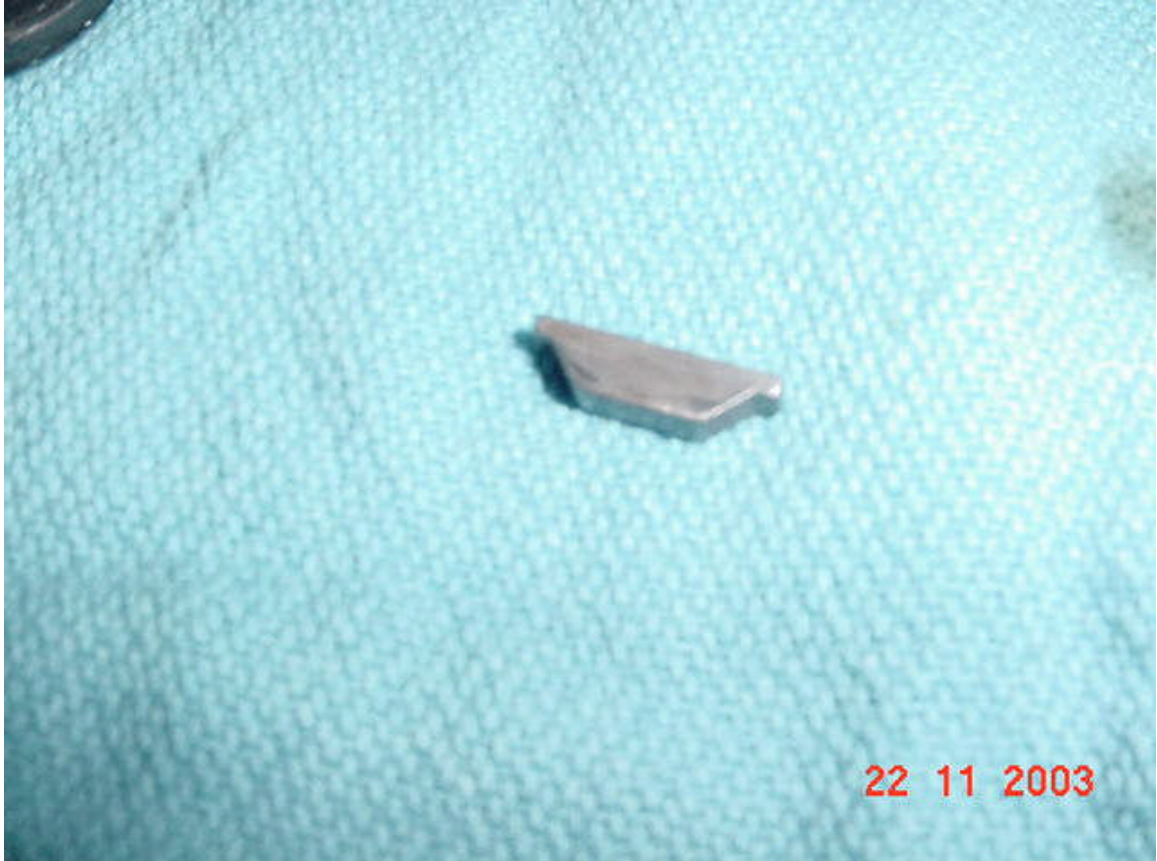
Remove the woodruff key by tapping gently with hammer until front end tilts upwards:

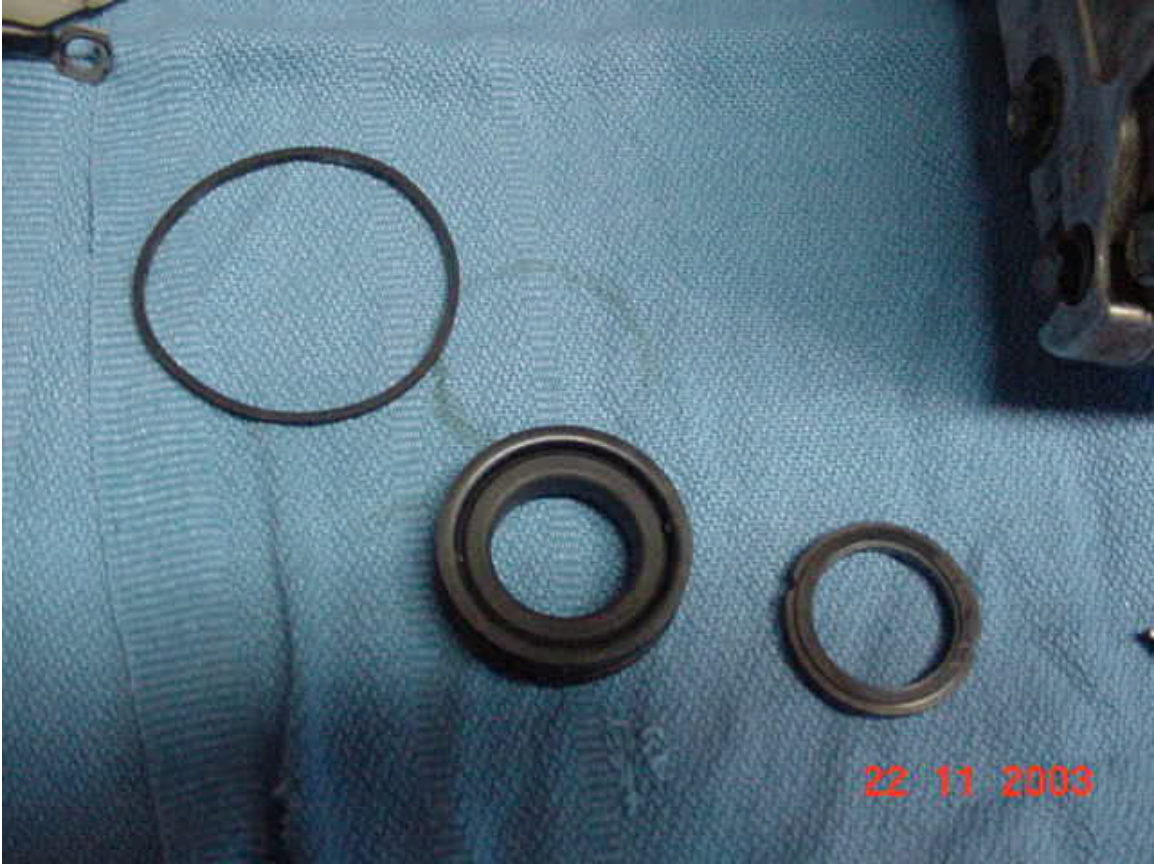
Liberally wipe down the shaft with refrigerant oil (either 525v mineral oil or PAG depending on what type of refrigerant you're going to use). The kit seal was two pieces – carbon (black) washer fits on top with small “step” on face upwards and edges fit into “tangs” on spring-loaded seal:

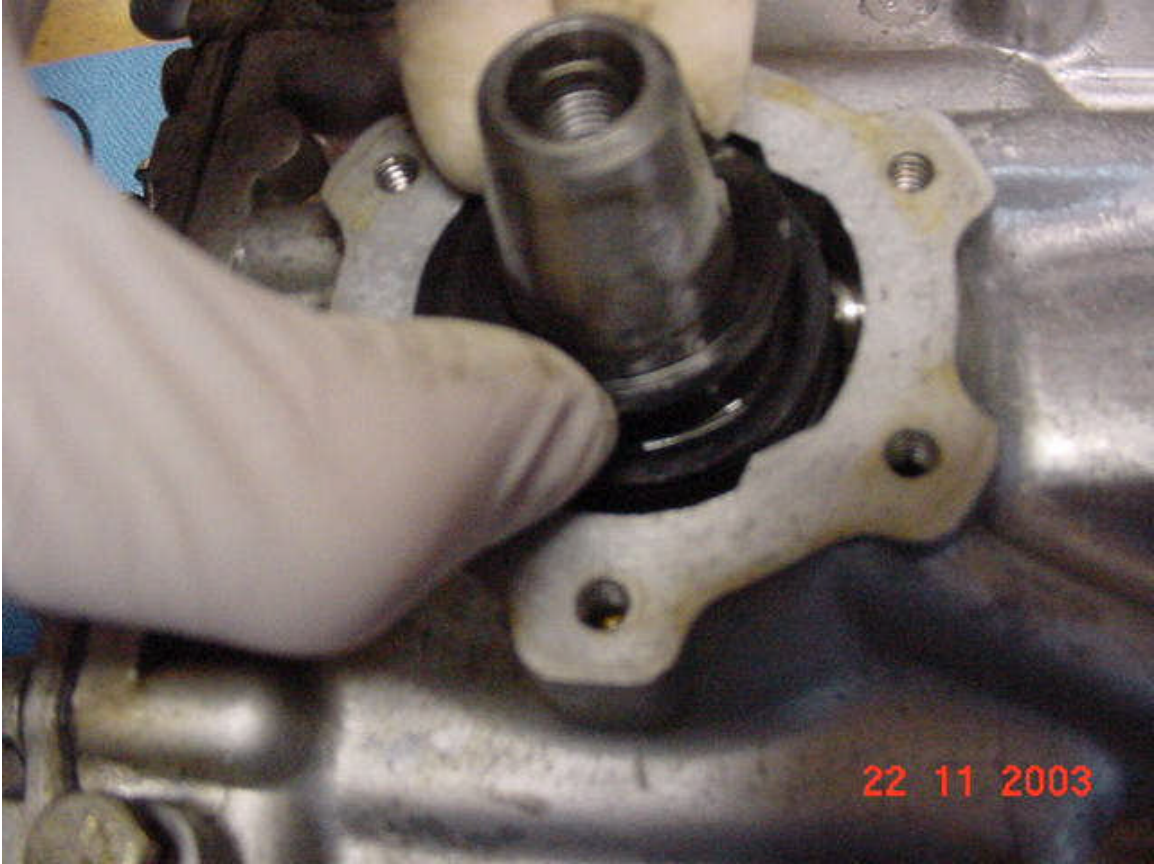
Carbon ring then fits on top, taking care to install with small “stepped” surface upward & edge detents aligned with seal:
