# Ferrari 328 A/C System Inspection, Leak Detection, Compressor Seal Replacement, & Recharge

*Carl Rose*

*November 2003/ revised June 2004*

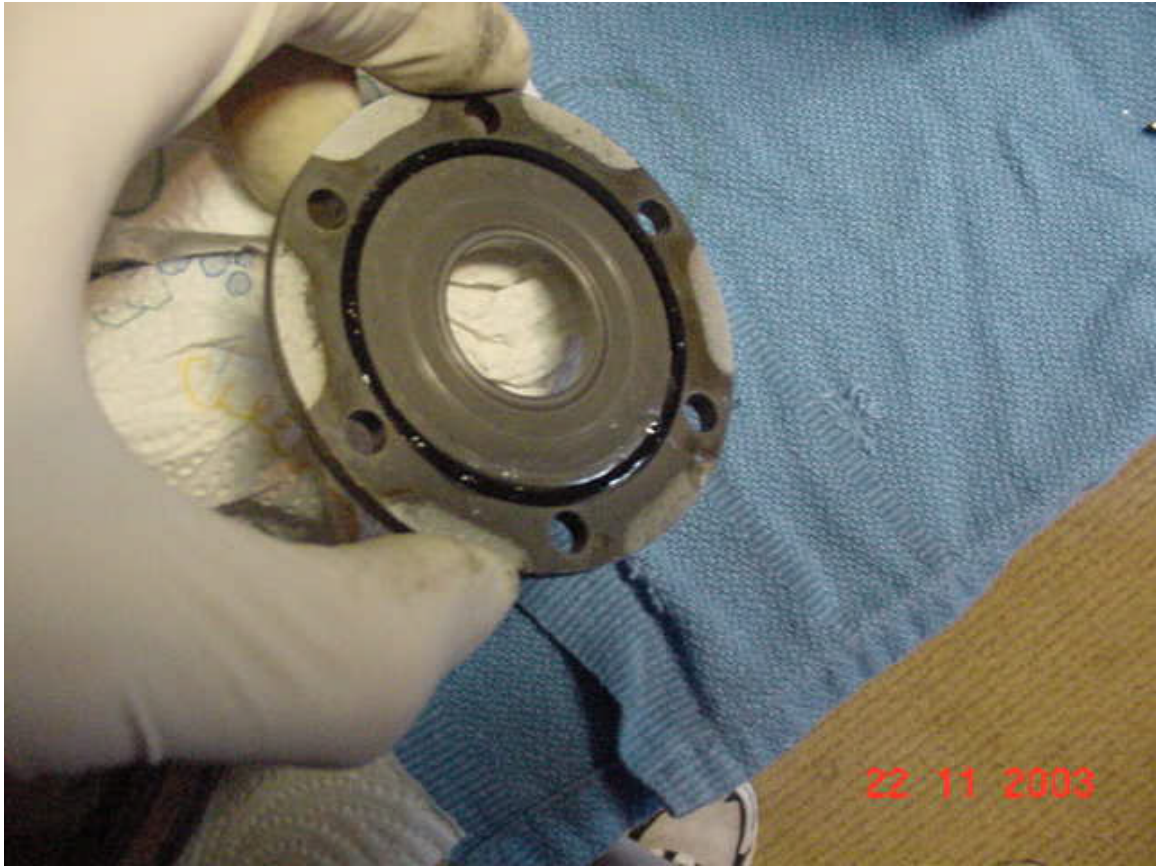
Fit a new o-ring to the circular front plate (I coated this ring with Nylog sealant) and set on top:

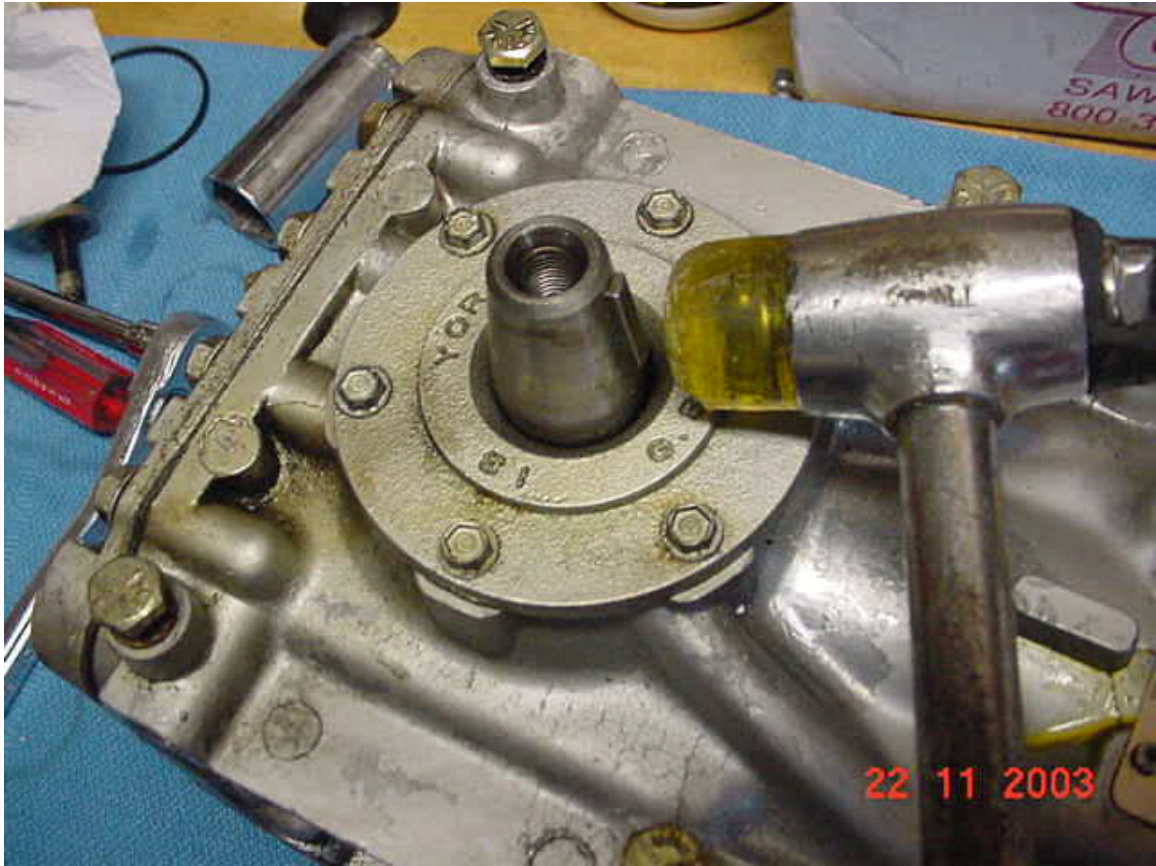
Rotate the compressor shaft a few times to lubricate the seal. Tap the woodruff key back into place:

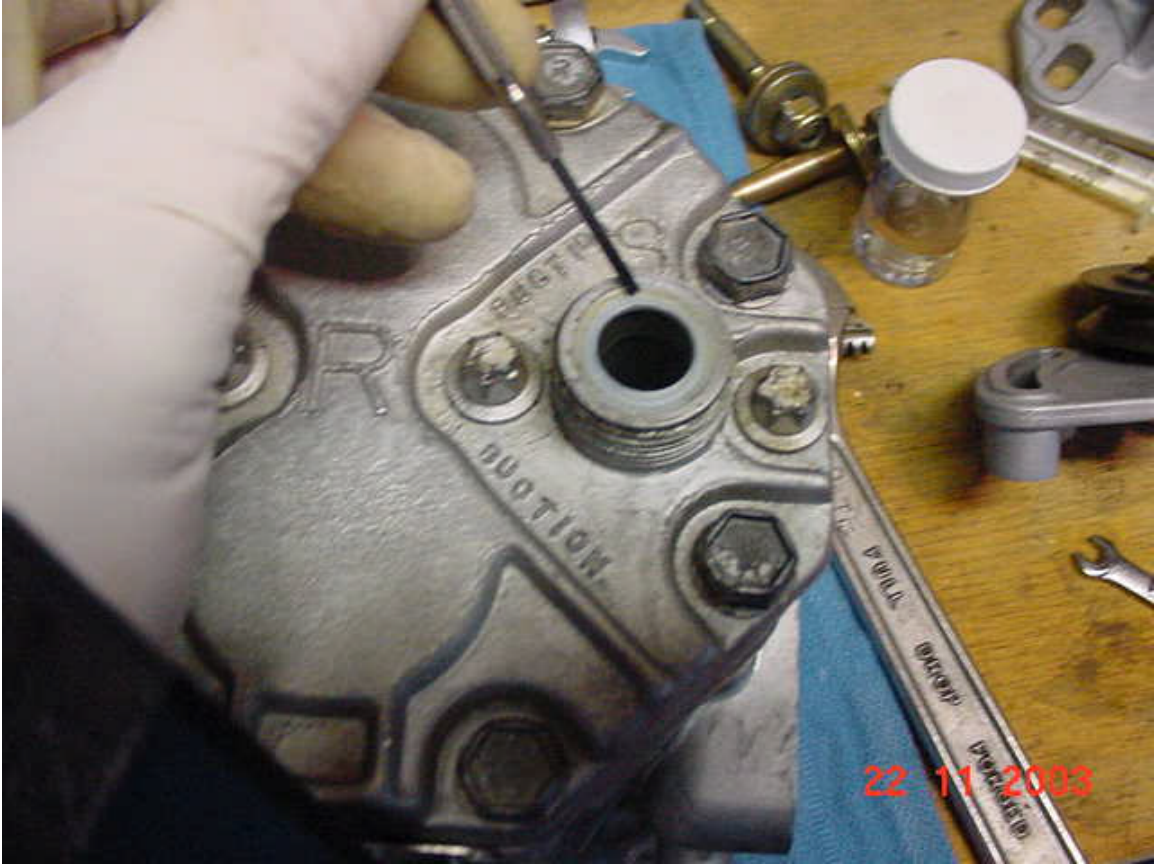
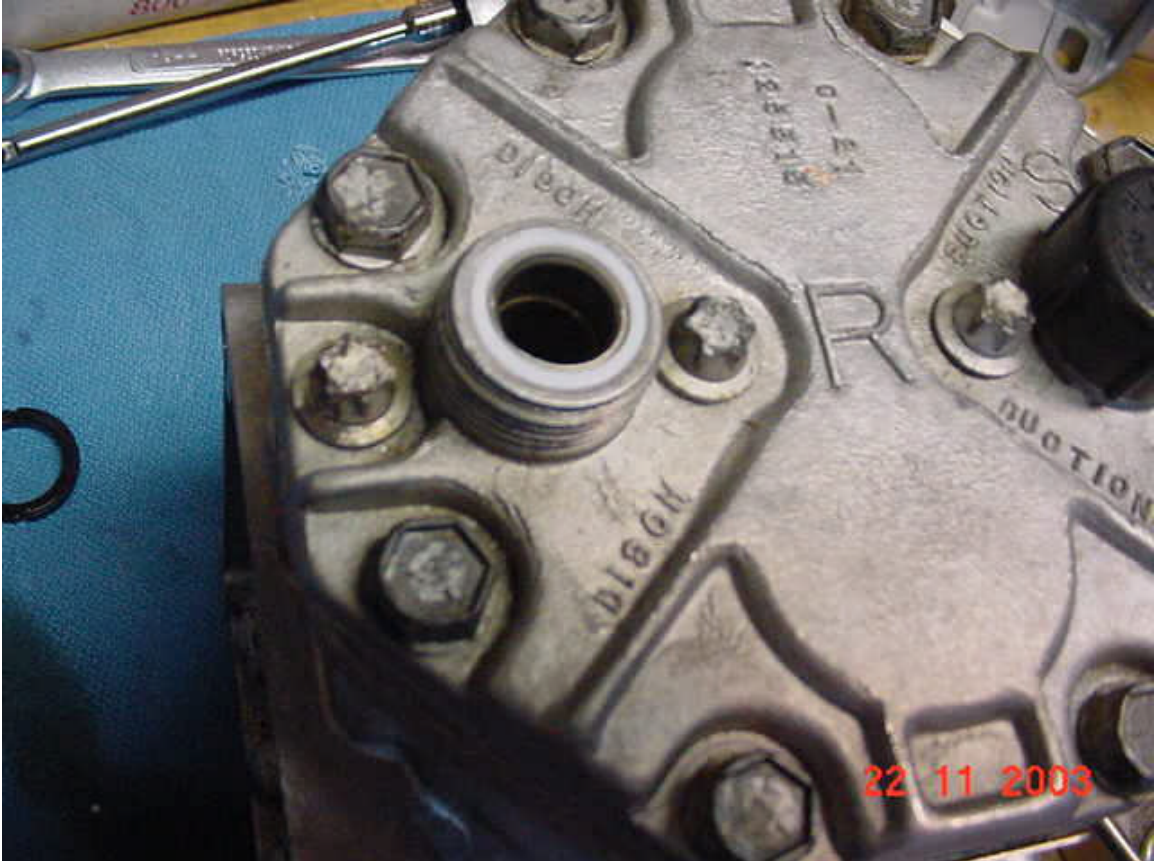
Remove the suction & discharge port covers. Pry out both Rotoloc Teflon o-rings and replace with new NAPA parts #207165:

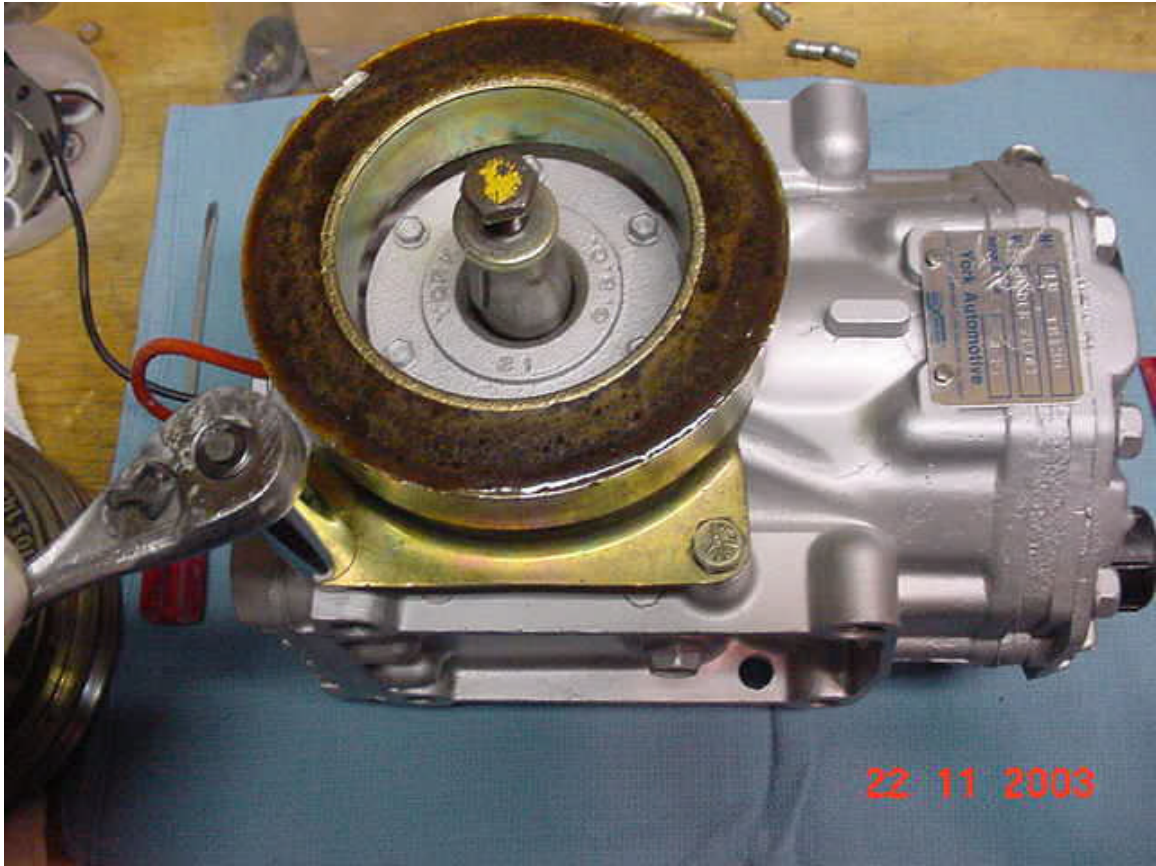
Replace the magnetic coil and tighten four 11mm bolts – I used blue loctite on these threads. [This photo is incorrect; leads should run off right of magnetic coil mount and along compressor body]:

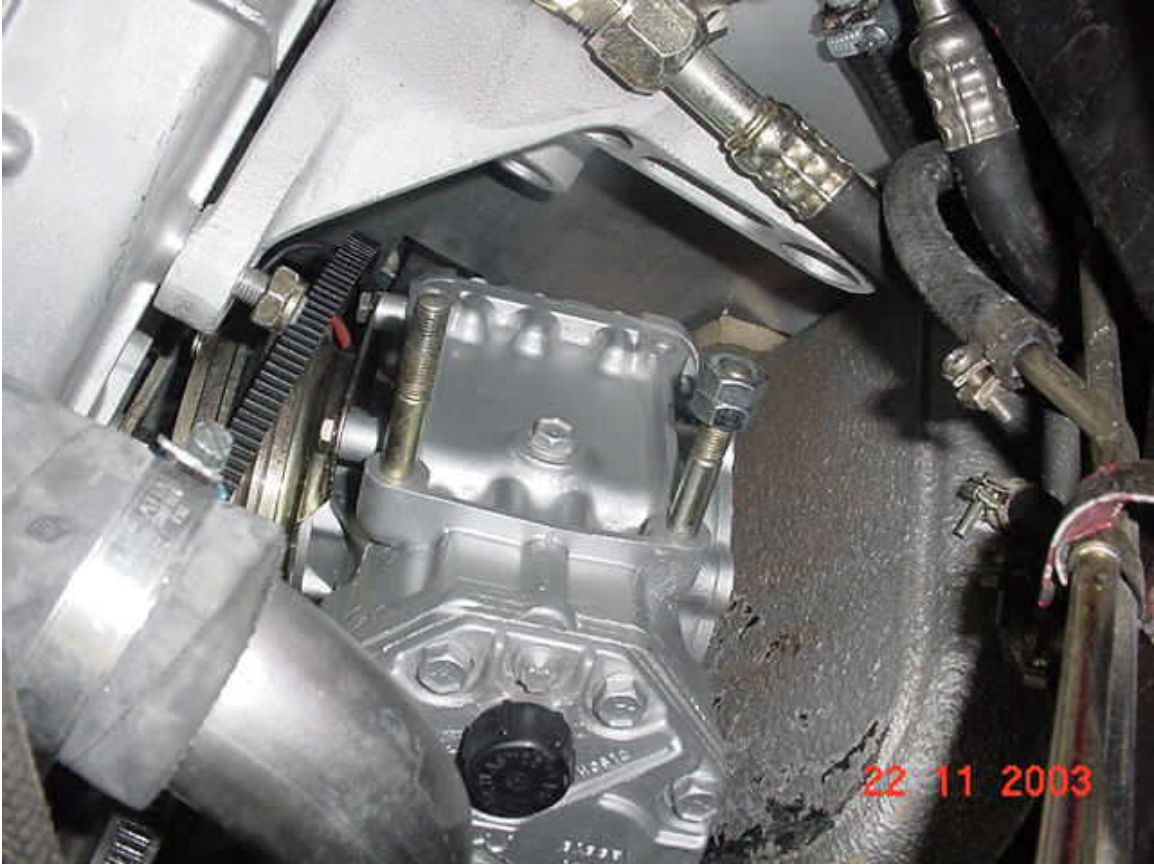
Maneuver compressor back into engine bay. I found this was easiest by starting with clutch pulley facing away from cambelt covers then lowering into area beside gas tank. Once in vicinity, there is sufficient room to rotate into correct orientation. Using the same double-nut technique as for removal, install three studs into compressor body – I used blue loctite to mount studs to compressor:

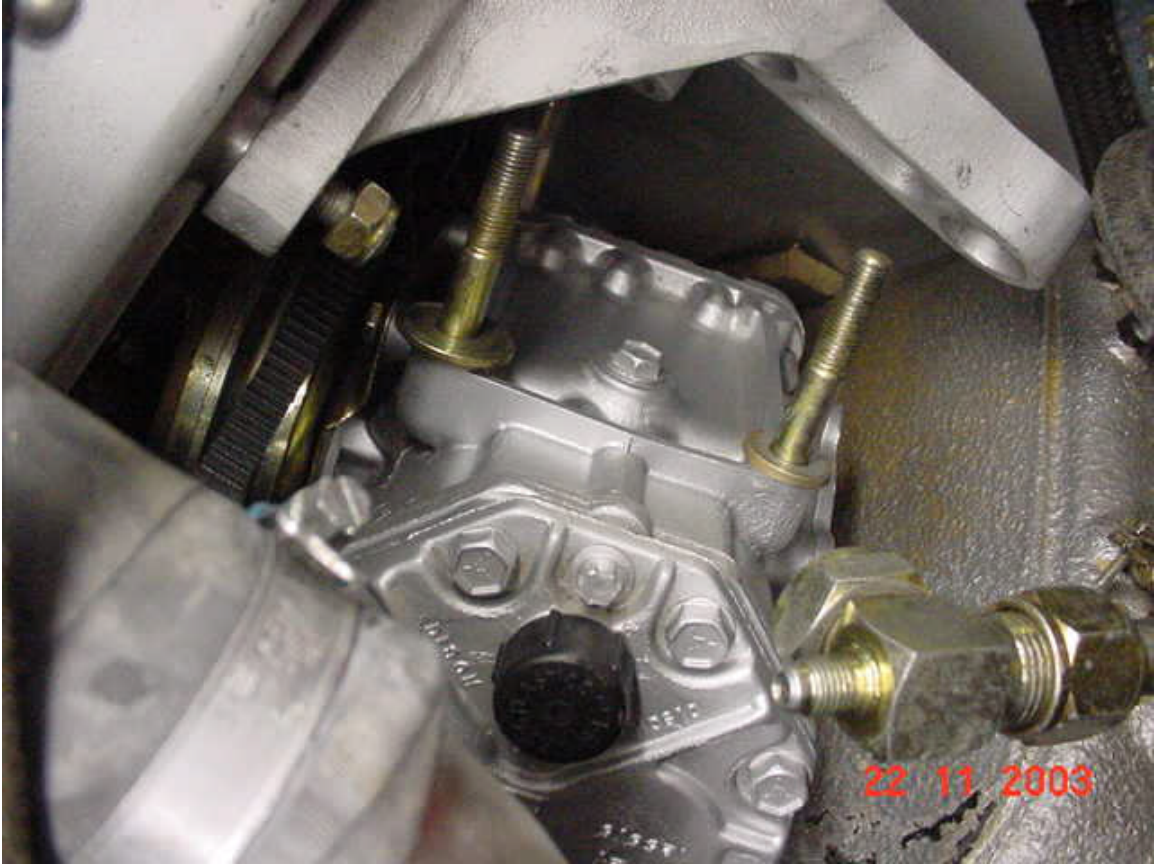
Put fasteners in proper sequence: "c"-shaped washer - large washer – lower cushion with sleeve - onto each stud:

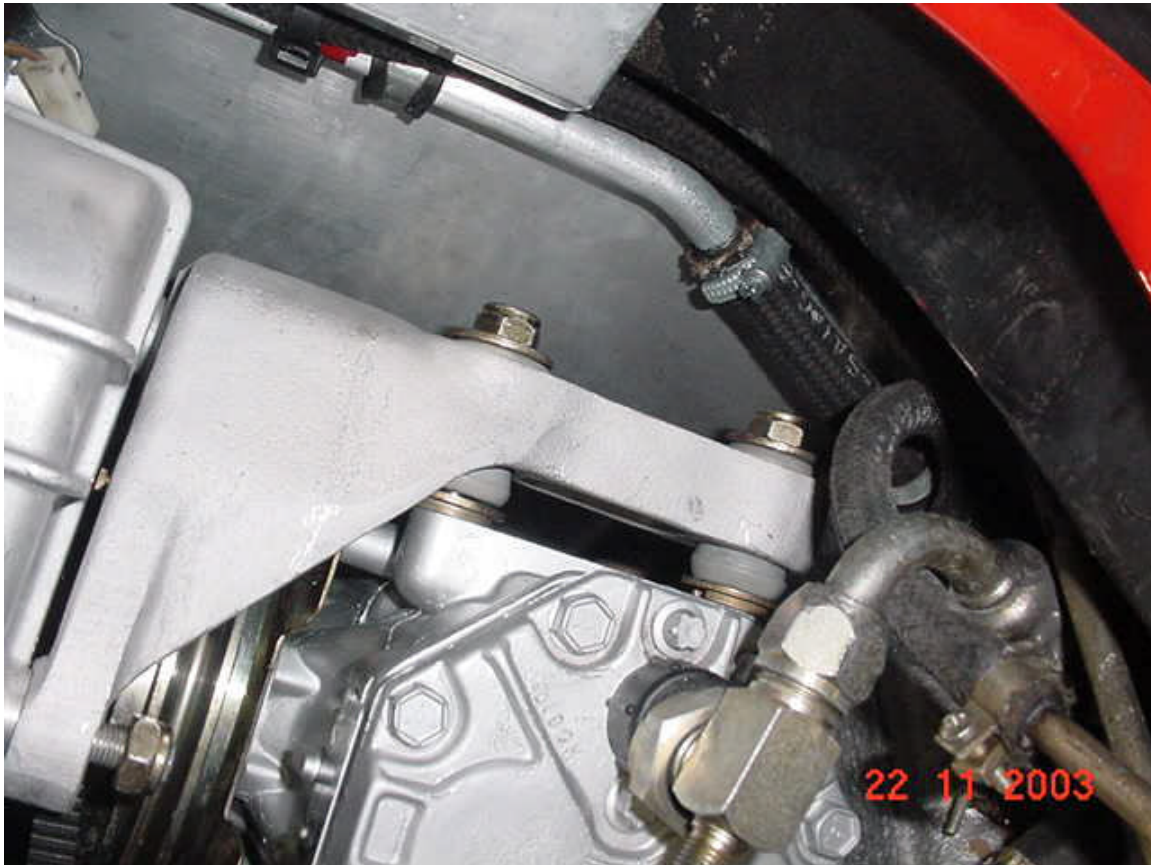
*Important: install the compressor belt loosely over pulley before affixing compressor in position – there is insufficient slack in belt to do so after installed, in which case you have to loosen compressor once again (don't ask how I discovered this). Working by myself, I lifted the compressor into place and temporarily spun large washer and nut on the top to hold in place while installing others. From top side, install rubber bushing – large washer – 17mm nyloc nut on each stud. Rocking compressor slightly & lubricating with Armor-All facilitates sliding bushings over sleeves:*

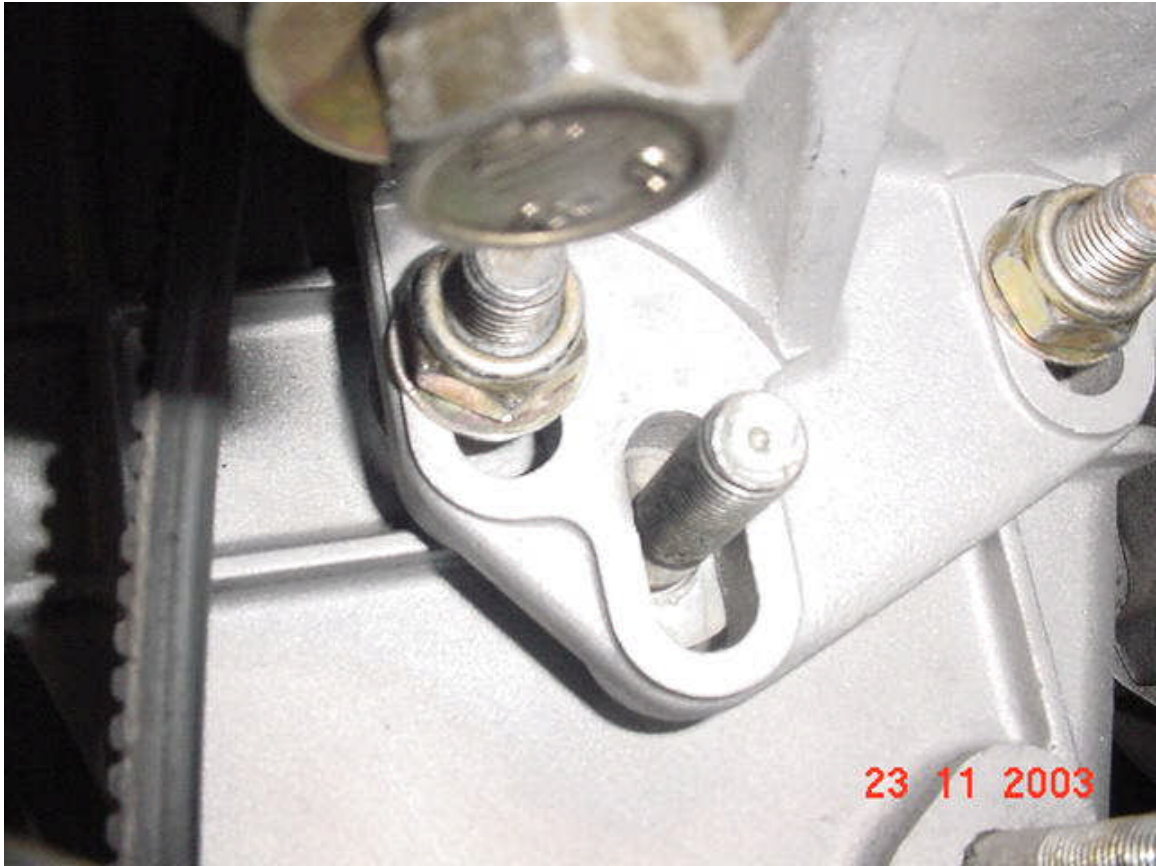
Start both large bolts into compressor ears by hand to avoid cross-threading, then install washer – 17mm nyloc nut on upper & right bracket studs. Upper nut (top left in above photo) is particularly challenging, as compressor mounting bolt obstructs access:

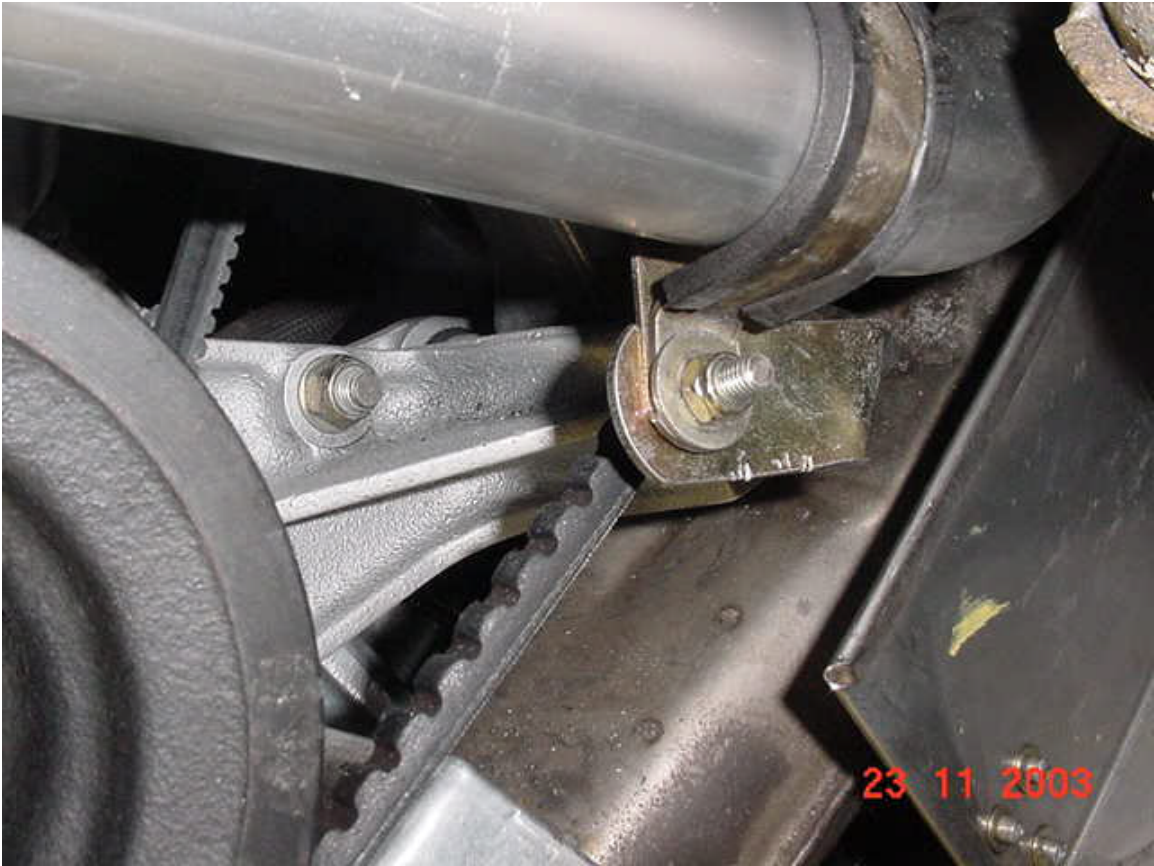
Tighten lower bracket-to-compressor 17mm bolts. A/C belt tensioner then pivots on left bracket stud (17mm) and lower cambelt cover stud (13mm) – center and right lower in above photo. Push upward until compressor belt tensions to 42 ft-lbs (used) or 48 ft-lbs (new) using Kriket belt tension gauge. Tighten pivot and locking nuts. Reinstall ascending coolant pipe hose clamp if previously removed:

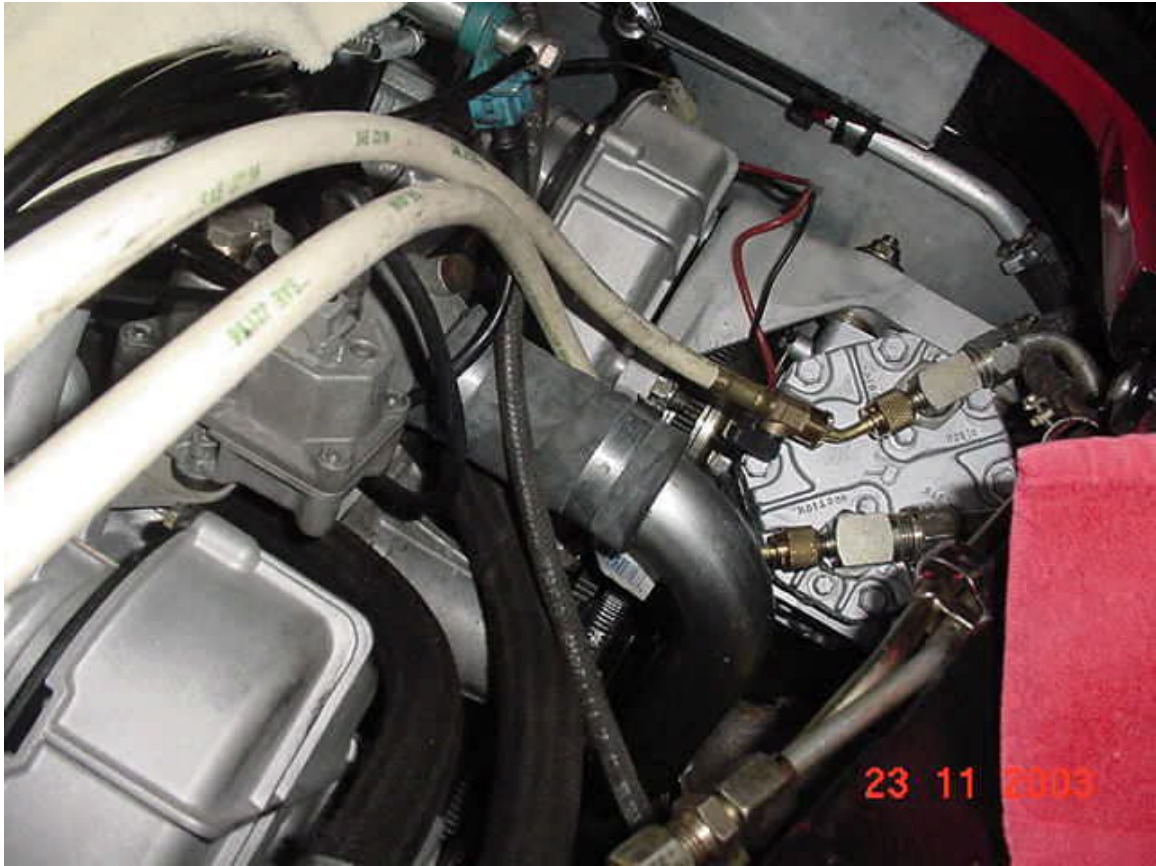
I then pre-installed gauge set & pulled vacuum to confirm system integrity prior to recharging:

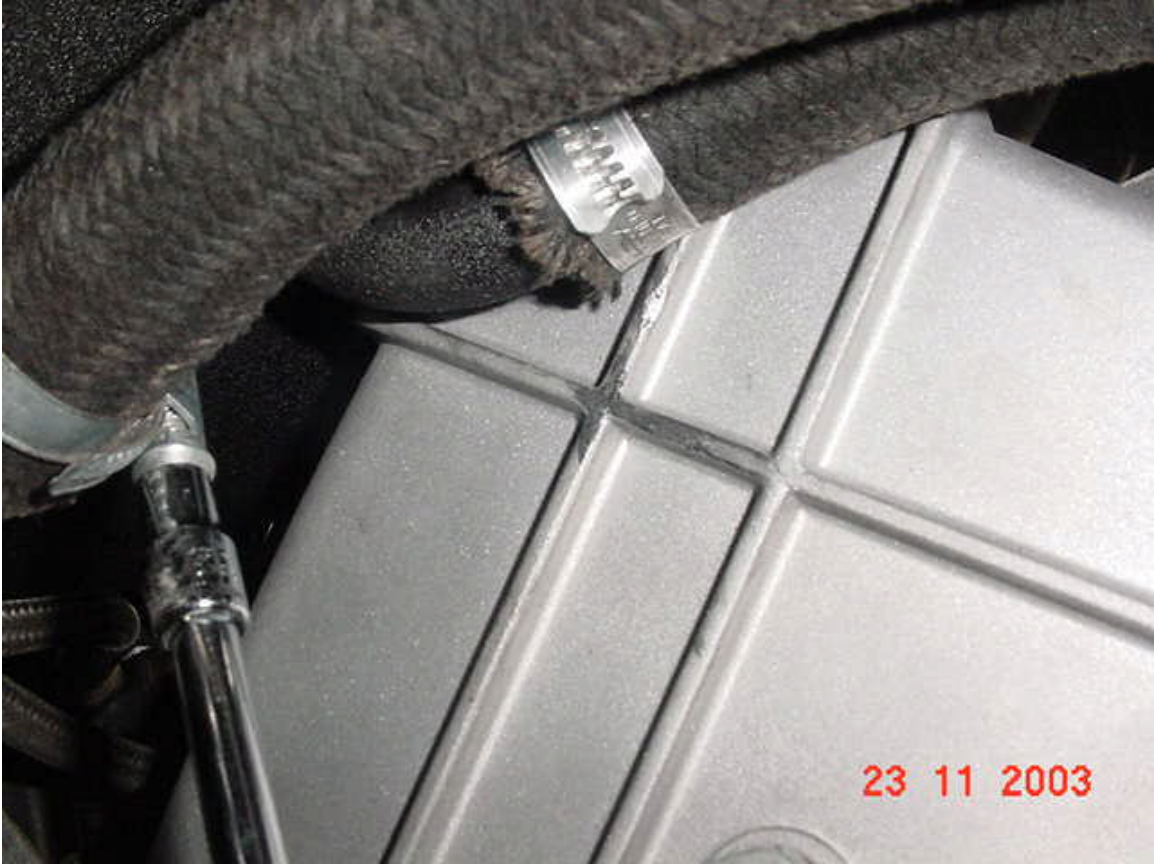
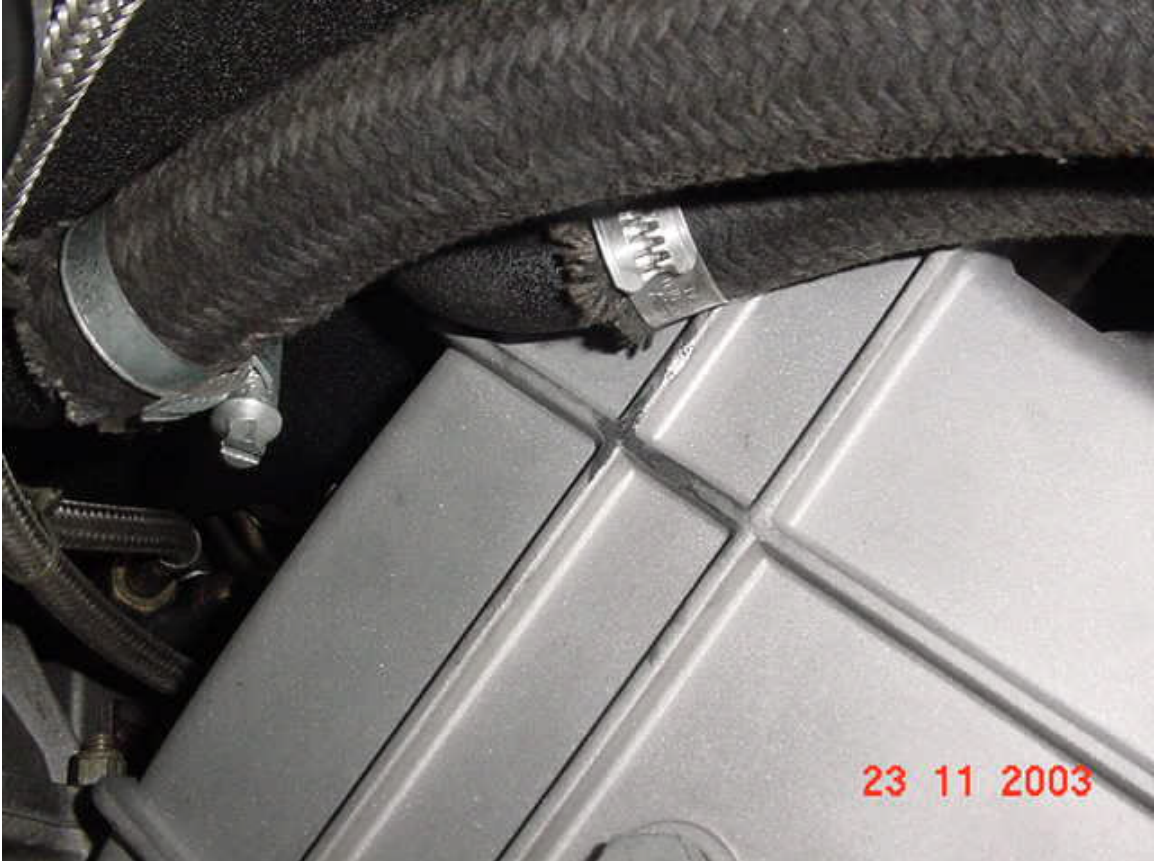
Refit lower airbox & air filter, remembering to install both hoses on underside (large hose clamp nut is 6mm nut & smaller 7mm):

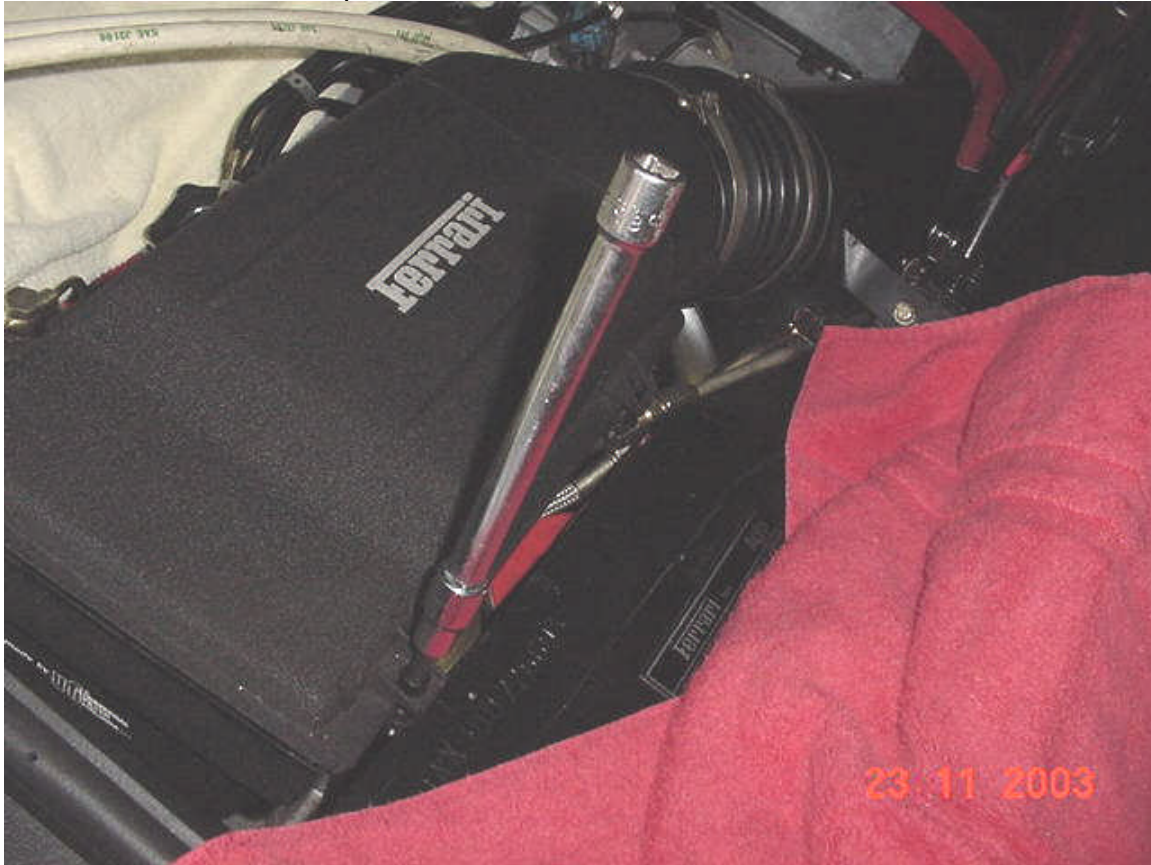
After liberally coating the inside with Armor-All, I was able to slide the rubber bellows hose back over the intake ducting and airbox top. Tighten four 5mm hex bolts to secure airbox top:

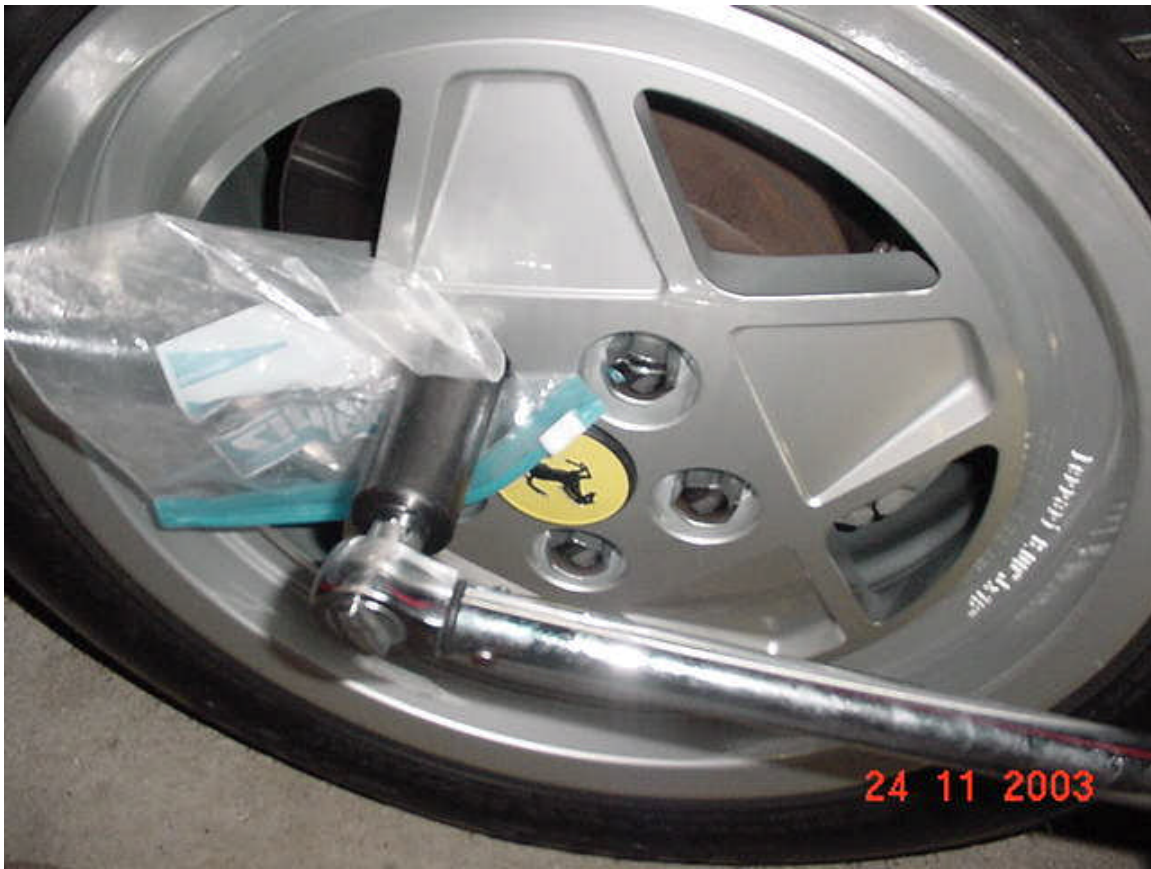
Replace fenderwell fiberglass shielding using the three 10mm and four Philips-head screws. Replace the wheel and seat bolts while on stand. Jack car slightly and remove stand. Torque wheel bolts to 72 ft-lbs:
