Field Studies to Address the Use of Compost to Mitigate Shoulder Cracking

Report 5-4573-01-1

Project 5-4573-01

Research Project Title: Use of Compost to Mitigate Shoulder Cracking

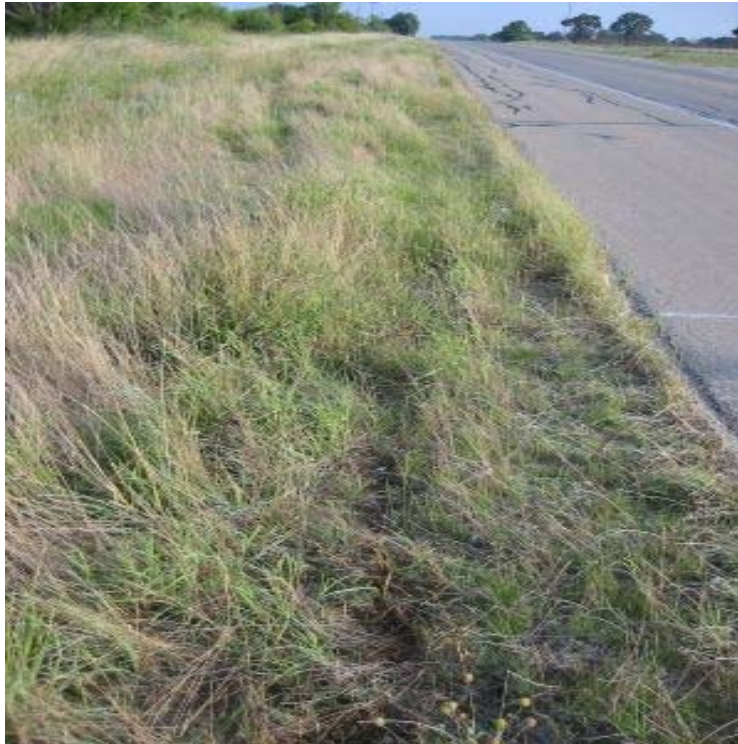
Figure 3: Vegetation at Stephenville site (picture taken on June 25, 2005)

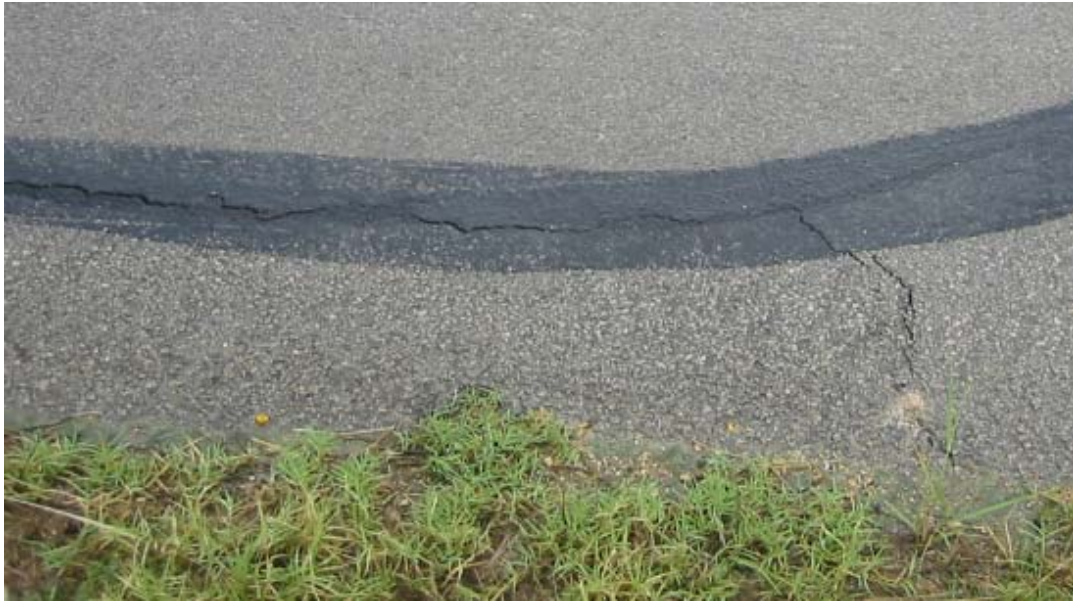
Figure 7: Shrinkage of the asphalt concrete

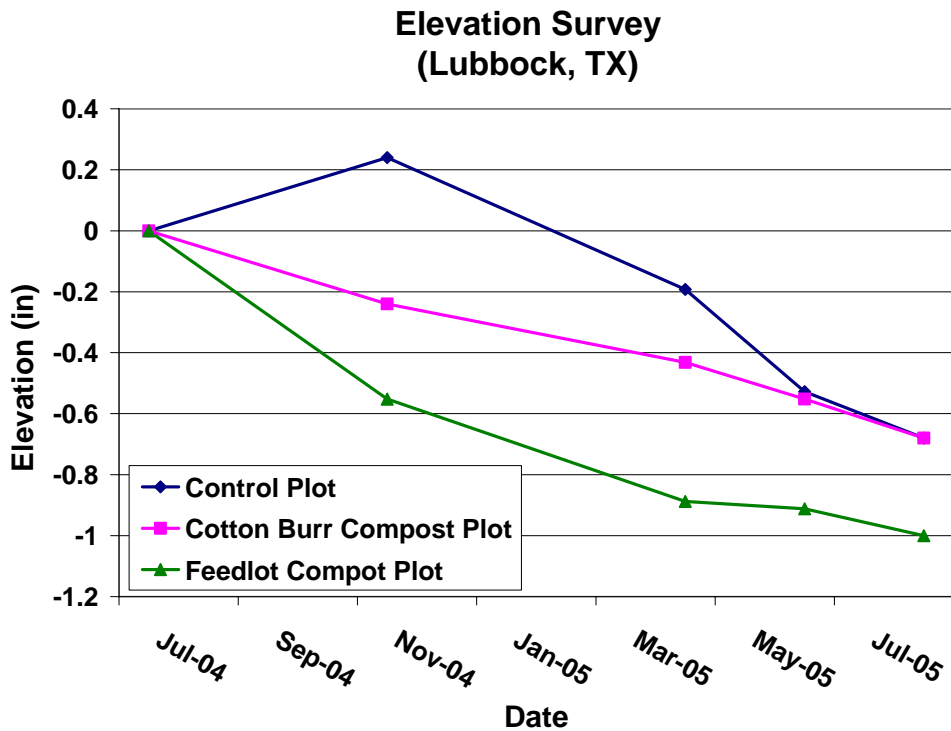
Figure 11: Elevation survey at Lubbock site

Elevation analyses were performed by comparing the elevation data of all three sections at all three sites. These results are shown in Figures 11 to 13. From Figure 11, it was observed that the erosions for the Cotton Burr Compost and the Control Plot of the Lubbock site were close to 0.65 inches. The highest erosion of 1 in. was recorded on the Feedlot Manure Compost plot. Manure Compost has been found to have a high rate of erosion. For the Bryan site (Figure 12), the erosions for the Control, Biosolids Compost, and Wood Compost plots were 0.85, 0.99 and 0.83 in., respectively. Vegetation growth observations indicated that the lack of vegetation in this site after construction increased the erosion rate. Figure 13 indicates a swelling nature of the control soil and the Cow Manure Compost, which are also noted in the laboratory results. Both plots experienced heaving during the wet season. The Biosolids Compost plot, on the other hand, only experienced erosion of 0.23 in. This indicates moderate surface erosion in this plot, most likely due to the lack of vegetation and lower organic contents of this material when compared to the one used in the Stephenville site.

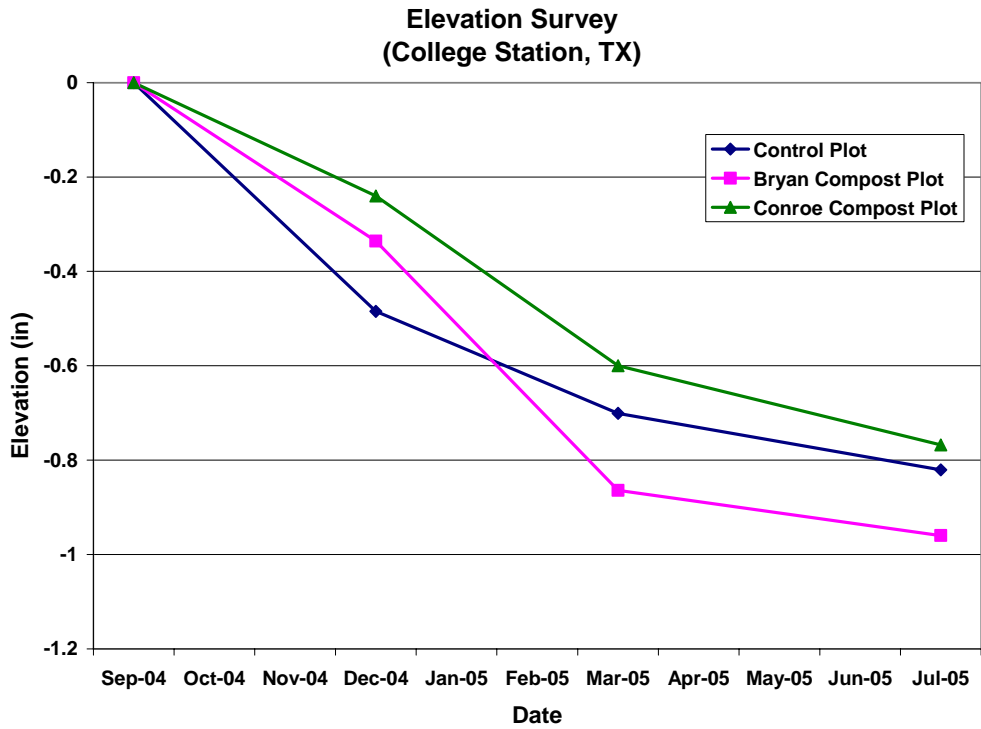
Figure 12: Elevation survey at Bryan site

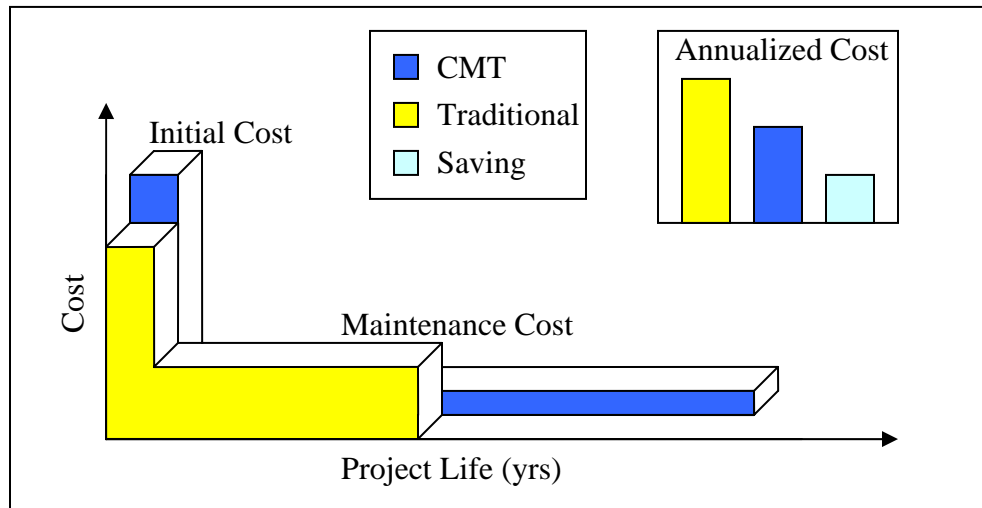
Figure 15: Cost comparison between traditional and CMT methods

This part of the study is focused on a cost analysis of the application of CMT in mitigating desiccation cracking. The objective is to determine if this method, over the long run, is a more economical alternative to traditional roadside management. Traditional roadside management was used as a base line in this analysis while the application of CMT was considered as an alternative. As this analysis is based on comparison, costs were determined for the traditional method as well as for the CMT method. Since CMTs were implemented at the selected sites, actual costs could be applied. Estimated traditional treatment costs were determined for comparison. Figure 15 illustrates the concepts of life cycle costs for CMT and traditional methods and also a potential saving.

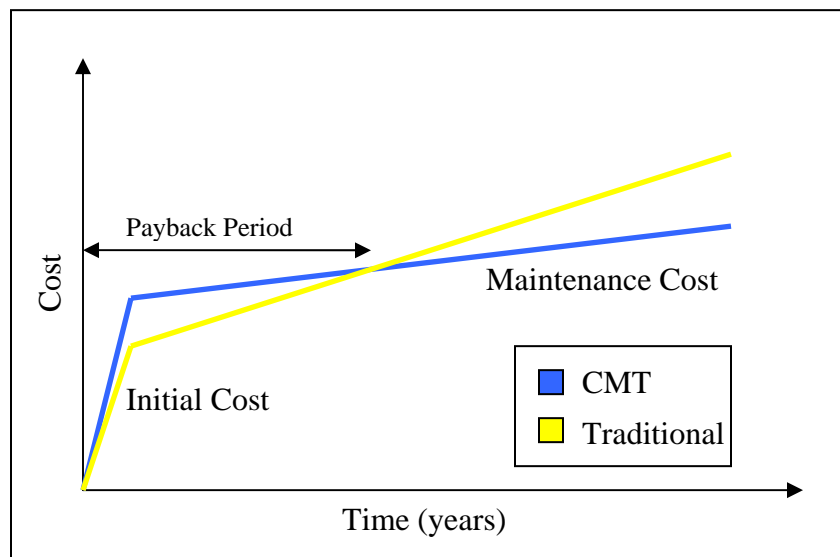
Figure 16: Accumulated costs over the design life

The cost analysis may show that the use of compost as a soil amendment is expected to be more economical over the long run. It allows an understanding of the benefits of using compost in roadside maintenance from a cost perspective. Figure 16 presents the probable accumulated costs over the service period. The type of graph allows an estimate for the payback period for investment. This analysis needs an accurate estimation of the service or projected life of the compost treatment which is expected to be beyond 2.5 years based on the monitored data of the Stephenville site. Better estimation of this time period will allow a comprehensive cost analysis of the CMT treatments which in turn will provide better cost effectiveness of the compost treatments for mitigating cracking on pavements.
