Flat Loop Thermosyphon Foundations in Warm Permafrost

Prepared for
Government of the NT
Asset Management Division
Public Works and Services

prepared by:
Igor Holubec, Ph.D., P.Eng
I. Holubec Consulting Inc.

March 2008

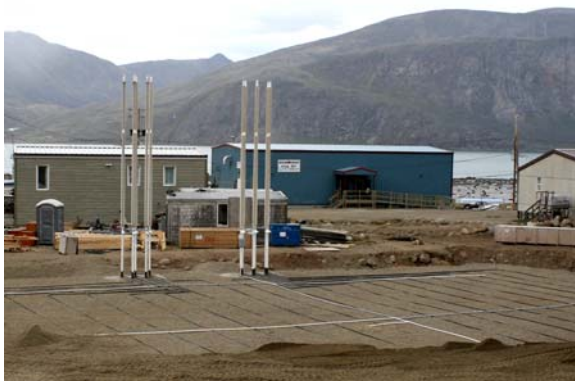
Components of the flat loop thermosyphon are: 1) evaporator pipes within a granular layer, 2) insulation right above gravel layer with the pipes to minimize the warming, and therefore prevent thawing, of the frozen ground, and 3) above ground surface radiators on top of the vertical conductor pipe to increase the efficiency of dissipating the heat. The components of the flat loop thermosyphon foundation are illustrated in a photo of Pangnirtung health centre thermosyphon foundation under construction.

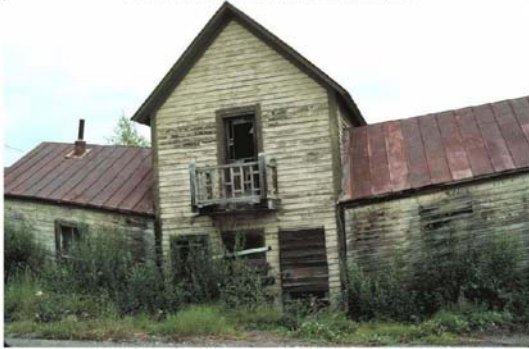
Photo 1. Thaw settlement of early buildings, Dawson City, NT

1.0 INTRODUCTION

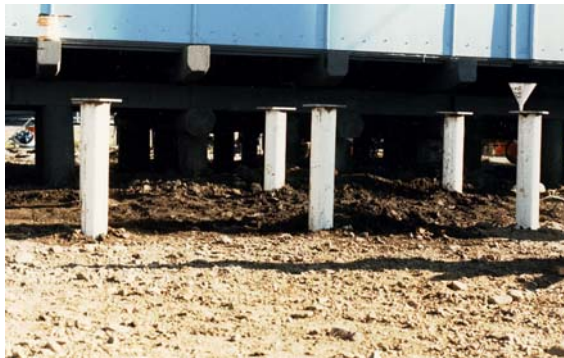
Photo 3. Slurry pipe pile foundation in Iqaluit, NU

in marginal or 'warm' permafrost where the ground temperature is at or warmer than -2°C . Steel pipe slurry pipe foundation for Aurora College residence is shown in Photo 3.

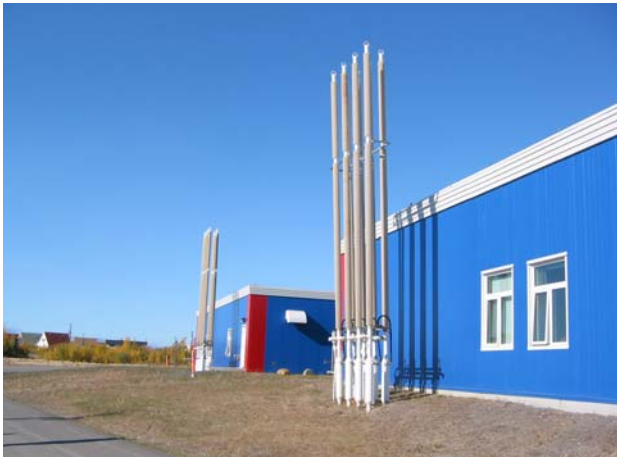
Photo 4. Radiators from a flat loop thermosyphon foundation at Inuvik Hospital.

It is a pressure vessel with the lower portion installed in the ground acting as an evaporator and the top portion above ground being a condenser. It was first used for the foundation of communication towers in Alaska in 1960 and proved itself on the Trans Alaska Pipeline System (TAPS) where 120,000 thermosyphons were installed (Heuer TF al 1985). The thermosyphon heat extraction system evolved from the installation of freezing pipes within the piles for the TAPS, to be followed by thermopiles that are pressured steel piles with a radiator below the building base, conventional sloping evaporators (sloped thermosyphon foundation) and finally the flat loop evaporator foundation (flat thermosyphon foundation) that is reviewed in this document. Radiators of a flat loop evaporator thermosyphon foundation at the Inuvik Hospital are shown in Photo 4.

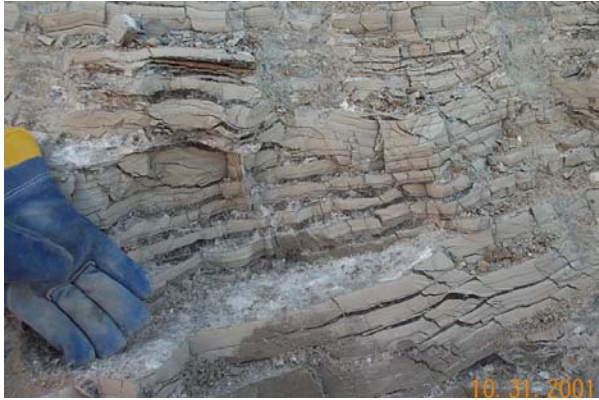
Photo 5. Layered sandy silt and ice at Diavik excavation.

Photo 5 and Figure 1 illustrate the extra care that needs to be exercised in the design and

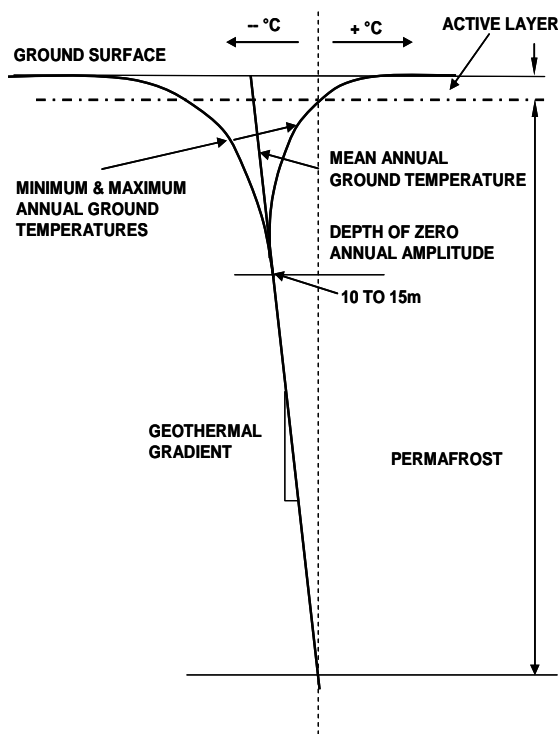
Figure 2. Schematic ground temperature regime in permafrost.

The next parameter that needs to be considered in the design of foundations in permafrost is the ground temperature. Ground temperature is complex because while it is predominantly dependent on the air temperature above the ground, it also depends on vegetation cover, terrain, snow depth during the winter, terrain slope, and mineralogy of the ground and greatly on the water/ice saturation level of the ground. The ground temperature fluctuates with the air temperature in the first 10 to 15m. However, there is a time delay in its response and this lag increases with depth. This ground temperature fluctuation in the upper 10 to 15m through the year as illustrated in Figure 2. Recent ground temperatures measured in Inuvik are shown in Figure 3. Parameters that describe the ground temperature are: depth of the annual thaw (active layer), ground temperature at the depth of zero annual amplitude and the geothermal gradient. Geothermal gradient also varies but has an average value of 1°C/54m (Johnston 1981). This means that the mean annual ground temperature (MAGT) varies only by 0.2 to 0.3°C between the ground surface and the MAGT at depth of zero annual amplitude; therefore, can be assumed to be the same for most of permafrost designs.

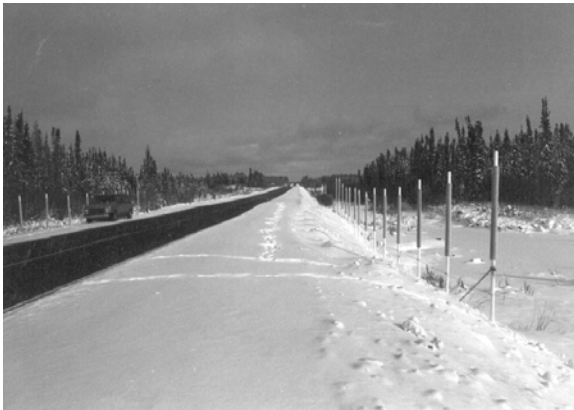
a) Thermoprobes – Joe Lake, MB. Highway stabilization (Courtesy AFC)

Thermoprobes – This is the first application of thermosyphons and its use illustrated by the TAPS project in Figure 9 (a). They have been used in Canada to maintain frozen ground around transmission towers and along railroad embankments in Manitoba. They do not carry any load (Figure 11, a).

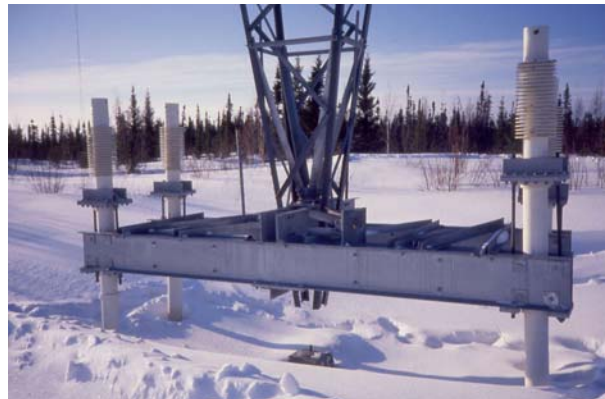
b) Thermal Piles – Manitoba DC Line, MB. (Courtesy AFC)

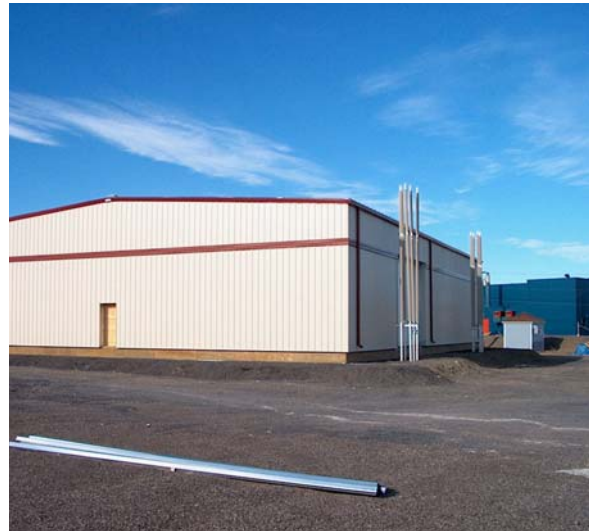
Figure 11. Photos of types of thermosyphon installed in Canada.

d) Flat Loop Thermosyphon Foundation – Airport maintenance garage, Inuvik, NT. (Courtesy AFC)

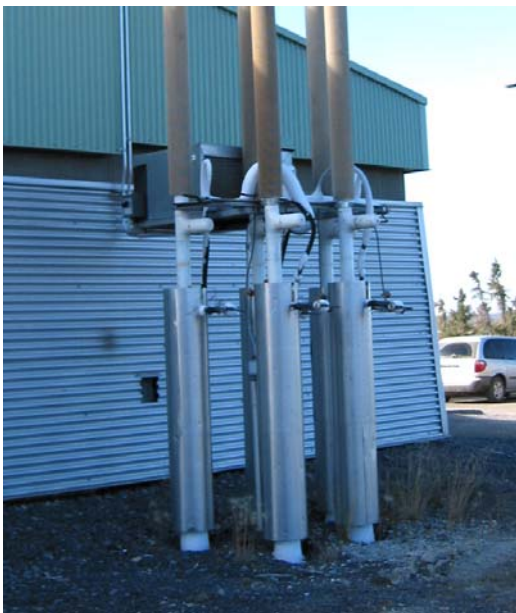
The cooling of the Flat-Loop TF was enhanced by the addition of mechanical cooling to enhance the rate of cooling in six installations (hybrid Flat-Loop TF). The hybrid installation involved adding a cooling coil around the vertical evaporator pipe, insulating the coil and connecting the coil to a refrigeration compressor. The mechanical cooling is activated when the air temperature becomes too warm to condense the carbon dioxide in the vertical pipe. The cooling provided by the coil around the vertical pipe condenses the vapour even during the summer and thereby keeps extracting the heat from the foundation. The size of the compressor determines the rate of cooling and therefore heat extraction. Normally the compressors are small and can be mounted on the evaporator pipes. Otherwise it may be a self standing unit installed adjacent to the radiators. An installation of a small compressor is shown in Figure 14.

Figure 14. Hybrid installation at the Young Female Offender Facility in Inuvik. Cooling coils wrapped with insulation are installed below the radiators and the compressor cooling unit is located behind the radiators.

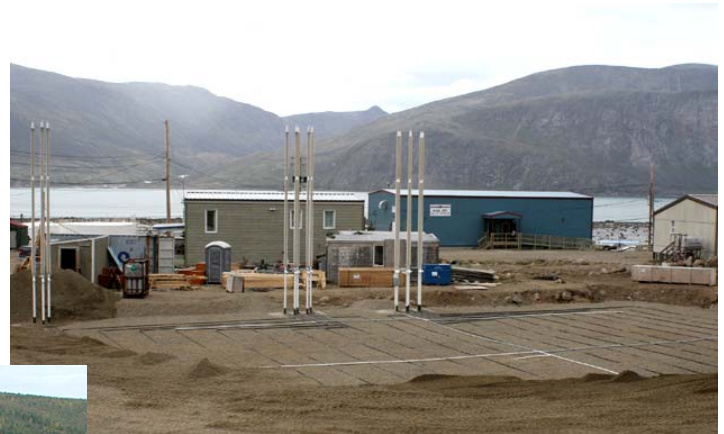
Figure 16. Flat Loop TF installation in progress at Pangnirtung Health Centre. Photo shows the evaporator pipes along the radiators in place.

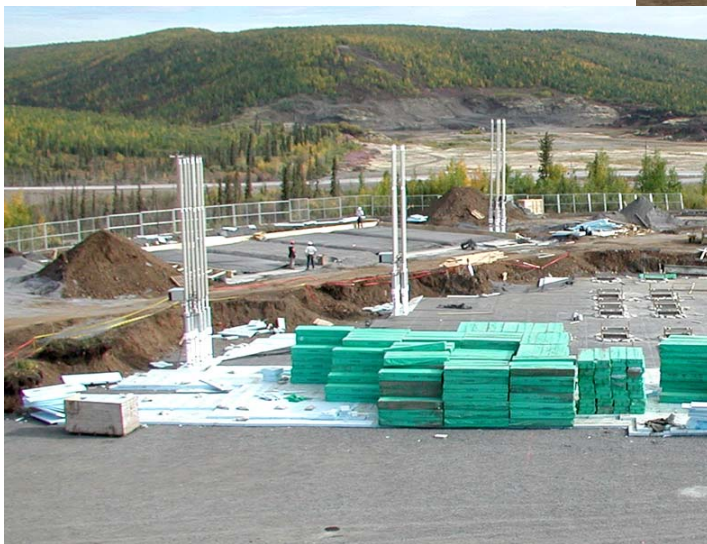
Figure 17. Insulation sheets being placed over bedding covering evaporator pipes at Inuvik hospital.

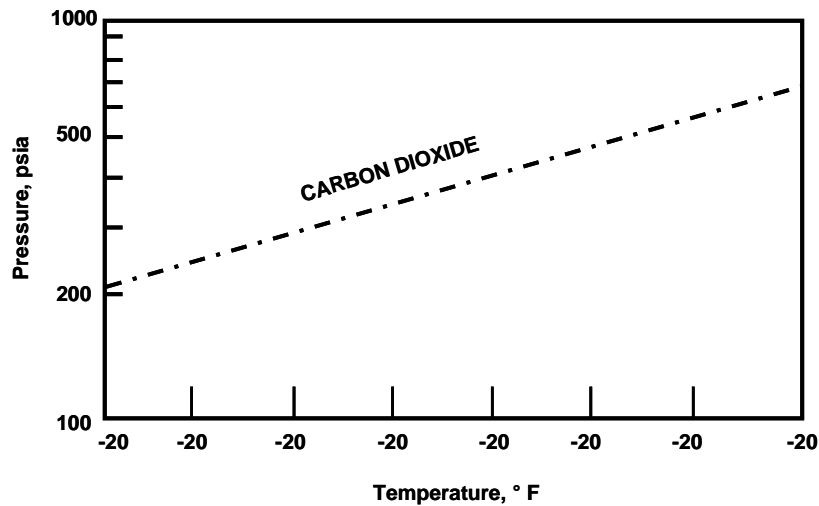
Figure 18. Saturation vapour pressure versus temperature (Heuer et al 1985)

The pressure range the carbon dioxide operates in the evaporator/condenser tubing is illustrated by the saturation various pressure versus temperature in Figure 18.

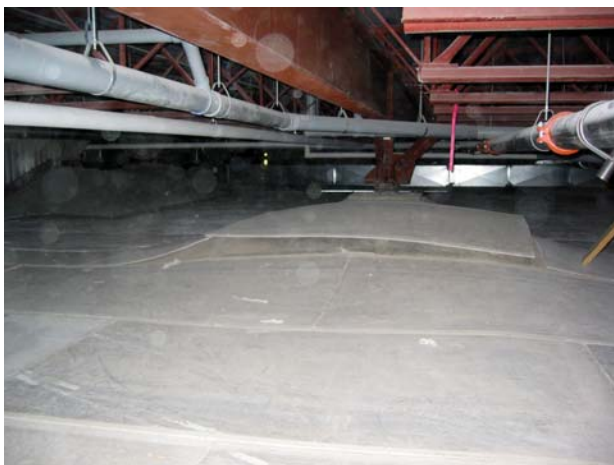
Figure 21. Services hung from floor girders at Inuvik Hospital

There is little difficulty in incorporating services in crawl space thermosyphon foundations. As is illustrated in photo in Figure 21, a crawl space design provides greater flexibility for installing sanitary piping and other services and also provides access for repair and modification.

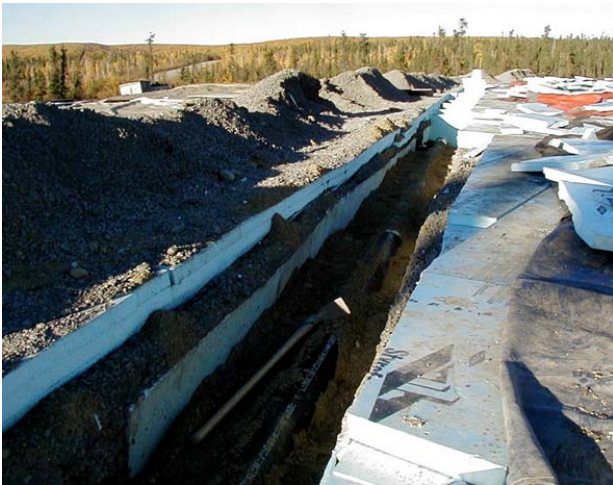
Figure 23. Buried sanitary lines at Inuvik YFOF

The installation of services in a slab-on-grade thermosyphon foundation need to incorporate the services within the granular zone; between the insulation above the evaporator pipes and the slab. Two approaches that have been used are: providing a corridor below the slab, as used at the Kuujjuaq air terminal (Figure 22) or incorporating the sanitary piping within the fill, as used in Inuvik at the FYOF (Figure 23).

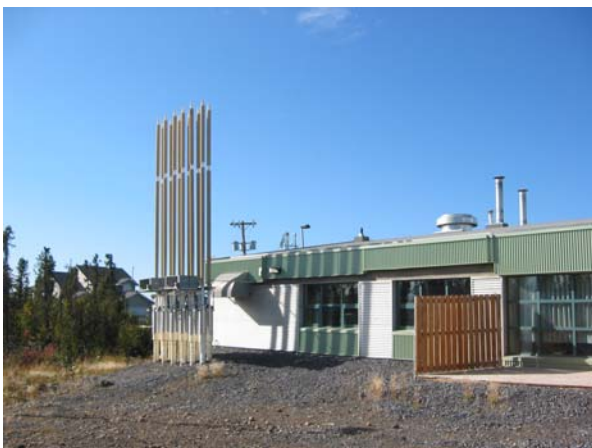
Figure 26. Radiators on the south side of the FYOF, Inuvik, NT

Arctic Foundation of Canada Inc (AFC) was selected to design and construct the thermosyphon foundations. The south side of the FYOF, along with the thermosyphon radiators, is shown in a photo in Figure 26. Figure 27 shows the plan and layout of the radiant heating system at the FYOF and Figure 28 shows a section of the foundation with the evaporator pipes, insulation and stratigraphy.

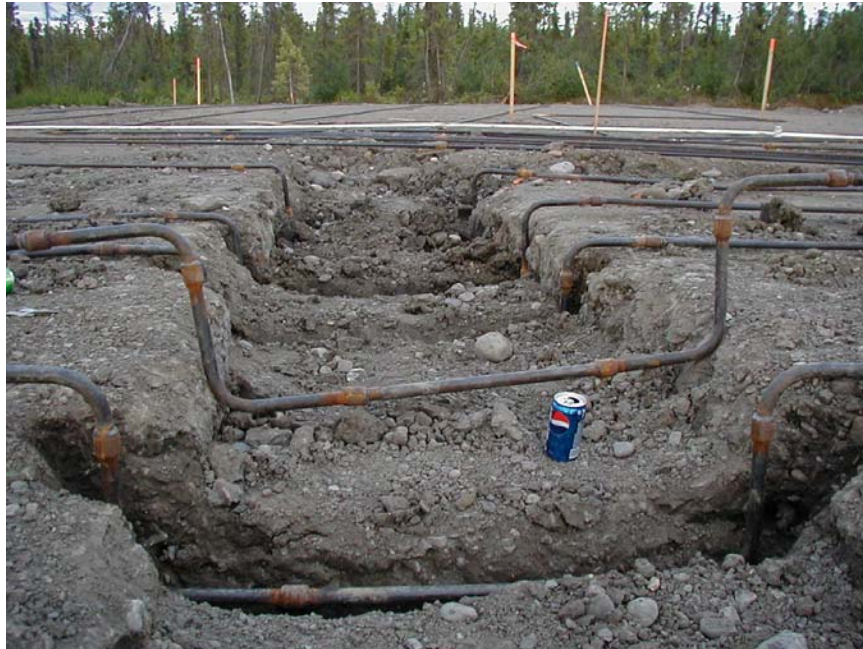
Figure 29. Evaporator pipe route across service trench, FYOF.

After completing the engineered fill, the contractor and engineer requested that the evaporator pipes be located completely within a granular engineered pad and AFC consented when they came to the site to install the evaporator pipes at about mid July. This modification required installing the pipes with four right angle elbows at each trench. This resulted that many of the evaporator loops were directed across one and up to 7 trenches (before extra radiators were installed) with each trench having four right angle elbows. Evaporator pipes being routed past a trench are illustrated in a photo in Figure 29.

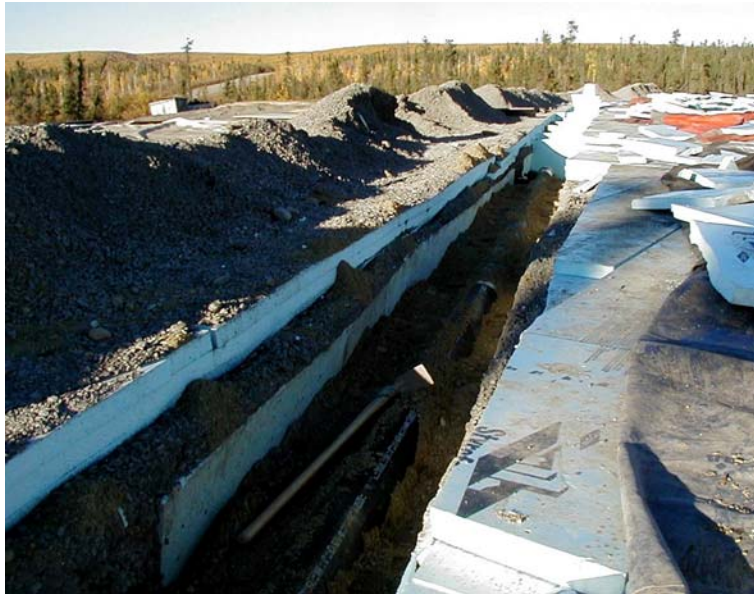
Figure 30. Sanitation and water lines within a lined service trench, YFOF, Inuvik, NT.

Subsequently the sanitation pipes were installed within insulated ‘troughs’ as illustrated in Figure 30.

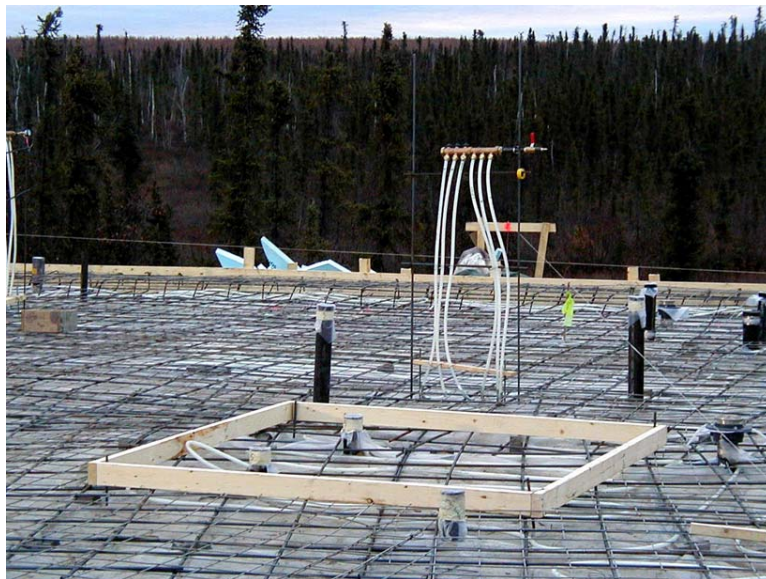
The building is heated with radiant piping in the slab floor. The heating pipes are located near the bottom of the slab and have been operating at higher temperatures for which was not designed. This introduced much greater heat to the foundation than the thermosyphons were designed to remove.

Figure 31. Radiant white tubing before concrete slab was poured. Tubes leading to a temperature control area. FYOF, Inuvik, NT.

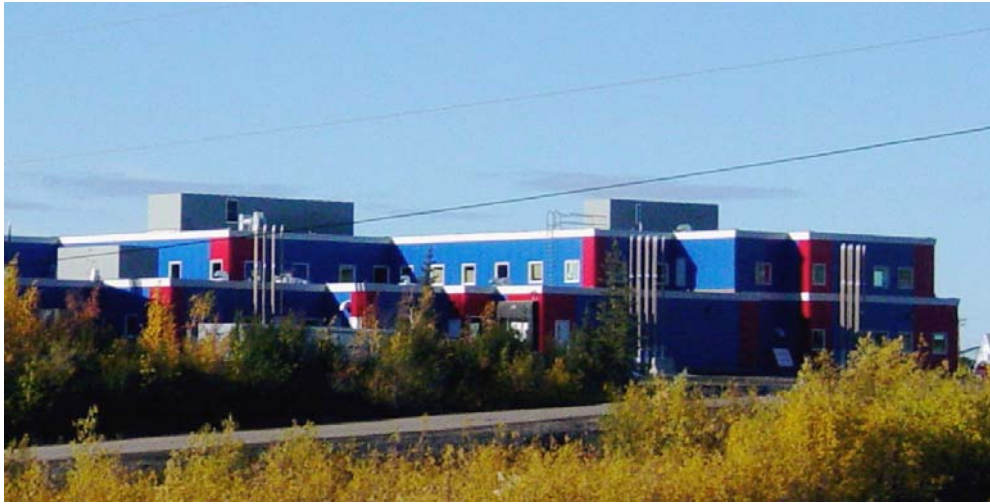
Figure 33. Inuvik hospital, NT.

silty sand and gravel fill and natural ground with peat cover. The constructed hospital is shown in Figure 33.

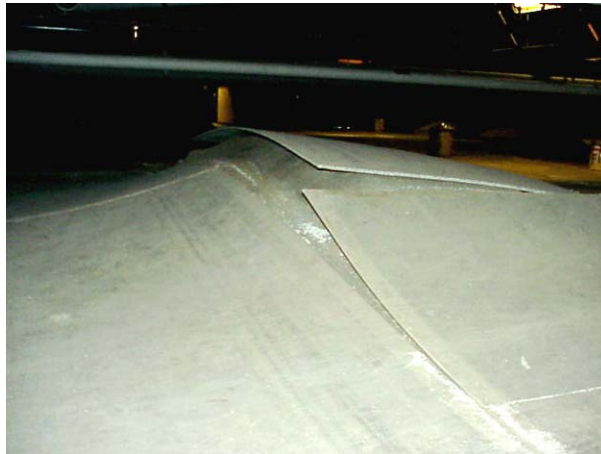
A major problem was that the pipe supplier shipped defective pipes that started to leak after the start of operation. As a result, 17 of 64 pipe loops at this project are losing liquid to different degrees and therefore their cooling capacity. The leaking loops are being recharged either annually or biannually. The second problem, that can be readily fixed, is that proper drainage control of surface water was not provided. Outside water has been penetrating into the granular bedding surrounding thermosyphon evaporator pipes where it freezes during the winter. The supply of water to the evaporator pipes has resulted in numerous large ice boils or 'pingos' to develop at the floor of the crawl space.

Figure 35. Ice mound developed at crawl space floor, Inuvik Hospital, NT

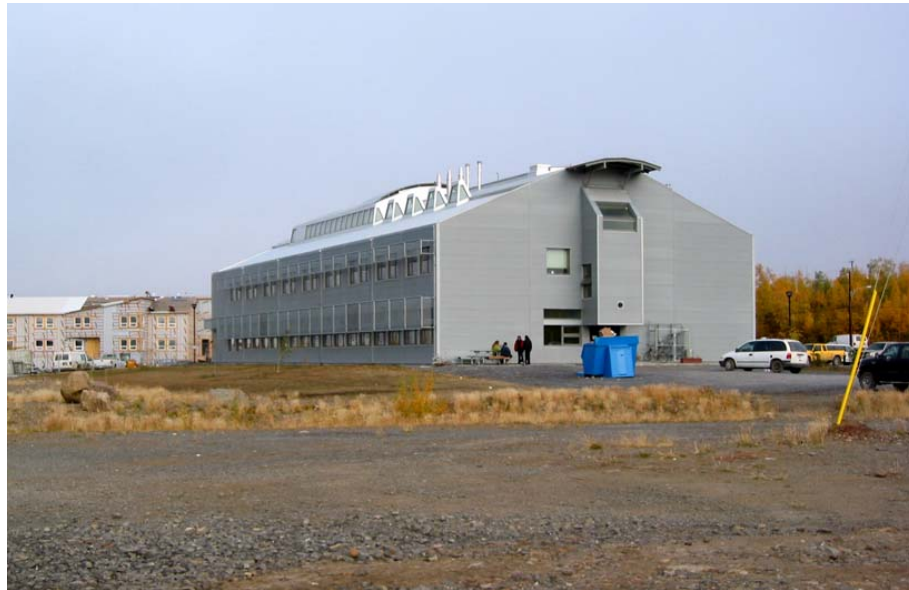
Figure 36. Aurora College, Inuvik, NT. Note: Good grade away from building.

The thermosyphon foundation was constructed on a well compacted 1.5m thick granular base. The evaporator pipes were installed within a minus 200mm bedding material and covered with 100mm of rigid insulation. The footings were located within a compacted granular zone that was about 1.6m thick. This zone provided ample depth to incorporate water and sanitation piping that was insulated and heat traced. The ground floor was more than 1m above the surrounding ground surface that the backfill around the perimeter sloped

away from the building. The constructed building with the surface grading from the building is illustrated in Figure 36.

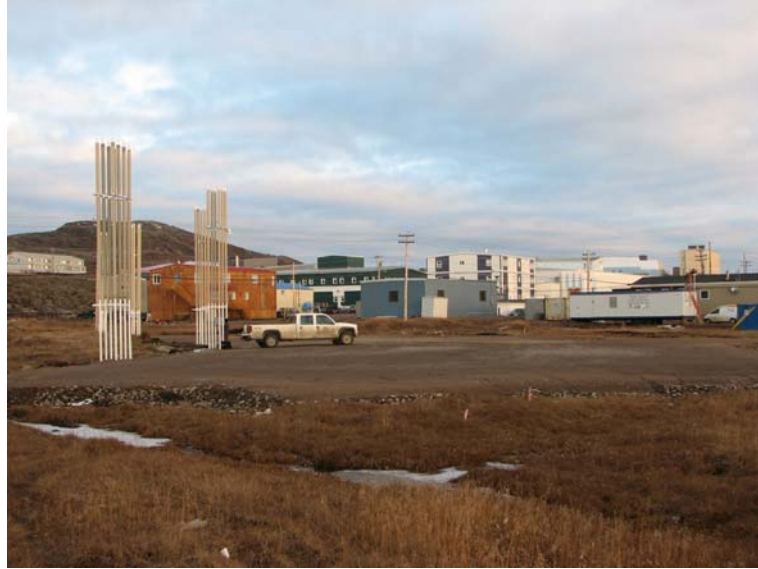
Figure 37. Foundation completed in fall of 2006, RCMP building, Iqaluit, NU

The construction schedule at the RCMP Building was: excavation and construction of the thermosyphon foundation in June 2006; the evaporator piping completed in early July; the thermosyphons charged in July 19, 2006. The surface granular base and building slab started in the summer of 2007. The foundation completed in the fall of 2006 is shown in Figure 37.

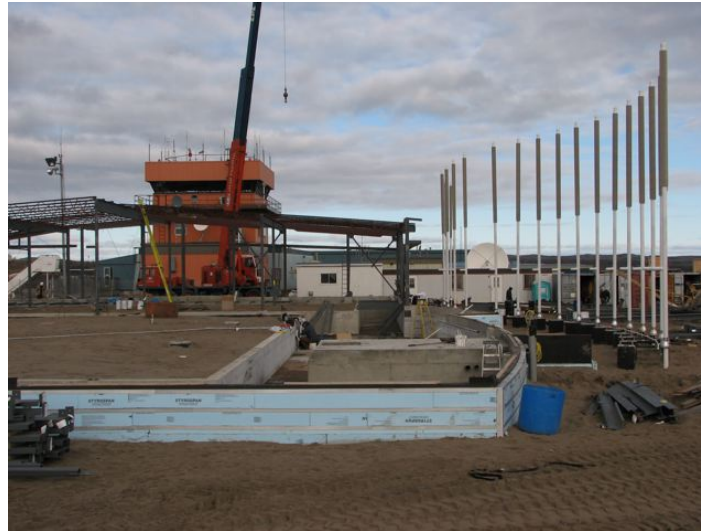
Figure 39. Kuujjuaq Air Terminal under construction, QC.

Kuujjuaq Air Terminal varies from the earlier two case histories by the following: a) it was constructed in warmer climate, b) ground consisted of finer grained soils and c) the foundation design. The terminal under construction is shown in Figure 39.

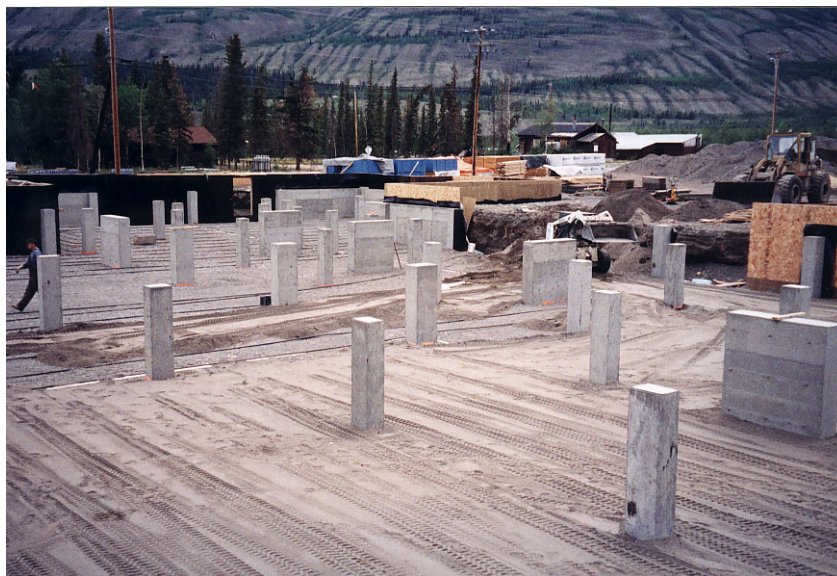
Figure 47. Covering of evaporator pipes at new Ross River School in progress (Arctic Foundations)

The basement of the new school was excavated and prepared in late spring of 1999 and the flat loop thermosyphon foundation was installed in early July 1999. The as-built elevations of the evaporator pipes and the surrounding ground are not known. Figure 47 provides a photo of the base of the crawl space being constructed in the summer of 1999.

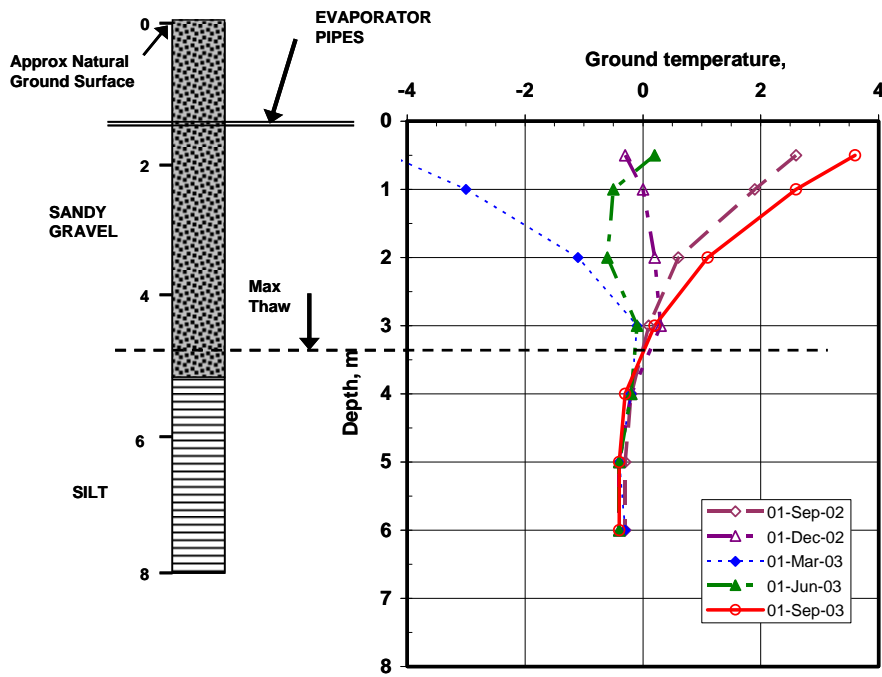
Figure 48. Typical ground temperature profiles below thermosyphon foundation at Ross River School (Arctic Foundation).

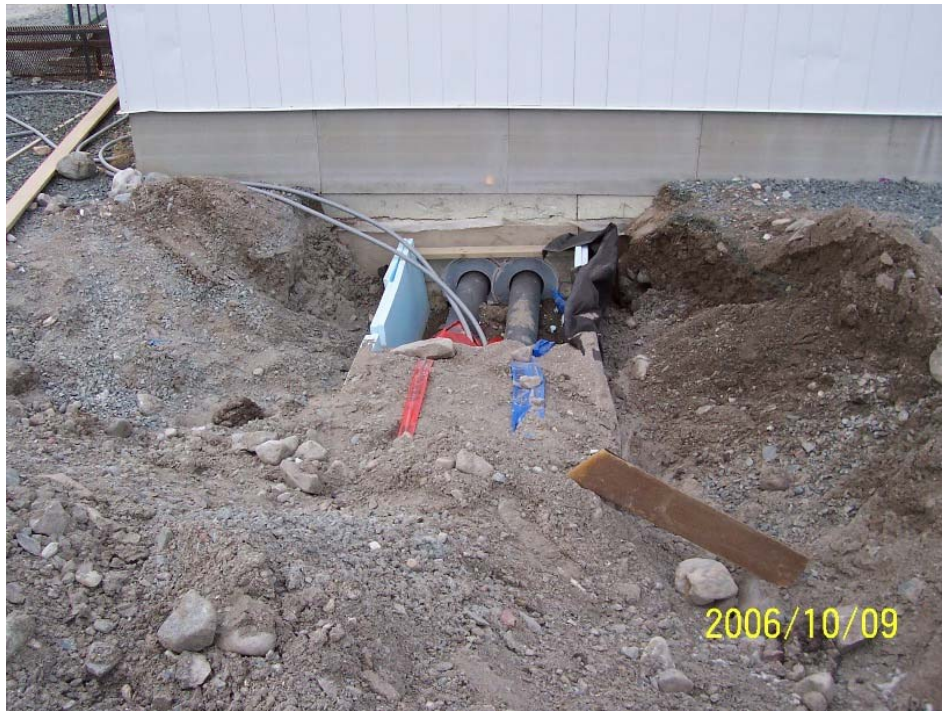
Figure A11. Installation of heating pipes below Rankin Inlet School from power plant.

The problem at this project was caused by burying heat supply pipes within the granular pad several years after construction of thermosyphon foundation and improper replacement of the insulation. These pipes provided excess heat to the school from a nearby power generator. The heat was brought by a large diameter insulated pipe that was installed into the crawl space. The heat from the pipe heated the foundation that the thermosyphon could not cope with. An additional problem was a leaking valve below the radiator on vertical conductor pipe that reduced heat extraction.

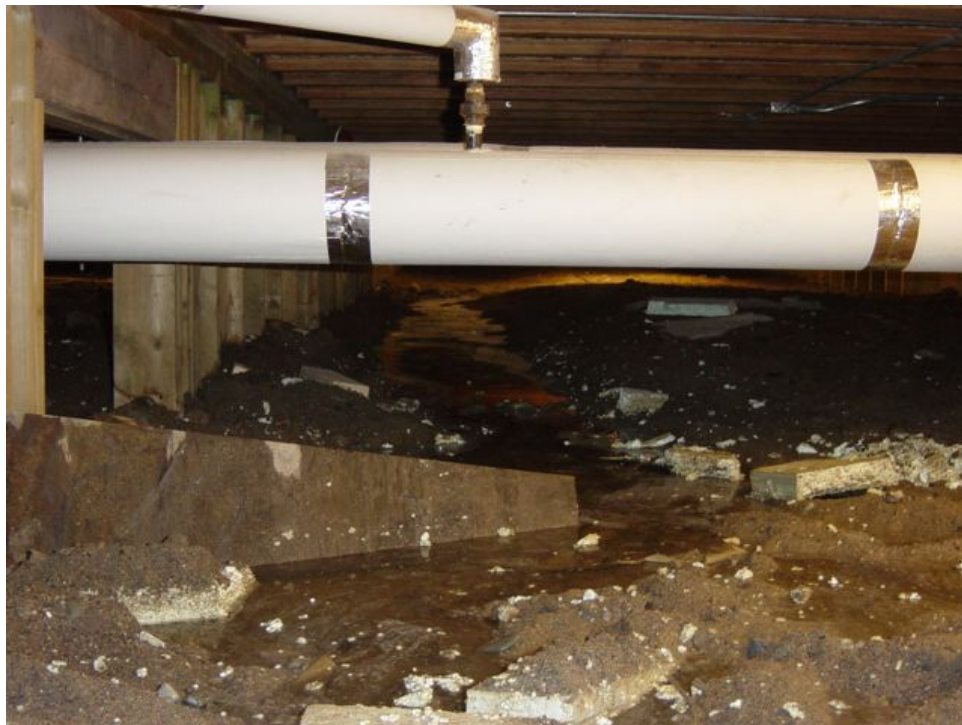
Figure A 12. Crawl space at Rankin Inlet School, NU, showing timber columns, ponded water and broken insulation.

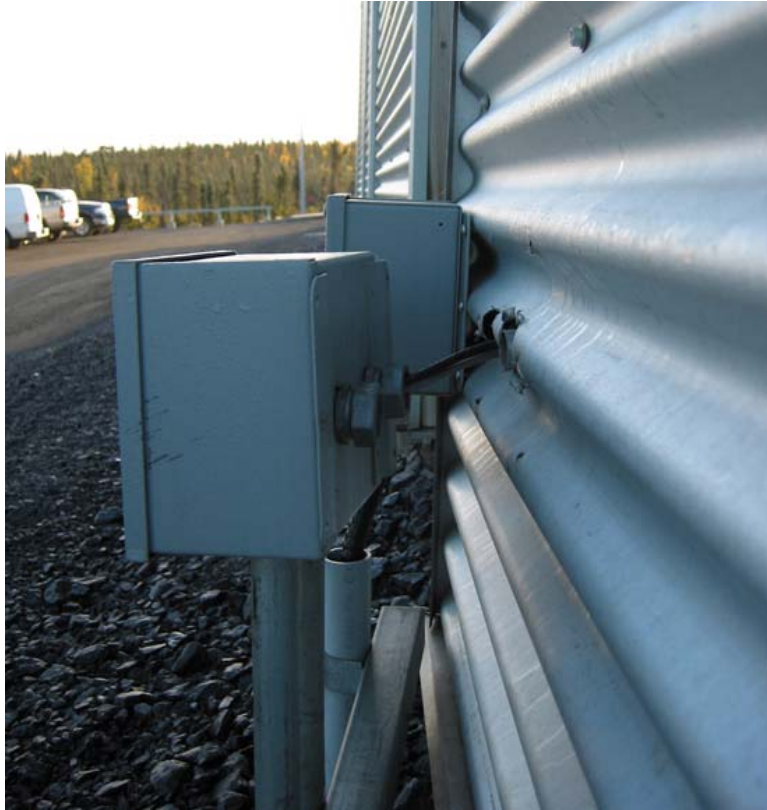
Figure A 20. Junction boxes moving down and out due to fill settlement, FYOY, Inuvik, NT

Finally, an additional flaw of the thermosyphon pad design was poor perimeter drainage around the granular pad. Surface water introduced into the gravel pad resulted in frost heave during the winter and thaw settlement the following summer. This resulted in cracking of the interior drywalls and minor electrical and plumbing failures around the building.

The above led to the addition of radiators and installing a refrigeration system to freeze the foundation. It took 3 years to finally freeze the foundation.
