FLOODS IN KANSAS CITY, MISSOURI AND KANSAS, SEPTEMBER 12-13, 1977

GEOLOGICAL SURVEY PROFESSIONAL PAPER 1169

By LELAND D. HAUTH and WILLIAM J. CARSWELL, JR., U.S. Geological Survey,
and EDWIN H. CHIN, National Weather Service, National Oceanic and Atmospheric
Administration

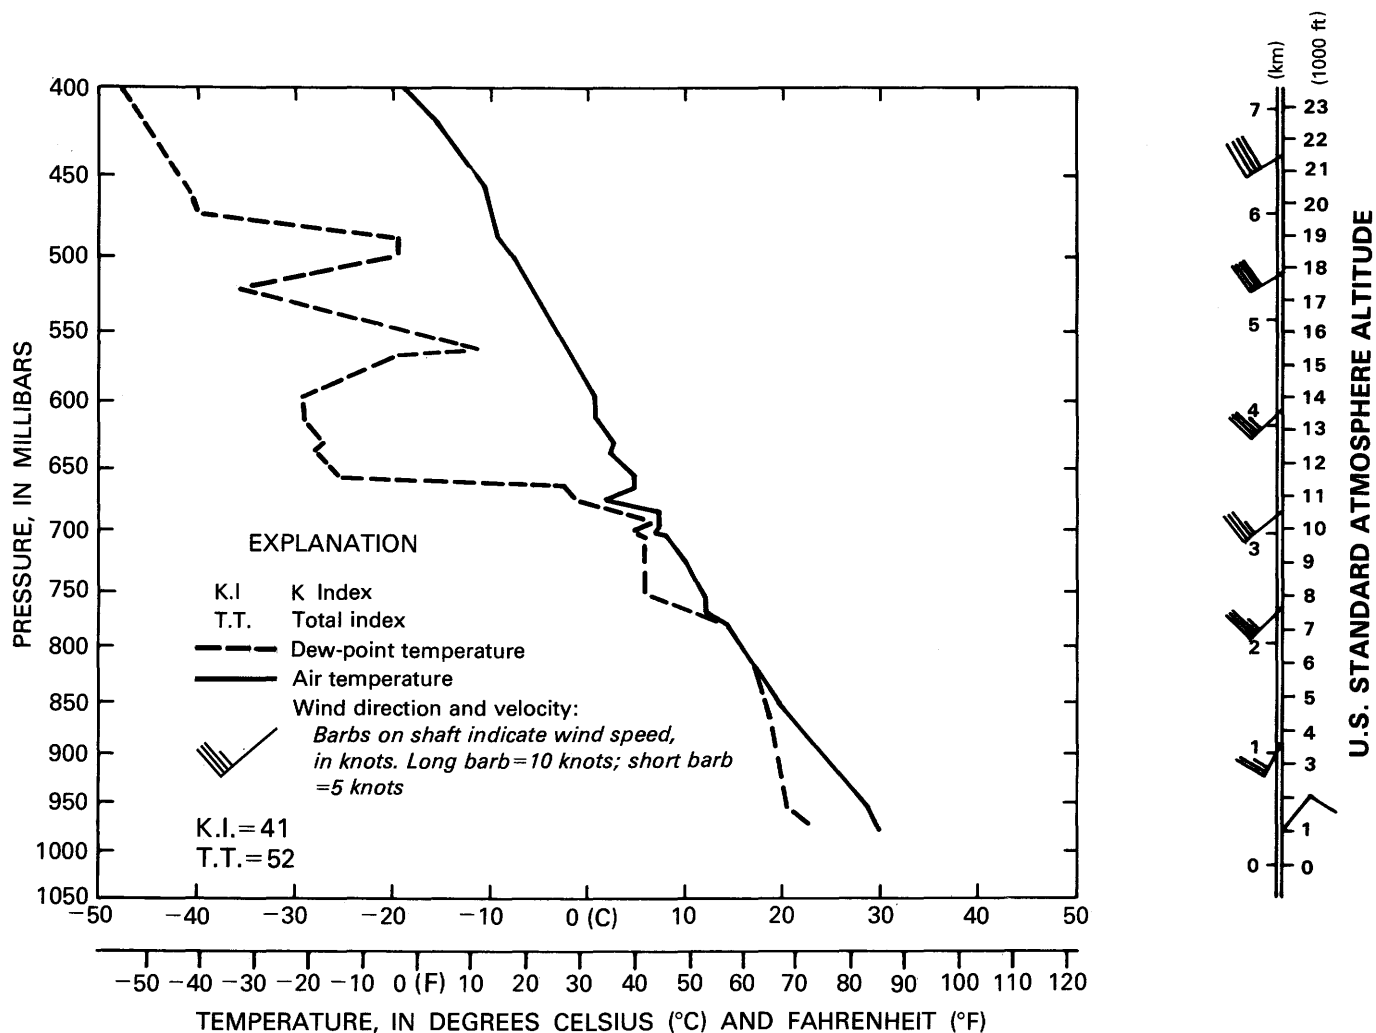
FIGURE 4.—Continued. B, Rawinsonde profile at Topeka, Kans., 1800 c.s.t., Sept. 12, 1977.

ime (fig. 3A). Figure 4B shows a moderately moist lower and midlayer capped by an inversion at about 670 mb and a very dry layer above. These soundings indicated that the low level southerly flow brought in moist air from the Gulf. Aloft the advection of much drier air from the northwest by the mid-tropospheric jet stream provided another ingredient for generation of instability. The presence of an inversion around 670 mb at 1800 c.s.t. prevented deep

convective overturning initially so that a progressive increase of instability could occur. Instead of being inhibiting factors, these are, in fact, contributing factors favorable to the development of intense convection. Even though Topeka, Kans., was not at the center of storm rainfall, the soundings should represent atmospheric structure in the fringe area during the latter part of the first storm (fig. 4A) and prior to the beginning of the second storm (fig. 4B).

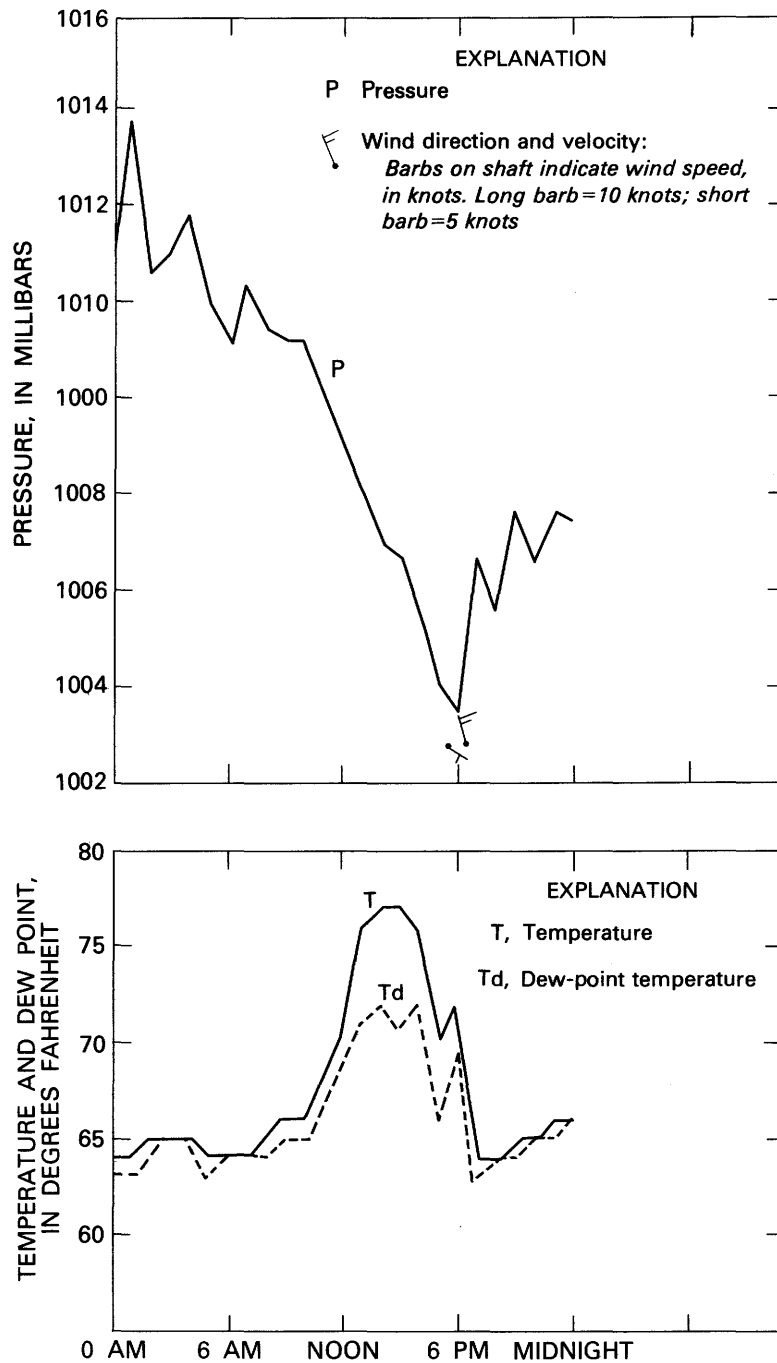
FIGURE 5.—Temperature, dew point, and pressure at Kansas City International Airport on Sept. 12, 1977. Wind speeds and directions near 6 p.m. are shown.

Near the end of the first rain period and during the initial period of no rain, fog was observed. This indicated the existence of a temperature inversion with its base near the ground. This condition was brought about by the warm front that was then just south of Kansas City. Evaporative cooling by raindrops falling into initial cooler air near the ground raised the dew point until fog was formed. Since the surface wind was light, the fog persisted until diurnal heating raised the temperature into the 70's (°F) in the early afternoon. This rain-cooled air mass extended from central Missouri to eastern Kansas; its southern boundary became a zone of convective activities and was situated south of Kansas City at 1800 c.s.t. Between storms there was an interlude of sunshine; and the atmospheric pressure began to change. At the Kansas City International Airport it fell from 1012.4 mb at 0700 to 1003.5 mb at 1800

c.s.t.; then it began to rise. Temperature also dropped 5°F in only 45 minutes, ending at 1830 c.s.t. In the same period, surface wind shifted from 140° at 5 kn to 340° at 20 kn gusting to 32 kn (fig. 5). These observations indicated a cold front passage, just prior to 1830 c.s.t. Figure 6 shows the positions of surface

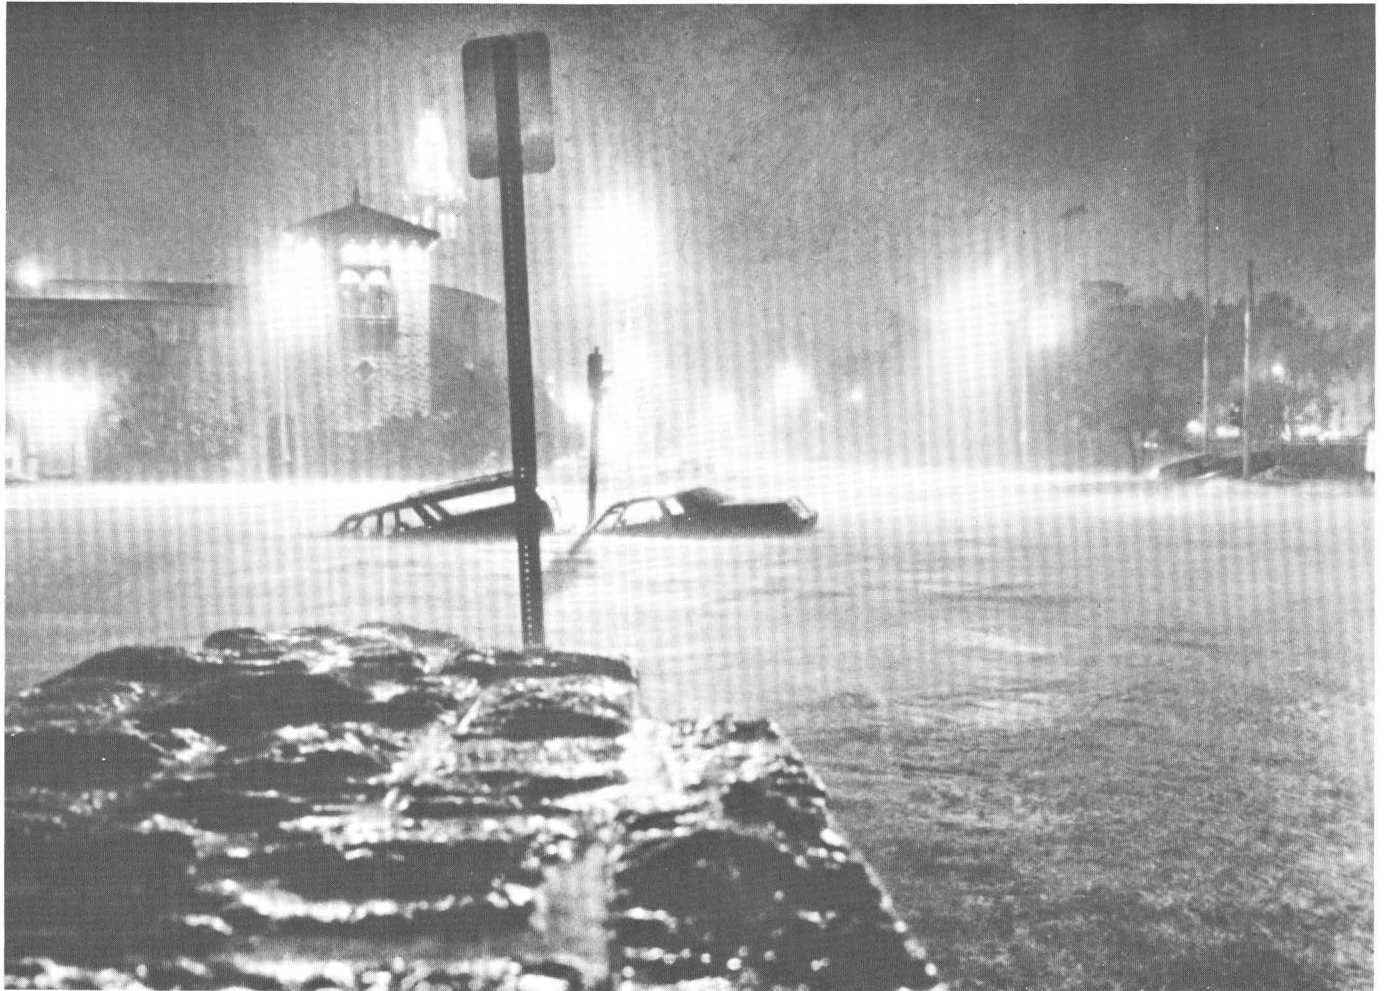
FIGURE 12.—Brush Creek, after flood crest, looking north on J. C. Nichols Parkway at Ward Parkway, at Country Club Plaza, Kansas City, Mo.

Mo., just upstream from the U.S. Geological Survey gaging station at Main Street, were flooded by as much as 6 ft of water, as evidenced in figures 12 to 16. Floodmarks can be seen in the window of the U.S. Post Office at Plaza Center (fig. 14).

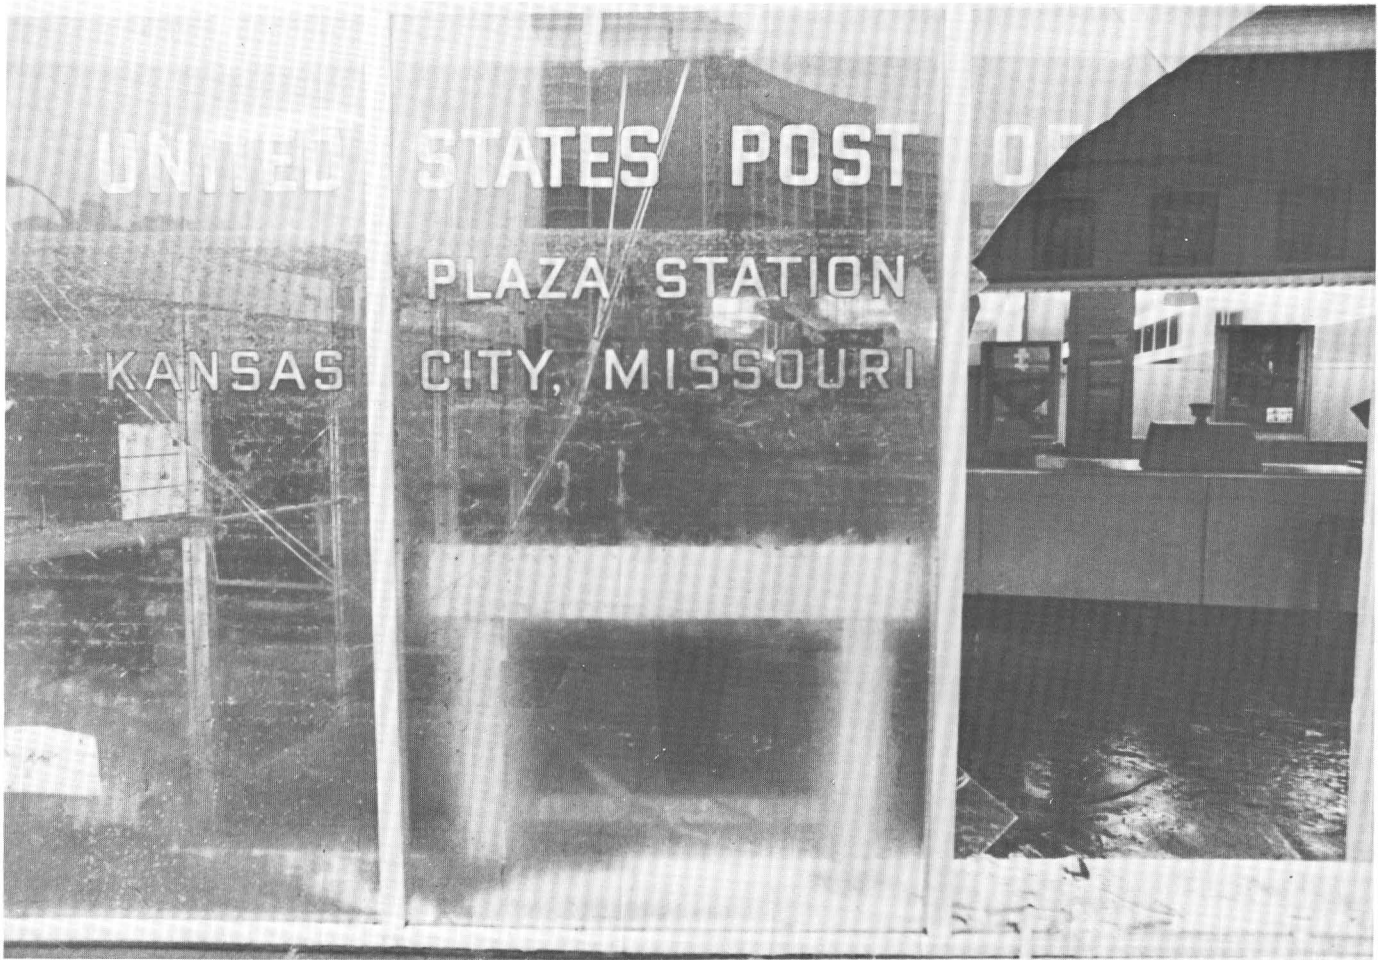
FIGURE 14.—United States Post Office, after Brush Creek flood crest, on Ward Parkway at Country Club Plaza, Kansas City, Mo.

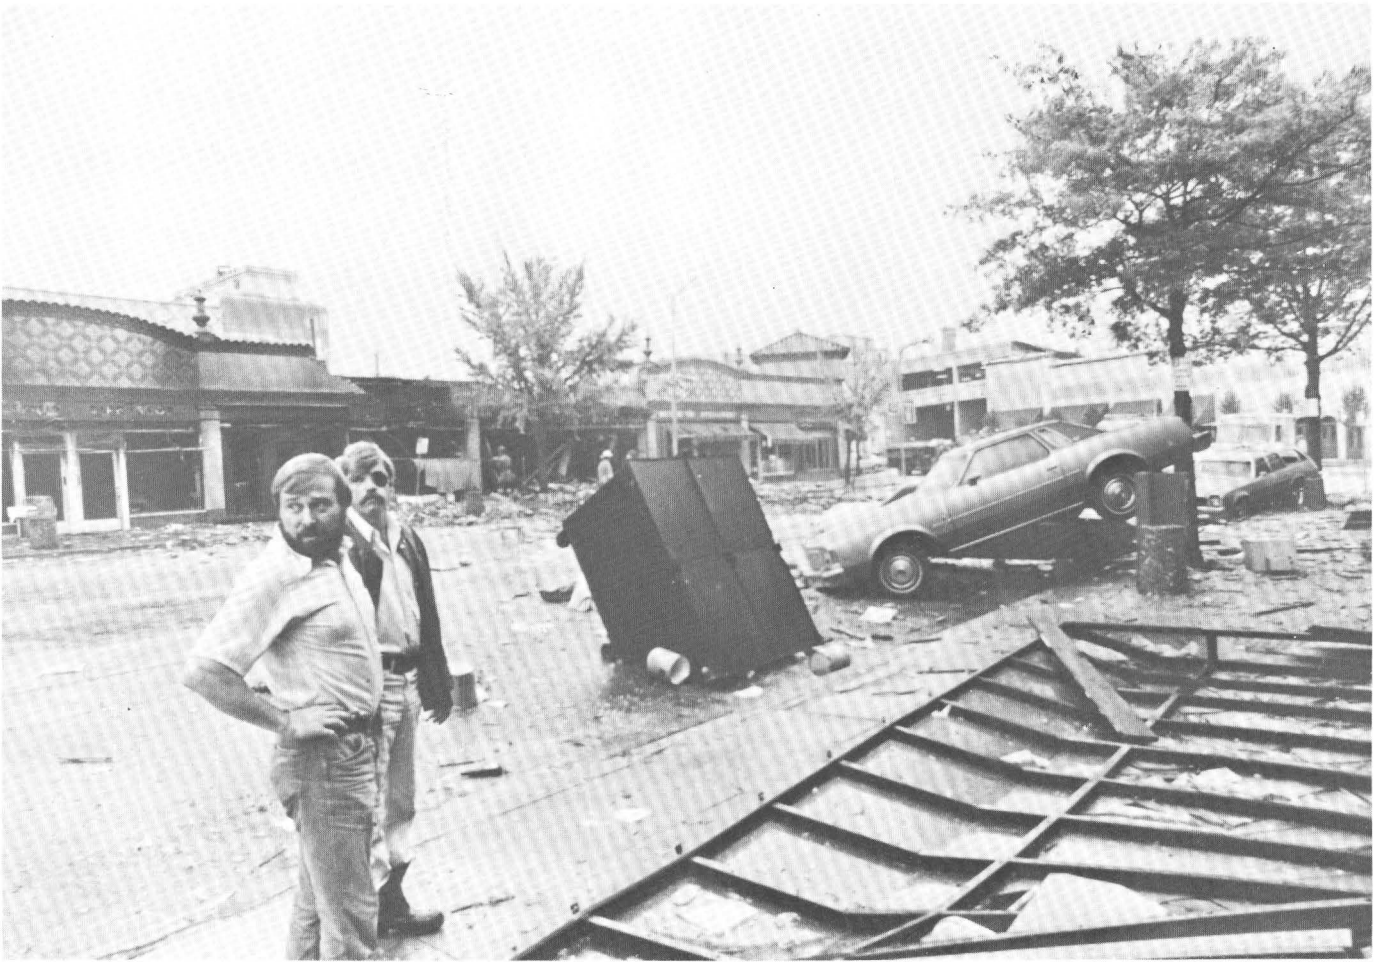
FIGURE 15.—View of 600 block of West 48th Street, after Brush Creek flood crest, at Country Club Plaza, Kansas City, Mo.

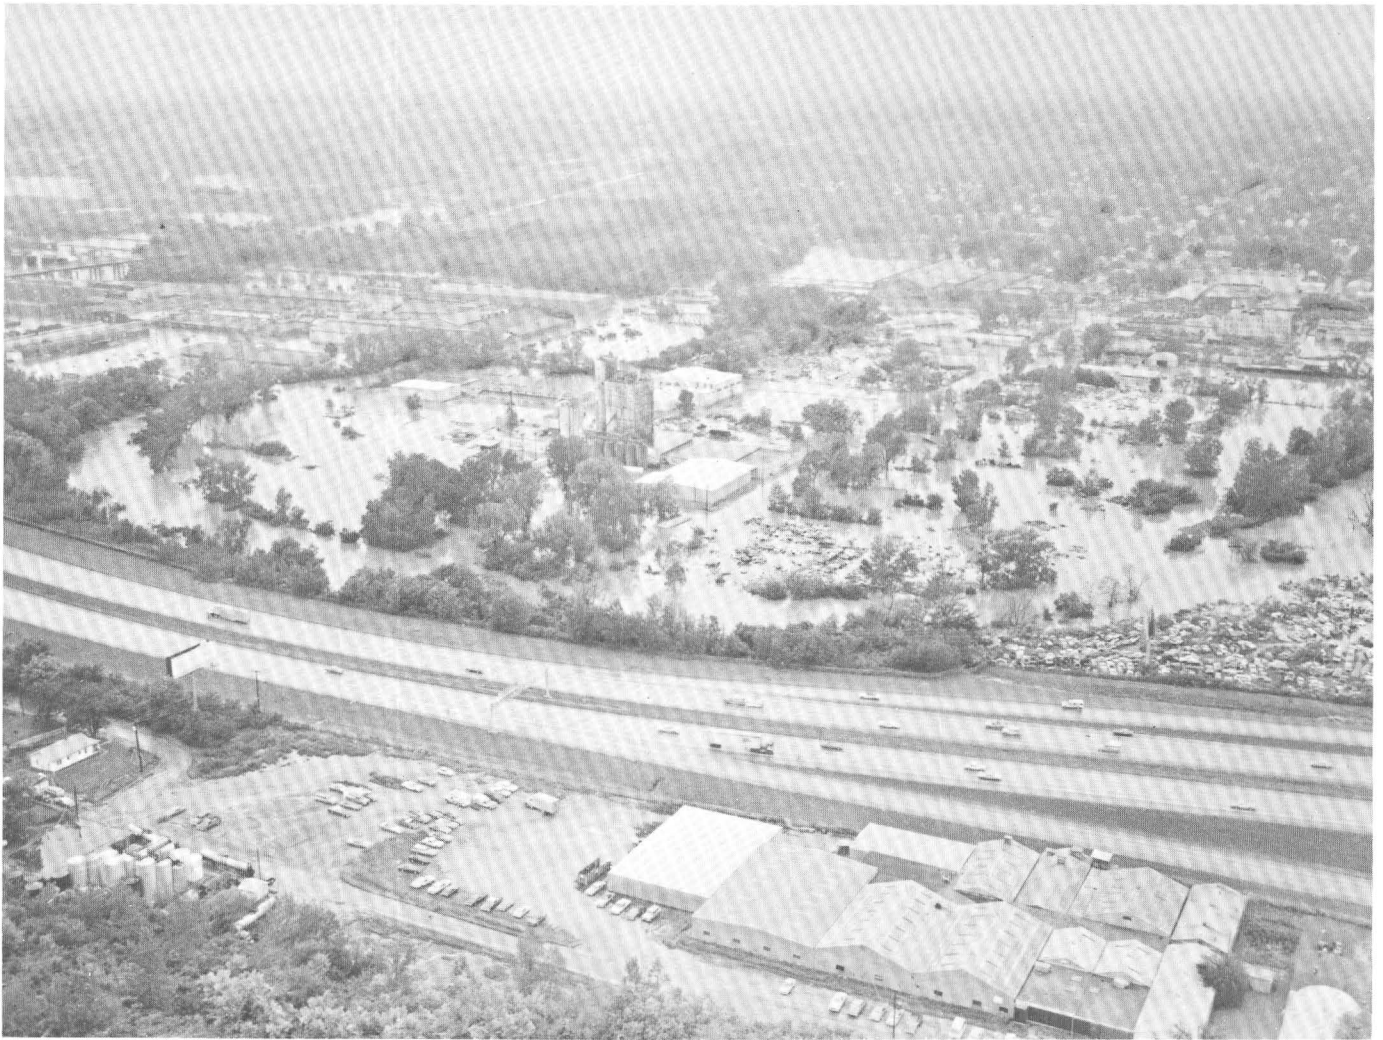
FIGURE 16.—Aerial view after flood crest, looking west along Blue River between 23rd Street and Truman Road, Kansas City, Mo.

The industrialized lower Blue River flood plain was damaged, also. Railroad tracks were undermined as much as 3 to 4 ft deep along bridge approaches. Figure 16 shows the general flooding in the industrial area in the Blue River basin between 23rd Street and Truman Road.

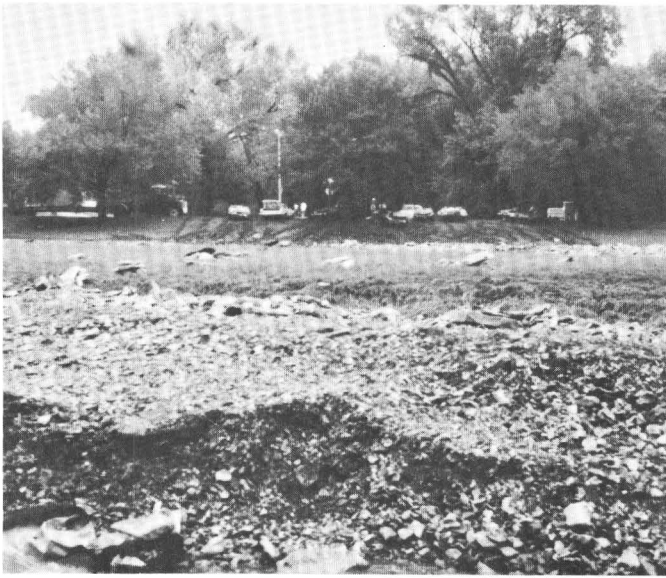
FIGURE 36.—Recently deposited gravel and scattered coarse material on left (north) Brush Creek flood plain approximately 1,000 ft downstream from Woodland Avenue bridge, Kansas City, Mo.

The apparent source for much of the fluvial material shown in figure 36 is the Kansas part of the basin in the Mission Hills area. However, some of the material came from retaining walls and other structures that were torn out during the flood. Figure 38
