From "opus craticium" to the "Chicago frame" Earthquake resistant traditional construction

Randolph Langenbach

Conservationtech Consulting, Oakland, California

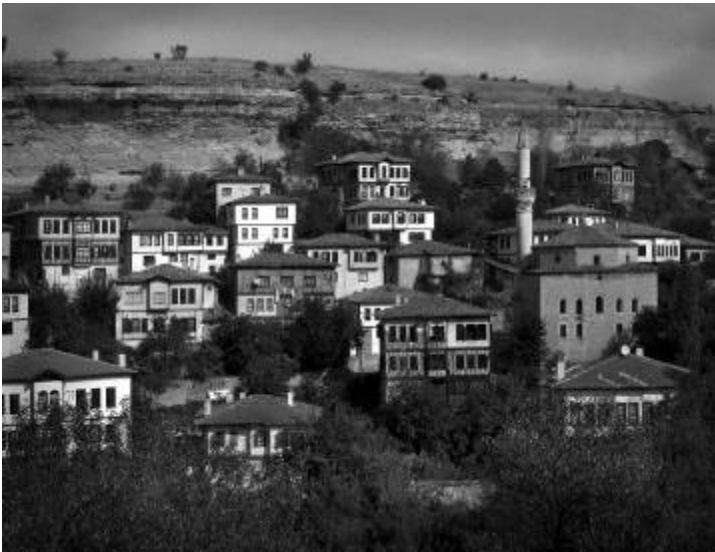
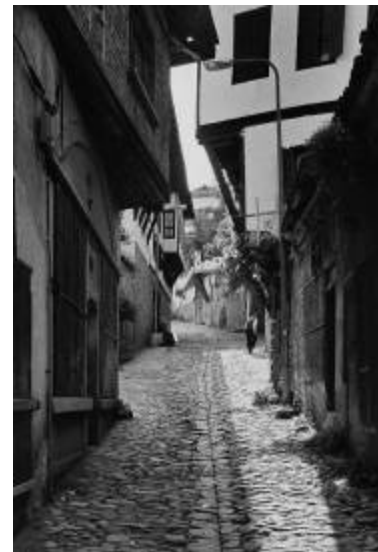
Figure 1: (a) Safranbolu, Turkey: traditional houses .

(b) Safranbolu, showing upper story jetties of himis construction.

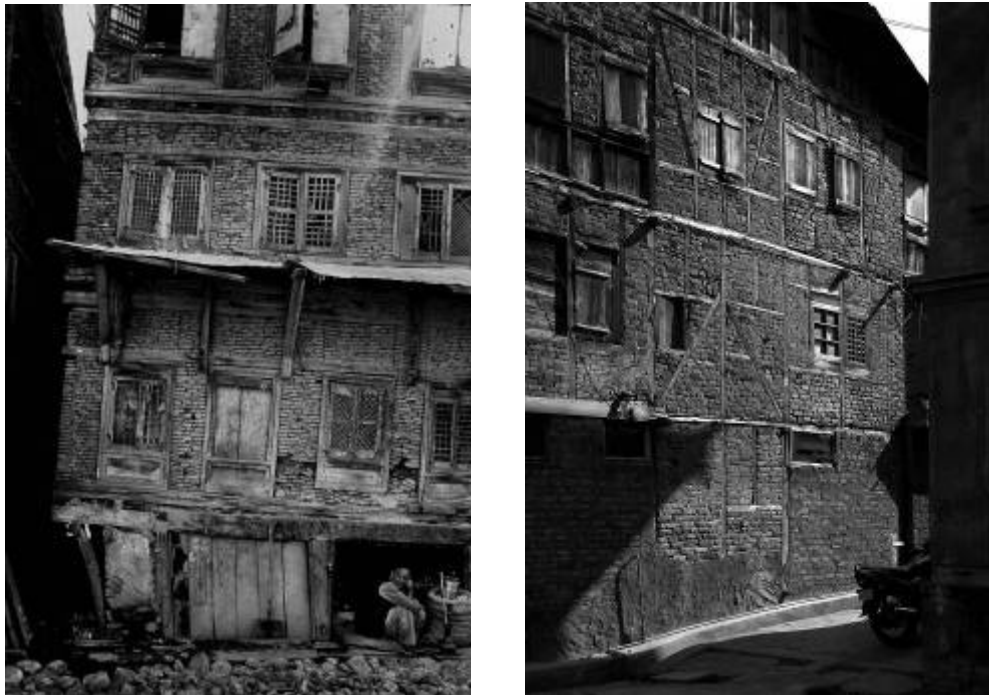
Figure 2: (a) Old canal side warehouse of *Taq* construction, Srinagar, Kashmir, 1981.

(b) *Dhajji Dewari* construction, Srinagar, 2005.

Arriving in the City of Srinagar in 1981 was like being catapulted back in time – not a century, but half a millennium. When seen in 1981, Srinagar had, for the most part, escaped the rampant modernization that had erased similarly unprotected historic city centers in other parts of the world. Most of the traditional buildings in Srinagar can be divided into two basic systems of construction. The first system, sometimes referred to as *taq*, consists of load-bearing masonry piers and infill walls, with wood "runners" at each floor level used to tie the walls together with the floors, all of which is locked together by the weight of the masonry overburden (Figure 2a). The second system, known as *dhajji-dewari*, consists of a braced timber frame with masonry infill. With its thin, one-wythe thick walls, it provides an efficient and economical use of materials, which helps to account for its use even for new construction until about two decades ago (Figure 2b). (Langenbach, 1989)

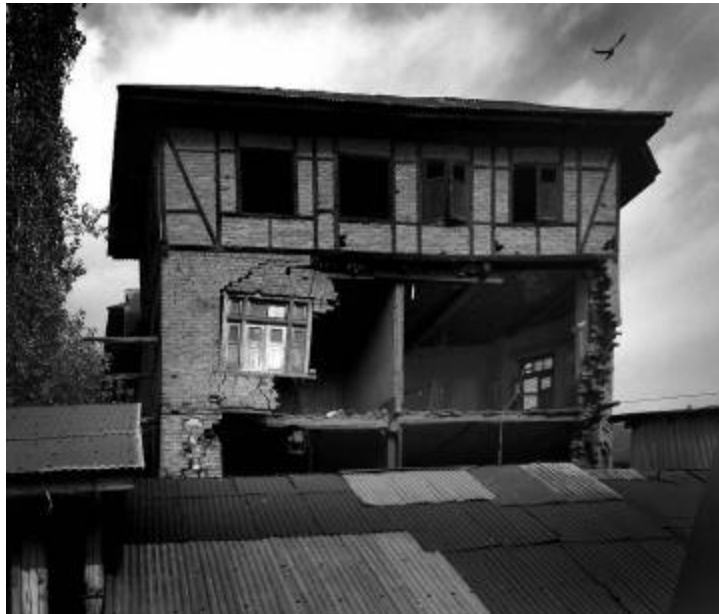
Figure 3: House in Baramula, Kashmir damaged in 2005 earthquake showing how unreinforced masonry collapsed, leaving the top story of *Dhajji Dewari* in place.

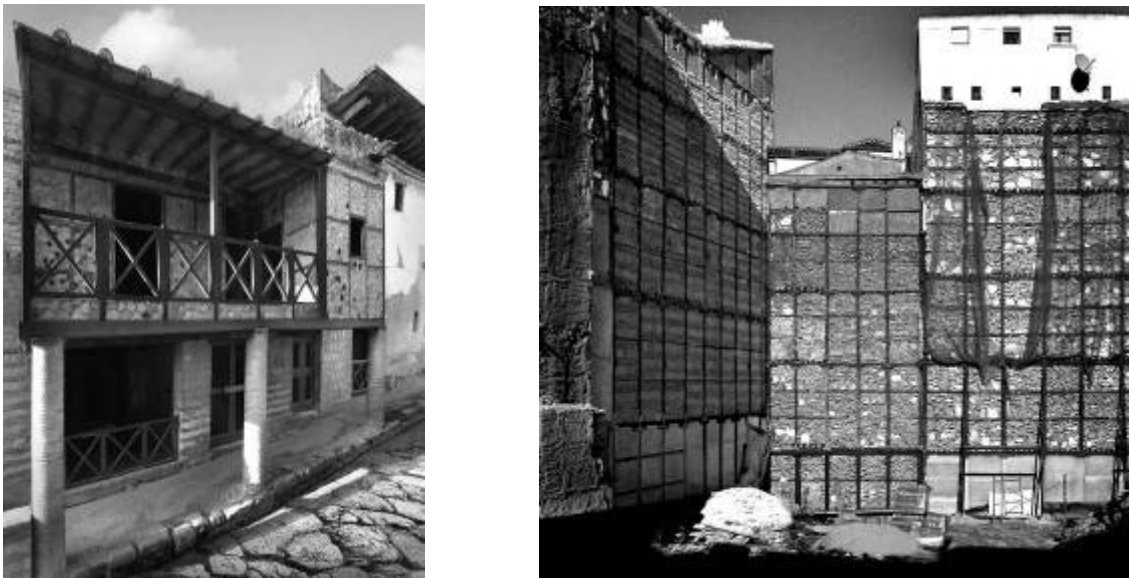
Figure 4: (a) House of the Opus Craticium, Herculaneum, Italy, 2002.

(b) rear of 18&19thC. timber infill buildings in central Madrid.

When archeologists dug up the port town of Herculaneum that had been buried in a hot pyroclastic flow from Mount Vesuvius in 79AD, they found an entire two story half-timber house which he identified as one of the masonry construction typologies described by Vitruvius as “*Craticii*” or “*Opus Craticium*” (Figure 4a). This example in Herculaneum may provide us with the only surviving example of the form of construction that had been used in ancient Rome for the seven or eight story tenements (*insulae*) that filled that city of a million and a half people. Masonry bearing walls would have been too thick at the base to fit on the known footprints of these ancient buildings with space for rooms left over, so it is likely that the Romans constructed many of these tall buildings with timber frames and infill masonry. (<http://mars.acnet.wnec.edu>).

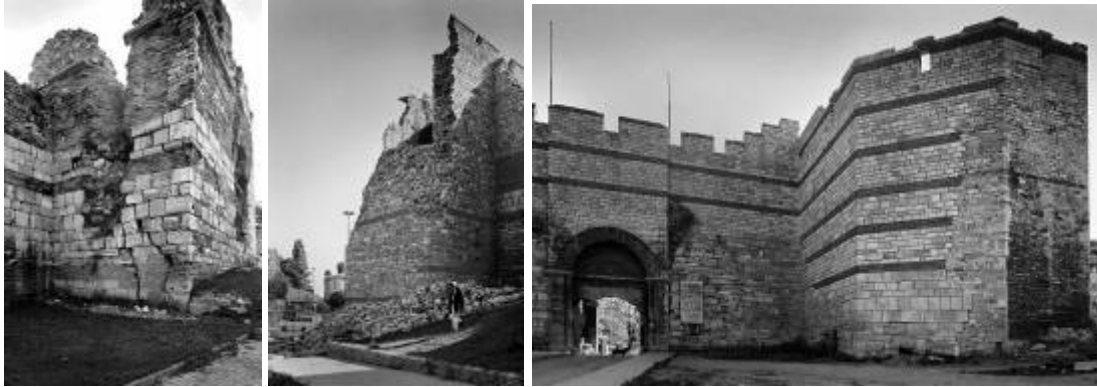
Figure 5: (a) Original section of Theodosian City Wall, Istanbul after 1999 earthquake.
(b) Modern reconstruction of a part of the City wall that collapsed during 1999 earthquake.
(c) Modern “restoration” work shows the artificial look that results when the work is conceived without its original structural rationale.

belts of red brick are an integral part of the architecture. Modern restorers, who reconstructed a portion of the walls, mistakenly treated this only as an architectural element by applying a brick band as thin layer on the surface, rather than as a structural layer extending through the masonry (Figure 5b & c). When the 1999 earthquake struck, this newly constructed section collapsed, while the surviving 1600-year-old heavily deteriorated portions of the wall were unaffected by the earthquake. (Figure 5a). This system evolved into the timber-laced systems described below.

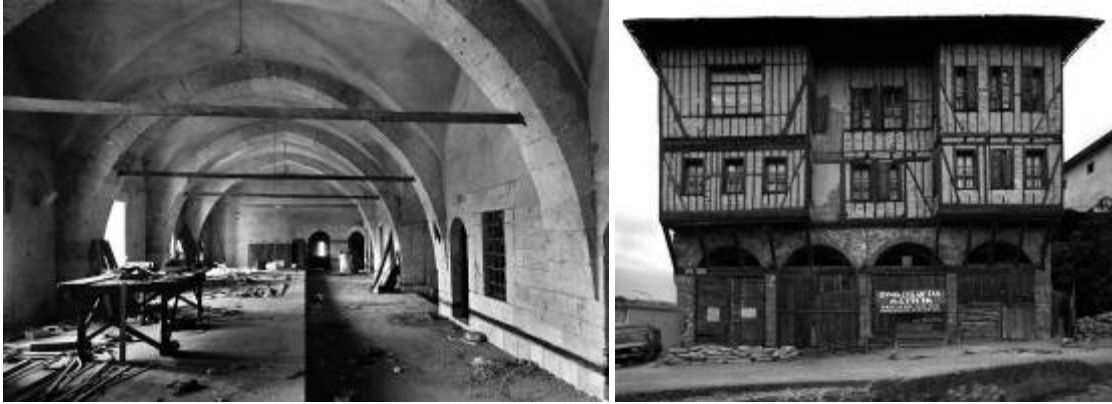
Figure 6: (a) Caravansary, Safranbolu, Turkey showing timber hatil in bearing wall masonry visible on right at base of wall, 2000.

(b) House over shops in Safranbolu showing *himis* construction of upper stories, 2004.

The Turkish Ottoman-style house, with its tiled roof and overhanging timber-and-brick bays above a heavy stone first floor wall, has become an icon known worldwide (Figure 6b). The jetties provided more than extra space and light; they strengthen the buildings because the joists that cantilever over the walls below hold those lower-story walls firmly in place with the help of the weight of the infill masonry overhanging upper story. This upper story is almost always of *himis* construction. This construction utilizes a weak mortar of mud or lime holding a single wythe of masonry into a timber framework of studs and horizontal dividers rarely more than 60cm apart. Because the masonry is only one wythe in thickness, the walls are light enough to be supported on the cantilevered timbers.

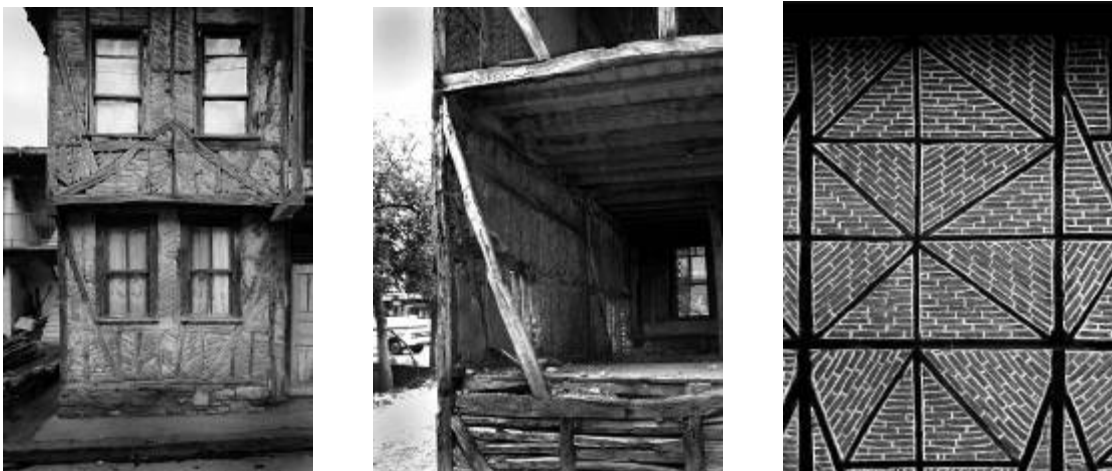
Figure 7: (a) *Himis* house in Gölcük damage district after the 1999 earthquake with no visible damage.

(b) An abandoned early 20th C. *himis* house, Gölcük. The house, even in its partially dismantled state, survived the earthquake with little additional damage.

(c) Detail of exterior wall of early 20th C. *himis* construction near Düzce.

In those regions most affected by the 1999 Kocaeli and Düzce earthquakes, most of the settlements were industrial towns developed mainly in the 20th century. The Kocaeli earthquake of August 17, 1999 killed approximately thirty thousand people. (Kandilli, 2000) The epicenter was just 200 kilometers east of Istanbul. In some areas of Gölcük and Adapazari, the earthquake destroyed more than a third of all housing units, almost all of them in reinforced concrete buildings. (Kandilli, 2000) While the laced bearing wall type was rare, there were clusters of *himis* buildings in the heart of these districts. The houses were constructed of *himis* from the ground up. These houses, mostly dating from the early part of the twentieth century, pre-dated the ruined reinforced-concrete apartment blocks nearby. Many of the older *himis* houses remained intact, with only a few heavily damaged (Figures 7a-c).

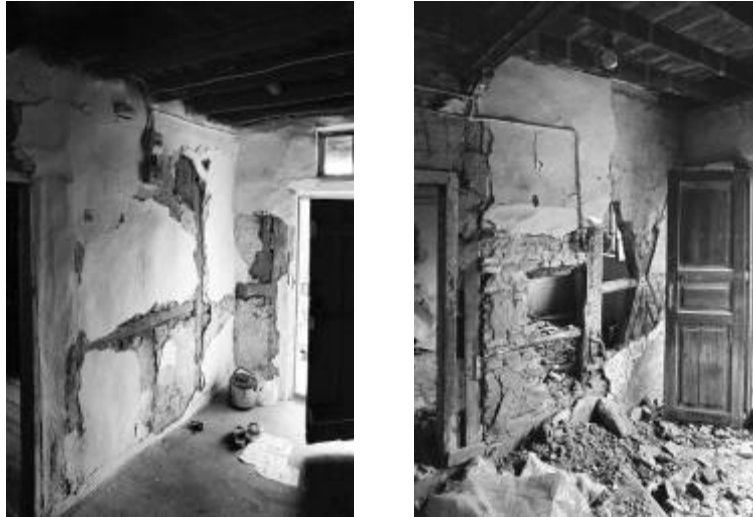
Figure 8: (a) Interior of *himis* house in Orta after 2000.
(b) Interior of *himis* house in heart of damage district in Adapazari after 1999.

the RC buildings affected by this earthquake with those in the 1999 earthquakes has revealed that the common RC buildings in Turkey have very little reserve capacity. They go very quickly from exhibiting little damage, as seen after the Orta earthquake, to collapse, as shown by the 1999 events. This observation contrasts with the performance of the traditional *himis* buildings shaken by the same earthquakes, where the small difference in the damage caused by the smaller and larger earthquakes demonstrates their ability to absorb the much increased shaking with little increase in damage (Figures 8a & b).

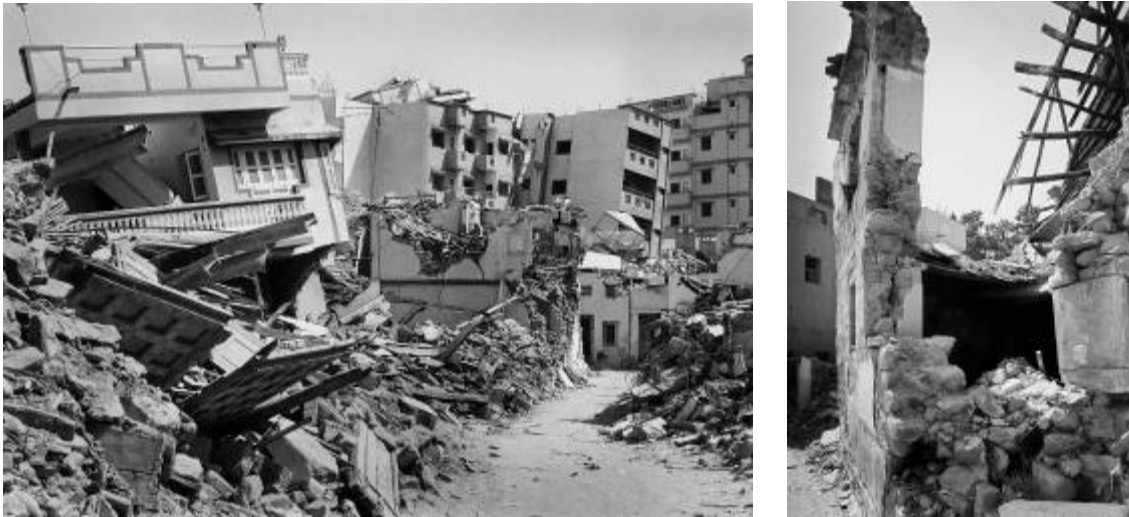
Figure 9: (a) Walled city area of Bhuj after 2001 earthquake.
 (b) Top-heavy thick masonry walls with shallow joist pockets collapsed easily.

There was no evidence of RC shearwall construction. The earthquake shook most of the rubble stone buildings to the ground (Figure 9a & b). Buildings with horizontally bedded ashlar performed better, but sections of their walls were often missing. Many of the RC structures appeared to have collapsed just as readily. Timber-reinforced construction, either the bearing wall type with horizontal timbers, or the infill-frame type, was extremely rare in Kutch. The one example found in this survey was part of the 19th C. Swaminarayan Temple in Bhuj, dating from the late 18th or early 19th Century. This structure was unscathed by the earthquake, while a modern reinforced concrete section of the complex collapsed (Figure 10a).

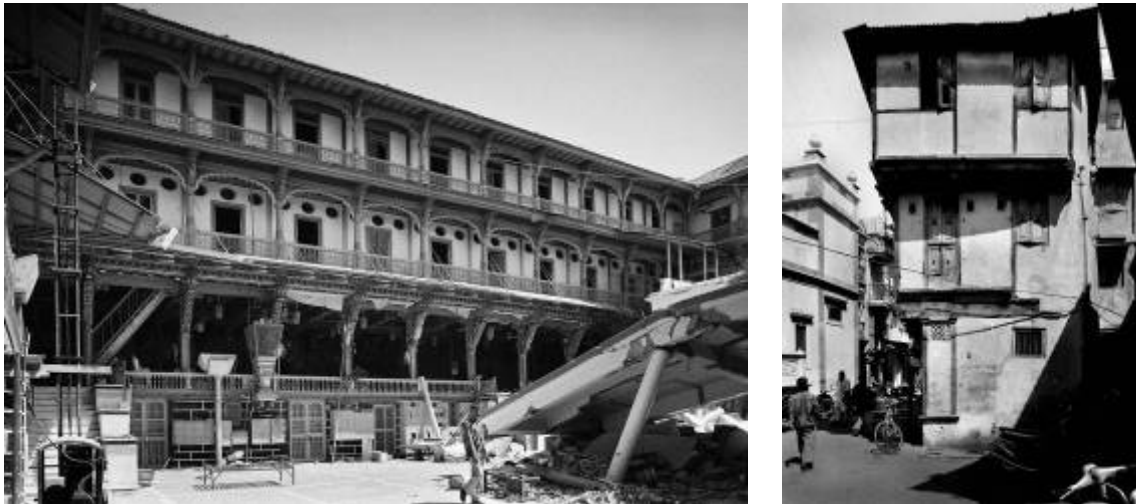
Figure 10: (a) Undamaged timber-laced masonry Swaminarayan Temple in Bhuj after earthquake.
 (b) Timber-laced masonry building in Ahmedabad historic walled city area after earthquake.

Ahmedabad was also affected by the earthquake, but the situation there was very different. Although a number of major reinforced concrete apartment complexes with soft stories and other poor details collapsed, the historic walled city section survived nearly intact. Of the tens of thousands of buildings in this area, only one that was unoccupied was reported to have collapsed. The difference between the masonry buildings in the historic walled city part of Ahmedabad, and the walled city area in Bhuj, is the presence of timber lacing (Figure 10b). The Ahmedabad buildings shared some of the building tradition found in Turkey and Kashmir, while Bhuj did not.

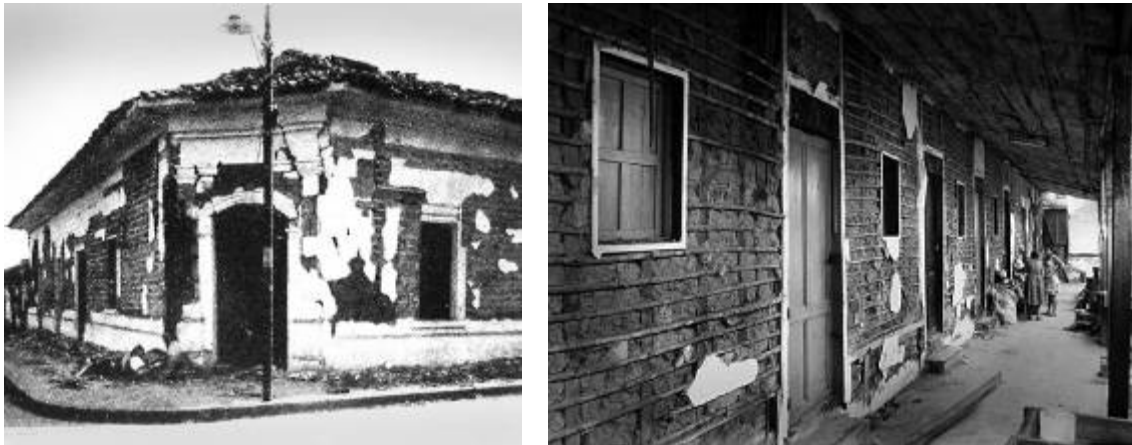
Figure 11: (a) J.R. Freeman's photo of *Taquezal* building in Managua after 1931 earthquake.
(b) San Salvador Bahareque building after 1986 earthquake showing a similar plaster shedding.

The October 10, 1986 earthquake in El Salvador provided the chance to study this discrepancy. Examination of the damage to bahareque buildings revealed that almost every case of structural failure originated where the wood armature was rotted or eaten by insects. Those structures with a greatest level of damage were invariably those which were the most rotten or consumed.

In 1931, Freeman observed that *"the only serious damage was the shaking off of...practically all of the plaster"* (Figure 11a). Likewise, in San Salvador in 1986 there were many *bahareque* buildings where the plaster had fallen off with no evidence of damage to the underlying walls (Figure 11b). The dislodging of the plaster from nearly the entire surface of the walls is evidence of the distribution of the earthquake stress throughout the wall, which is indicative of good behavior because the earthquake stress is dissipated throughout the wall with small movements between the masonry and wood of what is inherently a flexible structure. As a result, there is no single major destructive crack, and the energy of the earthquake is dissipated by the friction from the micro-cracking of the substrate which is confined between the studs.

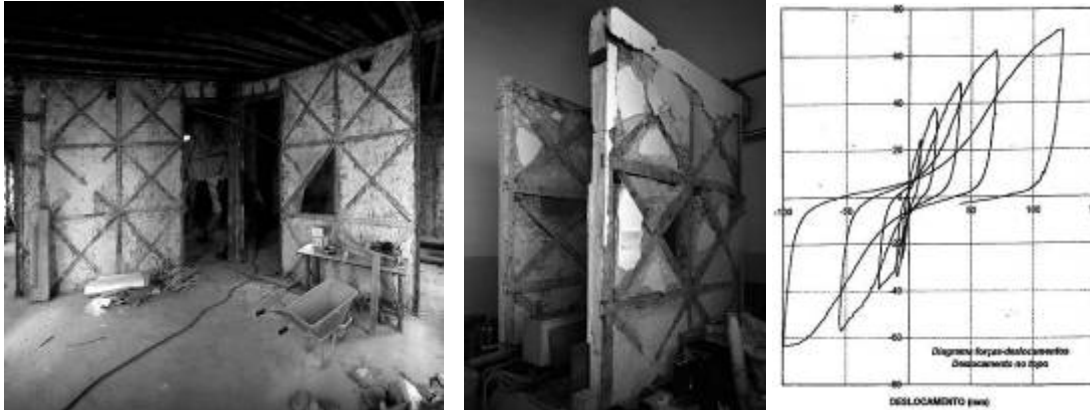
Figure 12: (a) 18th Century building in central Lisbon showing “Pombalino *gaiola*” construction, 2003.
 (b) *Gaiola* wall sections from a late 18th or early 19th C. building after having been tested.
 (c) Hysteresis diagram from one of the wall tests of the walls in figure 12b.

One of the largest earthquakes ever to hit Europe struck Lisbon in 1755, which also unleashed a destructive tsunami and fire. In planning for the rebuilding of the central area, Chief Minister Sebastiao Jose de Carvalho e Melo (who later became the Marquis of Pombal), gathered a group of military engineers led by Manuel da Maia to determine the best manner of earthquake-resistant construction to use for the rebuilding. For this, they developed the *gaiola* (“cage”), which has become known as Pombalino construction. The *gaiola* essentially is a well-braced form of half-timber construction. After testing a prototype, they made its incorporation into the reconstructed buildings a requirement (Penn, et al, 1995). Many of the new buildings with the *gaiola* were five and six stories in height, and most of these remain standing today (Figure 12).

The seismic capacity of the Pombalino walls was recently tested in the Portuguese Government’s lab, by subjecting actual wall sections removed from a building to cyclical tests. The wide hysteresis loops from these tests show that the walls were able to dissipate energy over many cycles without losing their structural integrity. The sample remained largely intact despite having been pushed cyclically beyond what would be expected from a large earthquake (Cóias e Silva, 2002 & Santos 1997). The loss of plaster shows, just as it did in Nicaragua and El Salvador, that the forces were distributed across the wall section (Figure 11a & b).

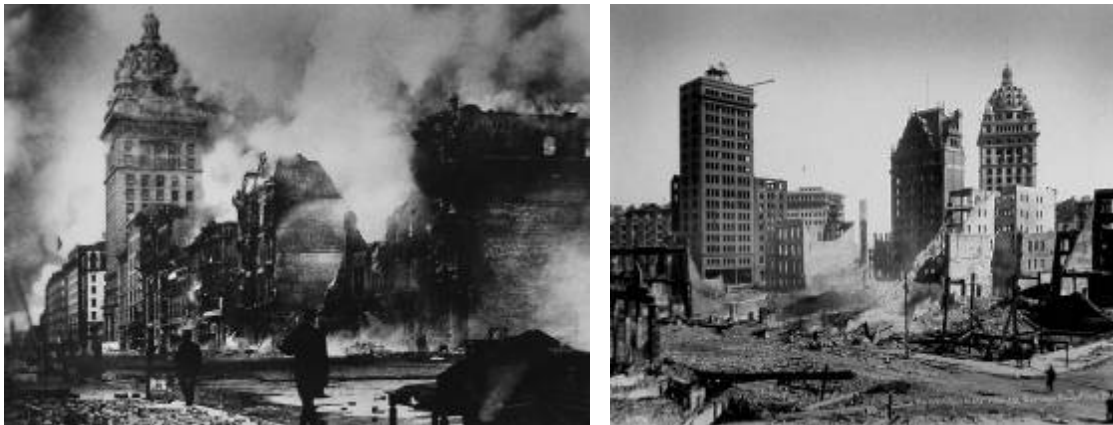
Figure 13: (a) Market Street, San Francisco during the post-earthquake fire of 1906, showing how even the new skyscraper of fireproof construction, the Hearst Building, caught fire from the wood windows and interior finishes (Bancroft Library). This building is still extant in 2006 in a remodeled state.

(b) 1906 view showing several of the steel skeleton “Chicago frame” buildings in burned-out condition. All of these are still extant in 2006 (Bancroft Library).

An engineer for The Roebling Construction Company of New York City that had patents on some of the pre-fire floor systems, reported in 1906: *“The successful manner in which the tall, steel skeleton frame buildings withstood the effects of the earthquake and the fire is most reassuring, in fact wonderful...These buildings had never before been subjected to violent earthquake shocks, and many architects and engineers doubted their ability to withstand such surface movements without injury.”* (Himmelwright 1906, p.7) Since even today a “design level” earthquake is expected to cause structural damage, it is remarkable that the San Francisco skeleton frame buildings had so little damage from an earthquake that met or exceeded what would now be considered a design-level event. The fact that such a large percentage of these buildings were restored after the earthquake and the fire is a testament to their lack of significant structural damage. Many of these structures have also survived redevelopment pressures to remain in existence now for more than a century after the earthquake (Figures 13 & 14).

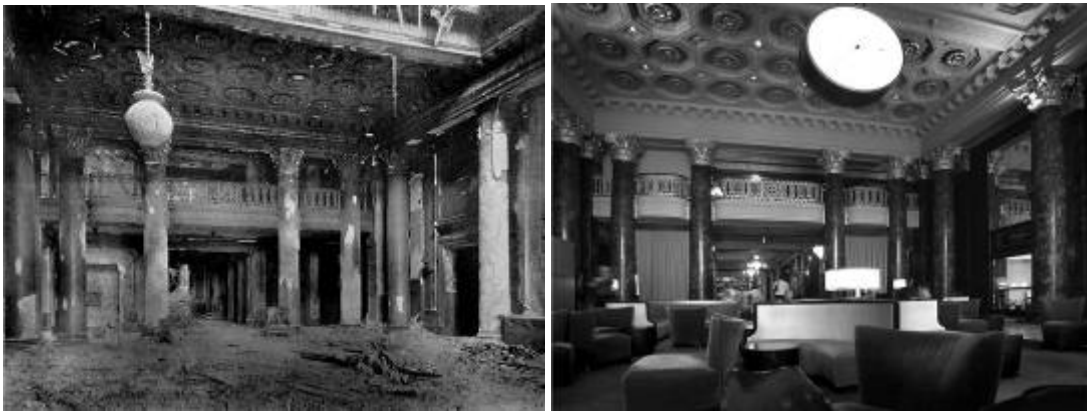
Figure 14: (a) Lobby of the St. Francis Hotel after the 1906 earthquake & fire (Roebling, 1906).
(b) Same view in 2005.

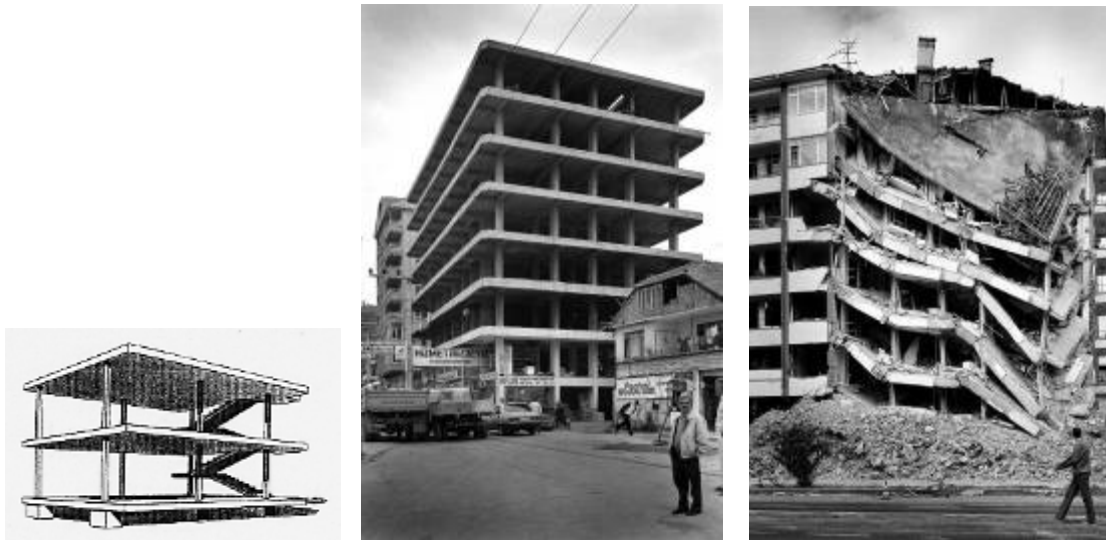
Figure 15: (a) Le Corbusier's conceptual Dom-Ino House, 1915
(b) Building under construction in Gölcük at time of 1999 earthquake
(c) Partially collapsed reinforced concrete infill-frame building in Gölcük, 1999.

NOTE: Unfinished bare frame reinforced concrete buildings were much more likely to survive the earthquake. The initial stiffness followed by the rapid degradation of the infill masonry walls, contributed to the collapse of many of the Gölcük concrete frame buildings.

The fundamental flaw with this approach is that this method of standard analysis is based on linear elastic behavior, which conflicts with the fact that buildings are expected to deflect into the nonlinear range in earthquakes. This has been recognized in codes through the use of ductility factors which are assigned based on the individual elements that make up a structural frame, but such factors are unresponsive to the conditions that exist when stiff and brittle membrane of “non-structural” infill masonry is added to the system, as this masonry is contained and restrained by the frame in a way that changes the behavior of the frame, sometimes with catastrophic results (Figure 15c).

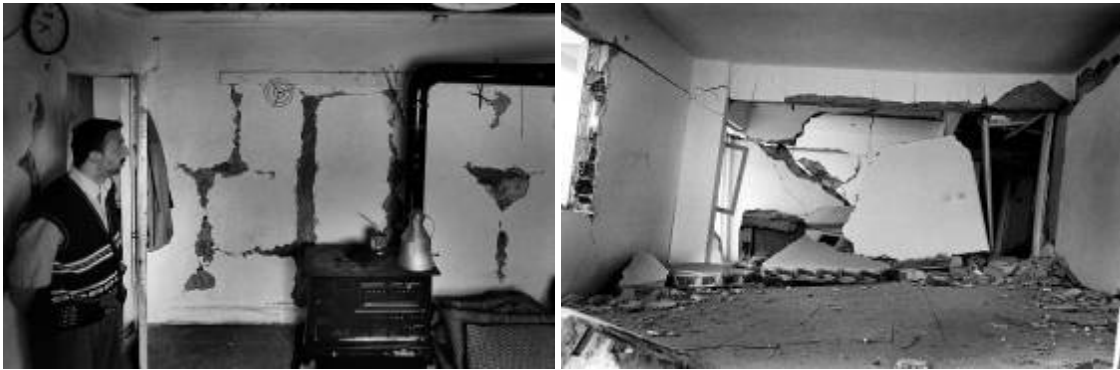
Figure 16: (a) Interior of house in Orta, 2000, showing the working of the *himis* wall construction. (b) Ruptured frame and collapsed masonry infill in Gölçük RC building after 1999 earthquake.

prevents the formation of large cracks that can extend across the entire surface. As stresses on the individual masonry panels increase, shifting and cracking begins first along the interface between the panels and the sub-frame members, and then in the panels themselves (Figure 16a). When the mortar is weaker than the masonry units, cracking occurs in the mortar joints, allowing the masonry units in the panel to remain intact and stable. The resulting mesh of hairline cracking allows the building to dissipate energy.

This energy dissipation from the “working” of the materials against each other also serves to damp out the excitation of the building by the earthquake. This working of the composite structure during an earthquake can continue for a long period before the degradation advances to a destructive level as demonstrated by the behavior of the *himis* buildings in the epicentral region of the 1999 earthquakes in Turkey when compared with the RC buildings that surrounded them. While these structures do not have much lateral *strength*, what they possess is lateral *capacity*.

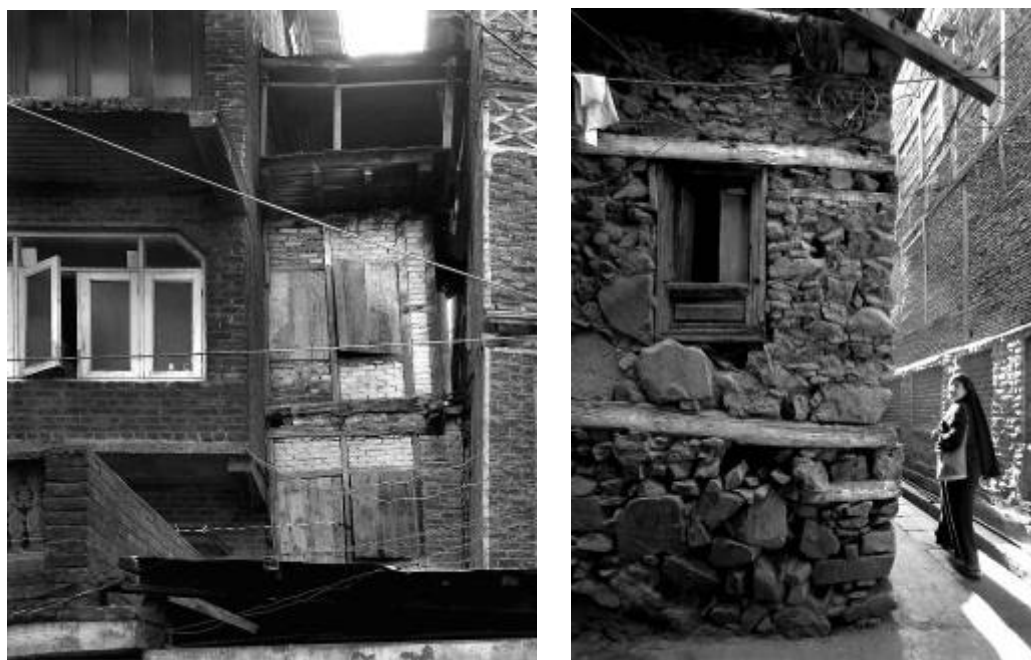
Figure 17: (a) Remnant of a traditional house in Srinagar, Kashmir in 2005.
(b) An historic house of *Taq* construction still extant in Srinagar in 2005.

NOTE: Rather than serving to as a condemnation, the good performance of traditional timber-laced construction in the damage district of the October, 2005 earthquake should serve as an inspiration for the preservation of these often unrecognized, but rich cultural artifacts.
