Reference
O100190-DP08-
164379-5

Frontal Impact test of a Flexxy hundbur small dog crate according to ECE Regulation No. 17

Frontal crash test of a dog crate has been performed according to the ECE Regulation No. 17 Rev.5, deceleration pulse.

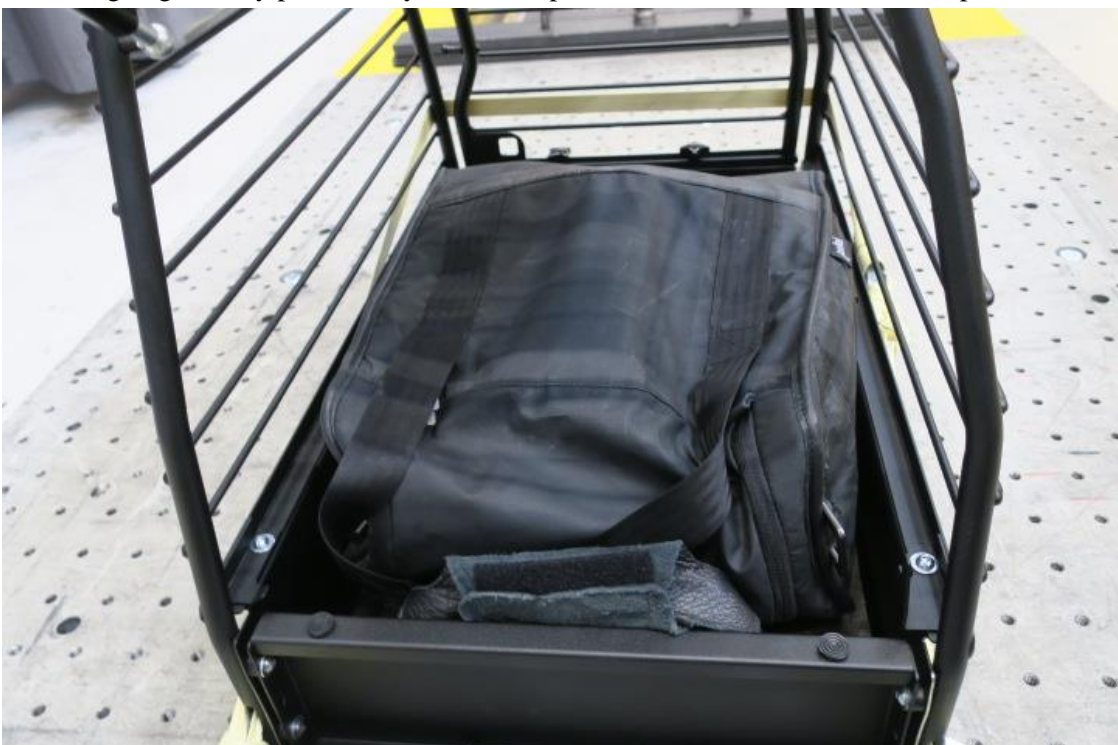
Photo 2 *Dog dummy*

The 15 kg dog dummy provided by RISE was placed 50 mm above the floor, see photo 2.

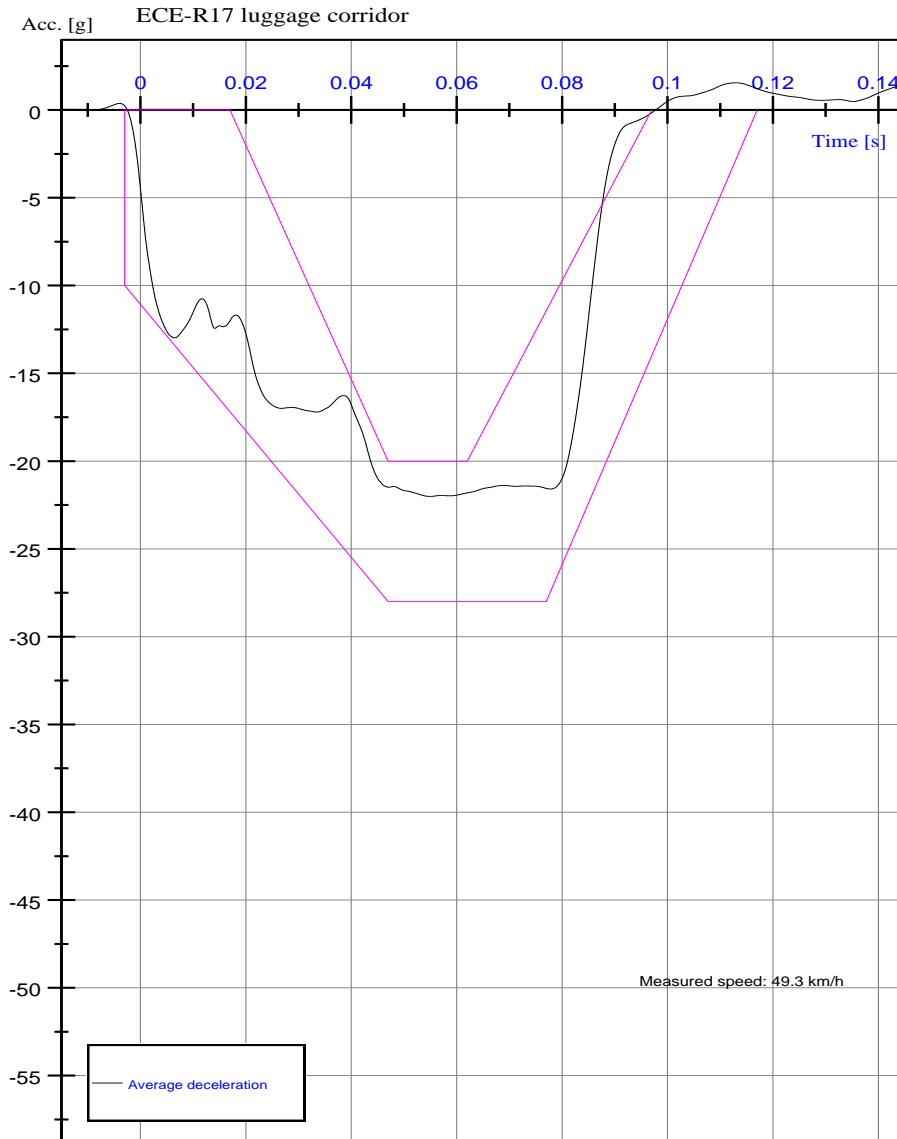
Appendix 1

Sled deceleration, Average pulse, CFC 60

Customer:	Bioberga AB
Test object:	Flexxy hundbur small, 15 kg
Standard:	ECE R17
Test date:	2021-08-12
Test:	5

The sled was accelerated to a speed of 49,3 km/h before impact.

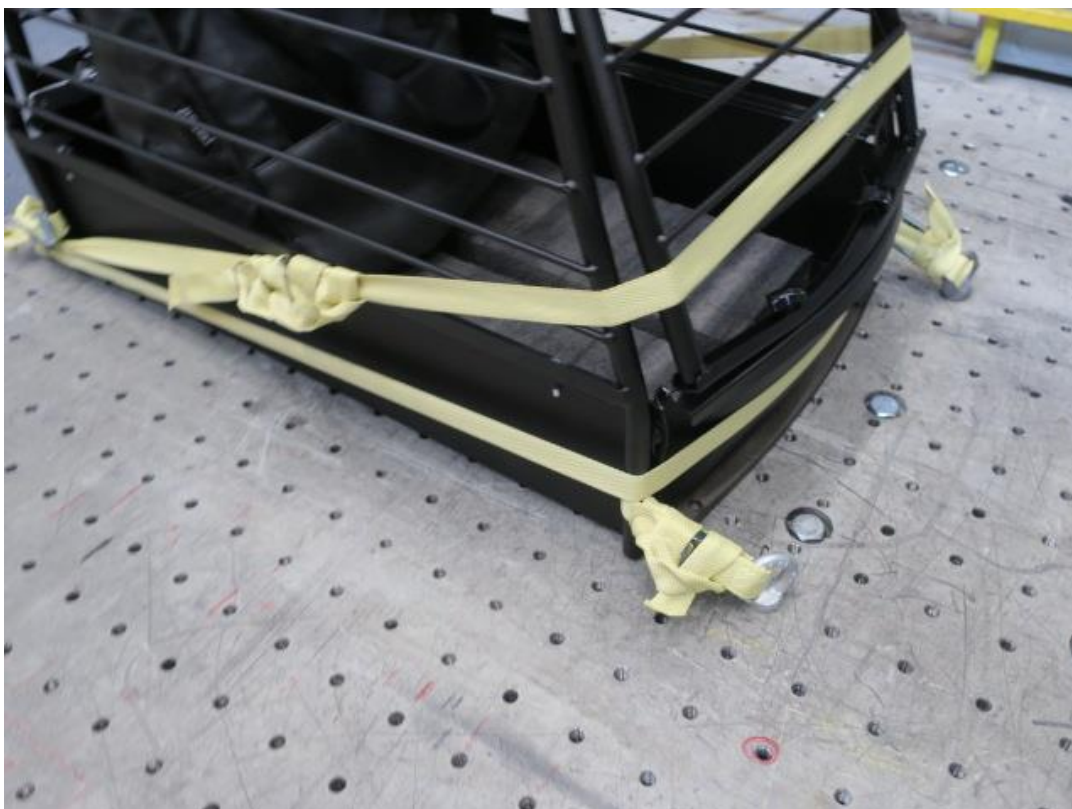
Photo 5. After test

Photo 6. After test

Photo 7. After test

Photo 8. After test

Some permanent deformations occurred in the rear part of the dog crate during the test, but did not increase the risk of injury in the event of a collision. The prescribed load was sustained inside the dog crate during the test and the front gate remained closed and was possible to open and evacuate after the test.

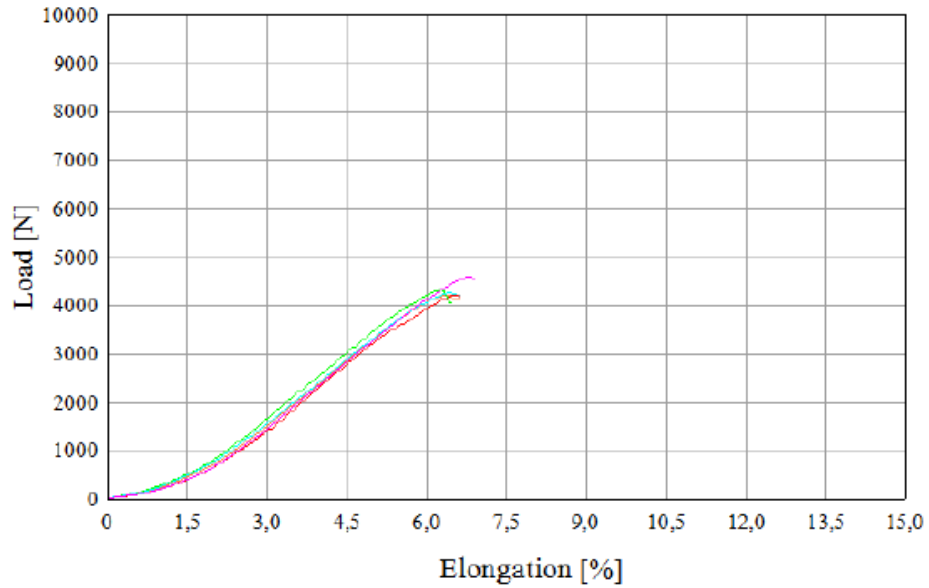
Report
Tensile Test - Maximum Load & Elongation

Product Code : JQ25-SURRNINGSSTYRKA	Load Range : 10000,00 N
Batch Reference : AK25BL	Elongation Range : 15,00 %
Date : 08.12.2020	Test Speed : 300,00 mm/min
Operator : HB	Initial Length L_0 : 300,00 mm
Temperature °C : 20	End at ? % from F_M : 25,00 %
	Preload : 30,00 N

No	F_M N	ϵ_B %	Remark
1	4212,80	6,68	
2	4319,80	6,52	
3	4264,80	6,68	Buckle
4	4213,10	6,69	
5	4596,00	6,96	
Mean	4321,30	6,70	
Std.Dev.	159,79	0,16
