COMPARISON OF 6.2L ARCTIC AND STANDARD FUEL INJECTION PUMPS USING JP-8 FUEL

INTERIM REPORT
BFLRF No. 218

Belvoir Fuels and Lubricants Research Facility (SwRI)
Southwest Research Institute
San Antonio, Texas

October 1986

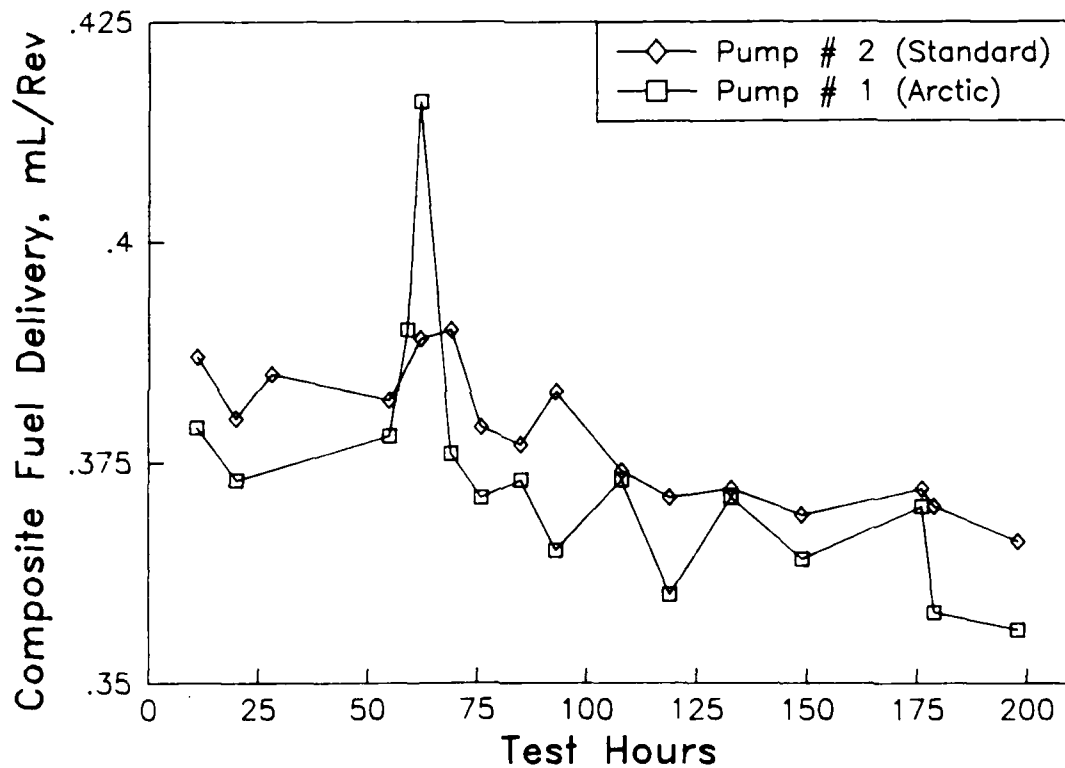
Figure 7. Composite fuel delivery on test rig with JP-8 fuel

Fig. 7 depicts the composite fuel delivery volume from pump Nos. 1 and 2 plotted against test hour. The one high point in the arctic curve may be operator error, or

it may be an actual temporary increase in fuel delivery. In any event, the trend for both the arctic and standard pump is a gradual decrease in maximum fuel delivery.

The decrease in delivered volume shown in Fig. 7 was reflected in engine fuel delivery as shown in Fig. 8. Note that the standard and arctic pumps experienced

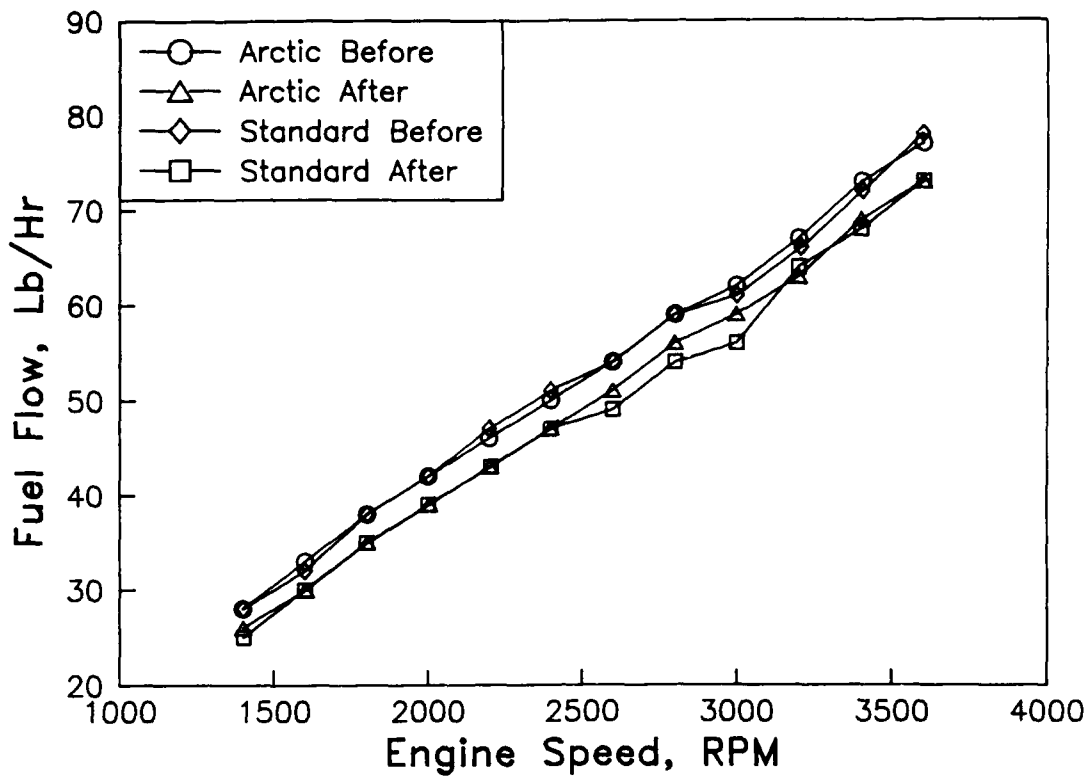
Figure 8. Full-load fuel flow

about the same amount of decreased fuel flow from before to after test. The fuel deliveries shown in Fig. 8 were taken from pre- and post-test full-load performance determinations.

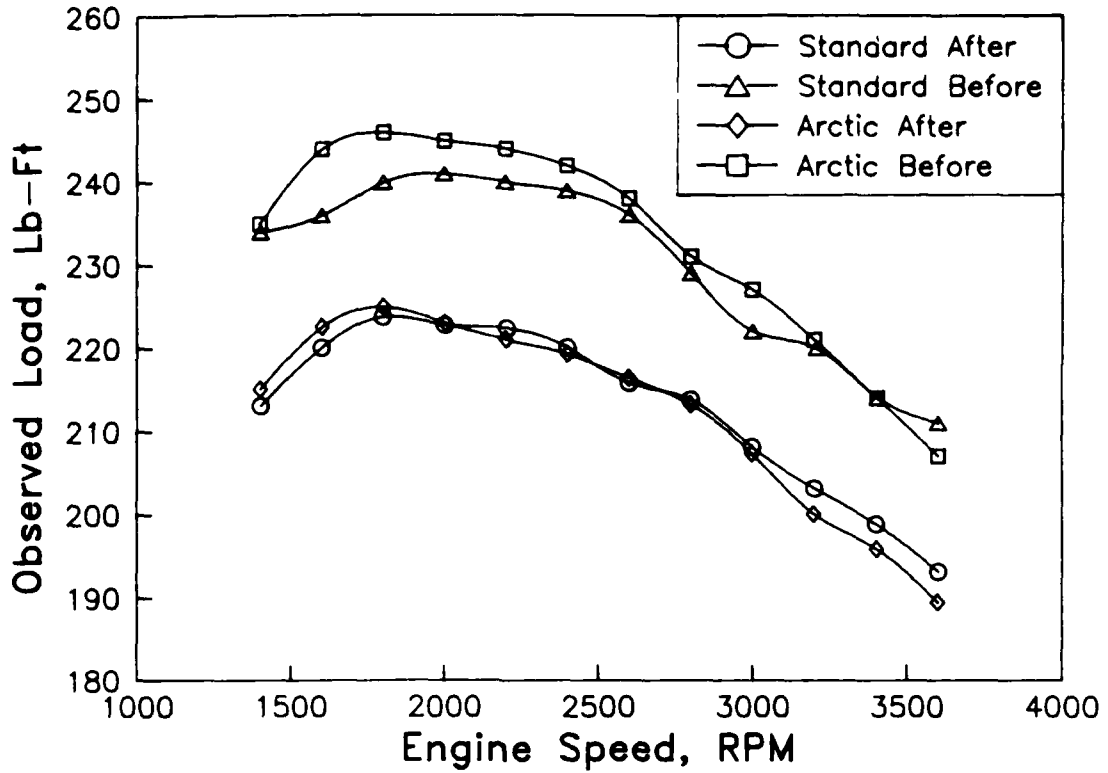
Figure 9. Full load performance with VV-F-800 DF-2 fuel

The decrease in fuel flow produced a decrease in maximum load that the engine would produce. Fig. 9 shows the observed load versus speed curves for the arctic and standard pumps (1 and 2) both before and after test. Note that the before-test arctic curve was taken after the re-calibration by the pump service representative and is different from that shown in Fig. 1. Both the arctic and standard pumps experienced about the same amount of deterioration in maximum torque.

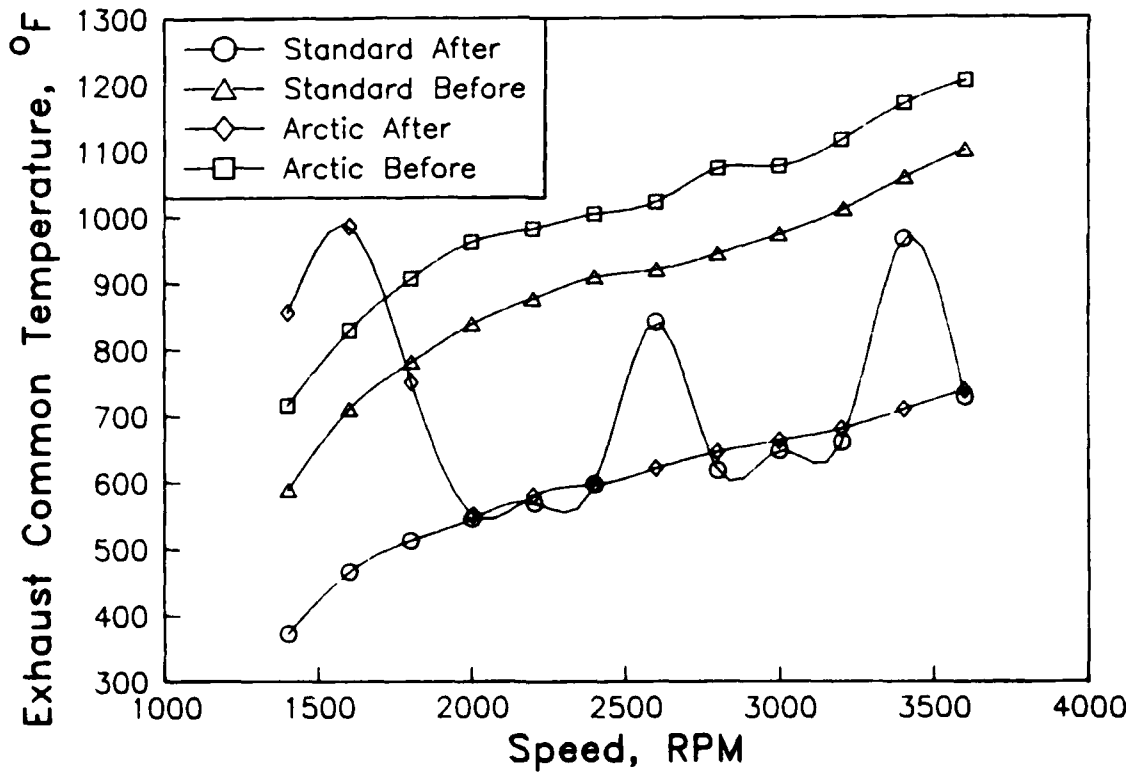
Figure 10. Exhaust temperature with VV-F-800 DF-2 fuel

Exhaust common temperatures for the arctic and standard pumps before and after test are shown in Fig. 10. Note that there are five apparent anomalies in the arctic after-test curve. The causes of these high readings are unknown. Again,

the exhaust temperatures were taken from full-load performance determinations both before and after test. Both the arctic and standard pumps experienced drops in exhaust temperature when compared to pre-test values.
