# Fun on the Hotline

by David Skora

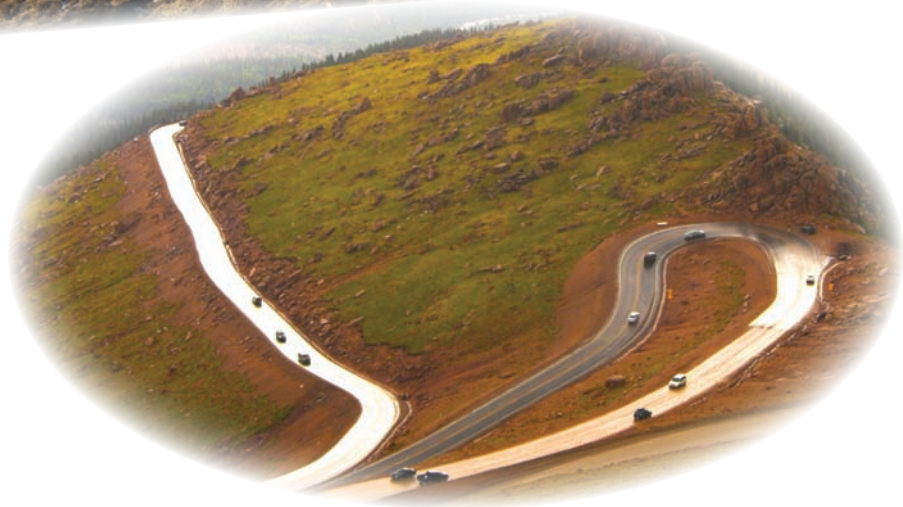
Figure 1: What’s up with these Volvos?

Take the guy who has the reputation in town of being able to fix anything. Then one day, a 2007 Volvo XC94 350hp, twin-turbo, sleeve valve engine with a 6-speed automatic shows up (figure 1). Yesterday the owner drove it up Pikes Peak and it was fine.

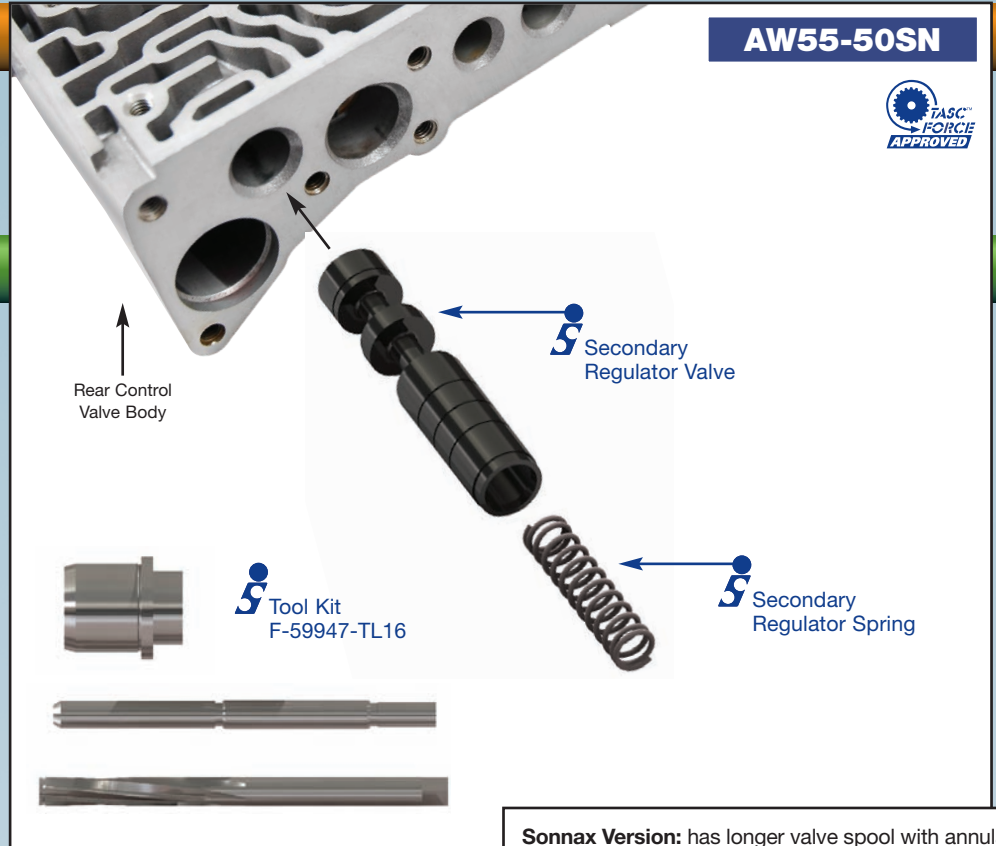
Bore wear at the spring end of the valve allows the SLT circuit and regulated converter pressure to cross leak. Bore wear at the balance end of the valve reduces converter and lube flow.

Install the new Sonnax Secondary Regulator Valve & Spring kit to restore hydraulic integrity to the circuit.

**Sonnax Version:** has longer valve spool with annular grooves which offers improved valve support and reduced wear.

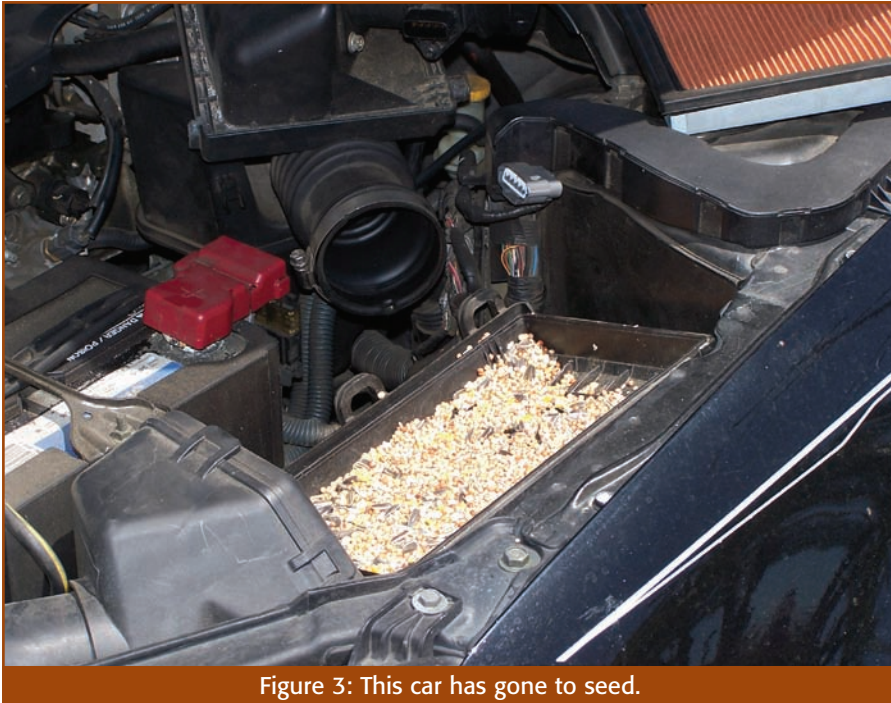
Figure 3: This car has gone to seed.

Still no luck. I found out that this engine uses a drive-by-wire throttle control. So I asked the tech to look at the throttle housing (figure 3). This time the tech reported success. When he opened the air cleaner to start removing the MAF and throttle intake ducts, he discovered that the air box under the filter was full of birdseed!

**When he opened the air cleaner to start removing the MAF and throttle intake ducts, he discovered that the air box under the filter was full of birdseed!**

He called the owner and asked him about it. The owner started laughing. A couple of days before, he'd helped his wife unload the groceries from the car. He'd set a large bag of birdseed on the ground next to the garage. He got distracted and forgot to put it in the cabinet. After he discovered the problem with the car, he noticed the bag had been torn into. He figured some squirrels had made off with the seed, but he never thought they'd hide it in an air filter box.

I asked the tech to email me a picture. (Figure 3)
