DOT/FAA/AM-02/19

General Aviation Pilot Performance Following Unannounced In-Flight Loss of Vacuum System and Associated Instruments in Simulated Instrument Meteorological Conditions

Final Report

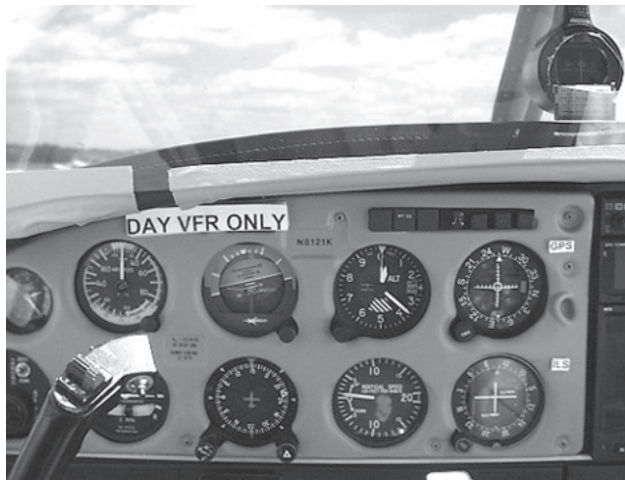
Figure 1. Archer instrument panel.

Aircraft. The two aircraft used were a simple (Piper Archer PA-28) (see Figure 1) and a complex (Beechcraft Bonanza A36; see Figure 2) airplane. Each was equipped with all Federal Aviation Regulation - FAR - required items for a single-pilot IFR flight. Polarized material was placed across the lower portion of the windscreen and left side window of each aircraft (see Figure 3) so that approximately the lower two-fifths of the windscreen was covered. The Francis hood used to simulate IMC (see inset, Figure 3) contained the same polarized material in the eye openings, oriented 90° to

Archer implementation of vacuum failure. Prior to each flight, an airframe and powerplant (A&P) mechanic disengaged the aircraft's engine-driven vacuum system. Therefore, the AI and DG were fully operational only via the standby vacuum system. During the flight, the evaluator disengaged the standby system via a switch in the cockpit, thereby failing the vacuum-driven instruments in a realistic manner.

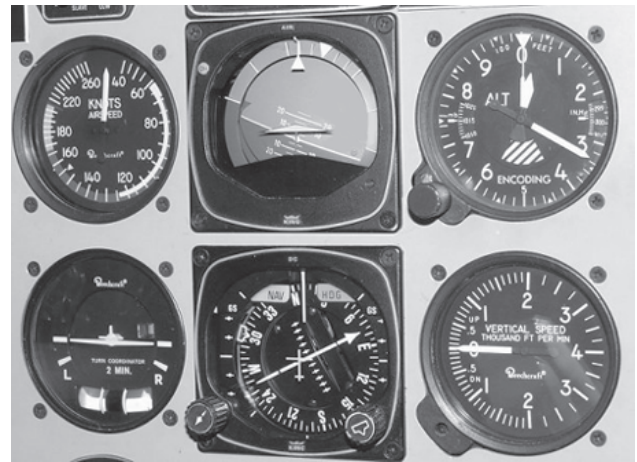
Figure 2. Bonanza instrument panel.

Bonanza implementation of vacuum failure. Prior to each flight, an A&P mechanic disabled the aircraft's engine-driven instrument air pressure pump. The AI was powered by the standby system. The HSI is electrically powered, so no maintenance was required before the flights for that instrument. During the flight, the evaluator disengaged the standby air pressure system and HSI via their individual circuit breakers in the cockpit. It is important to note that, because the AI was vacuum-driven and the HSI was electric, this was not a "real world" failure. It would be rare for both vacuum systems *and* one electric instrument to fail during flight.

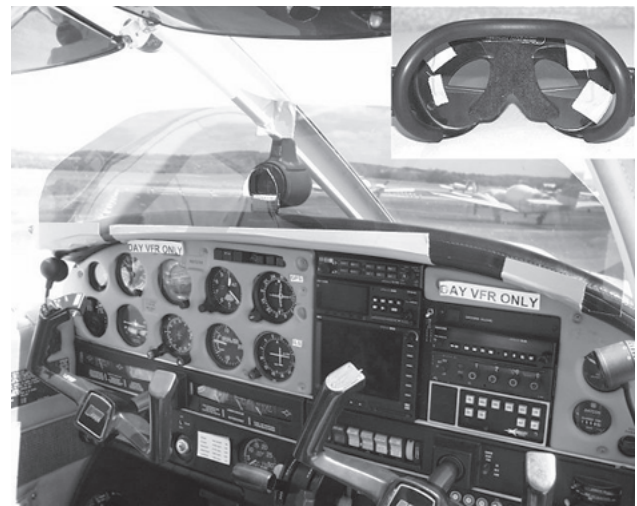
Figure 3. Polaroid material across windscreen of Piper Archer with (inset) Francis hood.

the windshield material. This arrangement allowed the pilots to see inside the cockpit, but eliminated the outside view immediately above the glare shield.

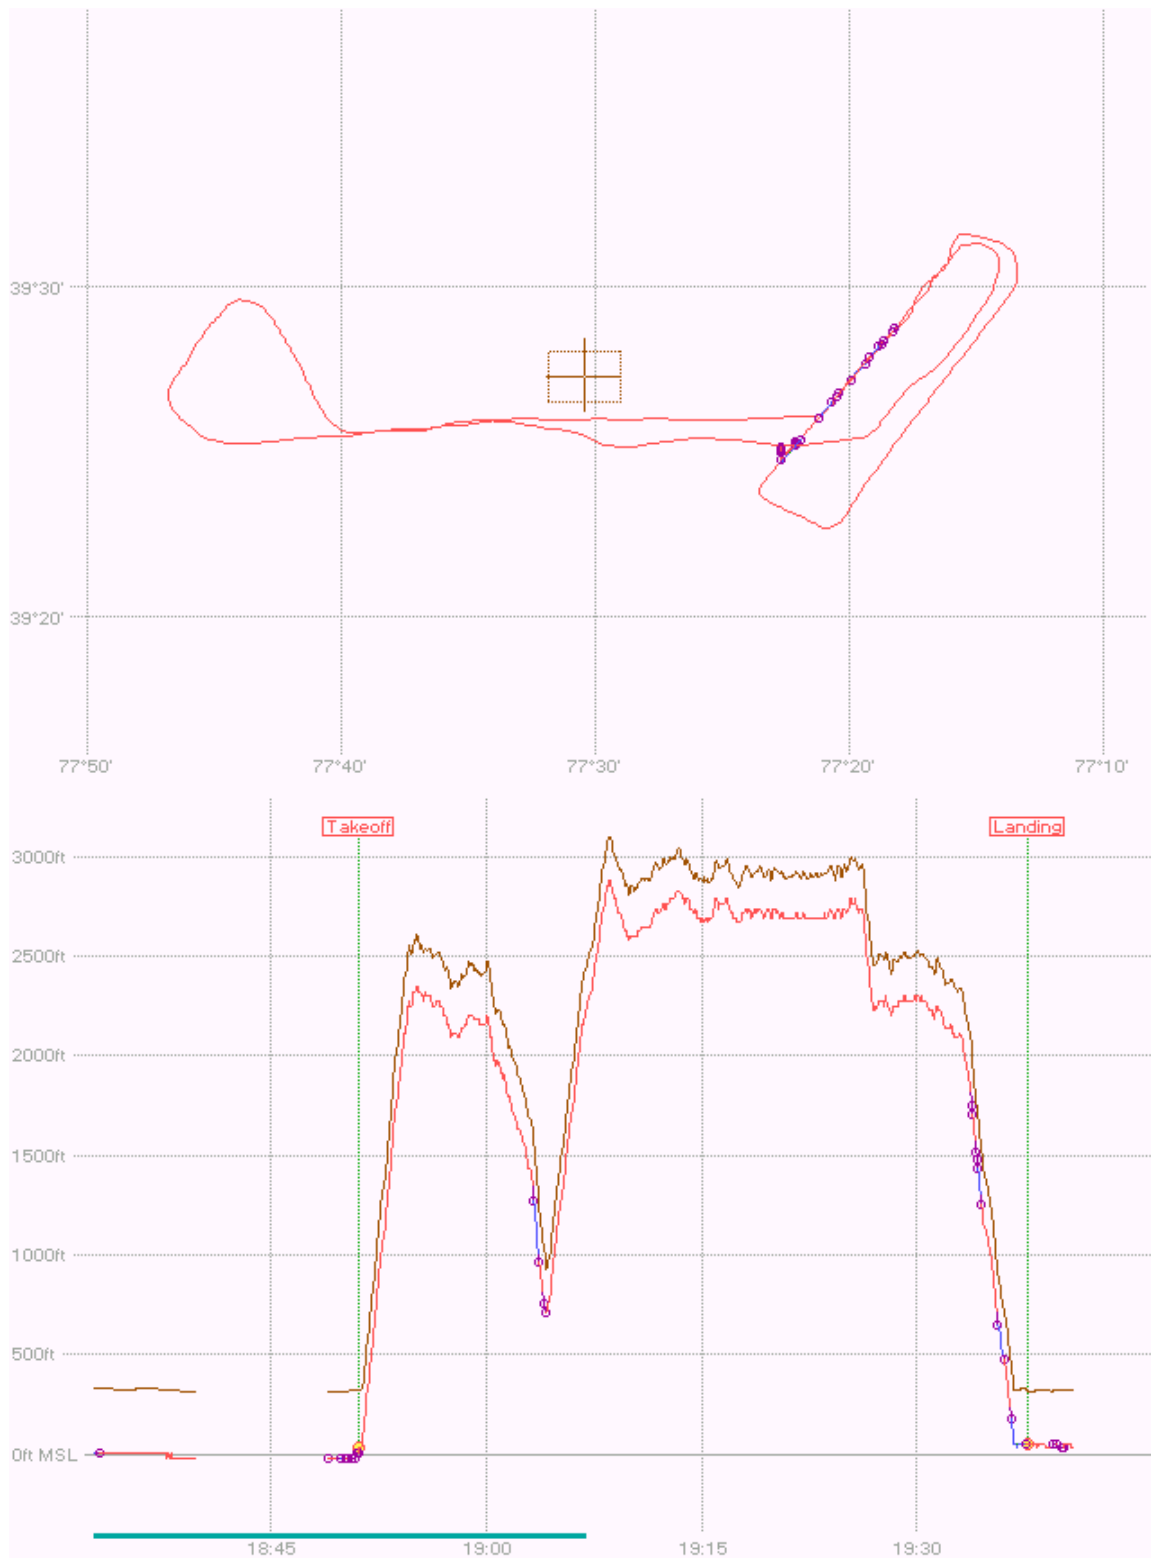
Figure 5. Example plan-view (top) and vertical profile (bottom) plots of a flight.

Archer. All of the PA-28 pilots were able to maintain control of the aircraft under partial-panel conditions. However, some became disoriented and were not able to successfully execute an approach and landing to the airport. Thirty-two percent of the pilots did not successfully complete the approach (i.e., 68 % were successful). An example of the horizontal and vertical-profile plots obtained from each flight is depicted in Figure 5.
