GREY EAGLE MINE SITE ASSESSMENT
HAPPY CAMP, CALIFORNIA

START#: 099605-006

TDD: T099603-0001

Prepared by:
Jay J. Guevarra
5/31/96

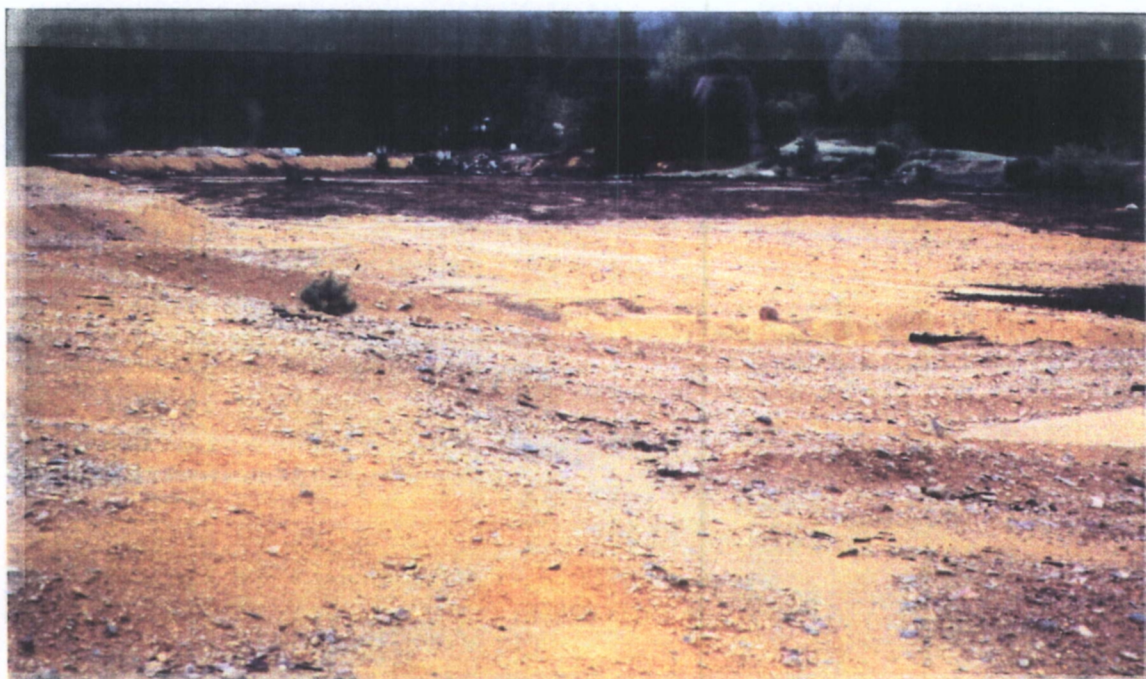
The START collected surface and subsurface samples throughout the mill/tailings pond area. Field analytical XRF data identified high concentrations of arsenic, iron, copper and zinc in the mill/tailings pond ("MP" samples) and on the edges of the mill/tailings pond ("LC" samples). Arsenic was present at the outer edges of the mill pond ("OE" samples). The grey colored soils contained high levels of copper and iron, while the yellow-orange and orange-brown colored soils were moderately contaminated with arsenic.

Photo 1: Mill Pond ("MP" sampling area)

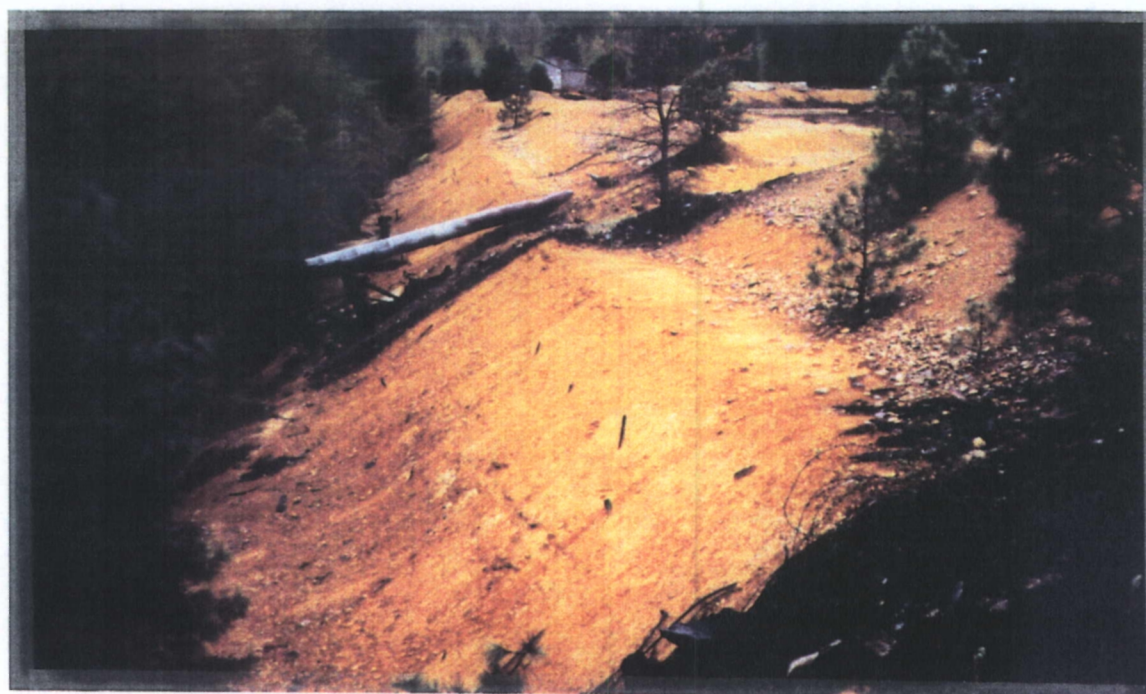
Photo 2: Edge of the Mill Pond ("LC" sampling area)

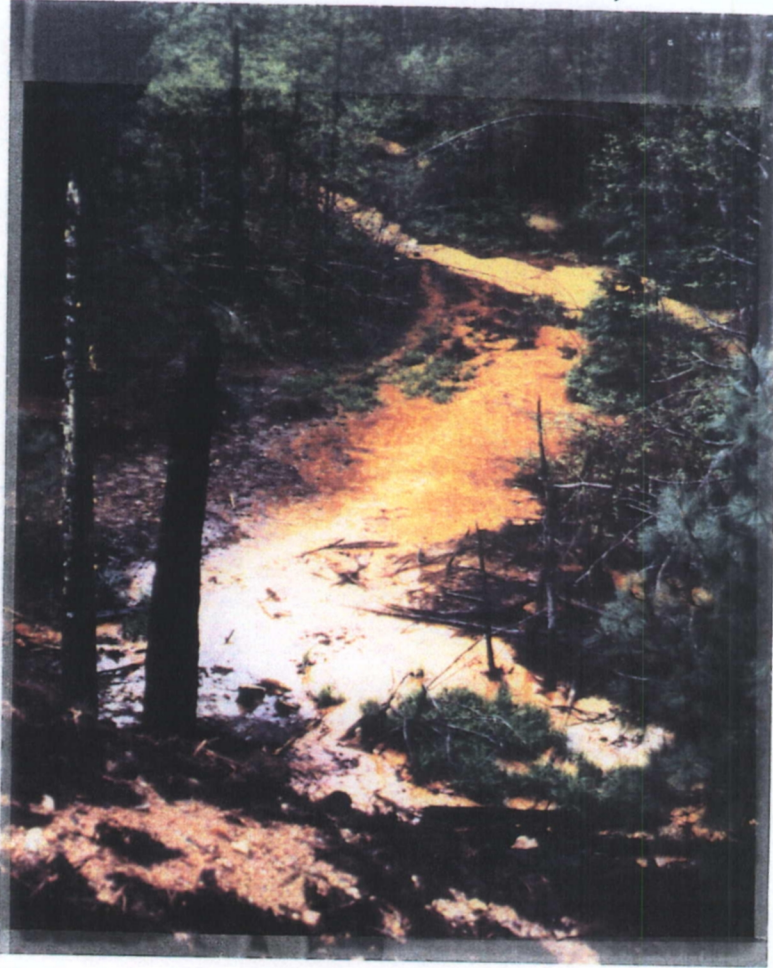
Leachate stream sediment samples ("LS" samples), had iron concentrations 2 to 5 times greater than sediment samples found in Indian Creek and samples collected in the mill/tailings pond. Leachate stream arsenic concentration was found to be below 100 mg/kg with all other analytes at or below the XRF detection limits. Keep in mind that high levels of iron may interfere with arsenic's spectrum. However, the two artesian spring samples (SP-1 and SP-2) had arsenic concentrations around 450 mg/kg which may suggest that arsenic is being released into the leachate stream. An aqueous sample collected from the leachate stream (sample IC-3) had a low pH, high sulphate content and high turbidity. Sample IC-3 had iron, nickel and zinc at greater concentrations than the maximum contaminant levels for "Primary Standards" or "Secondary Standards" in drinking water stated in Title 22 Article 4 section 64431 (a) and 64449 (a). The 96-hour bioassay study determined that the leachate stream is not capable of sustaining trout fingerlings and possibly most aquatic wildlife. A lethal concentration study was not performed.

Photo 3: Leachate Stream
("LS" sampling area)

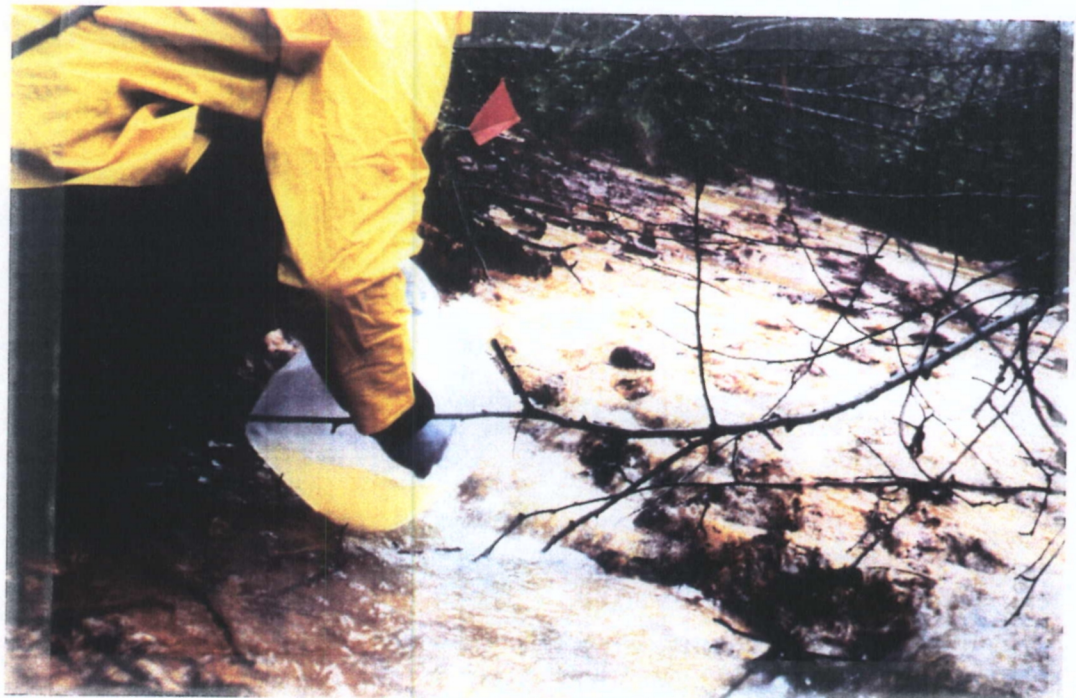
Photo 4: Sampling of
the Leachate
Stream

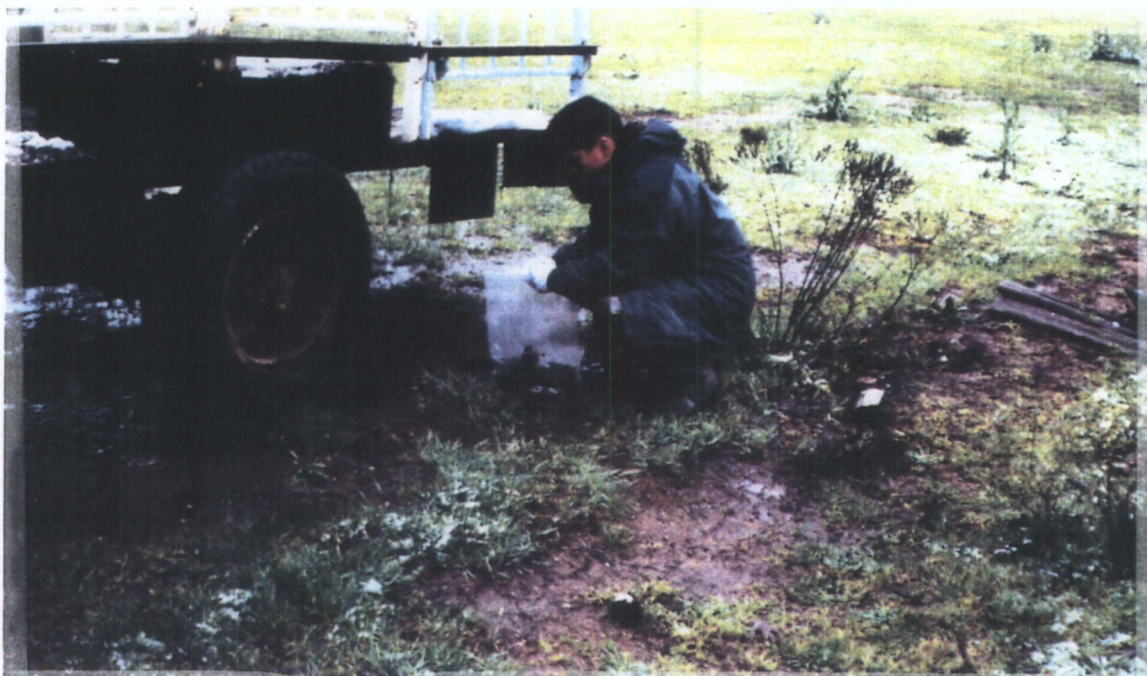
Photo 5: Collecting Soil Samples from Skip Davis's Property ("SD" sampling area)

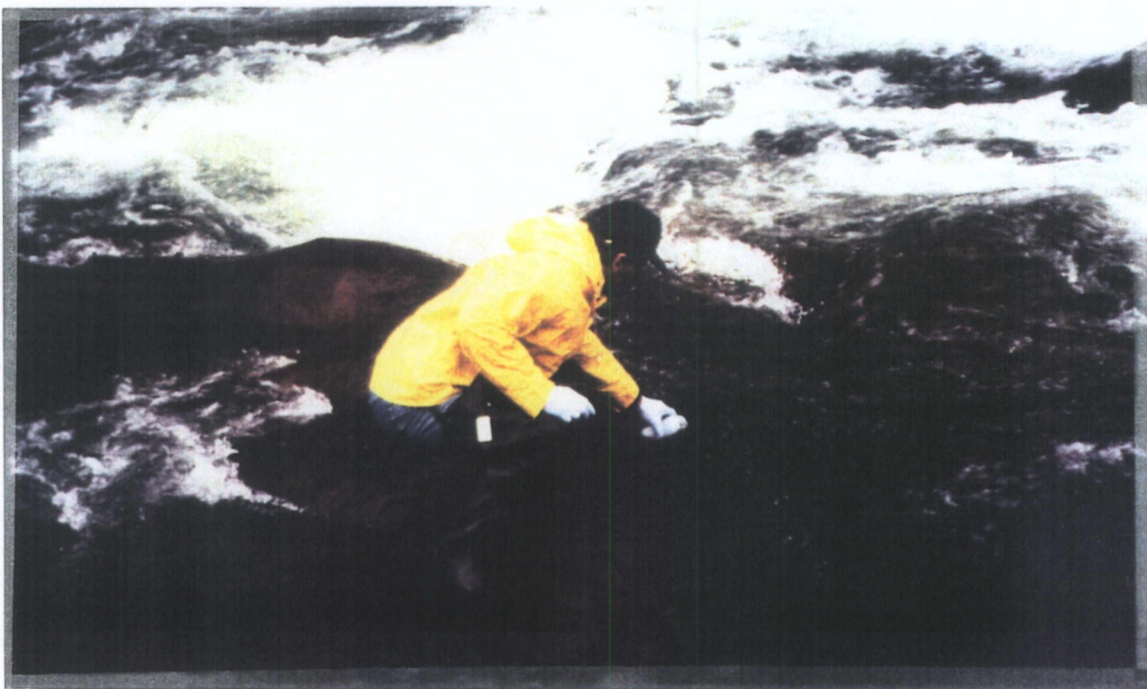
Photo 6: Collecting Water Samples from Indian Creek
