Article

Gully Erosion Control Practices in Northeast China: A Review

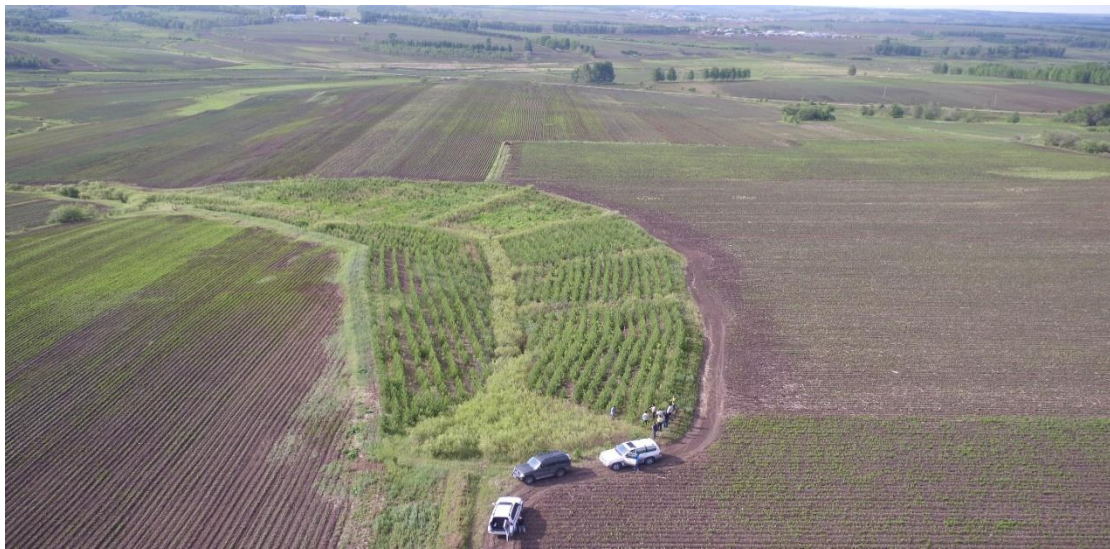
Figure 2. Biological system for gully control (photo taken by Dr. H. Li in May 2016, Bawuwu State farm, Heilongjiang Province).

The biological system is (a) to regrade steepness of the gully bank below 25°, (b) to construct arc-shaped continuous wicker drop structures at both headcuts and gully bed, and (c) to plant trees or shrubs offering canopy cover along the bank and/or downward on the bank slope. This system ensures that the flow entering the gully initially passes through the wicker drop structure to reduce flow energy and subsequently flows through a stabilized section of the gully. This allows vegetation rehabilitation in the gully (Figure 2). The system is applied in sloping areas with better water and soil resources.

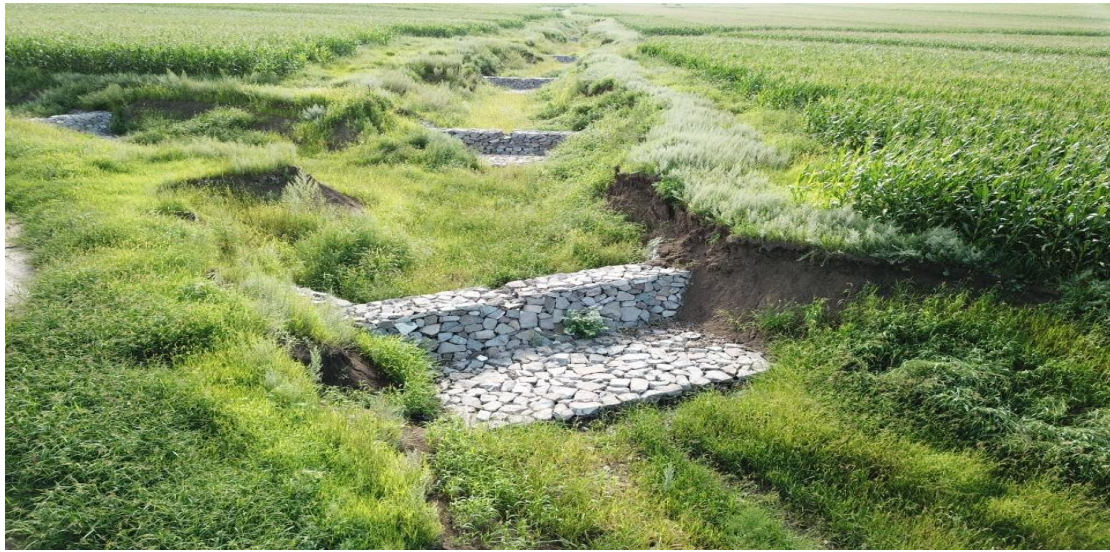
Figure 3. Engineering system for gully control (photo taken by Dr. X.Y. Zhang in July 2018, Arongqi County, Inner Mongolia Autonomous Region).

The engineering system is to set up drop structures at headcuts and check dams in gully bed locations with masonry for impeding flow scour. The raised gully bed derived from sediment deposition can be used to plant shrubs or grasses (Figure 3). This is a system with supplementary biological measures and is mainly applied in hilly areas with plenty of water.

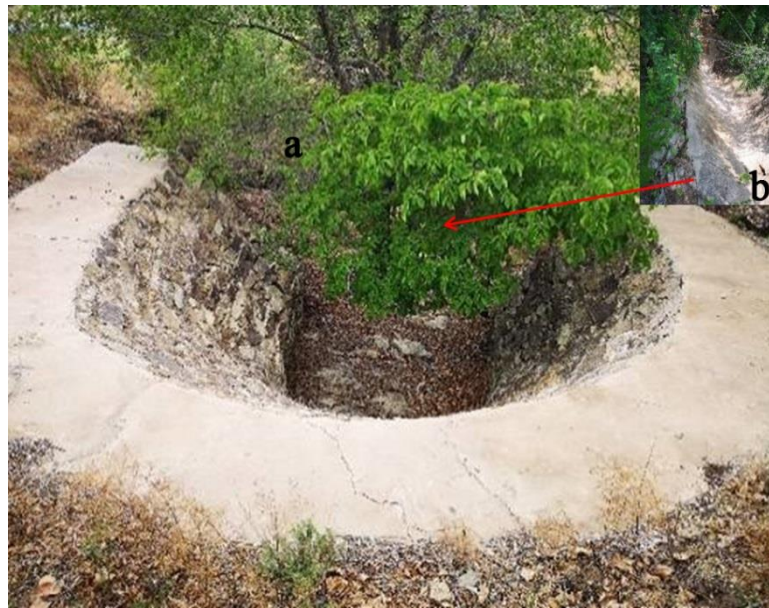
Figure 4. Arc-reinforced concrete and arc-concentrated and diversion masonry drop structure (photo taken by Dr. X.Y. Zhang in July 2018, Wulanhaote City, Inner Mongolia Autonomous Region).

The arc-reinforced concrete drop structure is an arc–chute structure constructed at the gully head with 20 cm thickness and 2 m width having slope steepness less than 45°. After grading, leveling, and compacting the gully, a 20 cm thick sandstone layer is paved, and then concrete is poured on the layer. The edge soil from both sides of the chute should be compacted within the slope of the chute. Bushes are planted for protecting the slope (Figure 4a). This kind of structure is regarded as a first-grade drop structure which is simple and easy to be implemented. Though the structure may experience slight movement with soil freeze/thaw activity, it seldom cracks or exhibits damage. Usually, it is applicable to small gullies (area less than 0.3 ha), ditches along the road, and forest perimeters where the water flow is relatively low in their upper reach.

Arc-concentrated and diversion masonry drop structure is a second-grade drop structure composed of a 2/3 arc–catchment chute, squared but sloped drainage chute and rock riprap (Figure 4b). The 270-degree arc can divert the runoff water from different directions into the guide chute, which stabilizes the gully head through draining the baffled water into the gully bed.

Masonry is used to build the arc–catchment chute, which is approximately 40 cm thick and 1.5 m high. Wall inclination angle is 50–75°, the upper is covered with 2 cm thick cement and parallels the soil surface. The drainage chute is also built by masonry, and its width is equivalent to the bottom of the arc–chute with 20 cm thickness. A 20 cm thick sandstone layer is paved under the structure, and a 30–50 cm high ear wall is built on both sides with slope steepness around 15–30%. The bottom is closely connected with riprap. This practice applies to medium- and small-sized gullies with more runoff from the hillslope.

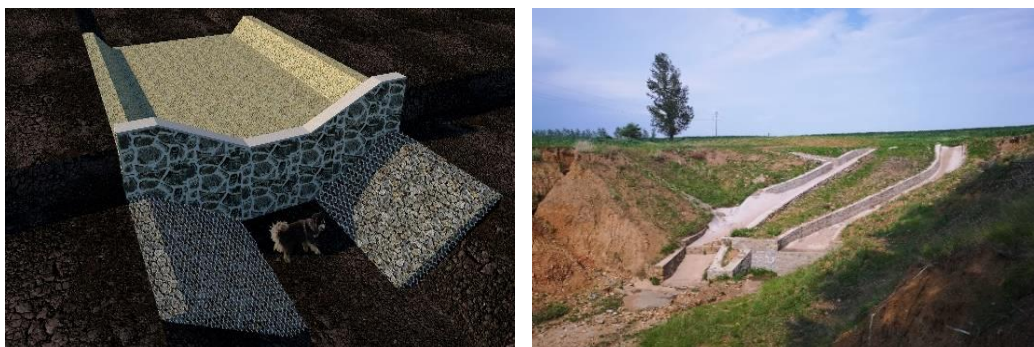
Figure 5. Masonry drop structure for medium-sized (left) and large-sized gullies (right) (photos taken by Dr. X.Y. Zhang in June 2018, Hailin County, Heilongjiang Province).

Masonry drop structure for medium-sized gullies is composed of a catchment chute, retaining wall and stilling basin. The catchment chute is arc-shaped with 20 cm thickness and constructed with small stones and cement. Its width is exactly the same as the headcut width (Figure 5 left). The side walls of the chute are built with masonry, having a 1.5 m high foundation; the exposed height above ground is no more than 3 m, and wall thickness is 0.5 m. The stilling basin is composed of 0.3 m thick masonry protecting walls along the gully bank and square pool at the gully bottom. This structure first collects the flow from the hillslope into the catchment chute and subsequently continues to direct the plunging flow into the stilling basin, and finally into the gully bottom. This is a first-grade drop structure specifically used for headcut control of medium-sized gullies. Prevention of freezing expansion to the foundation is of crucial importance to avoid wall cracking, and thus, the wall base should be built beneath the frost layer.

Masonry drop structure for large-sized gullies is composed of a long aqueduct with low slope gradient, vertical walls, and a stilling basin (Figure 5 right). The building materials are all masonry. The aqueduct is a U-shape chute after the headcut is graded. The chute cross section is designed to meet the maximum 3–6 h rainfall occurring once every 10 years. The chute thickness should be 30–50 cm, while the chute extending to the gully bottom should not exceed 25° slopiness. The aqueduct can be linear or

curved. The vertical wall with 1–2 m height is built beneath the aqueduct. The top surface of the wall is at the bottom of the aqueduct, with the same width as that of the aqueduct. The wall thickness is 50 cm. The stilling basin is built adjacent to the vertical wall. This structure is applicable to large-sized gullies with wider headcuts and a slight slope. This structure has higher building costs, though it is more effective in controlling gully erosion than simpler structures. We recommend building a diversion structure and shaping the ground to discharge the flow into one aqueduct. Additionally, for soft or less stable soil areas under the aqueduct, laying and pouring concrete to enhance stability is suggested.

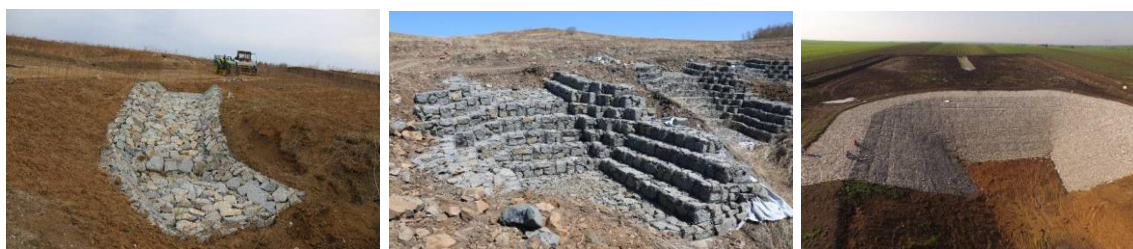
Figure 6. Drop structures with small-sized gabion (**left**), medium-sized gabion (**middle**), and large-sized gabion (**right**) (left and middle photos taken by Dr. X.Y. Zhang in April 2018, Dunhua City, Jilin Province; right photo taken by Dr. H. Li in June 2016, Hailun City, Heilongjiang Province).

There are basically three types of drop structure with gabion. The first is the drop structure with a small-sized gabion. Usually, this drop structure is an “S”-shaped chute, which is constructed from the headcut inlet along the gully with riprap (Figure 6 left). The thickness of the gabion is over 0.3 m with padding layer underneath, while the surface of the padding layer is covered by geotextile filter cloth (a tough nonwoven material). The wire–mesh container is 1 m × 1 m wide, and chute length depends on the actual situation, but the slope should not exceed 45°. It is a simple structure and easy to construct with less material and lower cost than other structures. This structure is applicable to small gullies or semistable gullies with less upstream flow, but not applicable to gullies with more concentrated flow or strong flows at the headcut.

The multilevel terraced drop structure with a medium-sized gabion is composed of terraced gabions, protecting wall and stilling basin (Figure 6, middle). They are all built with 0.6 m high, 0.6 m wide, and 0.80 m long gabions. Though this structure requires relatively more materials, it is durable and relatively easy to construct. This multilevel terraced structure is applicable to medium-sized gullies with more concentrated-flow.

A drop structure with a large-sized gabion is also available. This slope-type ramp with a gentle slope in the upper part is connected to riprap below (Figure 6 right). The gabion is 1 m × 1 m in size and 0.40 m thick. There is a 0.2 m thick padding layer beneath the gabion. The padding layer is first covered by geotextile filter cloth and a plastic net. This structure functions well in transporting flow from multiple directions into the gully bottom and thus is applicable to gullies with a wider headcut. Although more materials are used and more work is required to regrade the headcut, its construction is relatively easier.

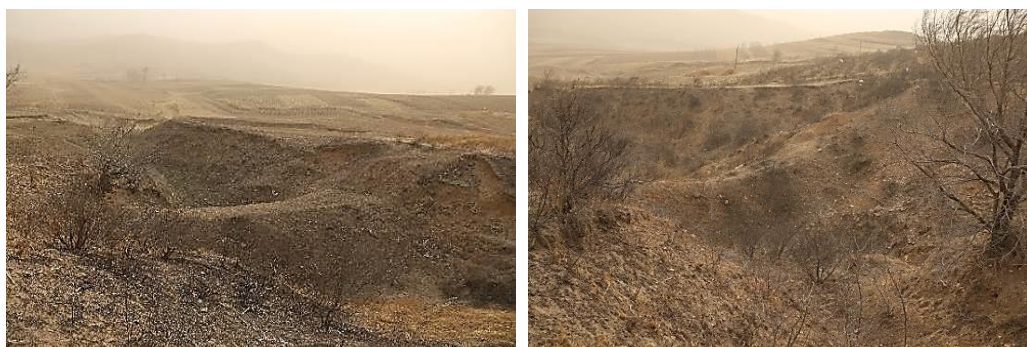
Figure 7. Typical soil check dams (photos taken by Dr. X.Y. Zhang in May 2018, Zhangwu County, Liaoning Province).

Soil from the gully bottom is used to build soil check dam across the gully. The dam is a trapezoidal structure, 1–3 m high and 0.5–1.5 m wide. The upper part is steeper than the lower part. It can consolidate and raise the gully bed and thus stop bottom incision. It can also stabilize the slope and prevent gully expansion and thus reduce sediments (Figure 7).

This practice can be applied in small gullies or medium- and small-sized gullies in semiarid areas for hillslope management. This type of check dam is the simplest and the lowest-cost practice for gully bottom control. However, soil check dams are relatively weak in protecting gully erosion because they mainly intercept runoff and silt and do not transport them. Lady Amherst pheasant (*Caragana sinica* (Buchoz.) Rehd), sea buckthorn (*Hippophae rhamnoides* Linn.), and shrub lespedeza (*Lespedeza bicolor* Turcz.) are usually planted on the dam.

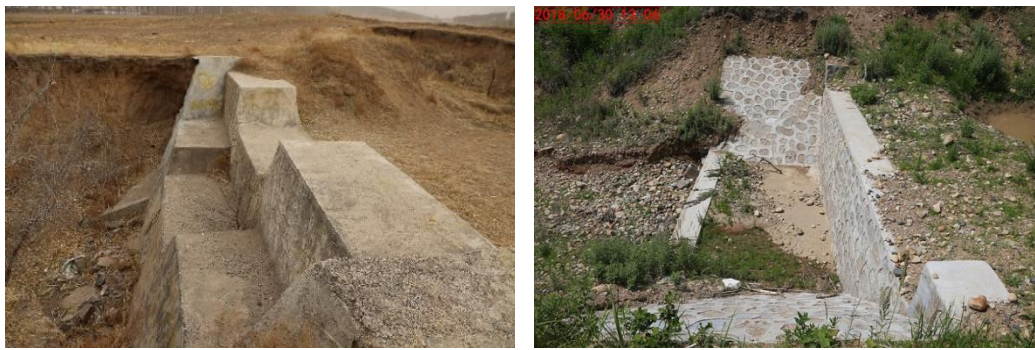
Figure 8. Step (left) and inverted trapezoid (right) type masonry check dam with cement surface (photos taken by Dr. X.Y. Zhang in May 2018, Zhangwu County, Liaoning Province and in August 2018, Hailin City, Hielongjiang Province).

In Northeast China, this type of check dam is usually composed of a trapezoidal body, bank protection wall, and stilling pool made from masonry, cobble, cement, and sand. The size of the structure depends on the gully topography. The height is first determined, and then the bottom width, beam ratio, and back slope ratio are designed. The design is clearly specified in GB/T 16453.3. In practice, the height is around 2–5 m.

The shape of the overfall outlet varies as in inverted trapezoid, either rectangle or stepwise. The size of the cross-section should meet the flood peak flow. The top of the bank protection wall should be at least 0.5 m wide. The stilling pool is a square chute constructed with masonry on the gully bed. Representative masonry check dams are shown in Figures 8 and 9.

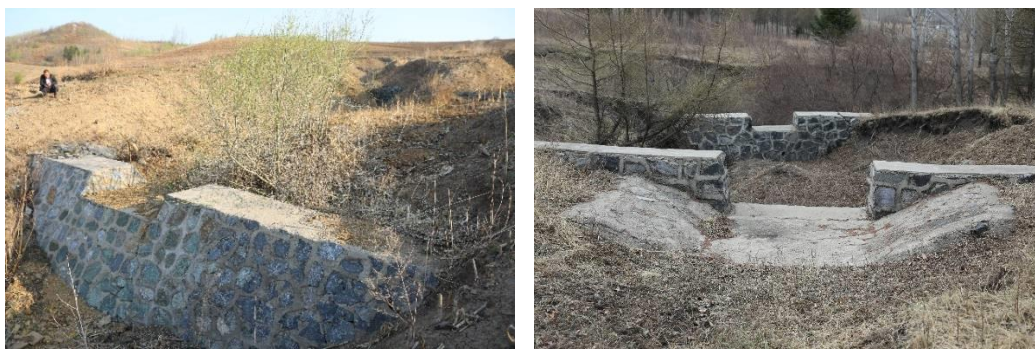
Figure 9. Rectangle type masonry check dam with cement surface (left) and masonry check dam supplement drop structure (right) (photos taken by Dr. X.Y. Zhang in April 2018, Liuhe County and Dongliao County, Jilin Province).

Sometimes, as required, the masonry check dam can also be used as a supplementary drop structure. This structure is often applied for deep headcut gullies, either small or medium-sized. It is composed of a flow-through opening, retaining wall and check dam (Figure 9 right). The opening is in the shape of an inverted trapezoid constructed with 0.5 m thick masonry, and its surface is covered by cement. The length and width depend on the actual size of the headcut. The retaining wall is constructed across the headcut. Its thickness is 0.5 m, while its height should be 0.5 m higher than the headcut line. There is an overfall outlet in the middle of the wall, and the horizontal line of the overfall outlet is 1 m higher than the horizontal line of the retaining wall bottom. A check dam is at the lower end of the retaining wall.

Available stone resources are required for this kind of check dam construction. Experience showed that this kind of check dam is easily damaged by freeze–thaw expansion, and thus, a 1.5 m deep foundation is recommended. Further, cement with high strength grade is preferred. With these requirements, the dam can last at least 20 years in Northeast China.

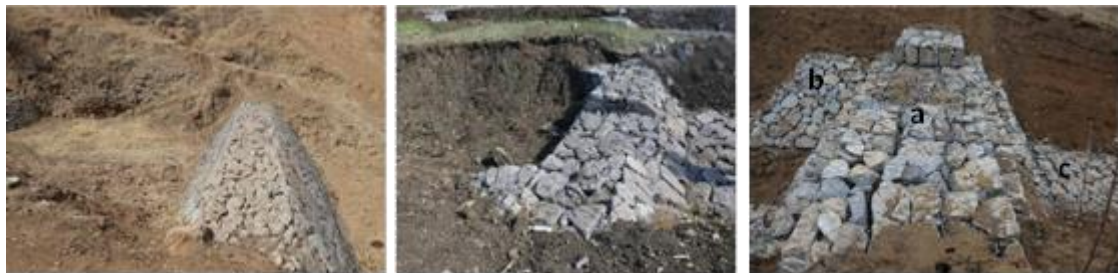
Figure 10. Gabion check dam with step body without an overfall outlet (**left**), double overfall outlets and riprap (**middle**), and footpath with a cement cover (**right**) (**a**, spillway; **b**, revetment; **c**, apron extension) (left, middle, and right photos taken by Dr. X.Y. Zhang in June 2018, Fuxin City; in July 2018, Kaiyuan City; and in April 2018, Fushun County, Liaoning Province).

The structure is similar to that of a masonry check dam, but with gabions as the building unit. Depending on the actual topographical conditions, a single dam body, step type, one stilling pool or two stilling pools are constructed. In general, the height of the dam body should not exceed 5 m with a width of 1.0–1.5 m on the top. It slopes more steeply towards the surface of the water but more gently against the water. Commonly, the gabion is 0.6 m × 0.6 m × 0.8 m. Larger stones are arranged externally, with small stones refilling the inside. The exposed crevices are controlled at ≤ 2.5 cm, and anticorrosion galvanized wire should be used for the gabion with a specification of 8 cm × 10 cm. A

single layer of a guard wall and riprap are paved, respectively. Figure 10 illustrates some representative gabion check dams available in the region.

Gabion check dams hold certain flexibility that can dramatically reduce the damage derived from freeze–thaw expansion to masonry check dams. This practice is easy to construct with fewer materials and a lower cost. However, as it has a certain degree of permeability, the interception of sediment is poorer compared to that of masonry check dams. Further, water channeling sometimes might occur due to water transport through the gully bottom or dam sides, which leads to a damaged dam and less functionality. Thus, a 0.5 m deep foundation is recommended when constructing the dam.

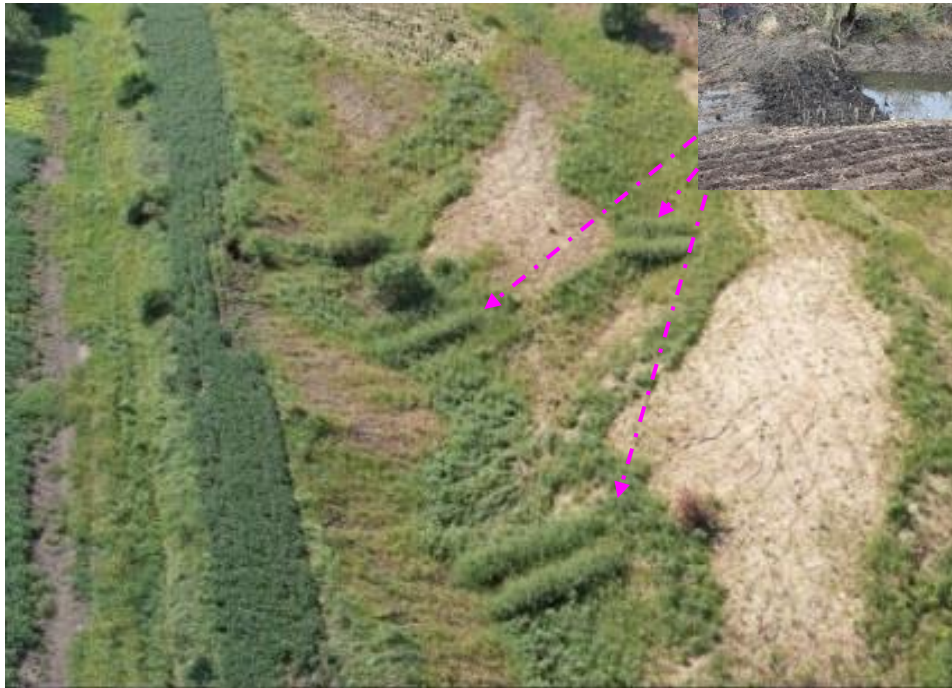
Figure 11. Typical wicker check dams (upper right corner, check dam establishment) (photo taken by Dr. X.Y. Zhang in July 2018, Kaiyuan City, Liaoning Province).

As indicated from its name, the core component of the check dam is wicker material. There are two ways to construct the wicker check dam. For a wicker check dam with stones, bunches of multiple wickers, fixed with wooden pins and connected with wire, are laid equidistant from each other. Soils or cobbles fill the spaces between the wicker bunches. For a wicker check dam with soils, 2–3-year-old willows with a 3 cm diameter are inserted into the soil over 0.5 m deep, and above ground 1.0 m high. Then, soils and cobbles are filled among the wickers. Usually, each bundle should have at least 10 wickers and be fixed by wooden stakes every 20 cm. The wicker bundles are laid parallel, crossing the gully with 0.5 m spacing (Figure 11). This is a living check dam with the perfect integration of plant components.

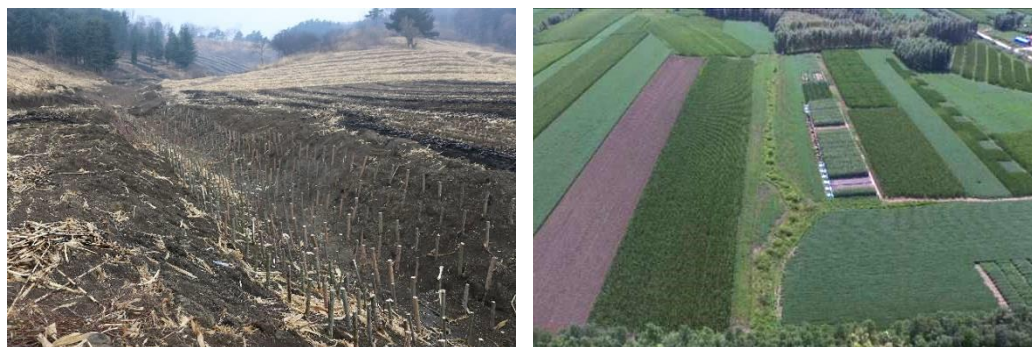
Figure 12. Shrub plant enclosure part view (**left**) and overall view (**right**) (left photo taken by Dr. XY Zhang in April 2017, Kaiyuan County, Liaoning Province; right photo taken by Dr. H. Li in May 2016, Hailun County, Heilongjiang Province).

This practice has been used to successfully implement over 1000 gullies in Baiquan County, Heilongjiang Province for the past 4 decades, which has saved at least 50 km² soil loss area and is being gradually implemented in the northeastern black soil areas. It is either set up from headcut to gully end continuously or arranged in sections according to soil and moisture conditions. The wide-arc-shaped structure ensures that all water flows through the continuous wicker. The wicker must be alive. The slope of the gully bank is regraded below 35°; interval spacing of the live wicker row is 0.5 m (Figure 12). The wicker trunk should be over 2 cm in diameter (5-years old willow) and is inserted 30 cm deep in soil. The above-ground part of the wicker should have at least two buds, and the top surface of the wicker is sealed by paint to reduce transpiration. To implement this practice, it is better to transplant the wicker within 3 days after cutting. If conditions do not allow timely transplanting, bury them in wet soil or soak them in water for short-term preservation. Regrading the slopiness is a must for the successful implementation of this practice. This practice is applicable to gullies inside farmland with better soil fertility and more rainfall, small gullies along roads or branch gullies among medium- and large-sized gullies.

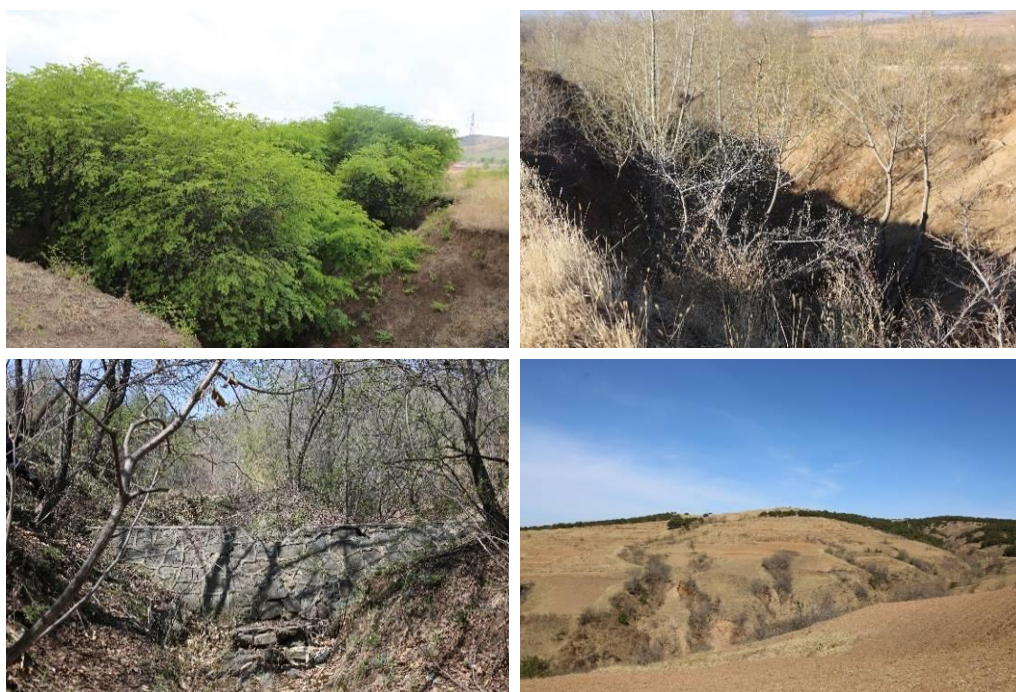
Figure 13. Shrub plants enclosing the gullies (**upper left**, sea buckthorn; **upper right**, hazel; **lower left**, false indigo; **lower right**, caragana-pea tree) (photos taken by Dr. X.Y. Zhang in April 2018, Tonghua City, Dunhua County, Liuhe County, Jilin Province and Fuxin City, Liaoning Province).

Instead of the continuous live wicker, shrub plants are also adopted. To actively developing gullies, shrub drop structures at the headcut with several shrub check dams inside the gully are often established after grading the gullies. The shrub drop structure at the headcut is composed of cross wickers with 20–40 cm spacing downward, and wicker check dams constructed every 5–10 m along the gully bed. Among the dams, live wickers are planted appropriately (Figure 13). For stabilized gullies, simultaneously some shrub plants, such as sea buckthorn (*Hippohgae rhamnoides* L), caragana-pea tree (*Caragana microphylla* Lam), hazel (*Corylus heterophylla* Fisch), shrub lespedeza (*Lespedeza bicolor* Turcz), false indigo (*Amorpha fruticosa* L.), and raspberry (*Rubus idaeus* L.) are planted in the gully bank or down the slope (Figure 13). This practice can develop a system with shrub plants enclosing the whole gully.

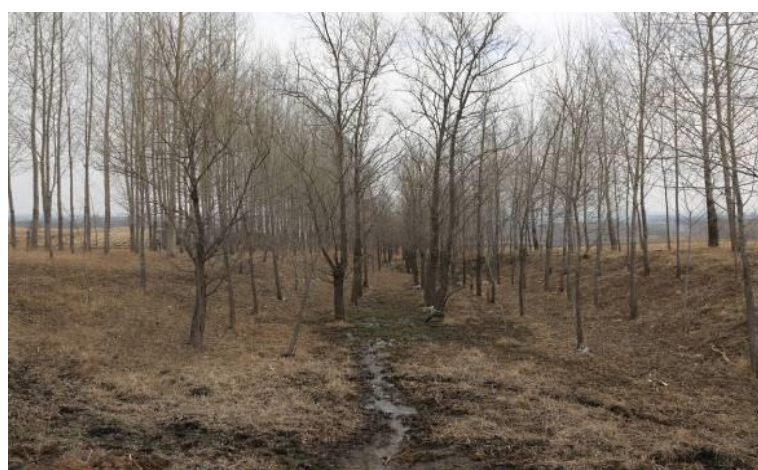
Figure 14. Arbor plant enclosure (**upper**, diagram; **lower**, 10 years after arbor enclosure) (photo taken by Dr. X.Y. Zhang in April 2015, Hailun County, Heilongjiang Province).

This practice forms a patch of forest. Arbor plants are planted along the gully bank and in the gully bottom. Planting density is denser than a cash forest. If conditions allow, shrubs such as sea buckthorn and shrub lespedeza are interplanted with arbor in a spacing of 1 m. Generally, arbor is planted with 1.5 m × 1.5 m spacings, while shrubs are planted with 0.5 m × 0.5 m spacing. Arbor willow (*Salix babylonica* L.), and elm (*Ulmus pumila* L) are planted on the flow path, while poplar (*Populus tremula* L), pine (*Larix gmelinii* (Rupr.) Kuzen) and eucalyptus are planted on both sides of the gully wall (Figure 14). Shrubs grow faster and can cover the ground quickly, which is beneficial to the initial management for the gully protection. Thus, it can quickly rehabilitate the vegetation of the gully.

This practice is applicable to medium- and large-sized gullies, particularly gullies along the road and in abandoned land. Depending on the gully site conditions, the artificial forestation by reasonable assembly of arbor trees or mixed with shrub can rehabilitate the ecological environment while managing gully erosion. Although vegetation has an excellent potential to trap sediments, it cannot stop the upslope migration of the gully headcut, but it likely controls gully incision.
