Hydraulic injection injury

Prepared by the **Health and Safety Laboratory**
for the Health and Safety Executive 2013

Alan McDonald
Health and Safety Laboratory
Harpur Hill
Buxton
Derbyshire SK17 9JN

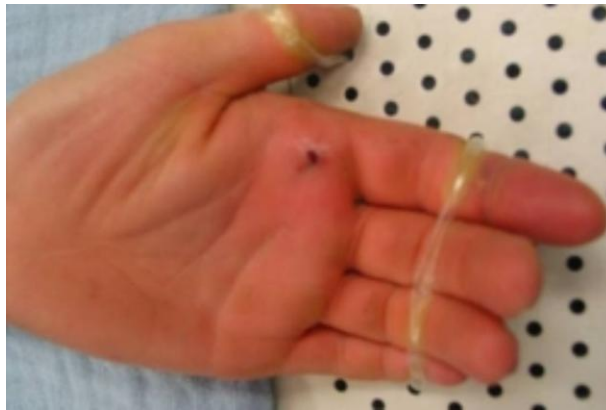
Figure 1 shows the left hand of a 33 year old industrial paint sprayer shortly after sustaining an injection injury of oil based paint to the base of the index finger. Note the seemingly benign nature of the puncture wound where the paint has entered the hand.

Figure 1 *Showing initial puncture wound following injection injury, picture by R Heirner.*

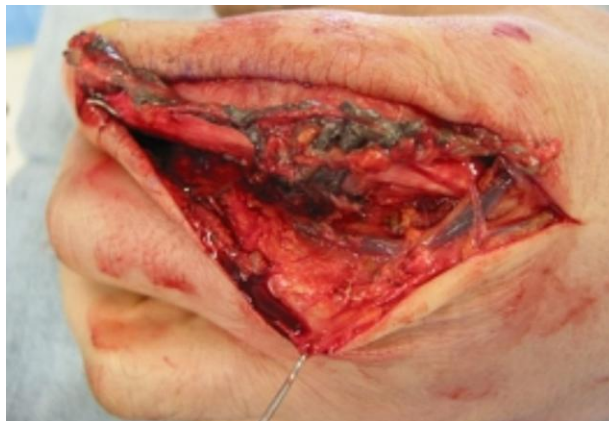
Figure 2 shows one of several incisions made during the debridement process to remove necrotic tissue and paint.

Figure 2 *Showing incision made during debridement procedure, picture by R Heirner.*

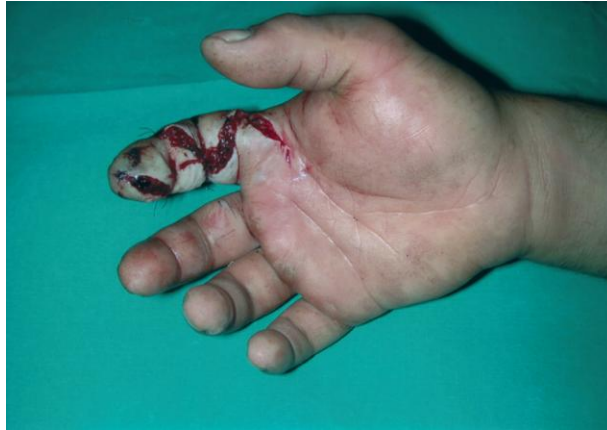
Figure 3 shows the right hand of 25 year old male 36 hours after sustaining a hydraulic injection of solvent into the pad of the index finger. Due to the initial innocuous presentation of a small puncture wound on the finger, medical advice was not sought upon sustaining the injury. Necrosis of the tissue can already been seen at the tip of the finger.

Figure 3 Showing hydraulic injection injury to right index finger, picture by ZH Dailiana.

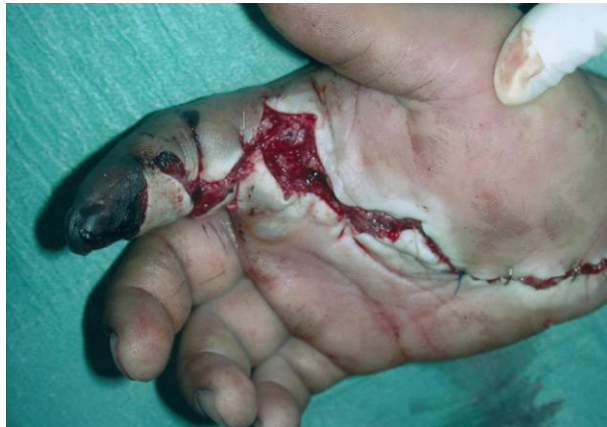
Figure 4 show the patient after undergoing a wide surgical debridement and pressure relieving of the compartments of the hand. This procedure took place 56 hours after the initial injury.

Figure 4 Showing the patient after surgical debridement procedure, picture by ZH Dailiana.

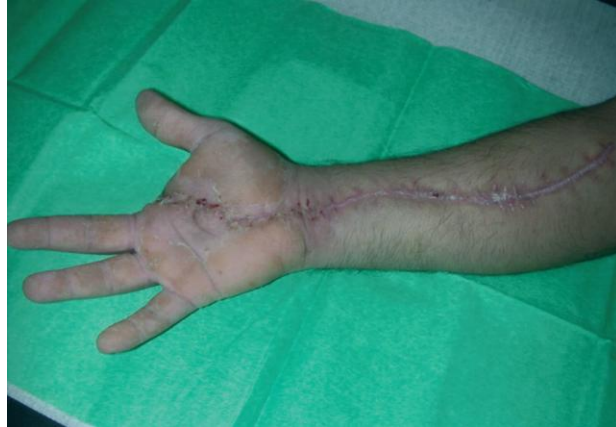
Figure 5 Shows the injured party after amputation of the index finger.

Figure 5 Showing the patient after amputation of the index finger, picture by ZH Dailiana

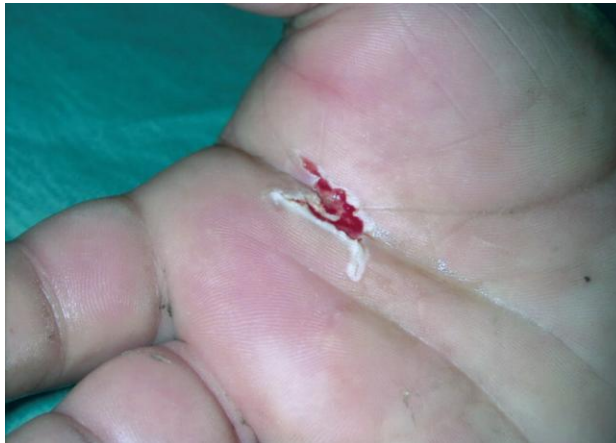
Another common injury site is the palm of the hand, commonly sustained when using a piece of hydraulically powered equipment at the point at which a material or component failure occurs. Figure 6 shows the palm of a 49 year old man after sustaining an injection of fuel oil from a leaking pump. At first inspection the wound may appear entirely superficial to both the injured party and medical professionals.

Figure 6 showing the point of injection of fuel oil, picture by ZH Dailiana

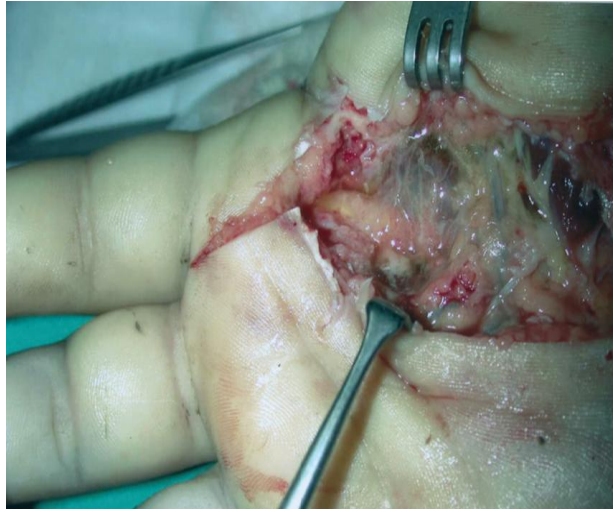
Figure 7 shows the same patient undergoing surgical derbridement in order to relieve the pressure from the inner compartments of the hand and remove necrotic tissue.

Figure 7 Showing surgical debridement procedure, picture reference Graphic 5, by ZH Dailiana

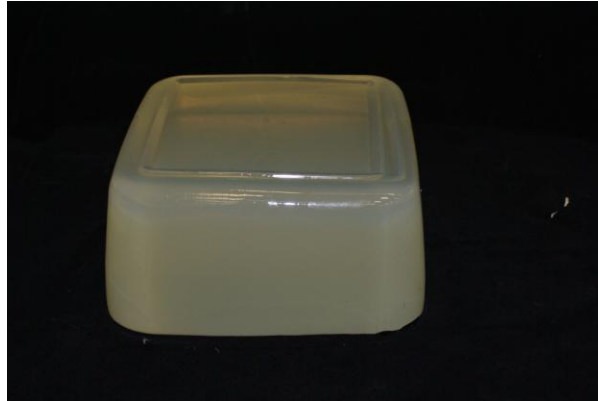
Figure 7 Showing a ballistics gelatine block prior to testing, picture reference *DSCO7288.jpg* by Alan McDonald.

produced for use in these tests. Figure 7 and Figure 8 below shows a ballistics gelatine block and moulded ballistics gelatine head.

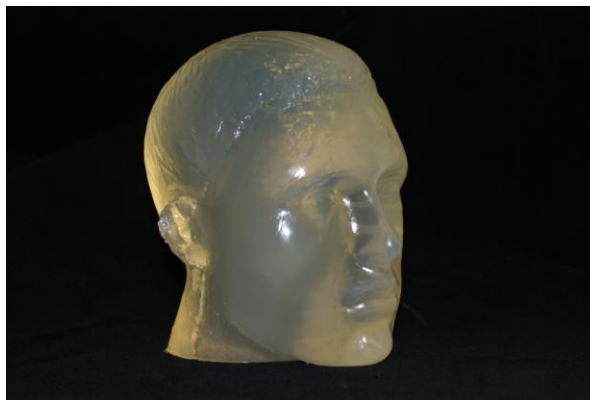
Figure 8 Showing a moulded ballistics gelatine head, picture reference *DSCO7286.jpg* by Alan McDonald

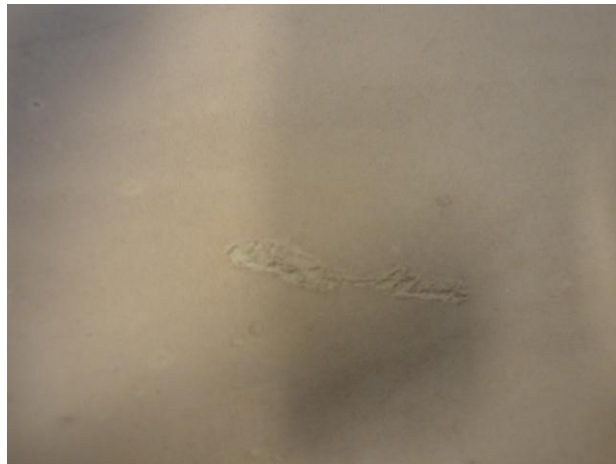
Figure 11 Showing damage to skin simulant sample, picture reference *DSCO1563.jpg*, By Alan McDonald.

Similar observations to those made during the 0.9 mm aperture test continued in tests with jet aperture sizes 0.8 mm to 0.4 mm, with the only notable difference occurring when the 0.3 mm jet was fitted to the test rig. At the same pressure of approximately 100 bar, a significant improvement in non-turbulent flow of the fluid was observed from the 0.3 mm jet. A sharp jet could be seen extending up to 40 mm from the jet aperture before any notable increase in the cross-sectional area of the jet occurred. Tests using the 0.3 mm jet resulted in puncture of the skin simulant sample within 10 mm and up to 40 mm proximity of the jet aperture. High-speed video of the 0.3 mm jet test puncturing the skin simulant was captured for subsequent analysis and presentation. Figure 11 and Figure 12 show the damage and puncturing of the skin simulant following these tests. The slot shaped formation of the damage is due to motion imparted into the jet aperture while manually opening the ball gate isolator. The diameter of the actual puncture was approximately 2 mm.

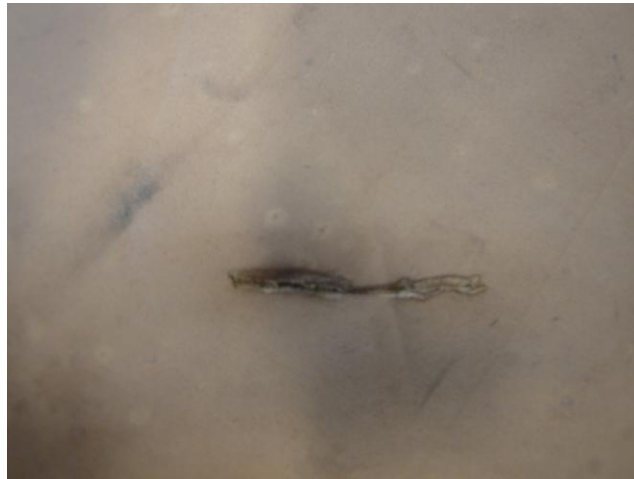
Figure 12, *Showing puncture damage to skin simulant sample, picture reference DSCO1564.jpg, by Alan McDonald.*

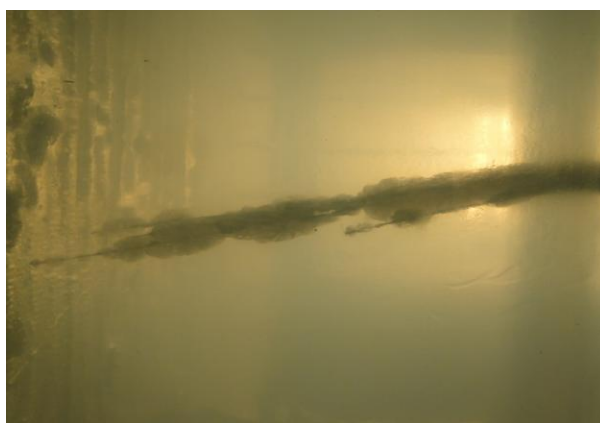
Figure 14 Showing remains of bubble like propagation of the wound path, picture reference DSCO1566.jpg , by Alan McDonald.

The primary objective of the tissue simulant tests, using ballistics gelatine blocks, was to capture high-speed video of a typical wound path created by injury through hydraulic injection for analysis and presentation. Although achieving penetration of the ballistics gelatine would have been more easily achieved than in the skin simulant tests, the 0.3mm jet at a pressure of 100 bar was used for these tests. Post-test analysis of the high-speed video showed that the fluid easily penetrated the tissue simulant creating a final wound depth of approximately 100 mm in approximately one second. The wound propagated through a series of linear incisions of a broadly similar diameter to the jet. A series of cavities opened up along the length of the incisions that were visually similar to the singular cavitation observed in high velocity projectile impacts, although on a far smaller scale and, most significantly, being opened by the inrush of fluid and not the transfer of kinetic energy. This resulted in the wound having the appearance of a series of interconnecting bubbles of diminishing size within the tissue simulant. As the pressure of the incoming fluid dissipated, the cavities could be seen pulsating and finally becoming static. Sample preparation of the wound path removed from the ballistics gelatine block, shown in Figure 13, clearly shows disruption of the tissue simulant and a significant quantity of fluid retained in the wound. Figure 14 shows the remains of the bubble-like cavities created during the propagation of the wound path.
