# INACTIVE AND ABANDONED MINE LANDS— Lone Jack Mine, Mount Baker Mining District, Whatcom County, Washington

by Fritz E. Wolff, Donald T. McKay, Jr., Matthew I. Brookshier, and David K. Norman

WASHINGTON DIVISION OF GEOLOGY AND EARTH RESOURCES Information Circular 98 March 2005

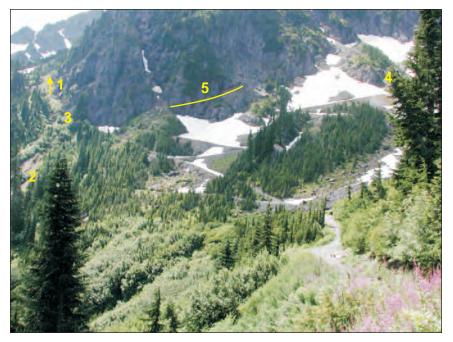
Figure 2. Lone Jack mine site overview. 1, trail to Lone Jack portal; 2, flotation mill site, next to talus; 3, Lulu portal; 4, Whist vein outcrop; 5, Lulu vein outcrop. View to the south.

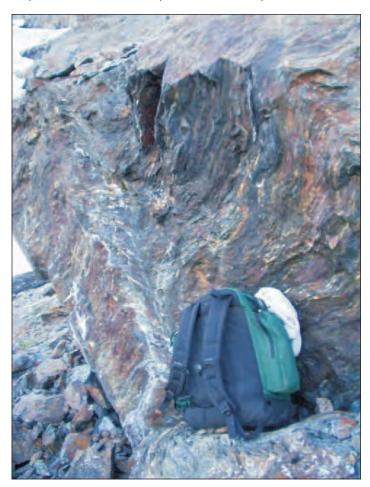
**Figure 3.** Exsolved quartz stringers in Darrington Phyllite talus beneath Lone Jack portal. Pack for scale.

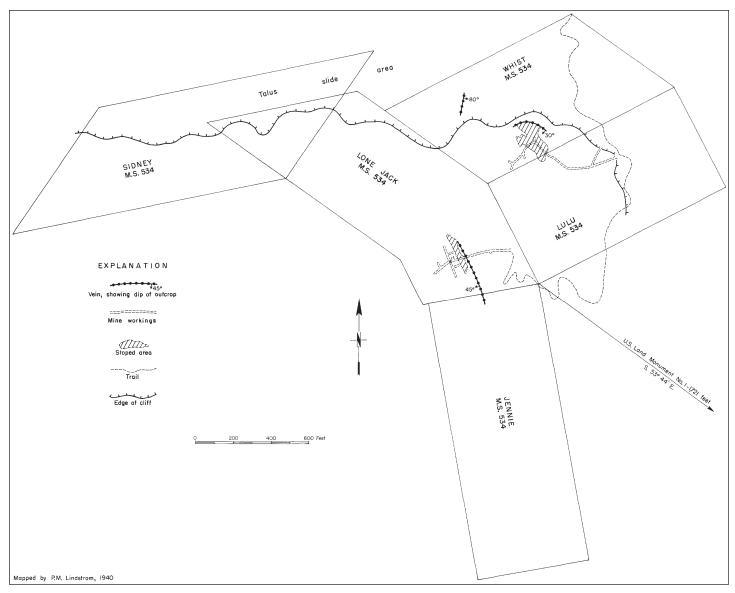
Figure 4. Patented claims, veins, and mine workings (after Moen, 1969).

The relationship of the three veins to each other and the claim boundaries is shown in Figure 4. The Lone Jack portal is the southernmost opening. It is perched on the south side of Bear Mountain and intersects a massive quartz vein approximately 3 feet thick, 300 feet from the portal (Figs. 5 and 6). The vein strikes N10°W and dips 45 degrees to the west. From 1900 to 1907, the Mount Baker Mining Co. operated stopes in this adit, dropping ore 2200 vertical feet to the aforementioned stamp mill via an aerial tramway. No further mining of any extent occurred in this opening after 1907. Grant (1985) felt that most of what was minable from this vein had been extracted. His report indicates that the vein appears to pinch out at the south end and is truncated 500 feet north at a fault where the stope opens onto a vertical cliff. An exploratory drift angles 250 feet to the northwest from this termination. It is largely in barren talc schist. The gold content in Grant's 35 samples, taken from the stope, range from 0.01 ounce per ton to 2.41 ounces per ton (Christenson, 1986). The Lone Jack adit can only be reached from the Lulu portal by following a steep, barely recognizable trail leading southerly through the avalanche chute and notch shown in the upper center of Figure 7. The stope is open to the surface 300 feet southwest of the adit at 5600 feet elevation. A large blue arrow spray-painted above the opening is visible above the trail. Safety at this point requires technical rock climbing equipment and skills.

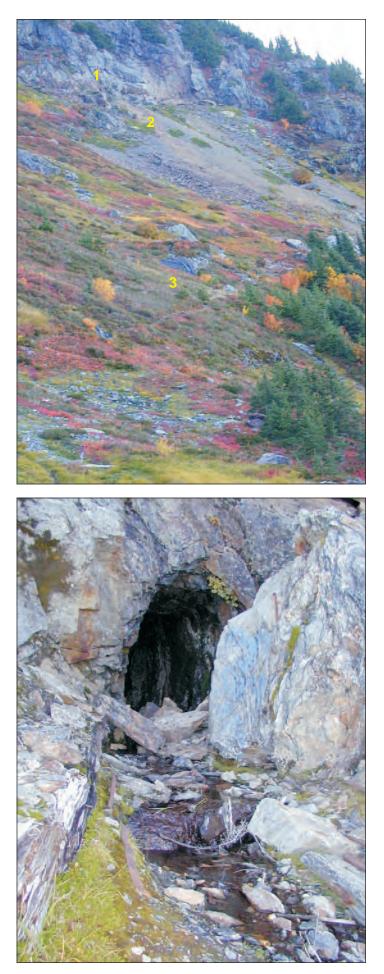
The veins of the Lone Jack group occur as three disconnected quartz fissure veins in pre-Jurassic black phyllitic schist, known as the Darrington Phyllite. The schist contains numerous stringers and lenses of exsolved quartz that formed during metamorphism of the schist (Fig. 3). Except for small amounts of finegrained pyrite, the exsolved quartz is barren. The gold-bearing vein quartz (see Fig. 9) is younger than the exsolved quartz and is probably related to Tertiary granodioritic intrusives in the Lone Jack cirque (Christenson, 1986). Lindstrom (1941) identi**Figure 5.** *(top right)* Lone Jack portal area, south side of Bear Mountain. 1, Lone Jack vein portal (hidden); 2, waste rock dump; 3, access trail. View to the north.

Figure 6. (bottom right) Lone Jack vein portal.

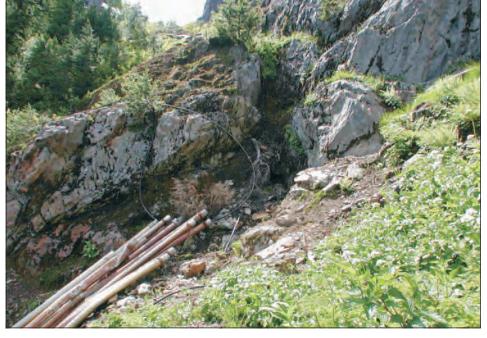
Figure 7. Trail to Lone Jack portal, taken from Lulu portal. View to the south.

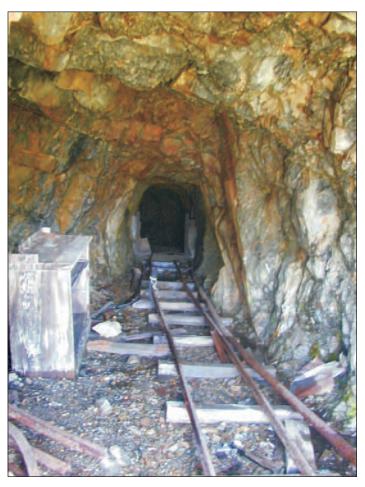
and appears stable (Fig. 8). The portal is Y-shaped with a pillar in the center. A bitsharpening forge and blacksmith shop were located at this point. A clear stream discharged approximately 10 gallons per minute from the portal in August of 2003.

Figure 8. Lulu portal entrance.

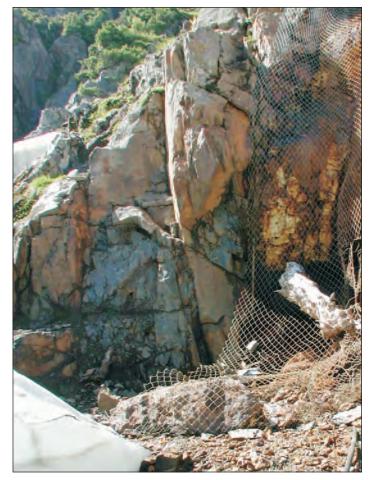
Figure 9. Whist vein outcrop and open stope.

The Whist vein had no development done on it prior to a new portal driven by Diversified Development Co. beginning around 1992 (DGER mine file). This vein crops out 800 feet northwest of the Lulu portal, several hundred feet higher in elevation. A dozer road connects the two openings. The Whist vein stands close to vertical and strikes S10°W. It is

the mine's northernmost geologic structure. It is exposed on the surface for 80 feet and then disappears under talus and vertical cliffs. In 1995 the company intersected the vein from a new adit below the outcrop. Some success was achieved in terms of gold values in 300 feet of drifting along the vein. A snowfield obscured the Whist portal on August 8, 2002. Mining has exposed the outcrop to the surface for a distance of approximately 40 feet. Efforts have been made to close the opening to public entry by covering it with chain link fencing and a collection of boards and timbers (Fig. 9). Crossland (1923) reported assay values of 0.8 to 1.3 ounces per ton gold taken at this point.

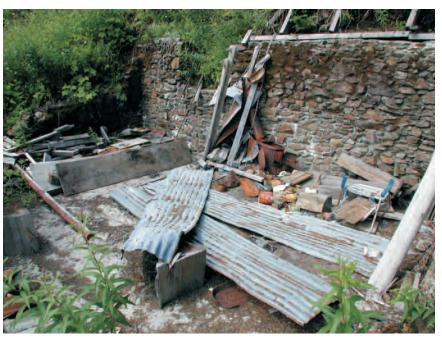
Figure 10. Historic building site.

Two steel containers, possibly for storing tools and/or powder, are present. Several hundred feet of 4-inch aluminum pipe were cached near the Lulu portal. A rock retaining wall indicates a building site of unknown provenance adjacent to the access road at elevation 4520 feet (Fig. 10).

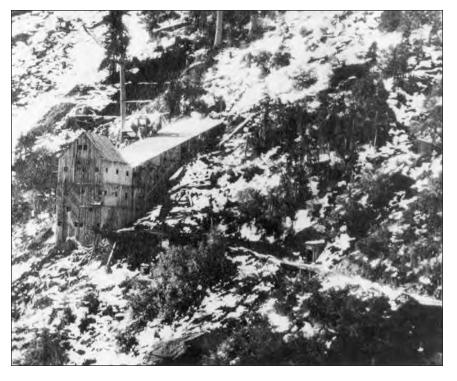
Figure 11. Combination bunkhouse/flotation mill constructed circa 1922 by Brooks-Willis Metals Co. Cutouts for (relocated) bunkhouse foundation in background. Photo courtesy of Whatcom County Museum, Bellingham, Wash.

Crossland's report (1923) indicates the Brooks-Willis operation constructed a combination bunkhouse/flotation mill (Fig. 11) on the steep slope below the Lulu portal and a sawmill and power plant on West Fork Silesia Creek. His report verifies that these structures were standing and in good condition in November of that year. A photo taken some years later (exact date unknown) shows the mill destroyed by avalanche and the relocated bunkhouse intact (Fig. 12).

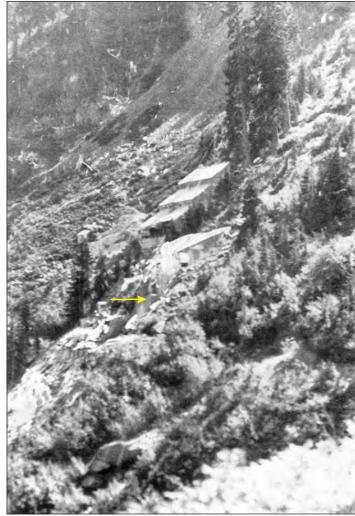
**Figure 12.** Flotation mill (arrow) destroyed by avalanche in foreground, relocated bunkhouse in background. Approximate date post-1924. Note trace of tramway cables in center. Photo courtesy of P. Jeffcott Collection.
