SB-10055157-2288

**Title: Ambient Air Temperature (AAT) Sensor Faults/Location/Diagnostics**

**Applies To: Navistar N13 Engines and Cummins ISX Engines Cummins ISB, N9 and N10**

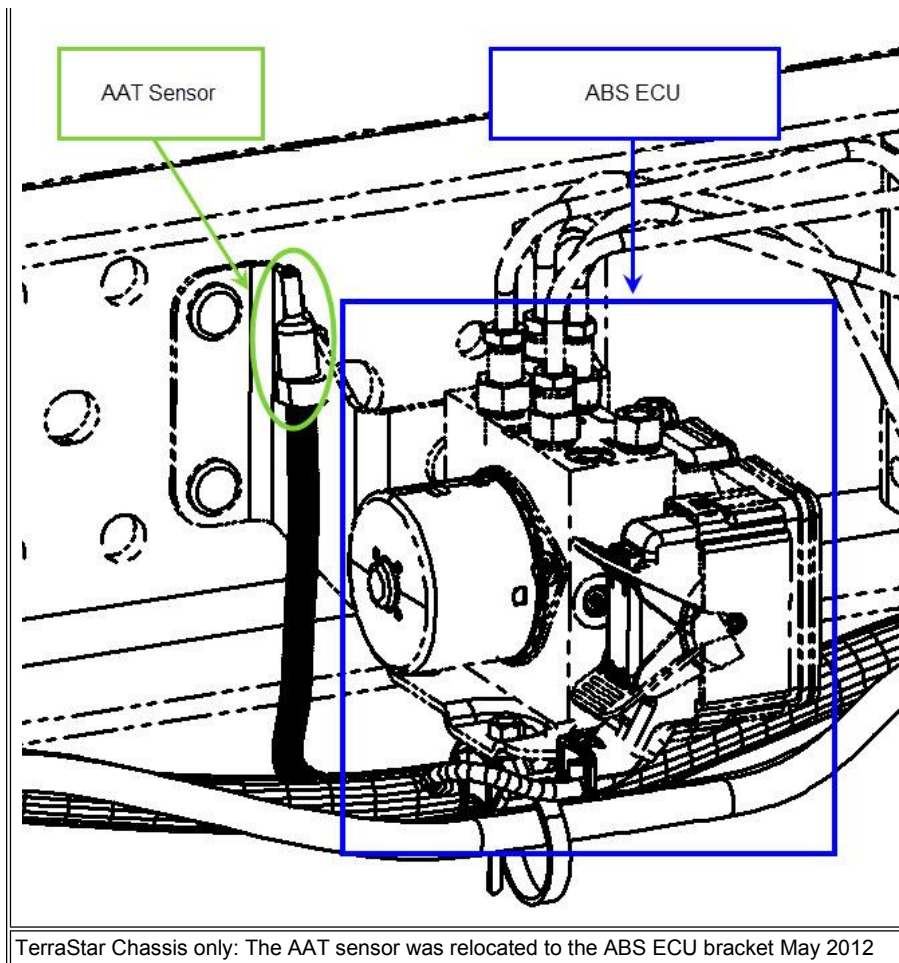
Figure 3

Medium Duty Chassis Standard Mounting Location for Cluster Sensor

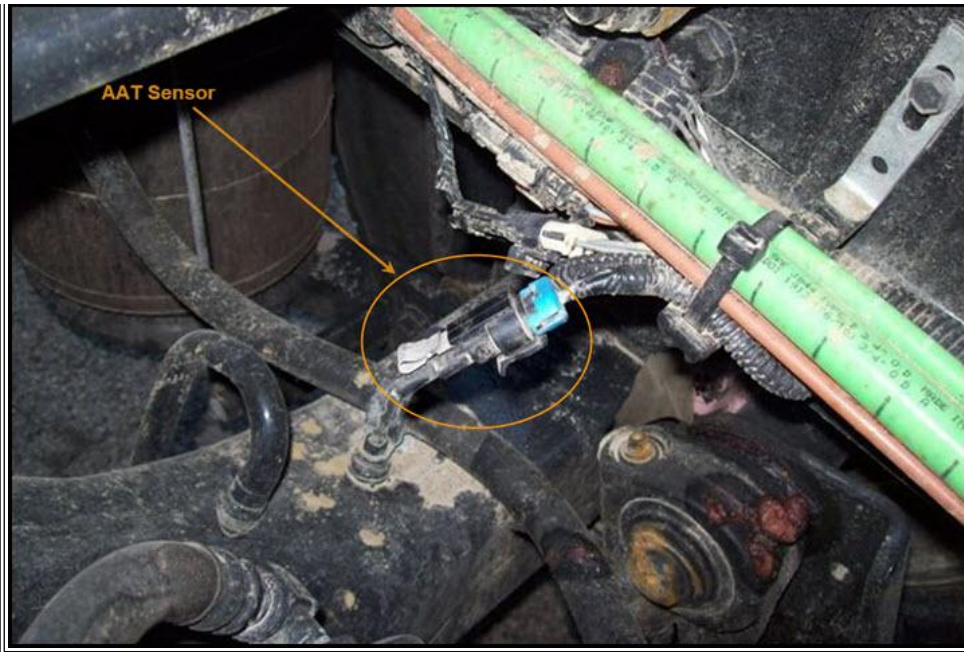
The engine sensor is located on the left frame rail midway between the back of cab and front drive axle, or near the front drive axle. The two photos below show both possible mounting locations (*Figure 4 and Figure 5*).

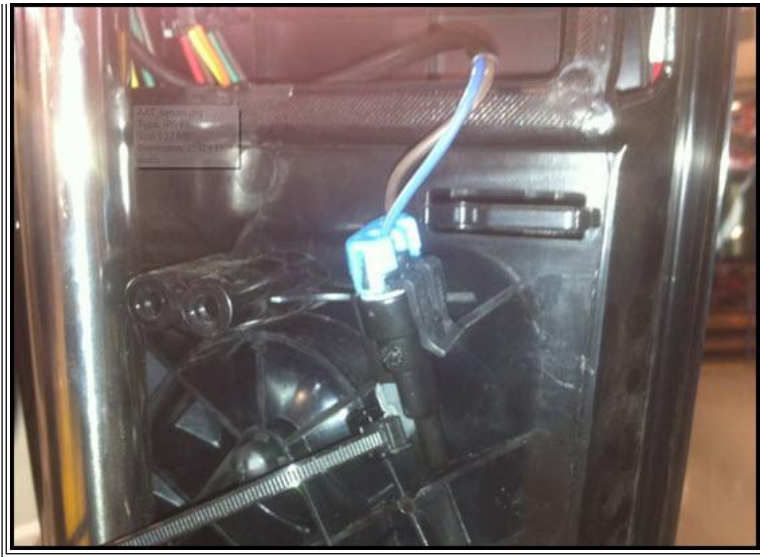
This article begins and discusses the Engine AAT Sensor, prior to and first. After August 23, 2013, Some SCR engines have the Engine AAT sensor mounted in the driver side mirror head and alternatively the sensor could be mounted to the horn bracket. The location depends on build date.

Big Bore Post August 2013 build w/SCR engine, driver's side mirror head (Figure 6):

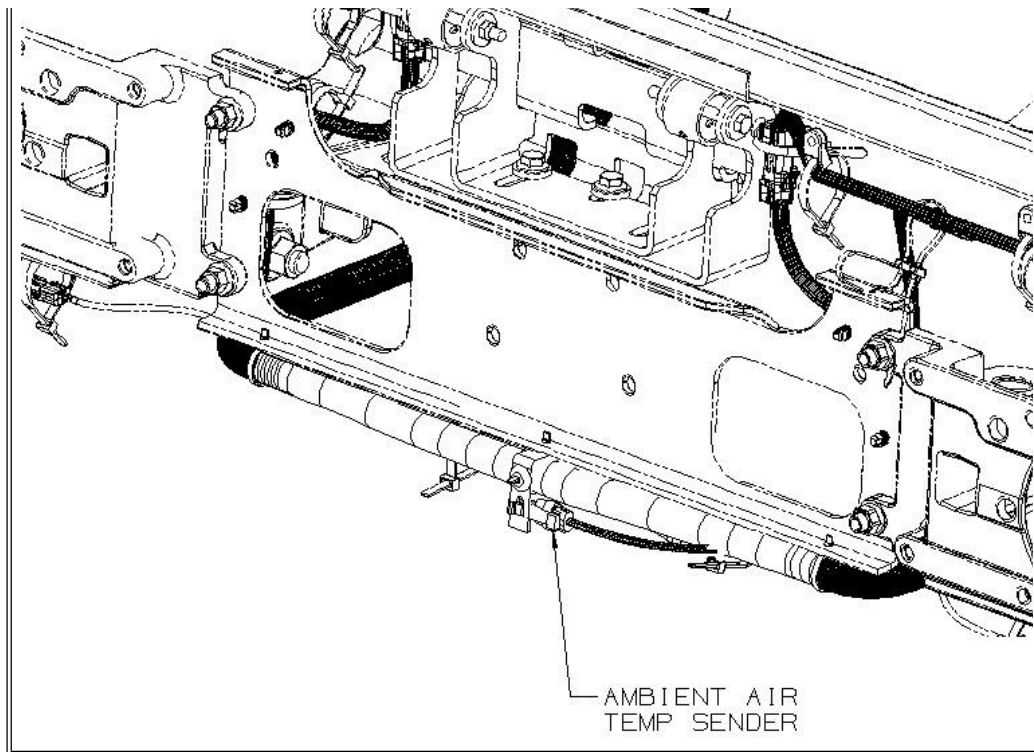
ISX15 and N13 Alternate Location PayStar / 9900i (Figure 8):
