Improved Reliability, Safety and Maintenance through Valve - in - Head Cylinder Body Replacements

Change Management Valve-in-Head Cylinder Body Case Studies

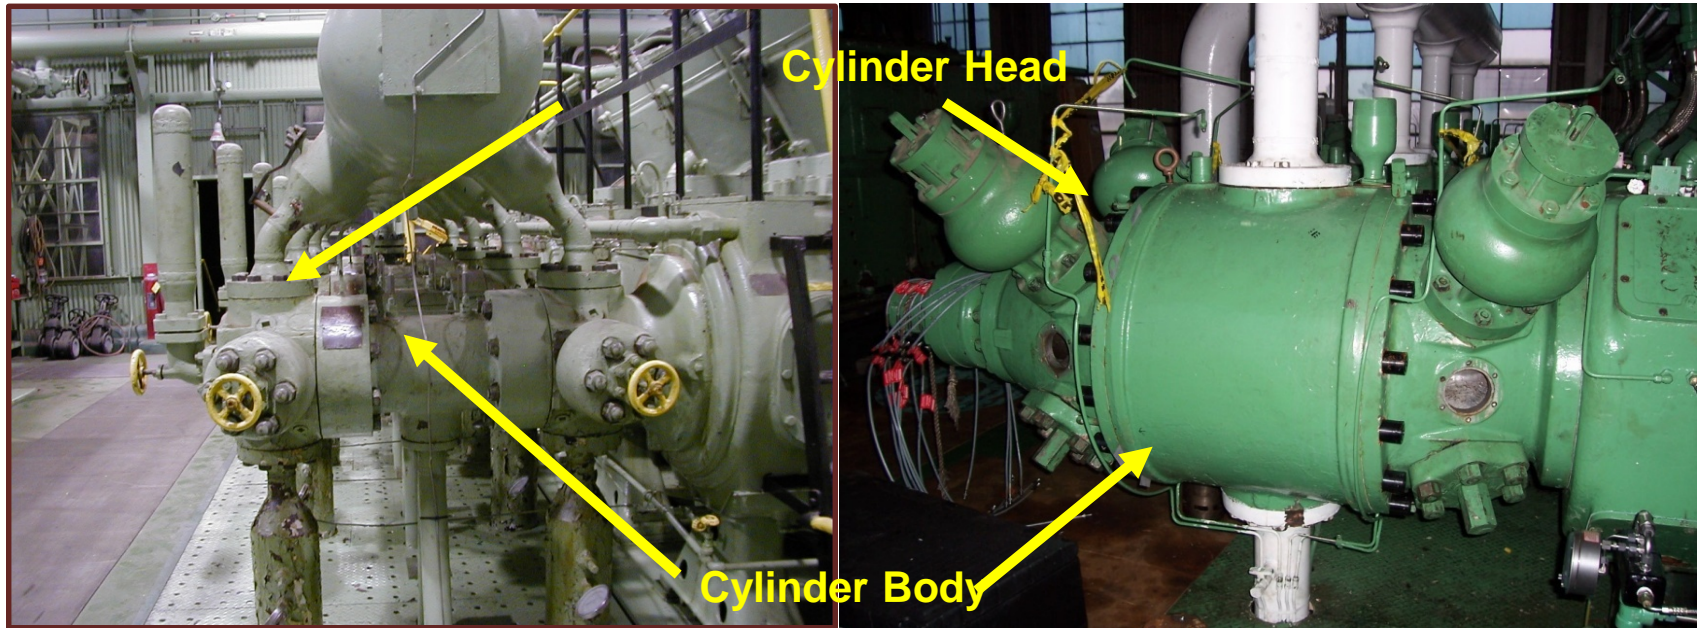
A typical valve in head design is shown. Essentially it is a three piece cylinder with a head end head that contains all of the head end valves, a cylinder body for the running bore, and a crank end head that contains the crank end valves.

Cooper Bessemer Cylinders installed in the 1930's

Clark Cylinders installed in the 1950's

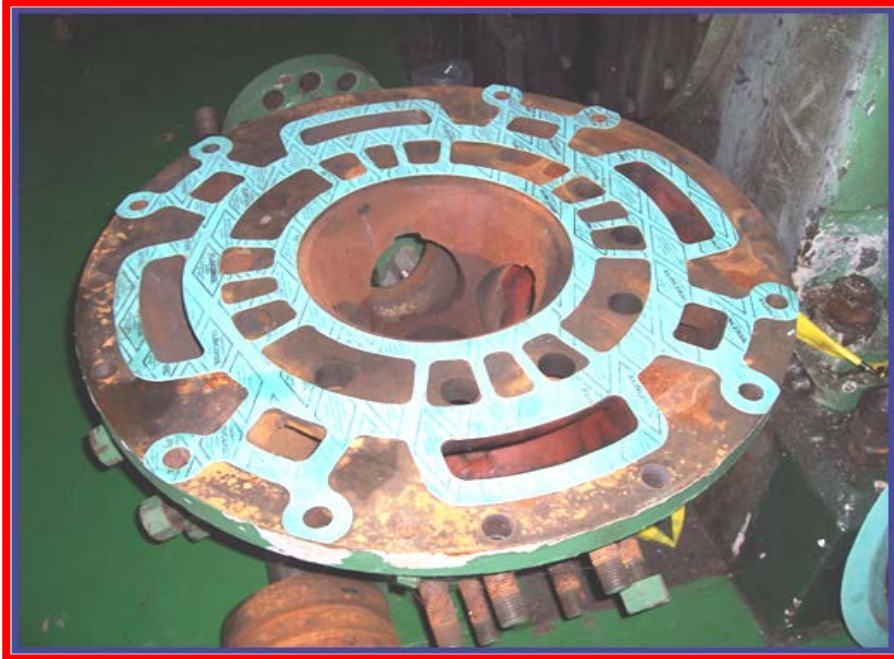
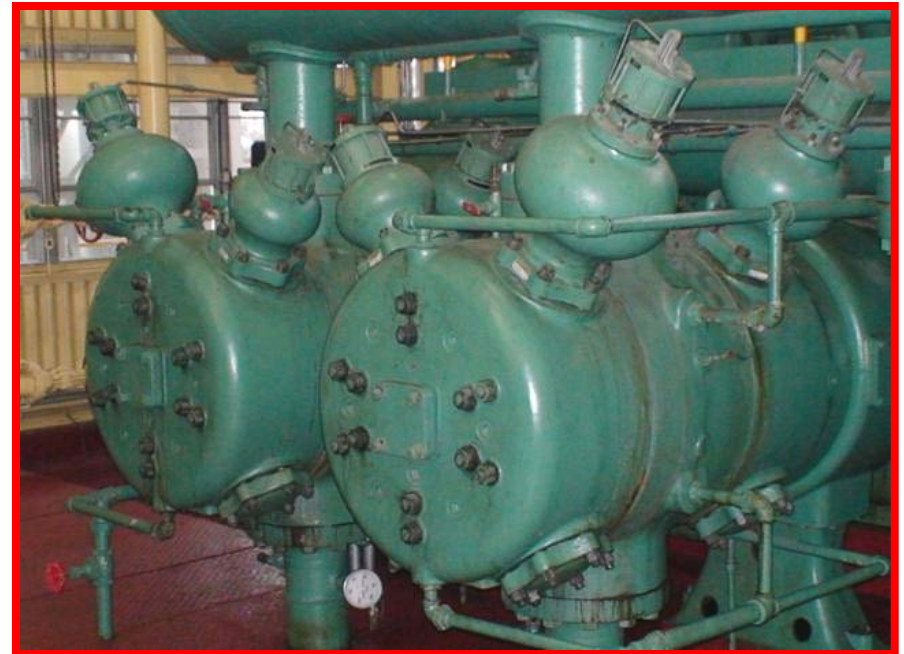
Size of gasket and bolt loading makes it difficult to obtain proper gasket crush

Gasket material discontinuation has made it difficult to design a reliable, leak free gasket that prevents leakage 100% of the time.

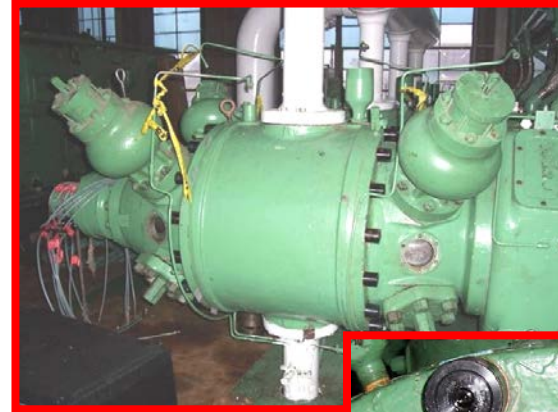
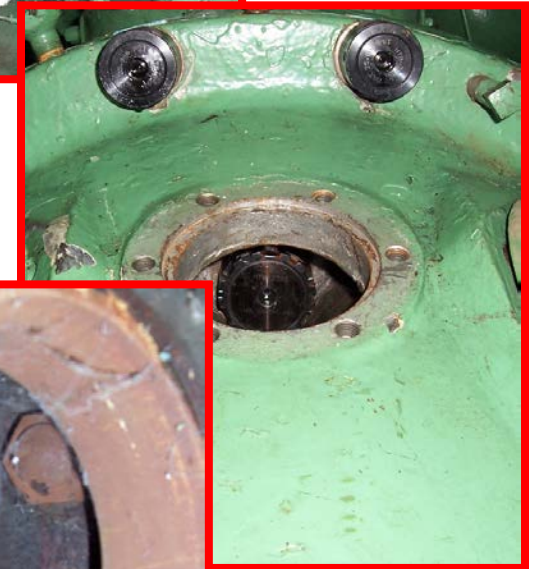
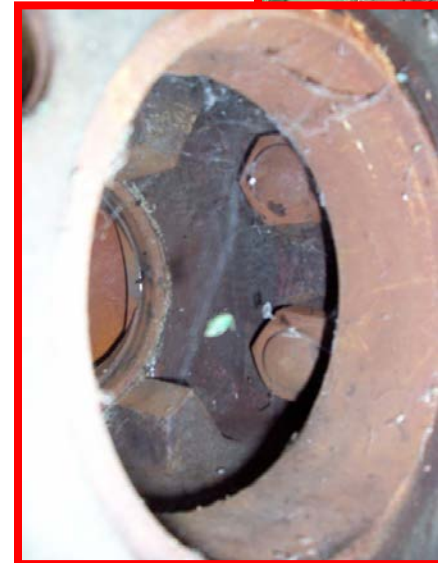
Maintenance nightmare

- The cylinder heads are secured to the body via numerous threaded fasteners that are not easily accessible.
- Have to access the threaded fasteners through the valve pockets.

Potential for fugitive emissions or worse a fire

- Threaded fasteners are not able to be torqued properly
- Often once pressurized, the cylinder leaks resulting in additional blow down.
- The leak could lead to a fire if ignition source present

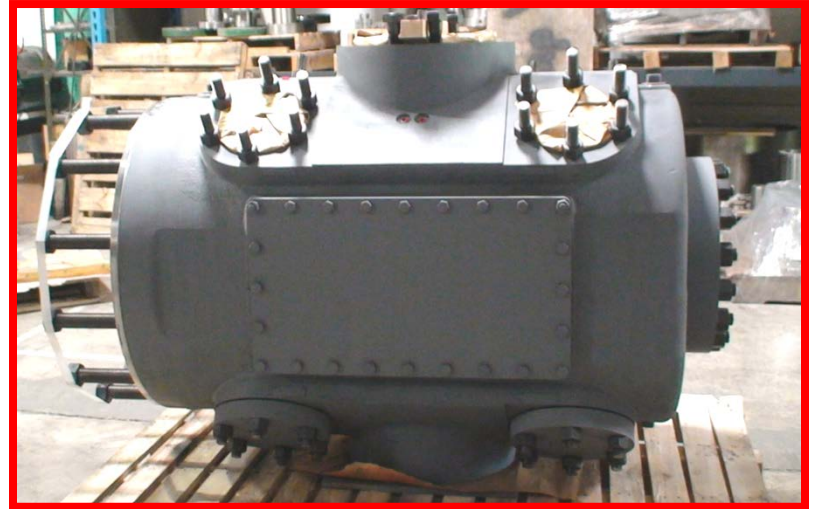
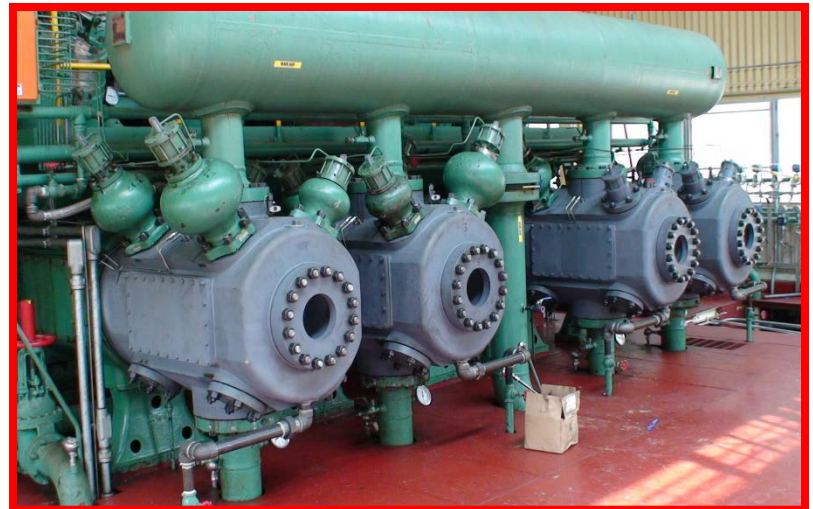
The Solution: Valve-in-Barrel™ Cylinder Body Design

Improves reliability and safety

- Gasket elimination reduces possible gas and coolant leaks thus increasing safety
- Fewer and more accessible fasteners reduce maintenance, labor, downtime, and frustration

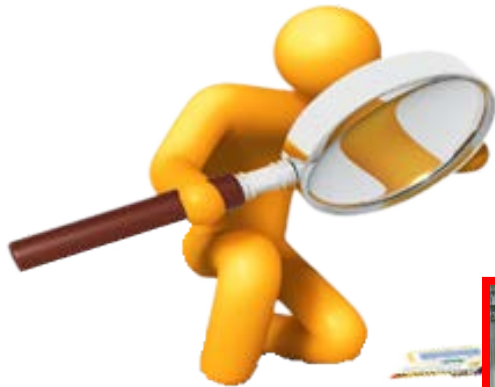
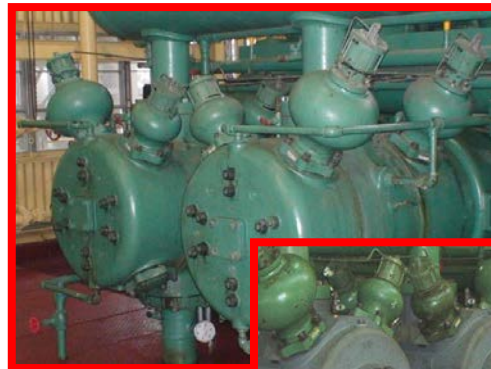
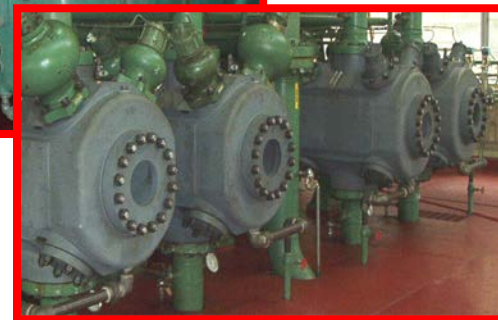
Increasing Cylinder Working Pressure

- Cooper Bessemer GMVA-10 integral compressor
- natural gas storage/withdrawal
- required higher MWP (1100 -> 1200 psig)
- problematic OEM valve-in-head design
- required bolt-in replacement (same connections)

- cast ASTM A395 ductile iron cylinder
- valve-in-barrel design – eliminated large gaskets
- “bolt-in” replacement
- utilized/refurbished existing valves and packing
- rerated/refurbished existing clearance pockets
- air cooled / non-jacketed
- 12.0 in. (304.8 mm) bore diameter
- 14.0 in. (355.8 mm) stroke
- 1200 psig (82.7 bar) MWP
- (16) cylinders replaced on (4) compressors

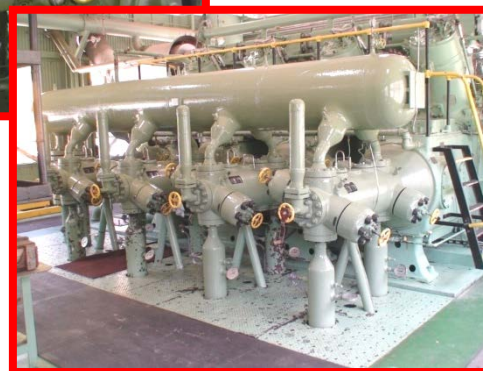
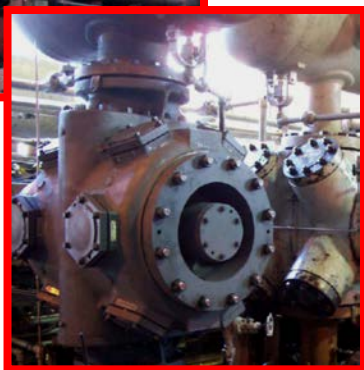
- Cooper Bessemer GMVA-10 integral compressor
- natural gas storage/withdrawal
- required higher MWP (1800 -> 2000 psig)
- problematic OEM valve-in-head 1940's design
- required bolt-in replacement (same connections)

- cast ASTM A395 ductile iron cylinder
- valve-in-barrel design – eliminated large gaskets
- “bolt-in” replacement
- utilized/refurbished existing valves and packing
- rerated/refurbished existing clearance pockets
- air cooled / non-jacketed
- 7.0 in. (177.8 mm) bore diameter
- 14.0 in. (355.8 mm) stroke
- 2000 psig (137.9 bar) MWP
- (20) cylinders replaced on (5) compressors

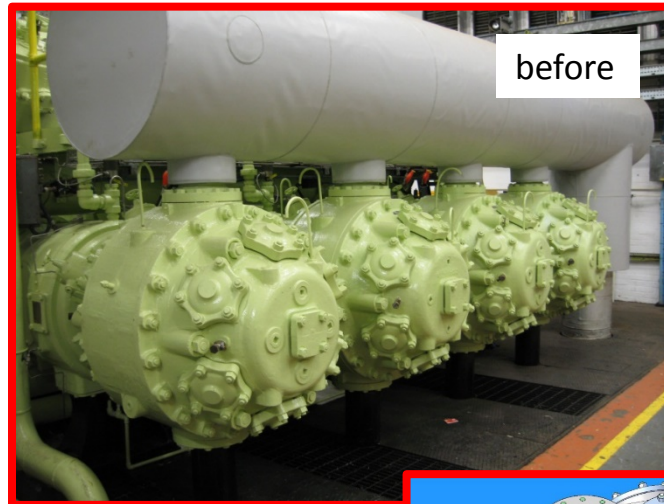
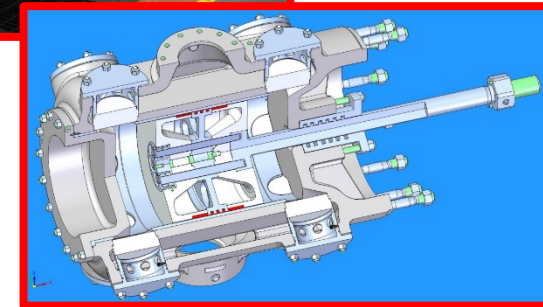
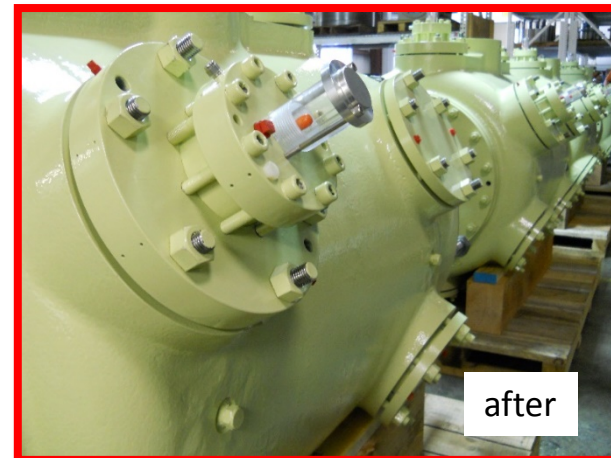
- C-B GMVA-8 Compressors
- closed loop propane refrigeration process
- problematic design
 - metal seals leaked
 - over-tightening cap bolts
 - cracks in multiple valve pockets
- no more used cylinders available
- required bolt-in replacement (same connections)
- OEM had no solution

- cast ASTM A874M ductile iron cylinder
- valve-in-barrel design – eliminated large gaskets
- o-ring valve cap seals – no metal seals
- “bolt-in” replacement
- complete assembly
- air cooled / non-jacketed
- 20.13 in. (511.3 mm) bore diameter
- 14.0 in. (355.8 mm) stroke
- 300 psig (20.7 bar) MWP
- (4) cylinders replaced on (1) compressors
- End user specified ACI cylinders through OEM

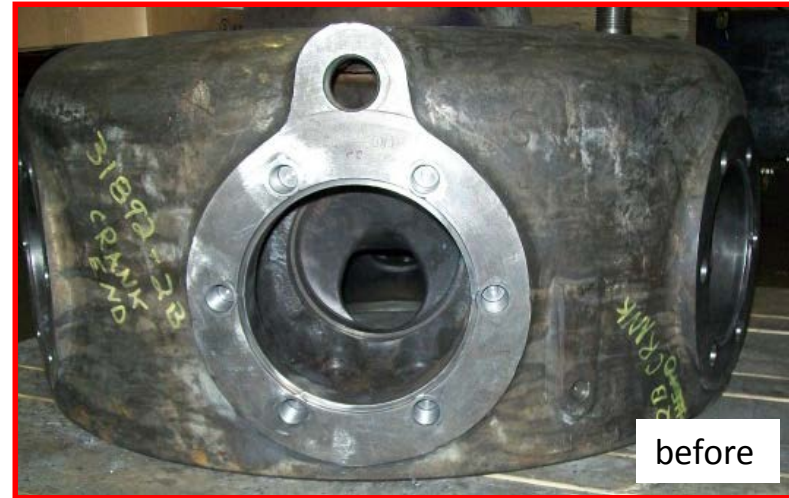
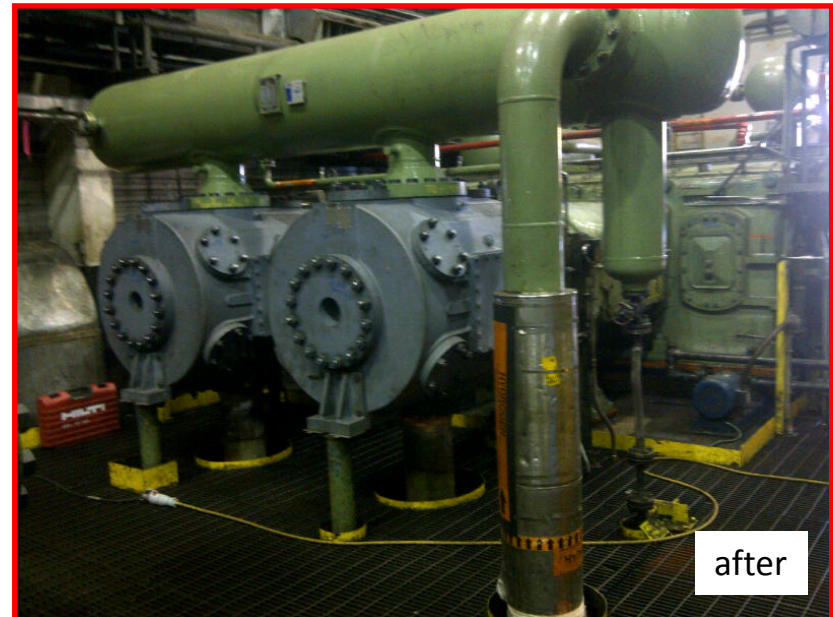
- 2 x C-B KM5 compressors – 4 cylinders
- Hydrogen rich process application
- existing 3-piece cylinder design assemblies were found to be leaking gas – cracks in valve stud holes
- existing cylinders no longer OEM production
- no like cylinders available in used market
- entire facility dependent on compressor operating and therefore down losing \$Millions per day.

- Supplied solution through compressor OEM
- Used an existing ACI design that was in production
- Made urgent design modifications to fit application
- Delivered (4) complete cylinder assemblies within 4 weeks ARO including hydrostatic and helium test.
- Only site modification was lengthening bottle nozzles about 1 in. Otherwise “bolt-in” replacements.
- cast ASTM A385 ductile iron cylinder
- liquid cooled / jacketed
- 14.0 in. (355.8 mm) bore diameter
- 14.0 in. (355.8 mm) stroke
- 1500 psig (103 bar) MWP

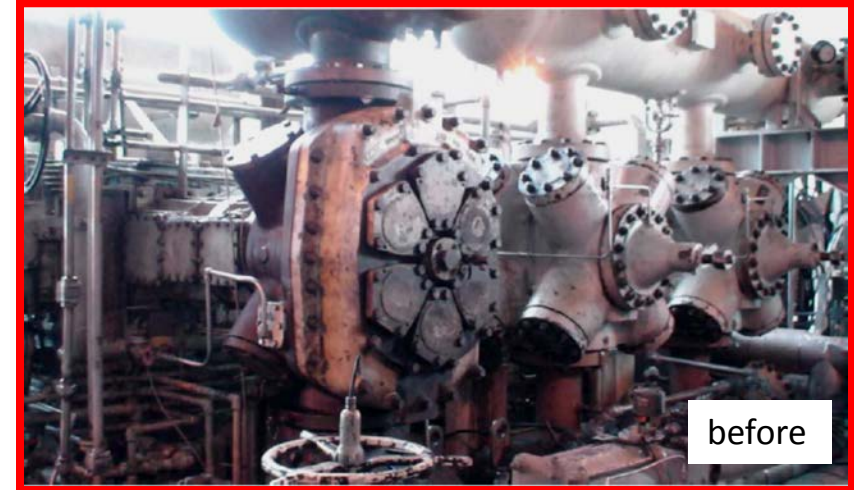
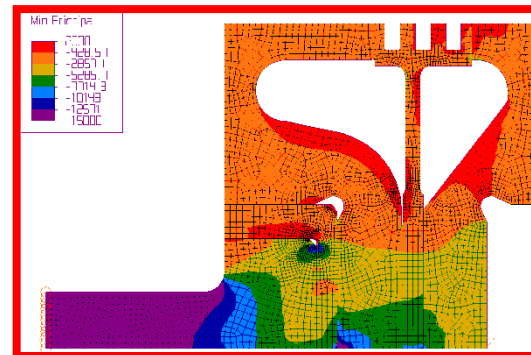
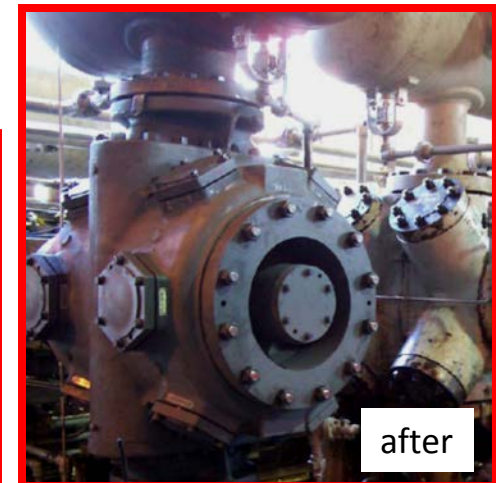
- Superior W76 compressor – 4000 hp (2983 kw)
- offshore sour gas lift
- multiple failed OEM 2nd stage pistons – 8 days!
- operating close to rod load limit
- high operating temperature
- severe safety & production loss issues
- wanted bolt-in replacement (same connections)
- OEM had no solution

- detailed redesign with multiple FEA studies
- temporary aluminum piston solution
- cast ASTM A395 ductile iron cylinder & piston
- better matched 1st & 2nd stages
- “bolt-in” replacement
- special offset adapters
- liquid cooled / jacketed
- 18.13 in. (460.4 mm) bore diameter
- 7.0 in. (177.8 mm) stroke
- 550 psig (37.9 bar) MWP
- also replaced (2) 1st stage cylinders
