Improved seismic-resistant design of adobe houses in vulnerable areas in Peru

- Raising seismic awareness in an Andean
community

Department of Engineering Sciences, Construction Engineering,
Uppsala University
Bachelor's Degree project 2015

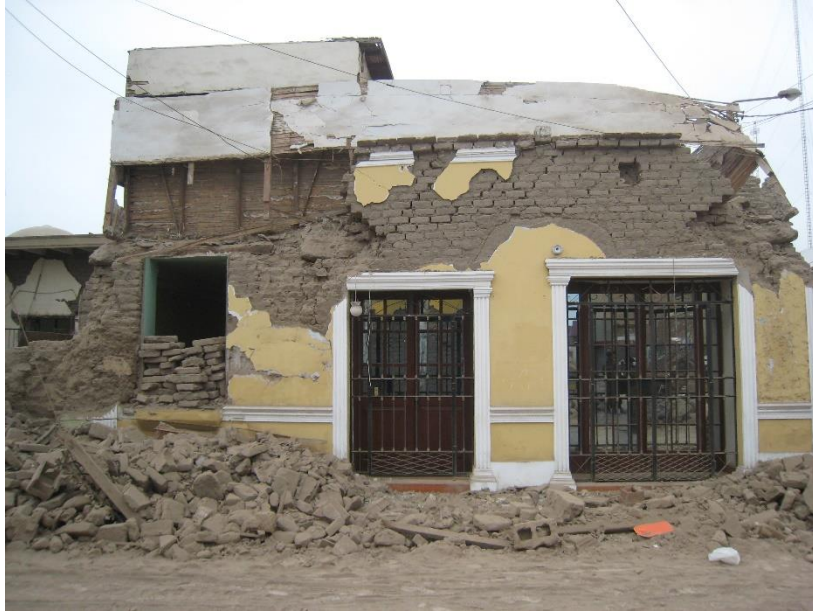
Figure 1.1: Adobe house destroyed by earthquake in Pisco 2007 (Photo: M Blondet)

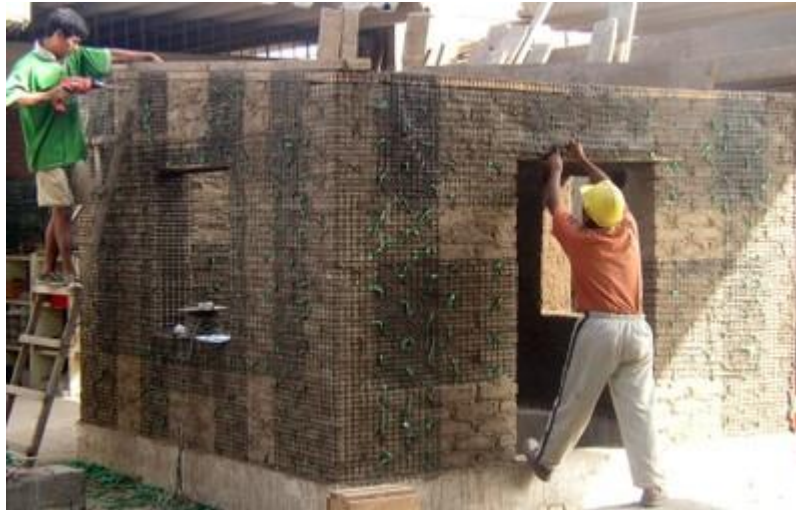
Figure 1.14: Adobe walls reinforced with polymer mesh (GEM Admin, 2013)

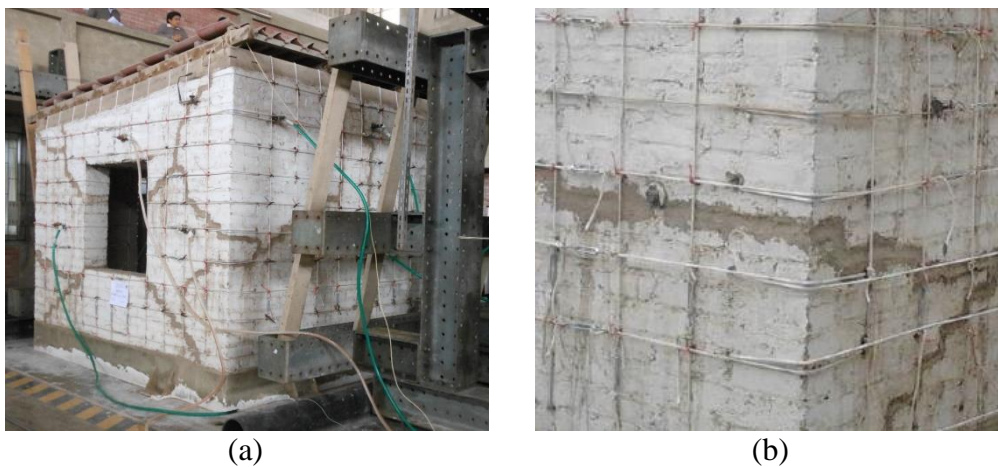
houses (Figure 1.16a). The system consists of covering the walls with equally spaced, horizontal and vertical ropes, tensioned with turnbuckles (Figure 1.16b). It was shown that the reinforcement helped to maintain structural integrity and stability. Furthermore, it prevented partial collapse and separation of the walls during shaking (Blondet, Vargas, Sosa, & Soto, 2014). A disadvantage of the mentioned method was the cost of the metallic turnbuckles. To overcome this disadvantage, it was decided to replace the expensive tensioning material. This was thought to be done by including simple knots that could add and maintain the necessary tension on the ropes, providing stability to the adobe houses. It is expected that without this element the reinforcement's price could be reduced while preserving its safety and effectiveness (Blondet, Vargas, Sosa, & Soto, 2014).

Figure 1.16: (a) Reinforced full scale model. (b) Detail of the reinforcement (Blondet, Vargas, Sosa, & Soto, 2014)

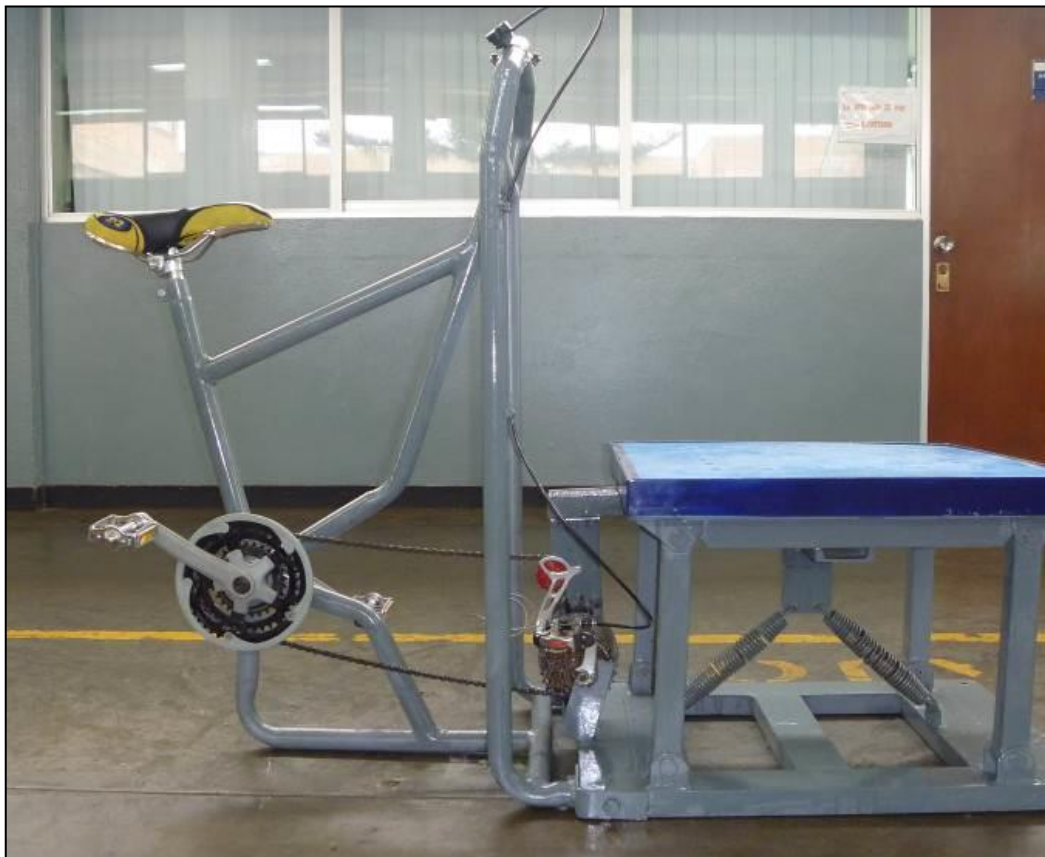
Figure 1.17: The Portable Shaking Table (Blondet & Rubiños, 2013).

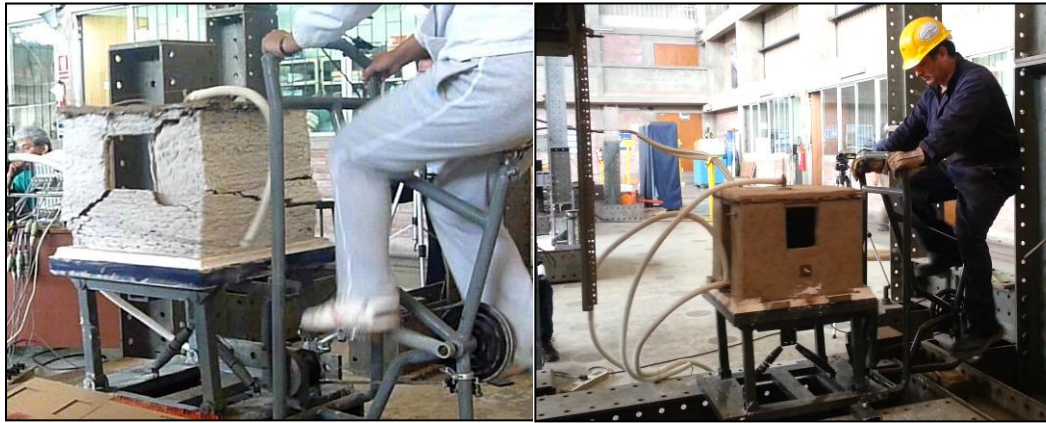
In 2011- 2013 two scaled adobe houses were built and tested in the lab of PUCP. The models had 580 mm² base and 350 mm in height (Figure 1.18). The construction was made with traditional adobe. One of the models was reinforced with a plastic-wrapped mesh and covered with mud plaster. The models were first built on a wooden platform and then moved to the shaking table. The construction of the models took seven days. The unreinforced house showed failures similar to real adobe houses during earthquakes. The improved model had excellent seismic performance (Blondet & Rubiños, 2013).

Figure 1.18: To the left: Test of unreinforced model in 2011. To the right: Test of reinforced model in 2013 (Blondet & Rubiños, 2013).

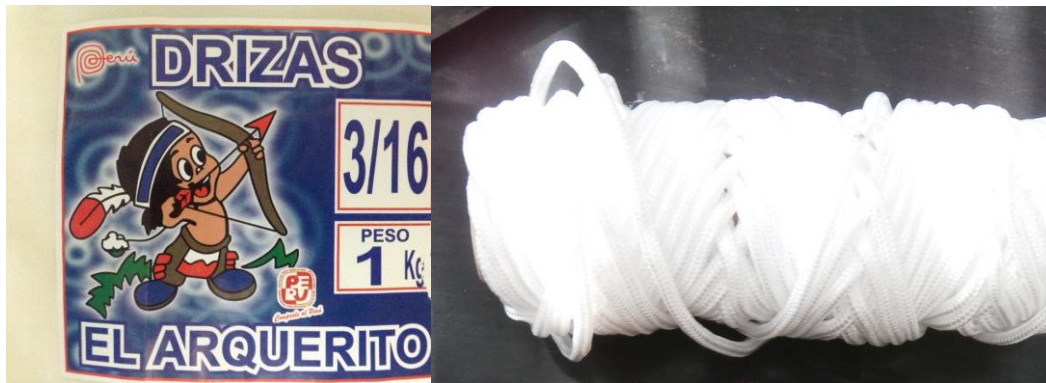
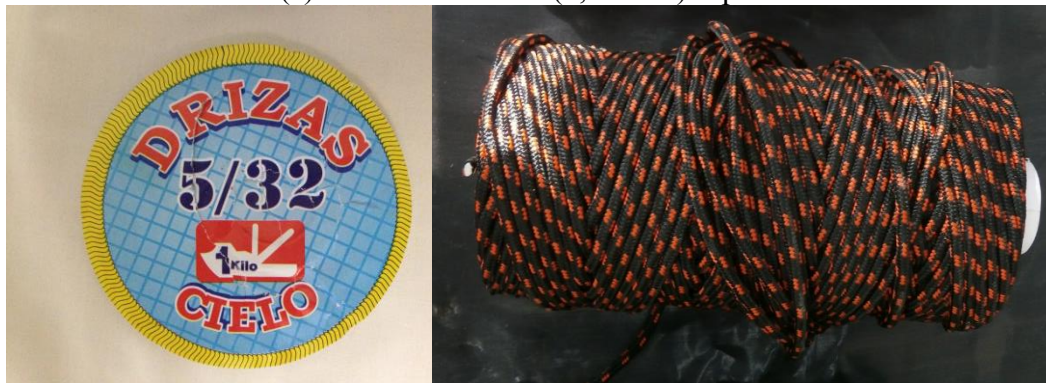
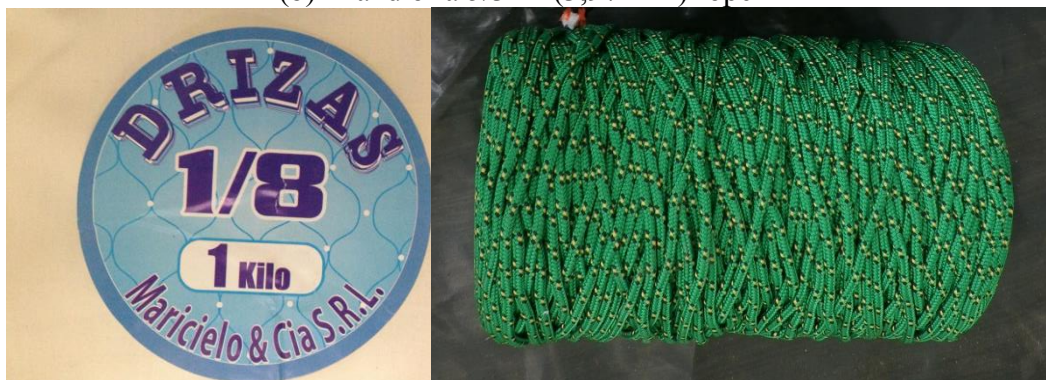
Figure 2.1: Different rope brands common commercially in Peru.

(a) Brand of a 3/16'' (4,76 mm) rope

(b) Brand of a 5/32'' (3,97 mm) rope

(c) Brand of a 1/8'' (3,175 mm) rope

The tests of the knots were performed with double braided ropes, called halyard, acquired in a local Peruvian market (*Las Malvinas*). The ropes are common commercially on the Peruvian market. The dimensions of the ropes were chosen in case of availability. Three of the used ropes are depicted in Figure 2.1 In Peru, rope is sold in English units (1/2", etc.). Henceforth the dimensions will be given in the metric system.

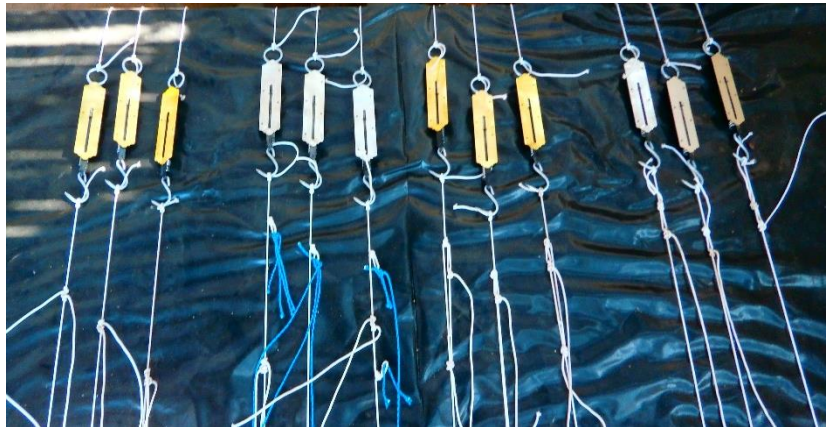
The experiments were done at a temperature varying between 18-20 degrees Celsius (night and day temperatures in Lima in April) by manually tying each sample to a 1,25 meter wide table (which serves the purpose of simulating the boundary conditions of the adobe walls) (Figure 2.18).

Figure 2.18: Manually test of initial tension and relaxation over time

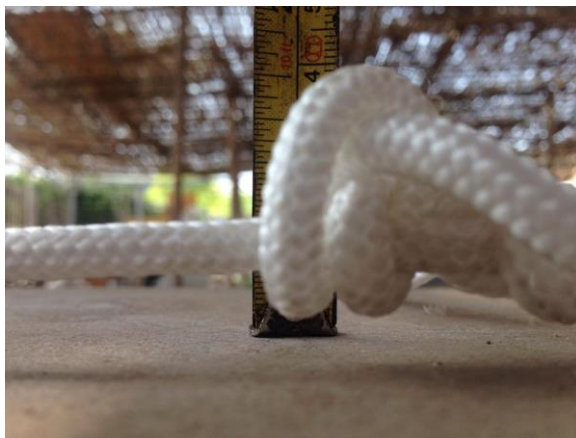
The sizes of the combined knots were determined with a simple measuring tape. Each knot was measured from table level up to highest point of the knots (Figure 2.21). The knots criteria for the knot sizes were marked accordingly Table 2.12.1.

Figure 2.21: A knot measuring 4 cm from table to highest point.

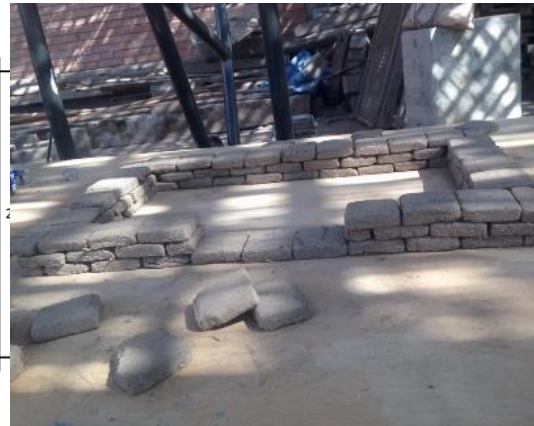
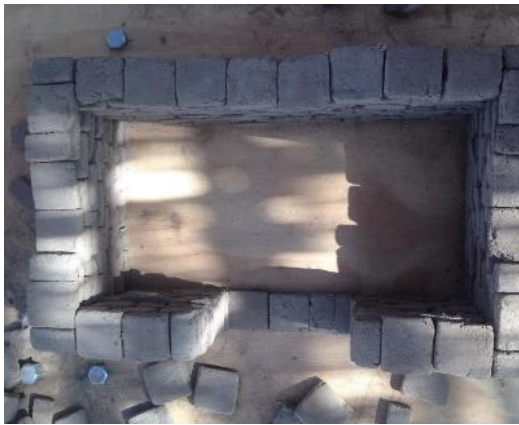
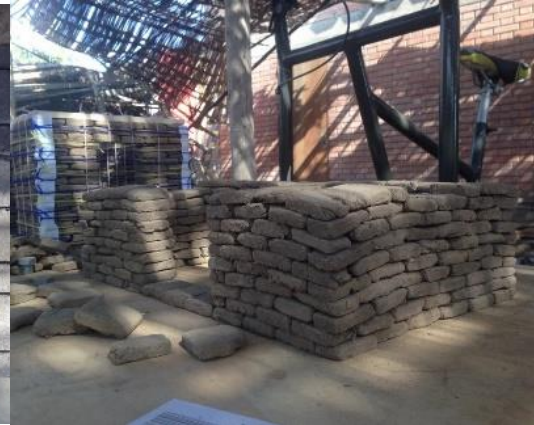
Figure 2.33: Construction of the non-reinforced house model

(b) Bricklaying that overlaps, creating joints

(c) The house progress

(d) The house progress

Figure 2.33 shows the construction of the model including how the bricks overlap. One long side included a door. A window was constructed in both short side walls. The lintels of the openings consisted of thin wooden slats similar in width as the adobe bricks. Table 2.4 summarizes the characteristics.

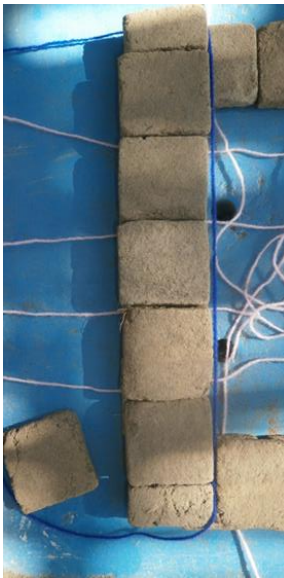
Another difference between the models were use of crossties. In the first model crossties were implemented to stabilize the walls, nevertheless it was found not making a great impact in testing. Moreover, the crossties were difficult and time consuming to preform considering the small scales of the models.

(a) Vertical (pink strings) and horizontal reinforcement (blue string)

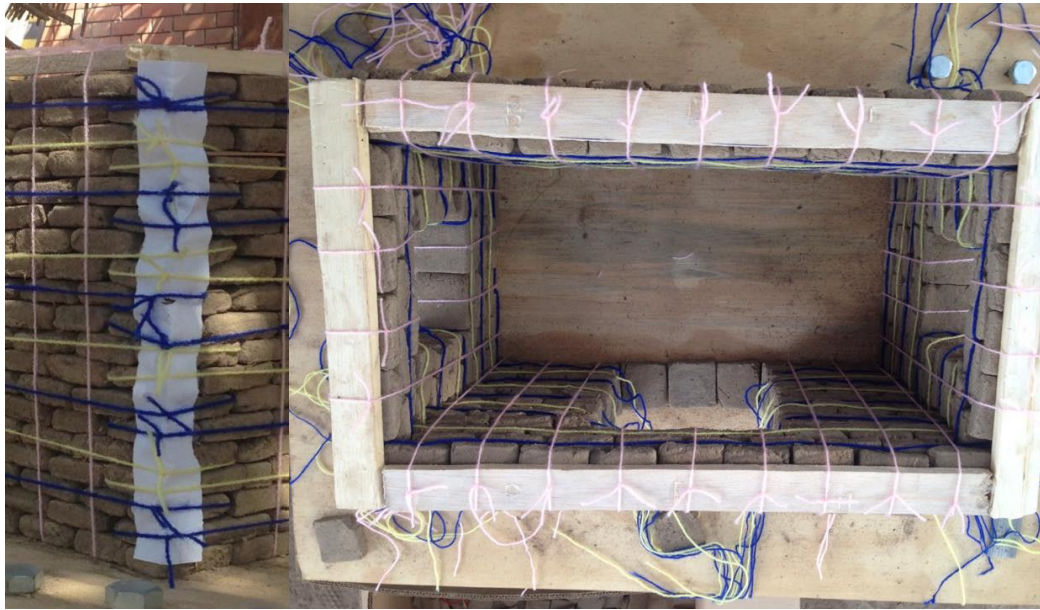
(c) Paper put on corners

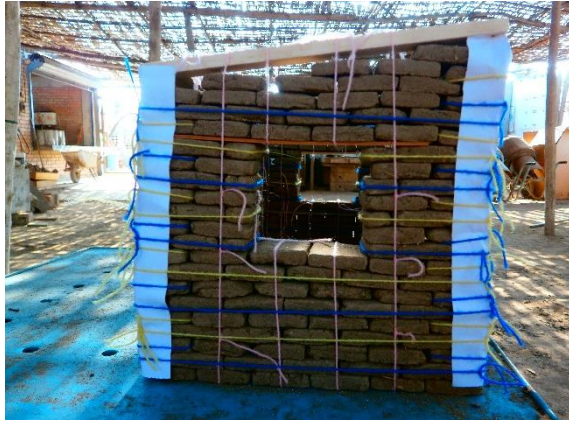
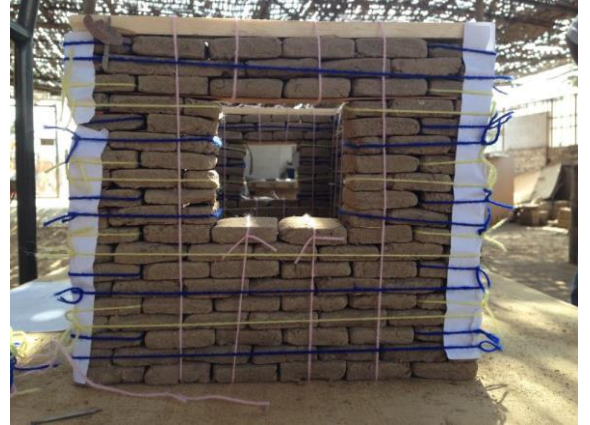
Figure 2.37: Differences in roof appearance

(a) Lent to roof

(b) Flat roof

To improve wall stability and prevent brick-separation at upper parts of the walls, the roof slope of the first model were flattened in sequential tests (Figure 2.37 2.37). Figure 2.38 show the finished models, and Table 2.5: **Characteristics of two reinforced adobe house models (Model 2 and 3)** enumerates in detail the characteristics of the Model 2 and 3.

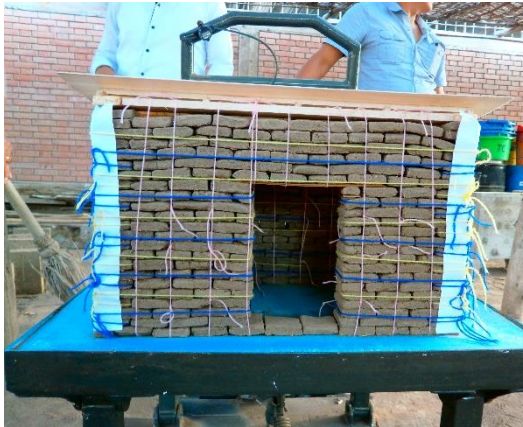
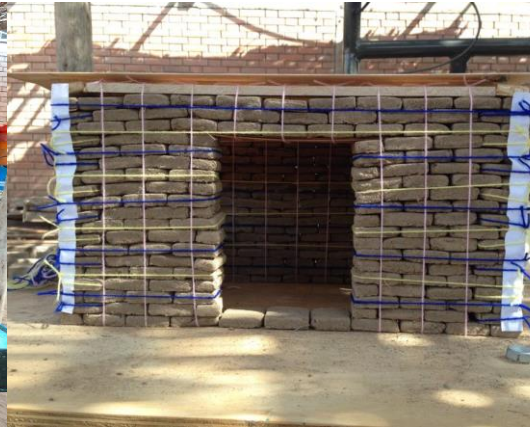
Figure 2.38: The fronts of the reinforced models

(a) Model 2

(b) Model 3

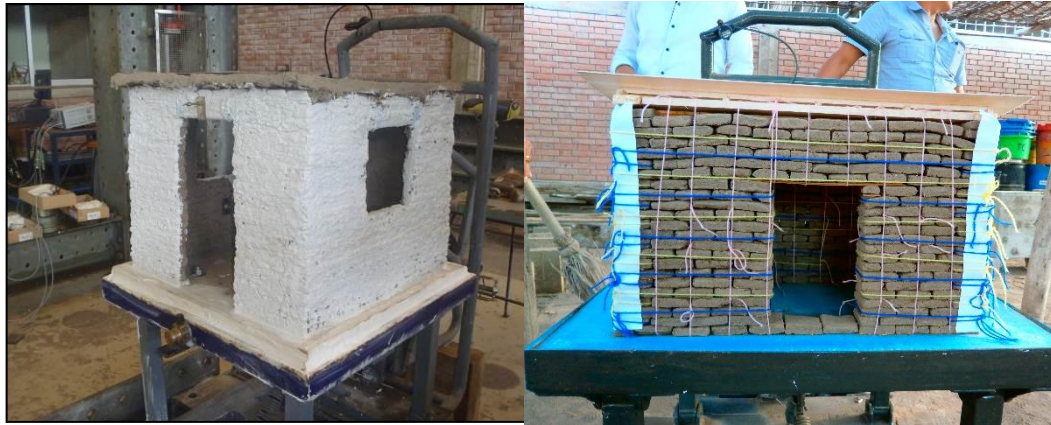
Figure 3.11: To the left shows previous reinforced test model, including mortar. To the right, the new reinforced model.

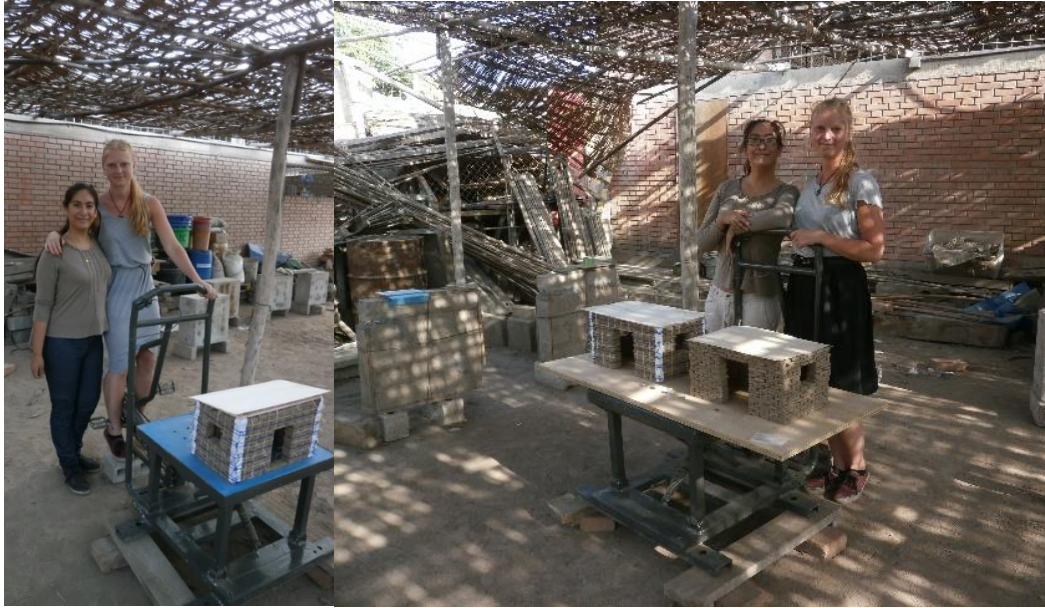
Figure 3.12: To the left, the previous shaking table allowing testing of one single model. TO the right, showing the extended table allowing parallel demonstration.

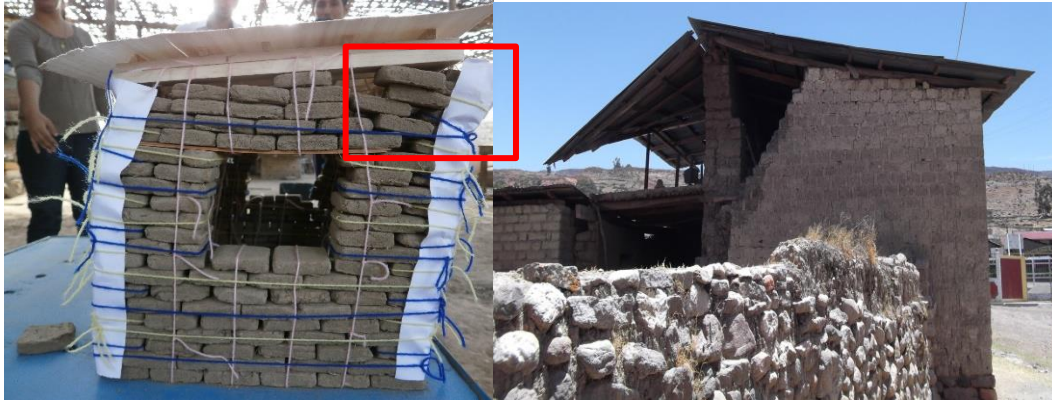
Figure 3.13: Partial collapse of walls and roof

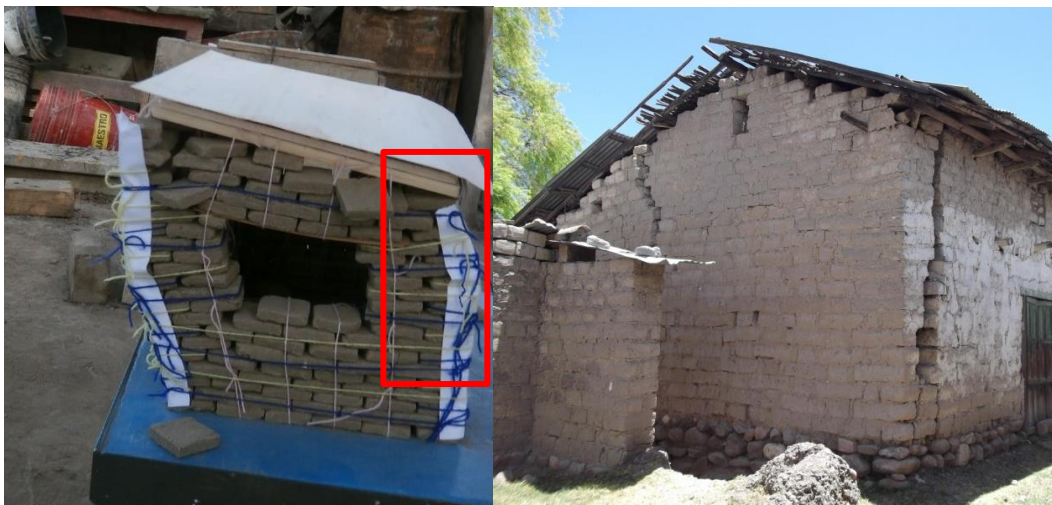
Figure 3.14: Vertical cracking in walls

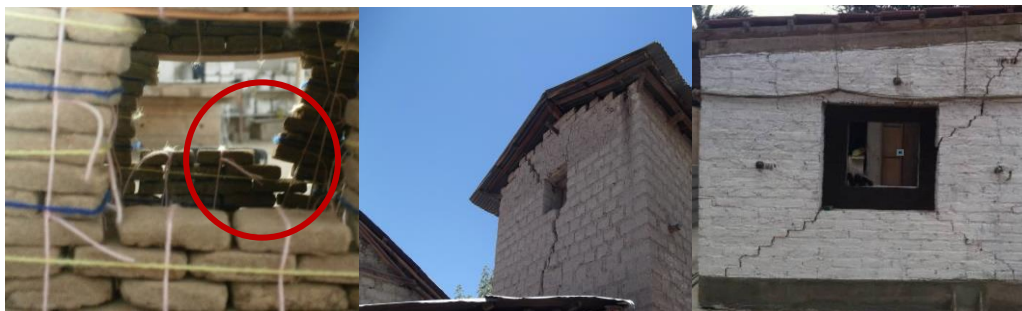
Figure 3.15: Diagonal cracking at opening (Blondet, Vargas, Sosa, & Soto, 2014) (Cribilleros, et al., 2014).

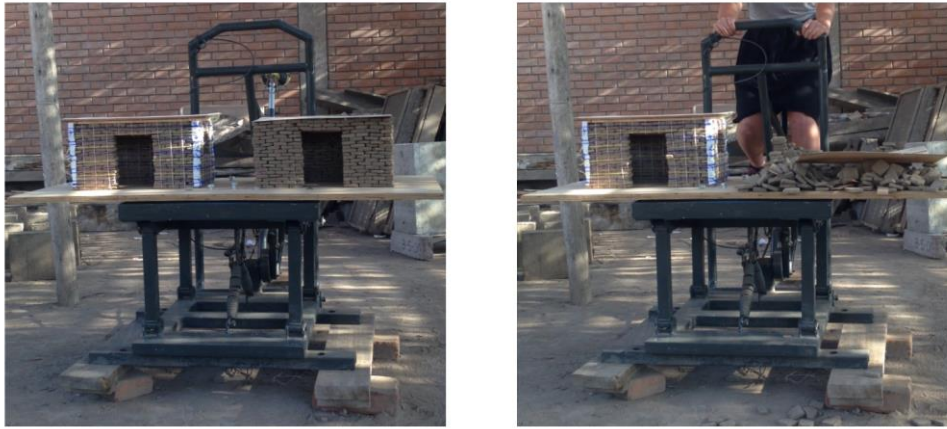
Figure 3.16: Left picture show the models about to be tested. The right picture show the collapse of the non-reinforced model.

The testing results showed that the yarn provided the reinforced house model from collapse whereas the unreinforced house model collapsed immediately (Figure 3.163.16). To improve the transference of awareness, and to evaluate the outcome of an in-site demonstration, questionnaires and open discussion

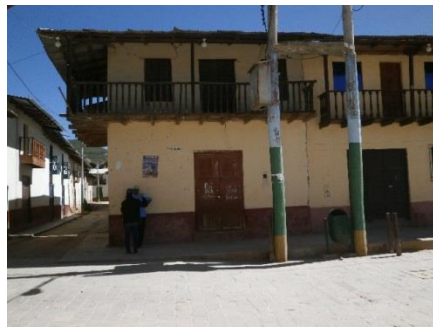
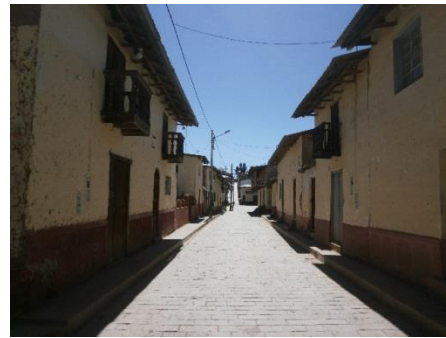
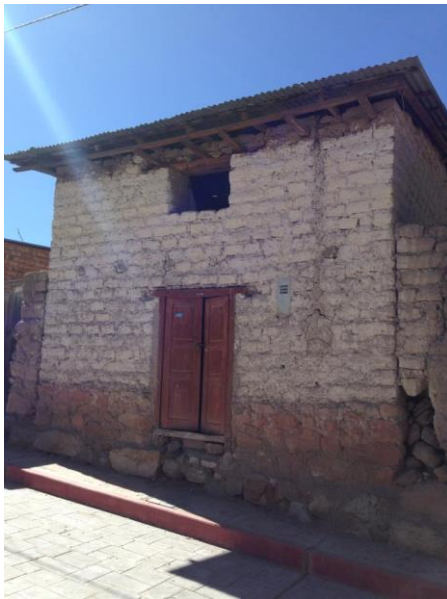
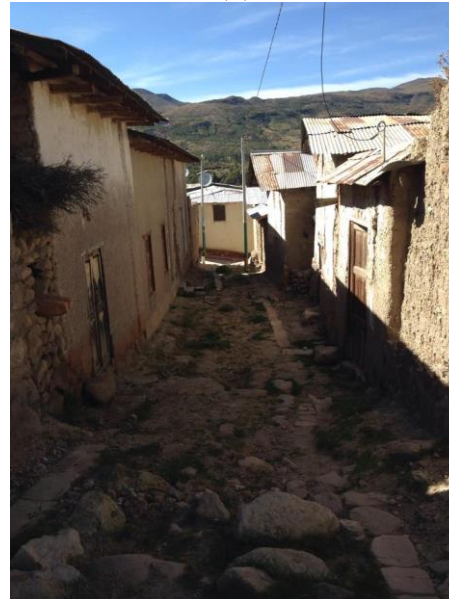
Figure 3.22: Typical adobe houses in Pullo; (a) and (b) houses close by the center of the village whereas (c) and (d) show houses further away

From a visual perspective there are two house types in Pullo. When studying the houses closer, it is found that the two typical houses have many similarities. In fact, the difference lies in its location. People inhabiting houses on the main square, or close by, was found having greater need to maintain their houses. Therefor significant damages from the earthquake was not to be found, and a sufficient layer (ca 25 mm) of colored mud plaster gypsum covered the facades. Figure 3.22a-b shows the area close to the main square and Figure 3.22c-d quarters further out from the center.

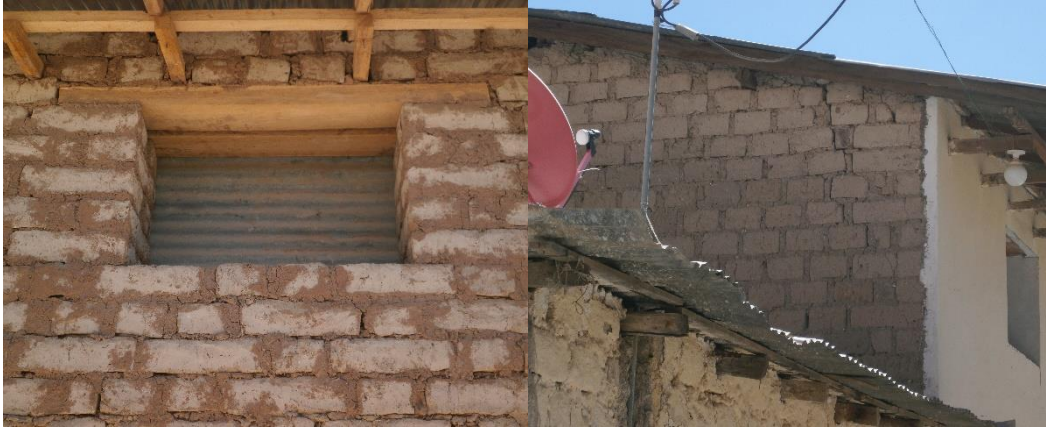
Figure 3.23: To the left the American style, and to the right a traditional brick laying.

In general, the construction of the houses is performed with two types of brick lying; the traditional (a technique used in the small scale models) and an American style (*Amare Americano*) (Figure 3.23). The traditional technique is performed with square bricks, with dimensions of for example $40 \times 40 \times 10 \text{ mm}^3$, whereas the American style are built with rectangular bricks, dimensioning for example $40 \times 20 \times 10 \text{ mm}^3$. The American style is thought to be more vulnerable to seismic forces, as the walls gets thicker leading to a greater massiveness and brittleness.

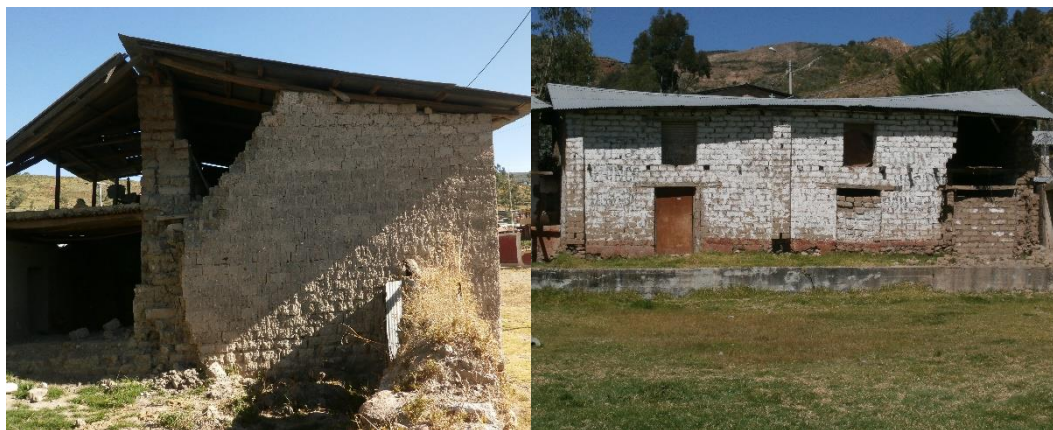
Figure 3.25: Partial wall collapse

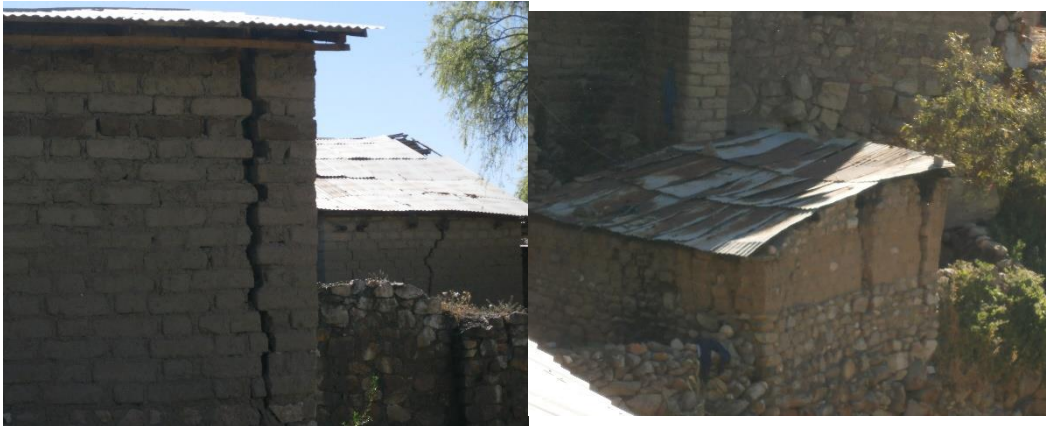
Figure 3.26: Vertical cracking

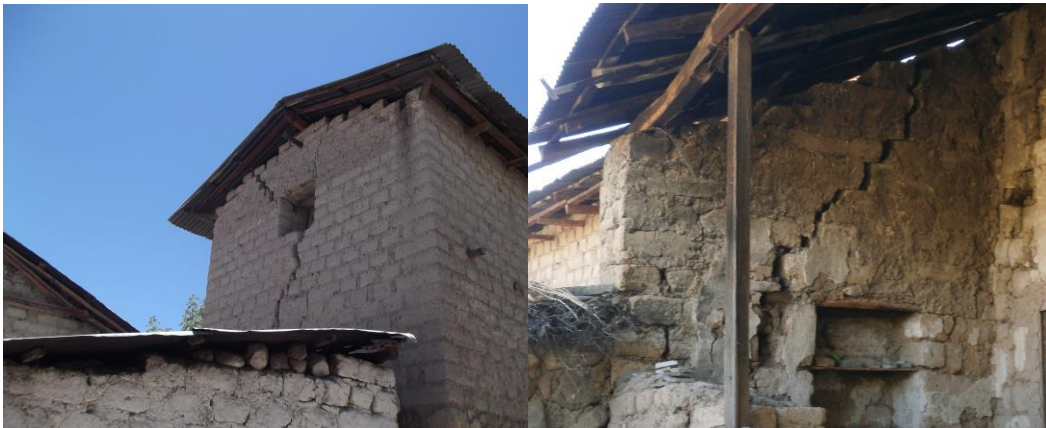
Figure 3.27: Diagonal crack near openings

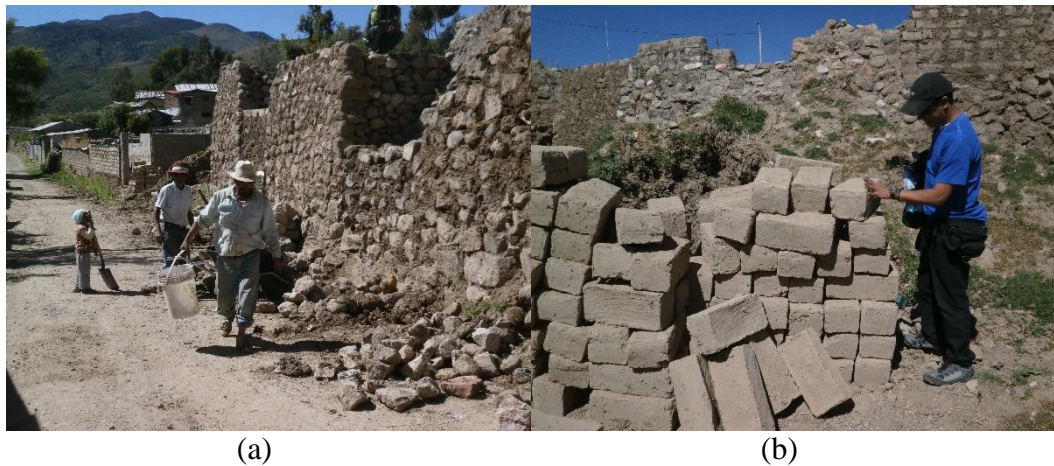
(a) (b)
Figure 3.29: (a) reconstruction of a wall damaged in the earthquake and (b) the adobe bricks used to do so.

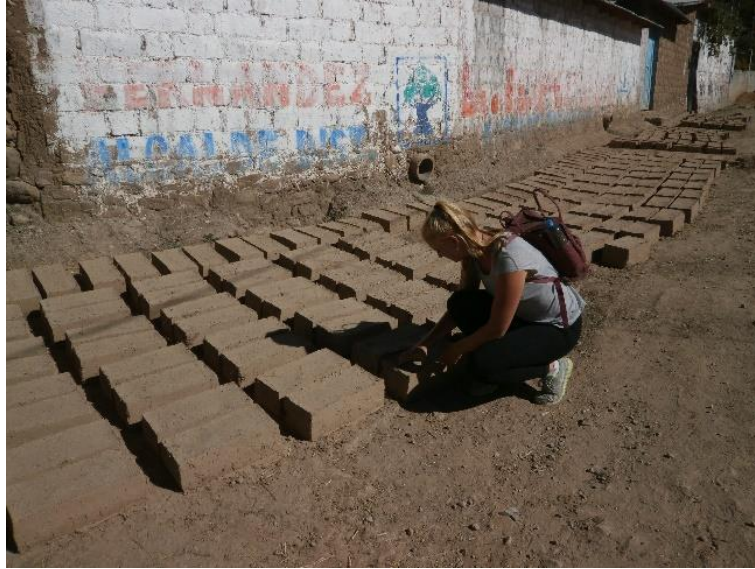
Figure 3.30: Drying site for adobe bricks

The drying site of the sold adobe bricks was found, as shown in Figure 3.30. The ground was dry and clean, but the site had no protection for wind nor rain which can lead to great decreases in sustainability of the bricks.

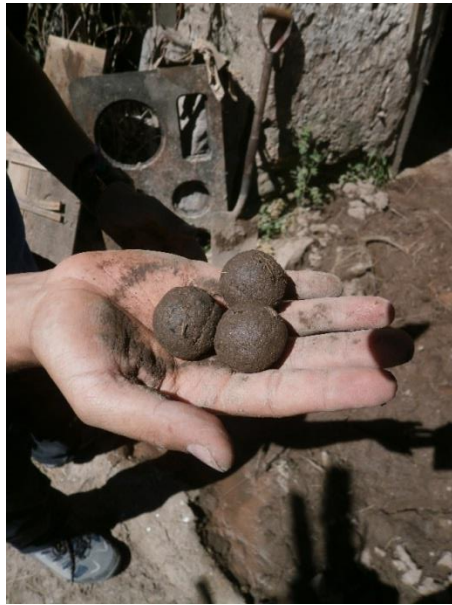
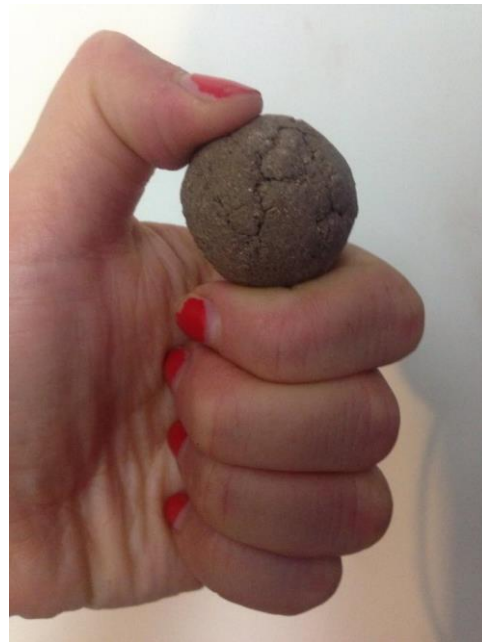
Figure 3.31: (a) Making mud balls, 20 mm in diameter, (b) trying to crush the ball between thumb and index finger.

The damages of adobe bricks around the village indicate that the soil selection is poor and causes low-resistant bricks. To investigate the soil properties, a sample of prepared mud plaster (Figure 3.31a) was tested by the dry strength test. It was found that the soil had adequate features (Figure 3.31b), a result that was unexpected. The test was taken from a garden belonging to Gamaniel Chilcilches Orio, the judge of piece of Pullo, as he at the time was building an improved kitchen. The preparing of mud plaster and the improved kitchen can be found in Figure 3.32. Gamaniel was well familiar with the importance of making a drying strength test. An additional test sample of soil was brought to PUCP's lab for further analysis.

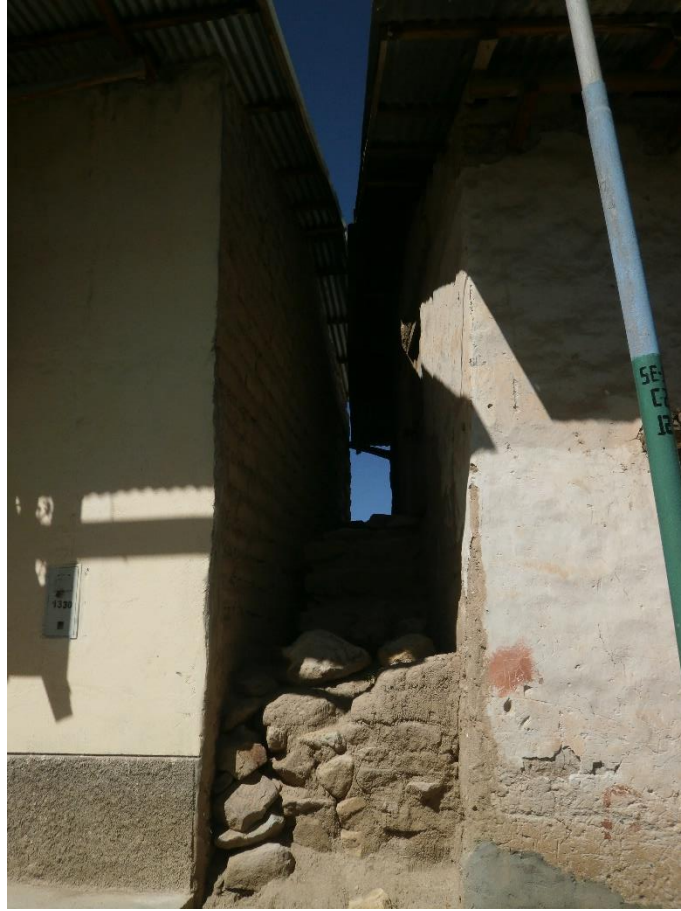
Figure 3.34: Buildings are not tied together

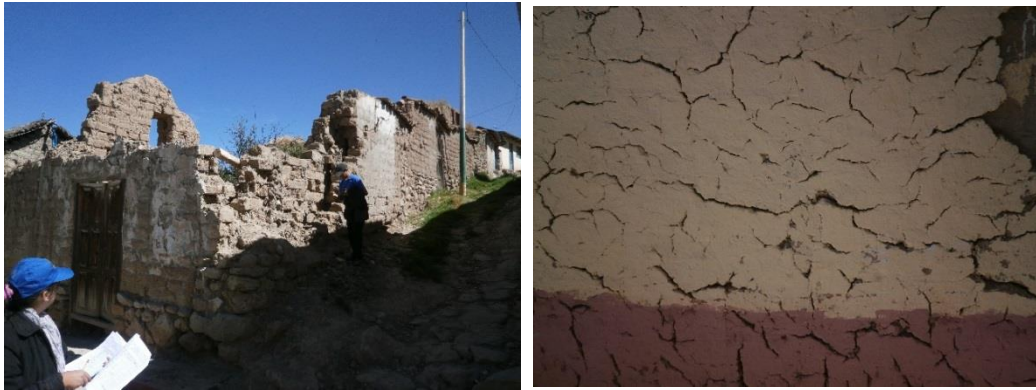
Figure 3.35: Aged house deficiencies

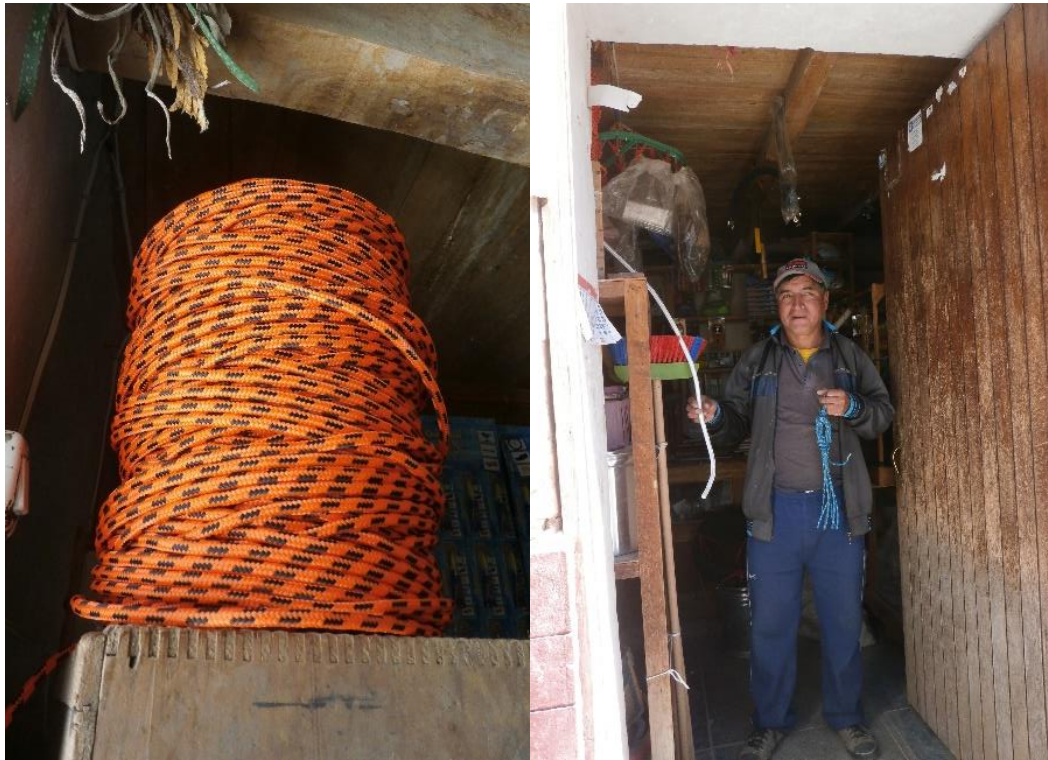
Figure 3.36: The ropes were found in a small miscellaneous shop.

An additional perspective of the investigation was to find how available the proposed reinforcement material (halyard ropes) are. In two small miscellaneous shops, similar ropes to those of the proposed reinforcement system were found (Figure 3.36). In conclusion, the nylon ropes are viable, which by all means is an important finding. Diameters of the ropes were

mainly of greater size than the ones presented in the lab-tests at PUCP. However one rope with diameter of 6,35 mm ($\frac{1}{4}$ "') were found, which is the one used in the full scale model tested in 2013 (Blondet, Vargas, Sosa, & Soto, 2014). The shops did not access more than one cone of rope, and was sold for about 0,3 USD (1 sol) per meter.

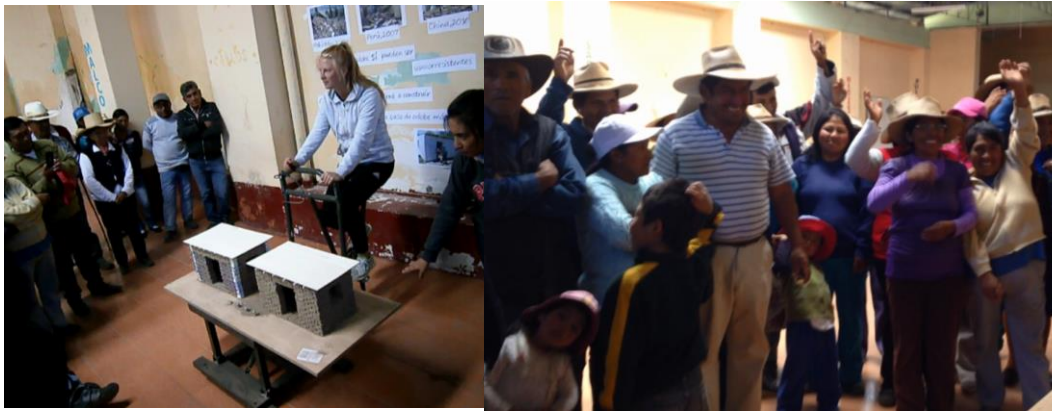
Figure 3.37: Demonstration with the portable shaking table. People raising hand to join the training program.

The portable shaking table created a fun and informal education environment. It is believed that collaboration and interaction was a successfully way to motivate and establish relationships between the inhabitants of Pullo and the research team. In the end of the performance people were asked to raise their hand if believing in improved adobe houses. A majority of the audience raised hand (Figure 3.37). Moreover, bringing elements of the research into field, made the people understand that PUCP are working forward together with them to find better housing solutions.
