Industrial Ergonomics and Workstation Design

Case Study # 1

Assessing lower back pain risks in a beef skinning workstation

Redesign of a Supermarket Check - Stand Workstation: A systematic ergonomics approach

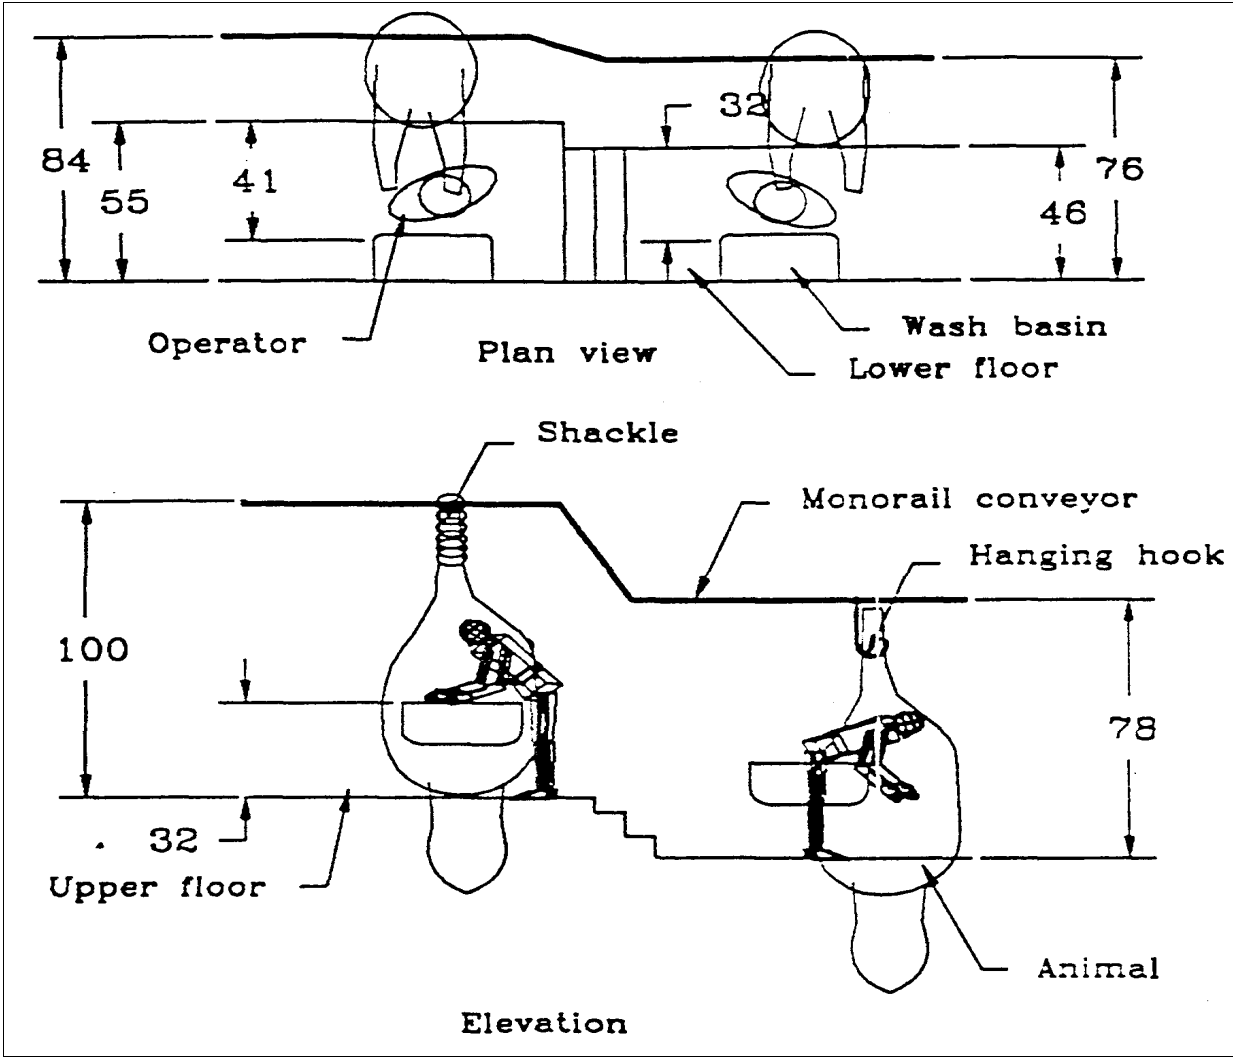
Sketch of the workstation

- In the beef skinning line, an overhead monorail conveyor carried the dead animals through a series of workstations. In each workstation, a specific set of de-skinning tasks were performed in a sequential manner.
- The average processing rate was 500 cows per 8 hour shift. The average cycle time in each station was about 60 seconds.
- A specific portion of the cow was skinned at each workstation, and the tasks performed were repetitive in each cycle.

- The tasks in the workstation did not require use of large physical force.
- The tasks involved skinning the thigh of the animal with a straight knife in normal standing position and then bent over to skin the middle and lower portion with a pneumatic circular knife (weighing about 1.5 Kg, including rubber hose).
- The most demanding task perceived by the workers was skinning the lower portion of the animal where they had to bend beyond waist level for the skinning operation.

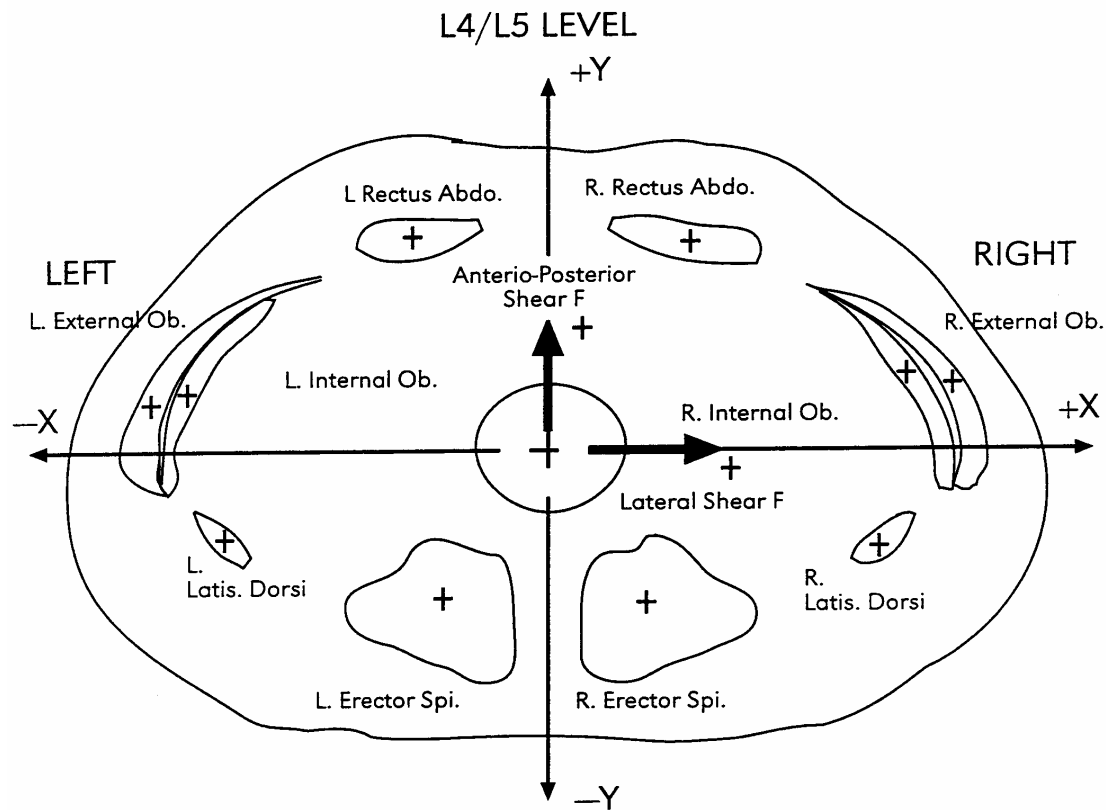
University of Michigan 3D Static Back Model

The two factors considered were biomechanical stress on the lower back and postural effects of bent torso.

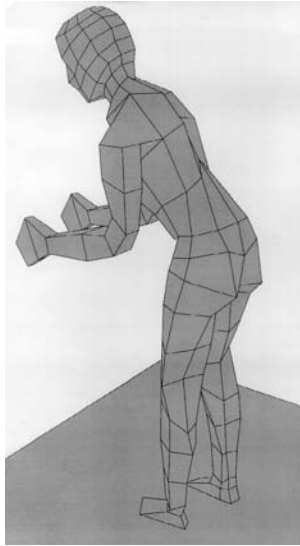
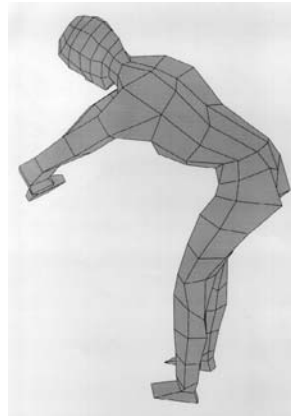
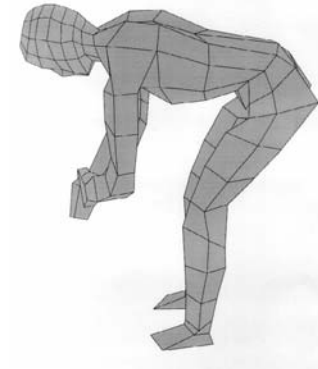
Back models and results

NORMAL SLUMP POSTURE

COMP. FORCE (N)

1574

BENT POSTURE

2164

37%

EXTREME BENT POSTURE

2253

43%

Max. compressive force
was 2253 N which was
66% of NIOSH Back
Compression Design Limit

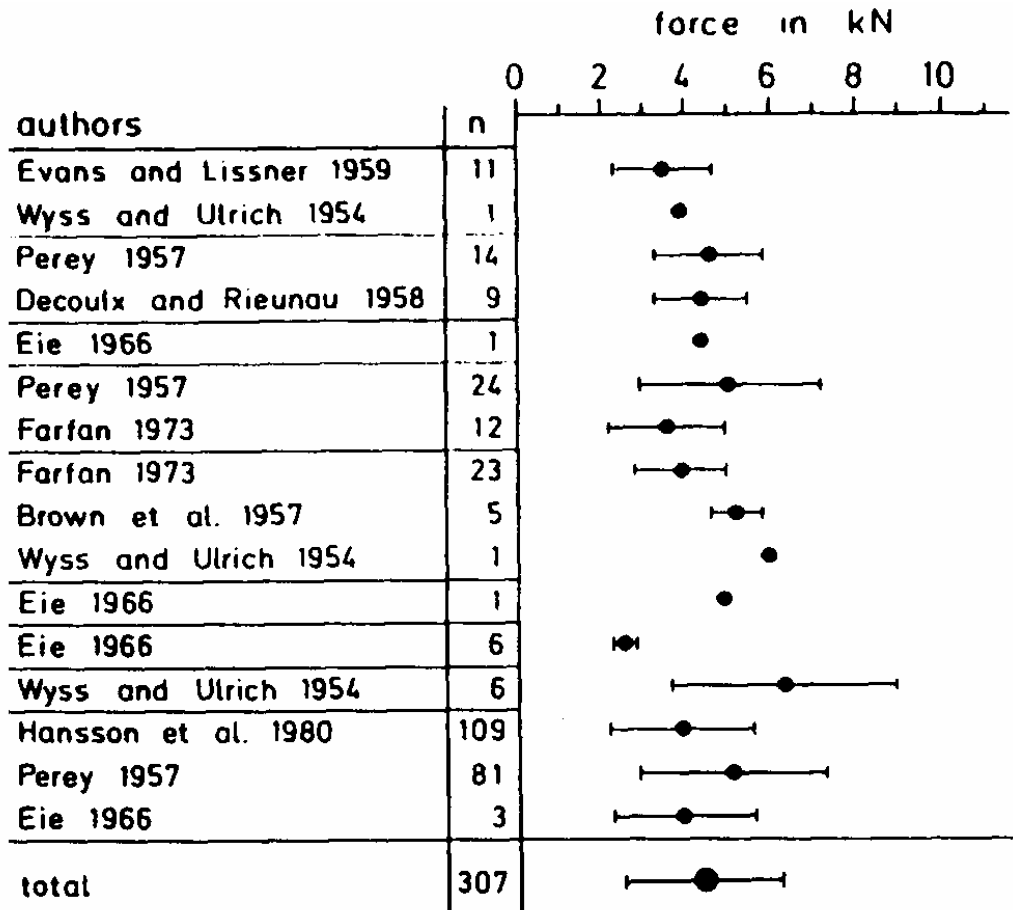
Compressive strength of lumbar vertebrae

NOISH Action limit =
3400 N or 770 lbs

From Jager and Luttman 1989

$$\mu = 4.36 \text{ KN}$$

$$\sigma = 1.88 \text{ KN}$$

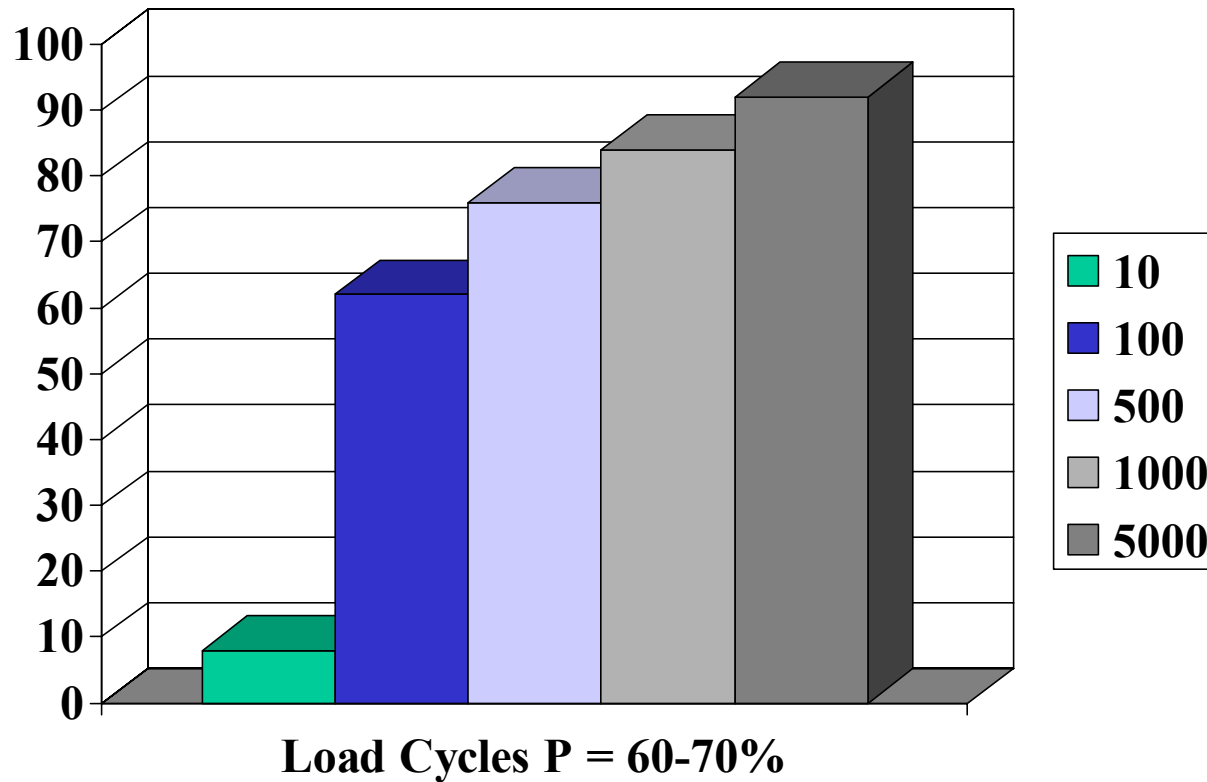
Fatigue fracture probabilities of human lumbar vertebrae at a cyclic load level 60-70% of the static limit (Brinckmann et al. 1987).

- Spine compressive stress of 2253 N with repetition of over 5000 in two weeks constituted high risk of structural failure (90% probability).
- Bent trunk posture was 48% of the cycle time which exceeded the acceptable limit (30%).
- Twisted back posture was 7.5% of the cycle time which was within the acceptable limit (25%)
- Twisted posture with back bent was 10.4% which also exceeded the acceptable limit (5%).
- Actions were needed in near future to alleviate the situation through redesign of the workstation, work method and tools.

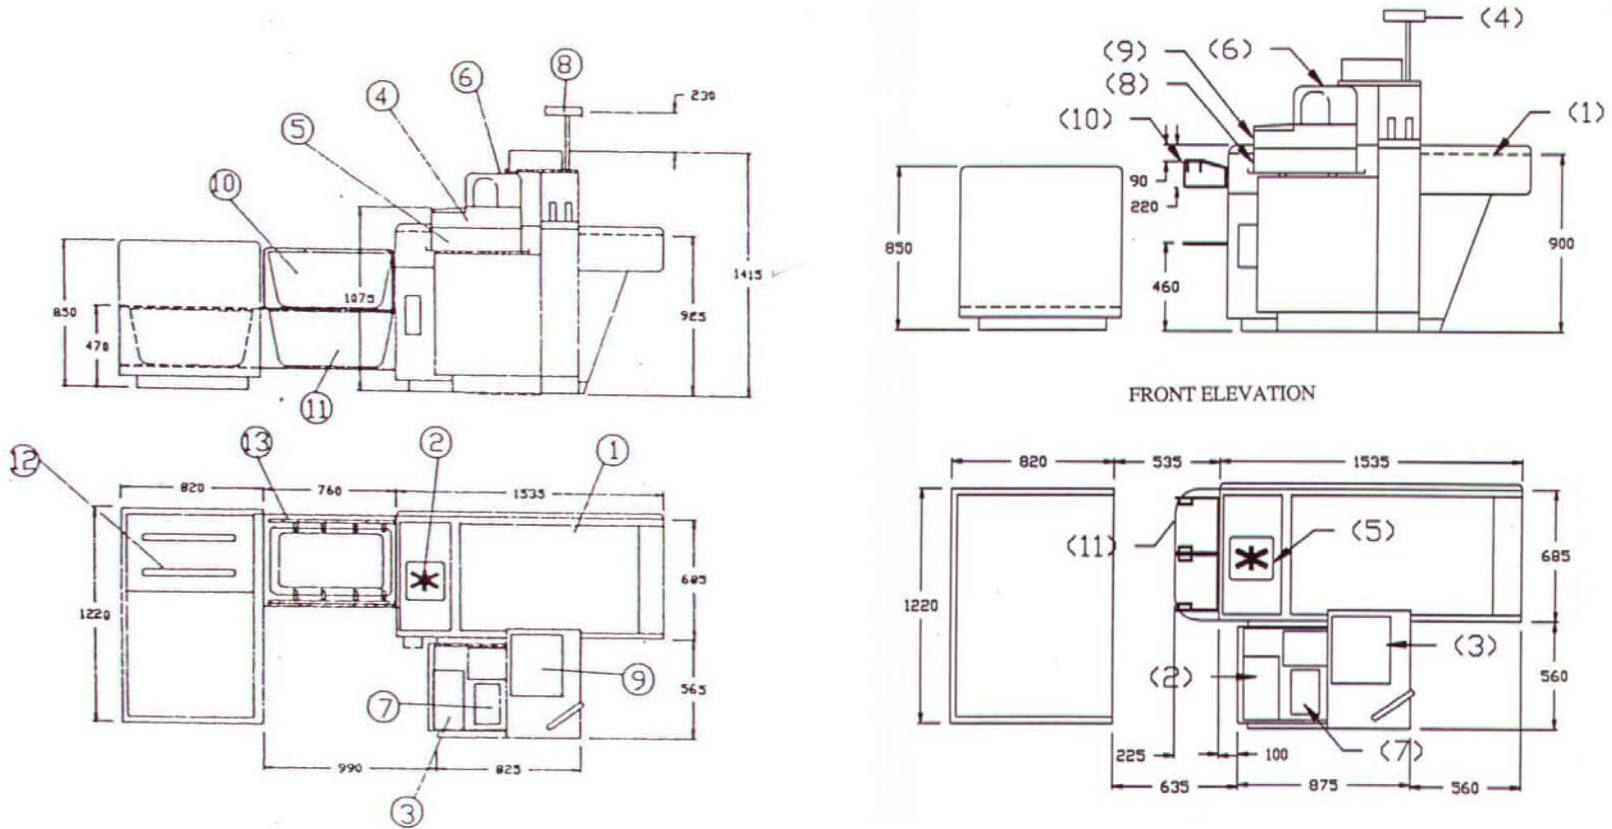
1. Obtain relevant information about the existing system.

- Work height too high for average female operators
- Excessive reach requirements on the conveyor belt
- Bent over or stooped posture
- Continuous turning and twisting to reach keyboard
- Excessive reach requirement to weigh scale
- Frequent turning to read display terminal

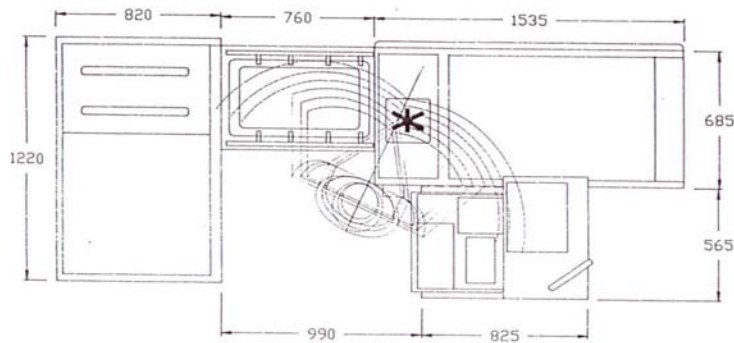
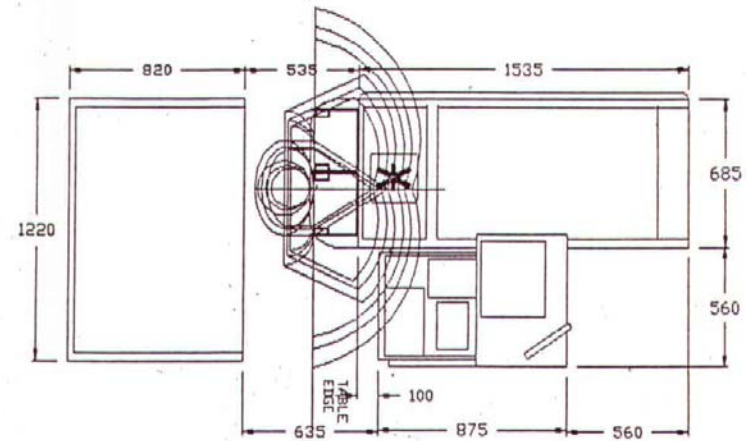
5th, 50th and 95th percentile reach envelopes superimposed on the work surface

- Work surface height was lowered from existing 92.5 cm (+ 15 cm average product height) to 85 cm for 5th percentile female.
- Normal and maximum reach areas for female operators were used to optimally locate the frequently used components of the workstation in forward facing manner.
- Lateral clearances for 95th percentile female was used for placement of keyboard
- Eye height and comfortable angle of vision was used to locate the product price display.
