INVESTIGATING THE USE OF SMALL- DIAMETER SOFTWOOD AS GUARDRAIL POSTS (DYNAMIC TEST RESULTS)

MIDWEST ROADSIDE SAFETY FACILITY
University of Nebraska-Lincoln
527 Nebraska Hall
Lincoln, Nebraska 68588-0529
(402) 472-0965

MwRSF Research Report No. TRP-03-179-07

March 28, 2007

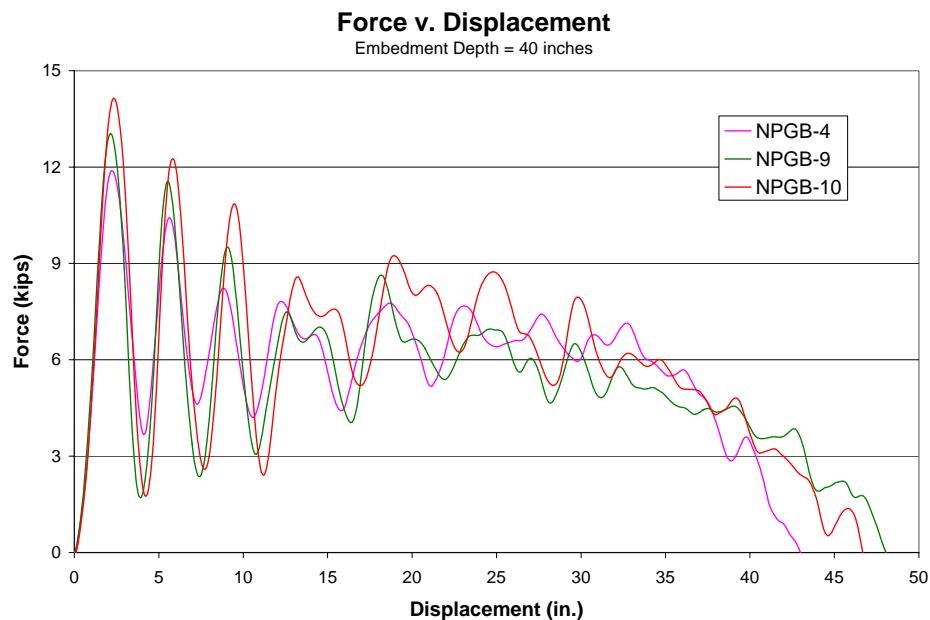
Figure 1. NPGB-4, 9, and 10 Bogie Testing Results

Results from three tests, tests NPGB-4, 9, and 10, are shown in Figure 1. The forces from the tests averaged 29.0 kN (6.52 kips) and 29.6 kN (6.66 kips) at a deflections of 381 mm (15 in.) and 597 mm (23.5 in.), respectively, with local force peaks exceeding that level.

In the tests, it was noted that the shallow posts with a 940-mm (37-in.) embedment depth pulled out of the soil while the majority simply rotated in the soil. The report also showed that more energy was absorbed by the system when the posts rotated in the soil rather than being pulled out of the ground. The total energy absorbed by the rotating posts with a 1,016-mm (40-in.) embedment depth averaged 29.8 kJ (263.8 kip-in.), while that of the posts utilizing a 940-mm (37-in.) embedment depth averaged only 24.9 kJ (220.4 kip-in.), resulting in a 16 percent decrease.

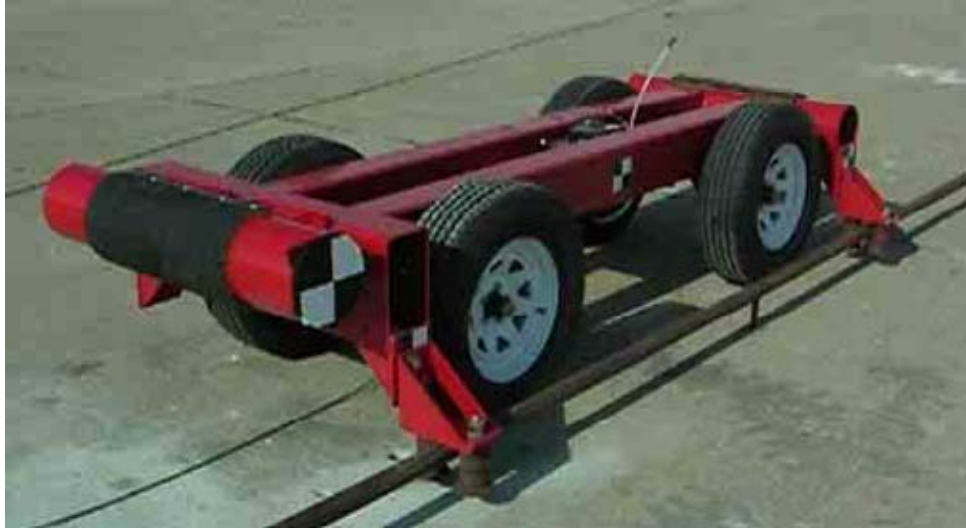
Figure 6. Rigid Frame Bogie on Guidance Track

A rigid-frame bogie was used to impact the posts. A variable height, detachable impact head was constructed and used in the testing. The bogie head was constructed of 203-mm (8-in.) diameter, 12.5-mm (0.5-in.) thick standard steel pipe, with 19-mm (0.75-in.) neoprene belting wrapped around the pipe to prevent local damage to the post from the impact. The impact head was bolted to the bogie vehicle, creating a rigid frame. The bogie with the impact head is shown on the guidance track in Figure 6. Use of this impact head allowed a 632-mm (24.875-in.) impact height, corresponding to the MGS mounting height. The weight of the bogie with the addition of the mountable impact head was 728 kg (1,605 lbs). The speed chosen for the first set of impact tests, 32 km/h (20 mph), approximated the lateral velocity of the posts in a full scale system impact.

A pickup truck with a reverse cable tow system was used to propel the bogie. When the bogie reached the end of the guidance system, it was released from the tow cable, allowing it to be free rolling when it impacted the post. A remote braking system was installed on the bogie allowing it to be safely brought to rest after the test.

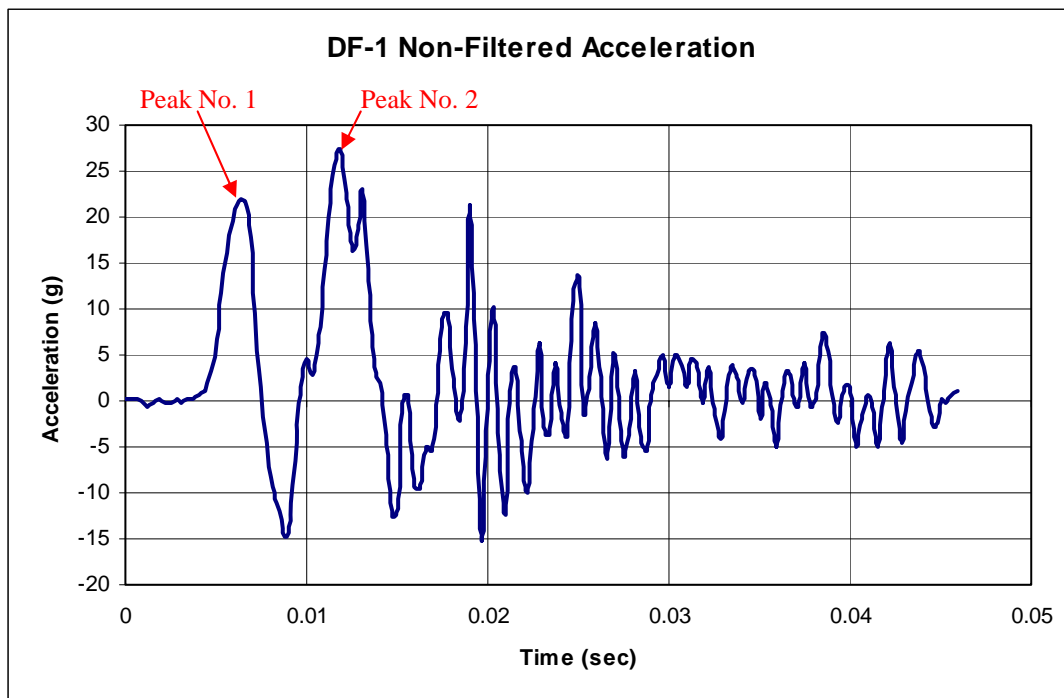
Figure 10. Bogie Test DF-1 Non-Filtered Acceleration

A sample raw acceleration plot is presented in Figure 10. The bogie acceleration trace exhibits two large distinct and separate acceleration peaks. The question was, is wood capable of behaving like this plot suggests?

The data shown in Figure 10 suggested that the wood post reached a peak force, relaxed, and then reached a second peak force, sometimes higher and sometimes lower than the first. The cases in which the second peak was lower than the first suggests that the fibers reached some maximum stress value, relaxed, and then failed at some stress value lower than the maximum reached previously.

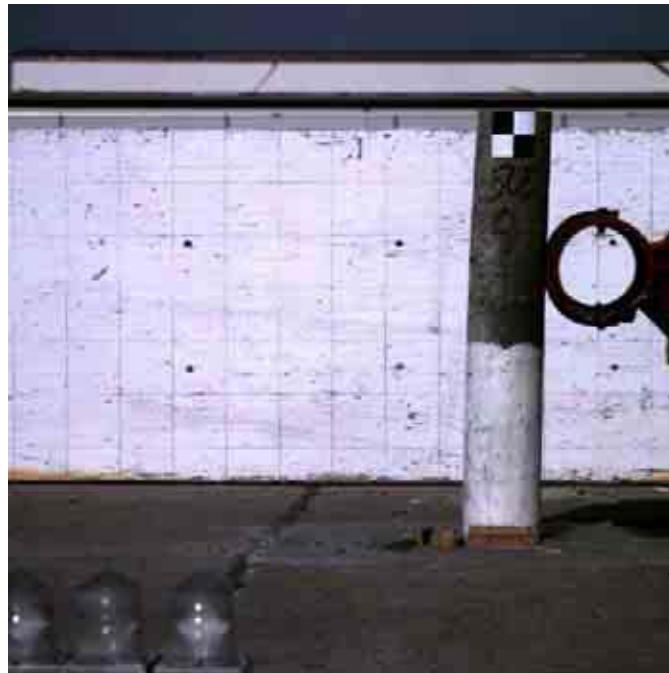
Figure 11. Bogie-Post Impact – Frame 102

To investigate this phenomenon further, the high-speed digital video footage from the post bogie tests was studied. The videos were used to identify the point at which the outer fibers in the posts clearly failed. In many tests, this failure point was very apparent and took place between two consecutive frames. For those tests, the numbers of the two consecutive frames were recorded along with the number of the impact frame or the frame in which the bogie first contacted the post. Examples of all three frames are shown in Figures 11, 12, and 13 for a post with the critical region painted white to show the fracture very clearly. Figure 11 depicts the frame at impact, Figure 12 shows the frame prior to post fracture, and Figure 13 shows the frame immediately after post fracture.

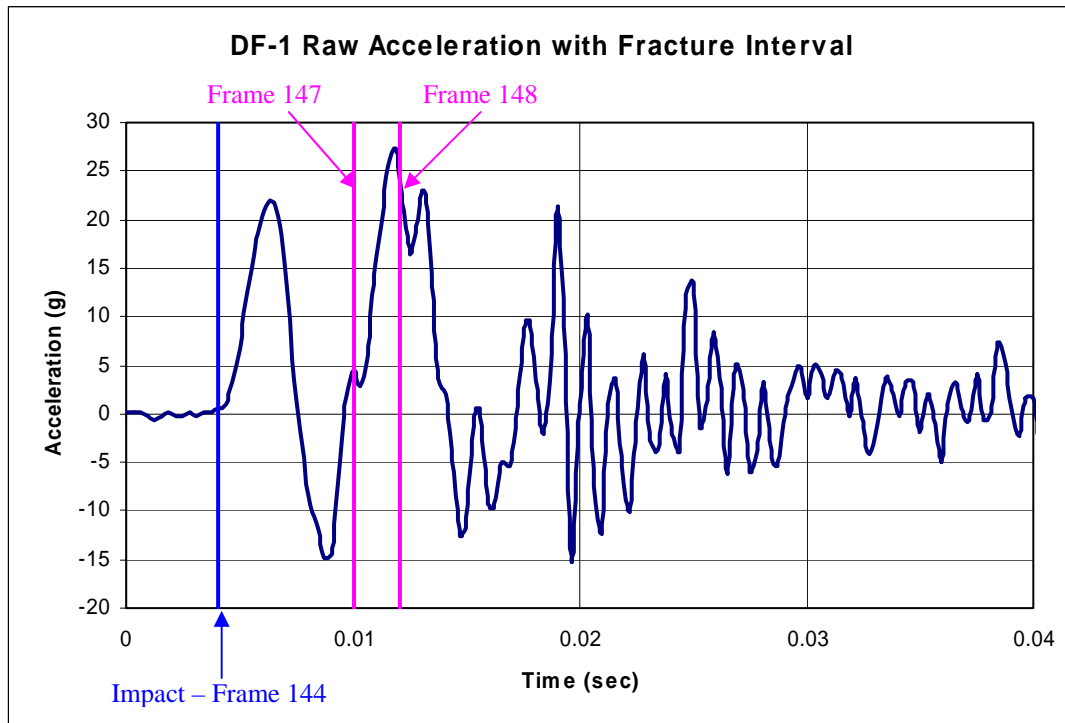
Figure 14. DF-1 Raw Acceleration with Fracture Interval

The frame numbers from the three figures were also used to calculate the time between them. For instance, since the camera recorded at a rate of 500 frames per second, the time

between consecutive frames is approximately 0.002 seconds. For test no. DF-1, the three frame nos. were 144, 147, and 148. Therefore, the time between impact and frame no. 147 was 0.006 seconds and the time between frame nos. 147 and 148 was 0.002 seconds. Plotting these times on the longitudinal acceleration plots, with the first rise in acceleration considered as the impact, will show where the fractures occurred relative to the acceleration peaks. A plot of this comparison for test no. DF-1 is shown in Figure 14.

Similar plots are shown below in Figures 15 through 39 for the remainder of the round one post tests in which a visible fracture was present. Impact is not labeled on these plots, but is always taken as the first rise in acceleration, similar to the plot of test no. DF-1. Plots containing more than two frame lines displayed more than one distinct fracture with a fracture occurring between each pair of lines.

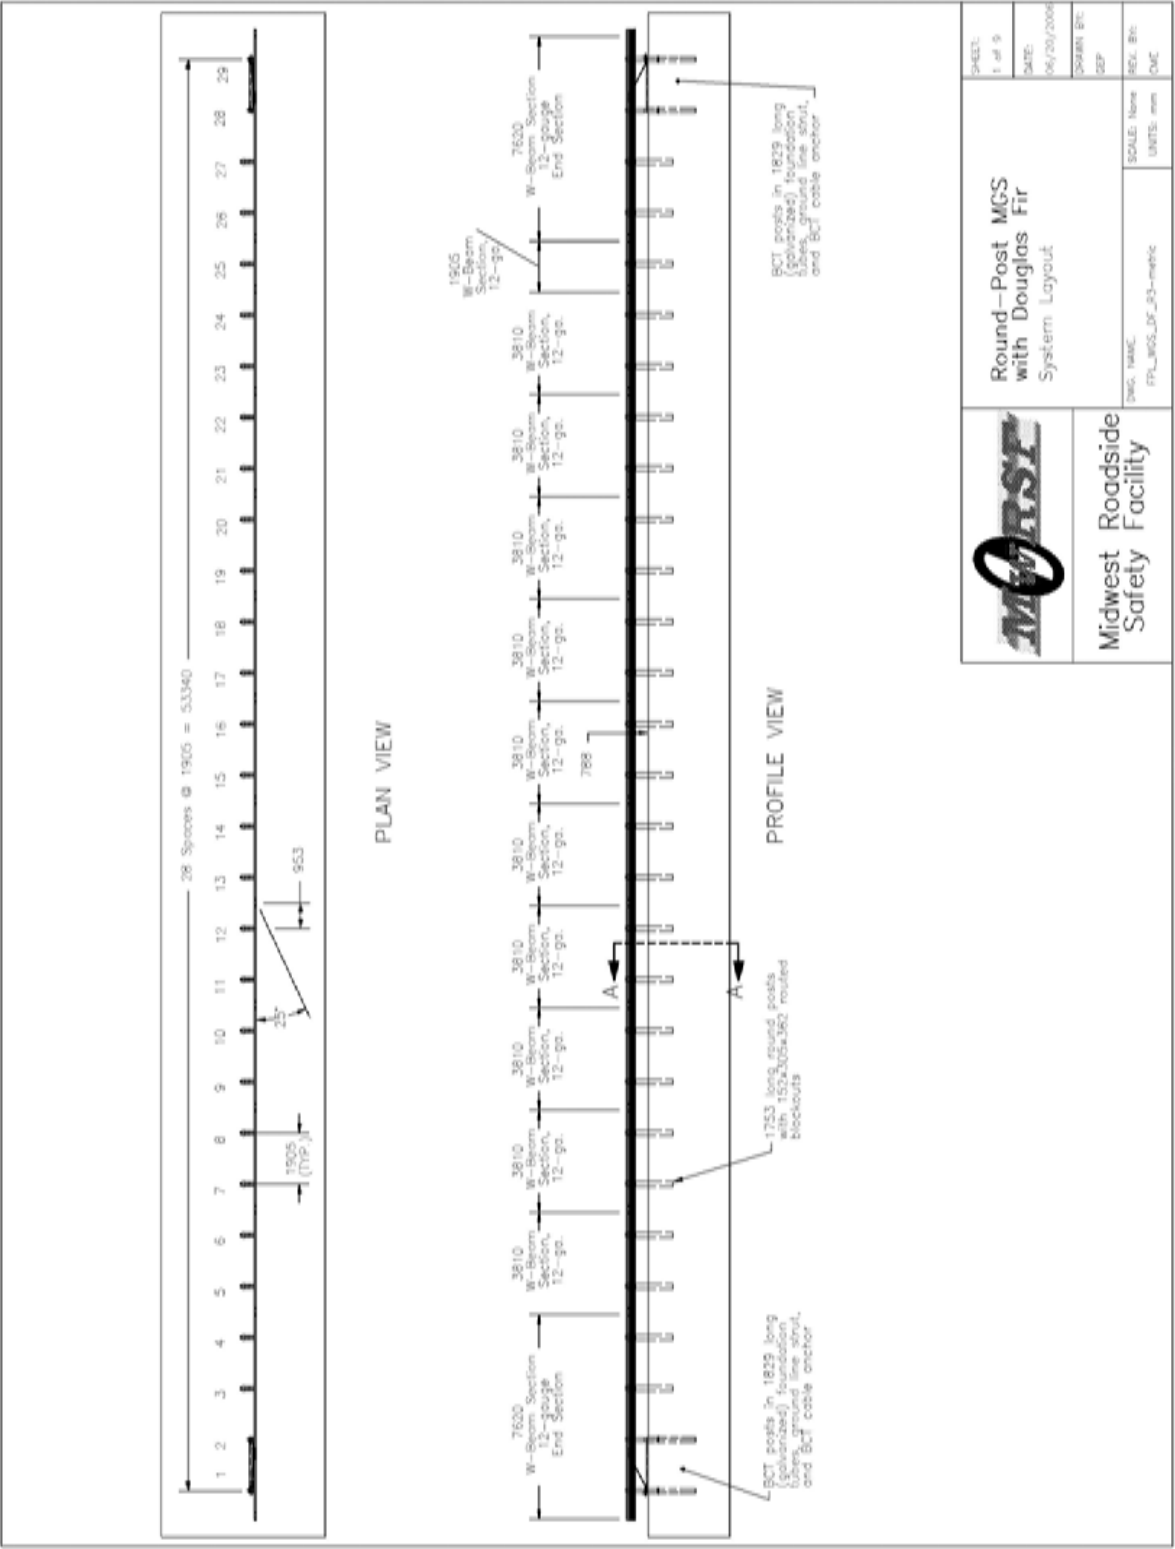
Figure 56. MGS Round Post Douglas Fir Details – System Layout

The Douglas Fir and Ponderosa Pine test installations were configured with an anchor system consisting of rectangular timber posts placed in steel foundation tubes. The anchor system was designed to replicate the capacity of a tangent guardrail end terminal. No crashworthy end terminal was tested, and therefore, none was installed in either system.

The posts in both systems were placed in a compacted course, crushed limestone material meeting Grading B of AASHTO M 147-65 (1990) as found in NCHRP Report No. 350. In addition, all lap-splice connections between the W-beam guardrail segments were installed with the upstream segment overlapping the downstream segment to reduce vehicle snag at the splices.

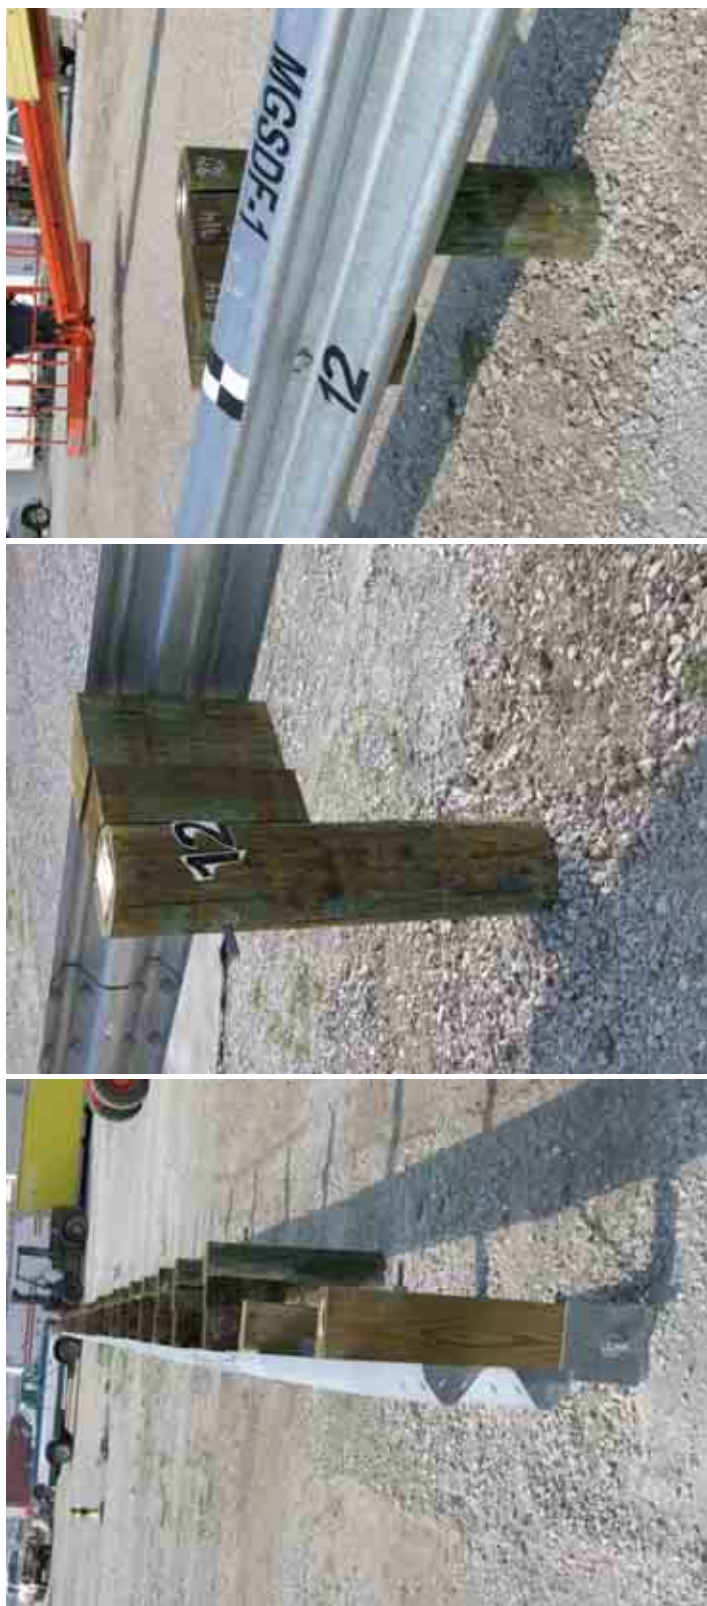
Figure 65. MGS Round Post Douglas Fir Photographs

Design details are shown in Figures 56 through 64 for the Douglas Fir system, Figures 69 through 77 for the Ponderosa Pine system, and Figures 84 through 92 for the Southern Yellow Pine system. Photographs of the Douglas Fir system are shown in Figures 65 through 68, and photographs of the Ponderosa Pine system are shown in Figures 78 through 83.

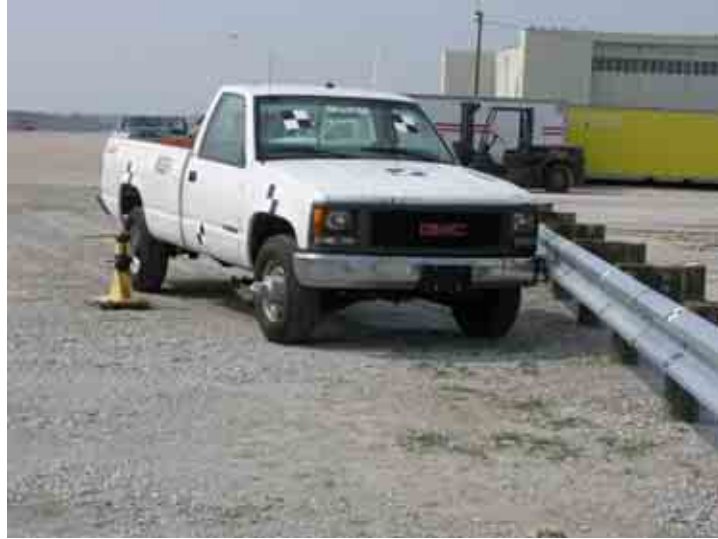
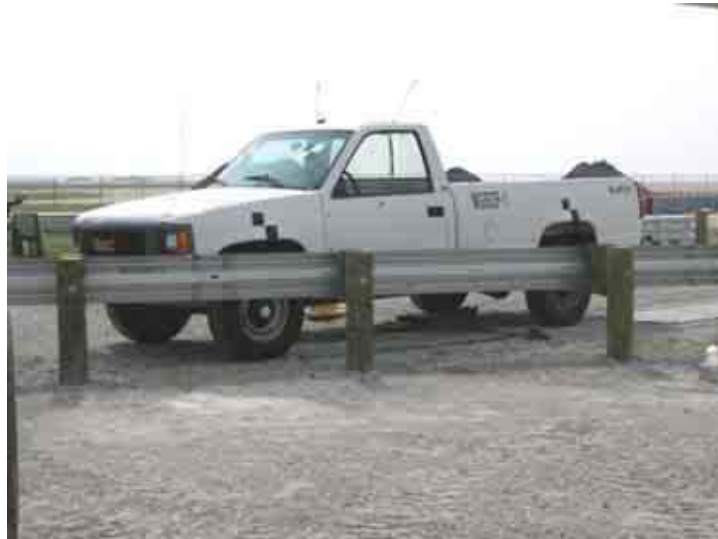
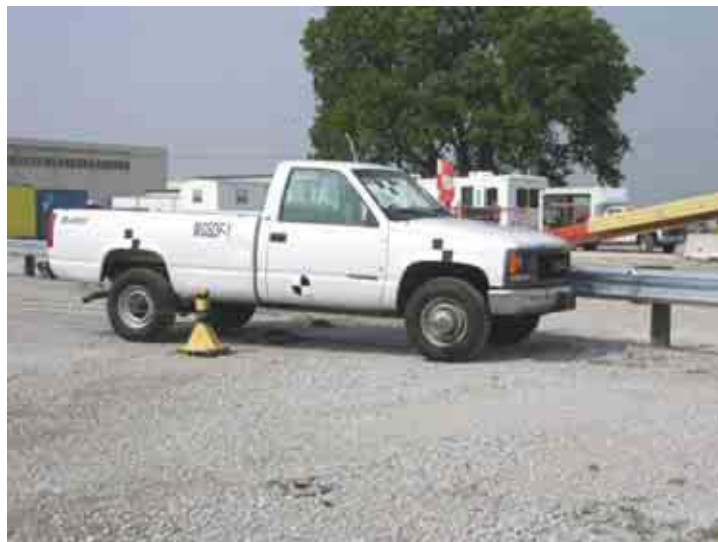
Figure 93. Test Vehicle, Test MGSDF-1

For test no. MGSDF-1, a 2000 GMC C2500 pickup truck was used as the test vehicle. The test inertial and gross static weights were 2,018 kg (4,450 lbs). The test vehicle is shown in Figure 93, with its dimensions shown in Figure 94.

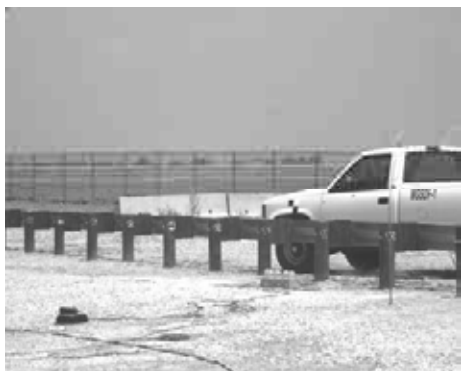
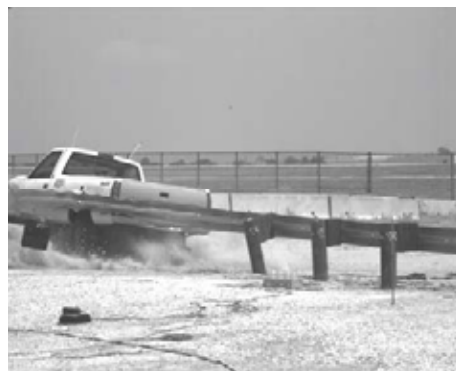
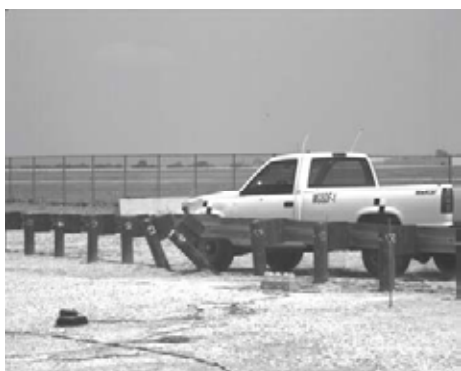
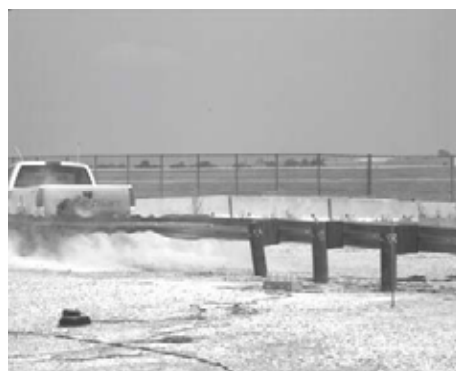
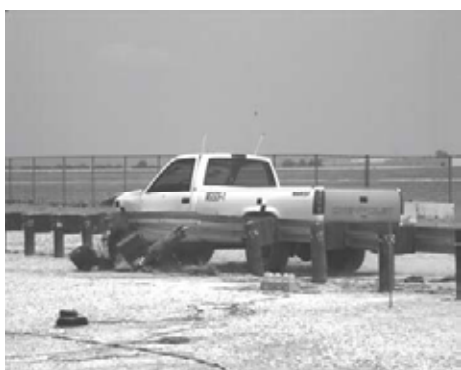
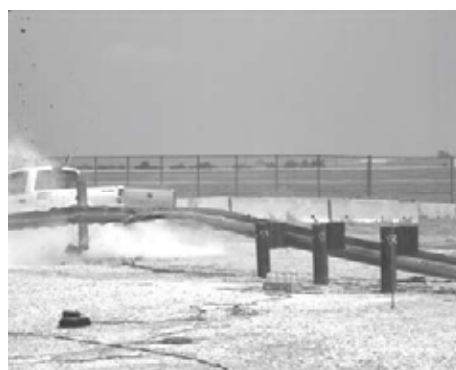
Figure 103. Additional Sequential Photographs, Test MGSDF-1

After 0.004 sec, the left-front bumper corner was crushing as post no. 13 deflected backward. At approximately 0.012 sec, post no. 12 began deflecting, and a bend developed in the rail between post nos. 12 and 13. After 0.024 sec, post no. 14 also deflected backward. At this same time, flattening of the rail was clearly evident in the impact region. Post no. 13 was the first post to fracture, breaking at 0.040 sec, at which time post no. 15 also deflected backward.

At 0.044 sec, post nos. 11 and 12 and their corresponding blockouts rotated downstream. At approximately 0.05 sec, a bend developed in the rail at post no. 15. Post no. 14 fractured after approximately 0.083 sec, the same time at which the posts and blockouts downstream of impact rotated toward the impact location. Approximately 0.104 sec after impact, post no. 16 deflected backward. At this same time, the left-front tire impacted the upstream face of post no. 14. The left-front tire slipped under the rail after 0.120 sec as the rail continued to crush the left-front corner of the test vehicle, and post no. 16 also deflected backward at this time.

At 0.148 sec, post no. 15 was impacted and pushed by the left-front tire, and post no. 17 began to deflect backward. After 0.154 sec, the damage being caused by the rail was largely concentrated to the left door panel. Post no. 15 fractured after 0.16 sec and continued to be pushed forward by the front of the truck and the left-front wheel. Post no. 17 began deflecting after 0.176 sec, followed by post no. 18 which began deflecting after 0.190 sec.

After 0.212 sec, post no.16 was impacted by the left-front wheel, causing it to fracture after 0.224 sec, the same time at which the rail developed a significant bend at post no. 17. The vehicle continued to push post no. 16 away from the system until 0.254 sec. The left-front corner of the vehicle was lifted slightly by the rail at 0.214 sec. At 0.270 sec, the left-front wheel impacted post no. 17 causing it to fracture. After 0.276 sec, a fold developed at post no. 18, which began to deflect at 0.286 sec and fractured after 0.322 sec. Upon the fracture of post no. 18, a bend developed in the rail at post no. 19.

Test no. MGSDF-1 was conducted according to NCHRP Report No. 350 Test Designation 3-11. The 2,018-kg (4,450-lb) pickup truck impacted the test article at a speed of 100.0 km/h (62.14 mph) and an angle of 25.5 degrees. The target critical impact point was 953 mm (37 ½ in.) downstream of the centerline of post no. 12. Actual vehicle impact with the barrier system occurred 152.4 mm (6 in.) downstream of the target. A summary of the test results and sequential photographs are shown in Figure 102. Additional sequential and documentary photographs are shown in Figures 103 through 106. An equivalent English-unit summary is shown in Appendix I.

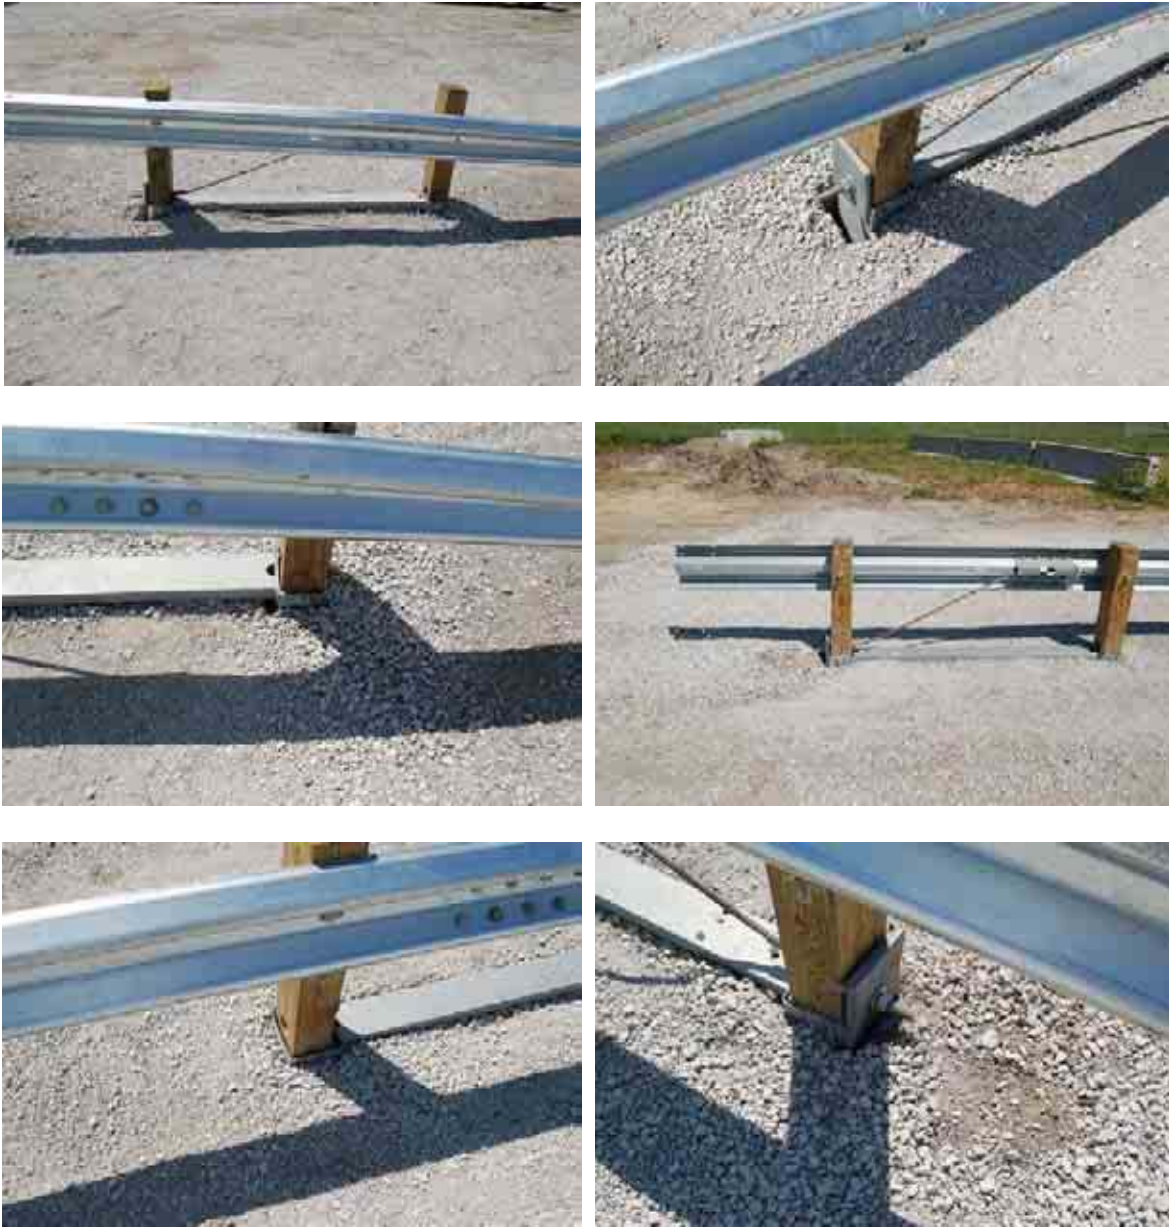
Figure 127. System Damage, Test MGSPP-1

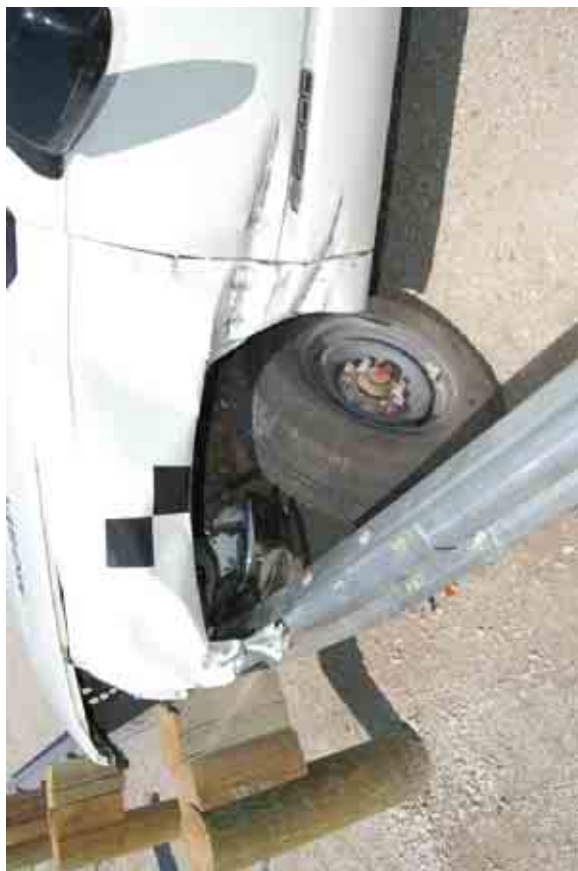
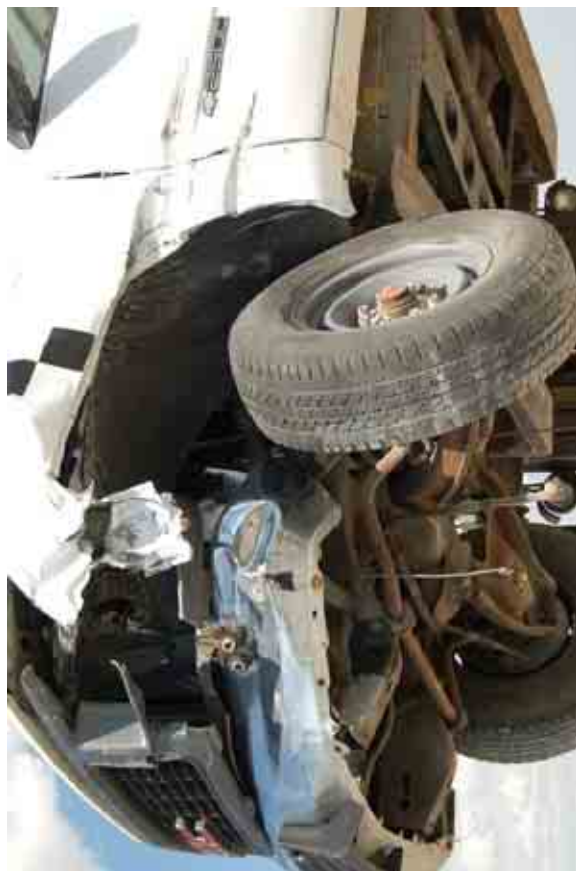
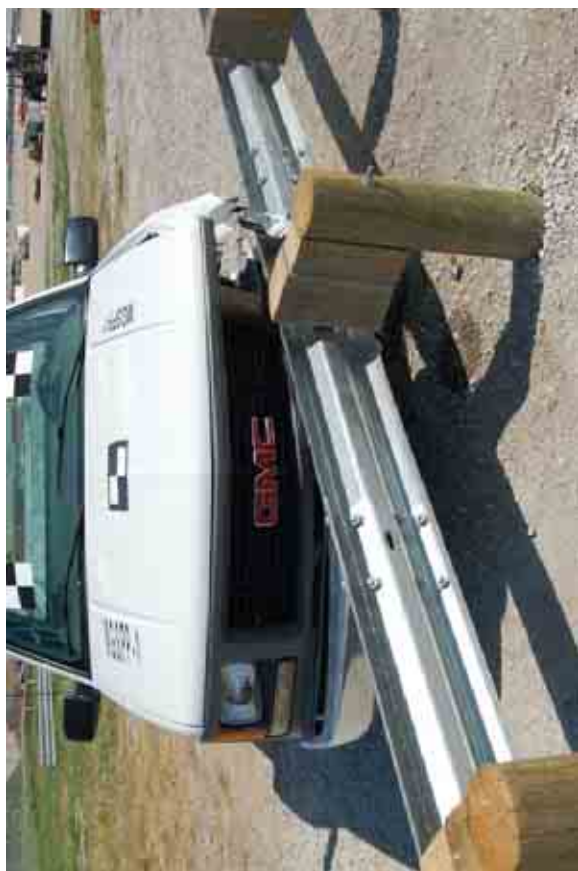
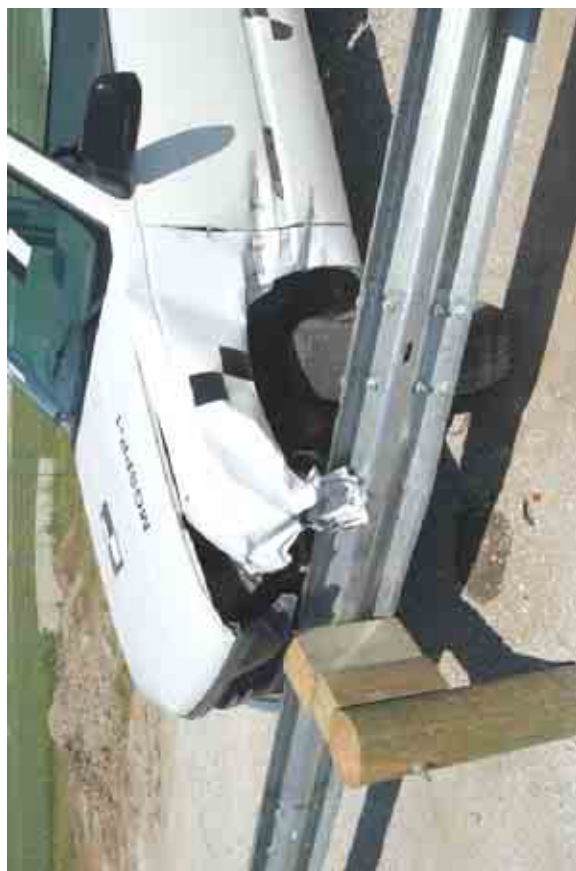
Figure 129. Vehicle Damage, MGSPP-1

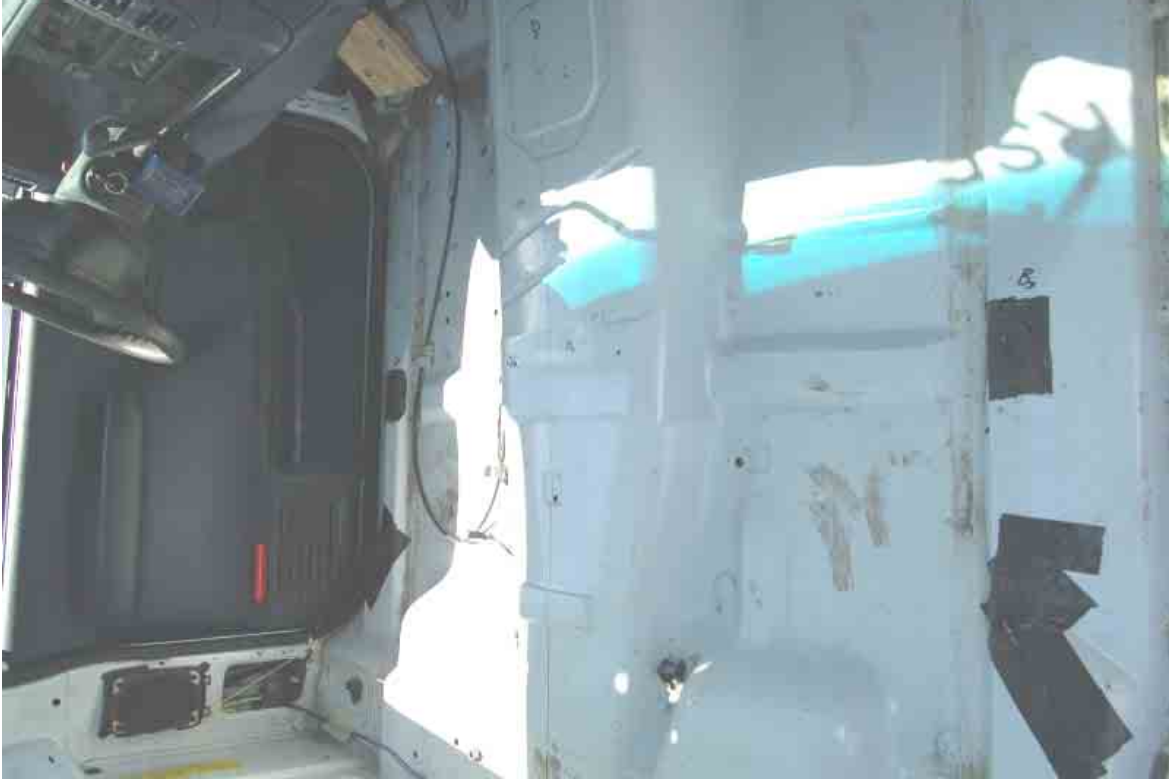
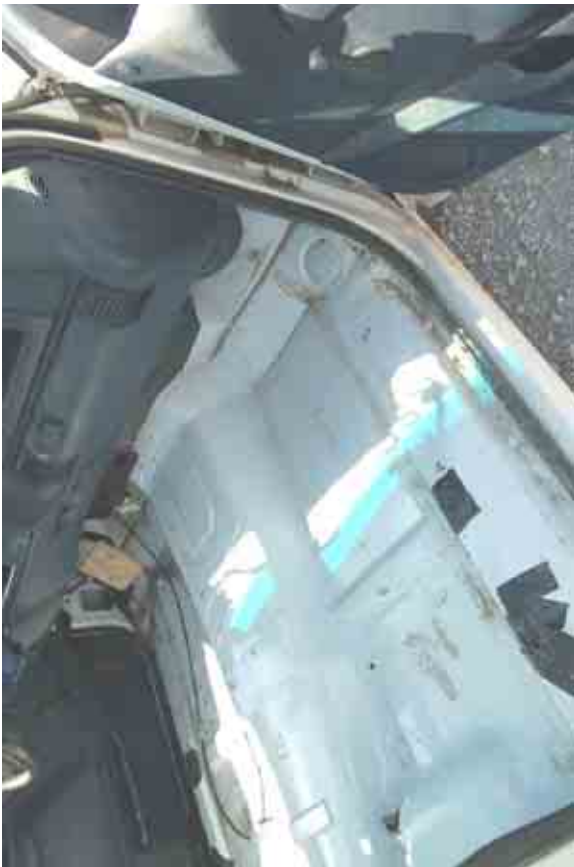
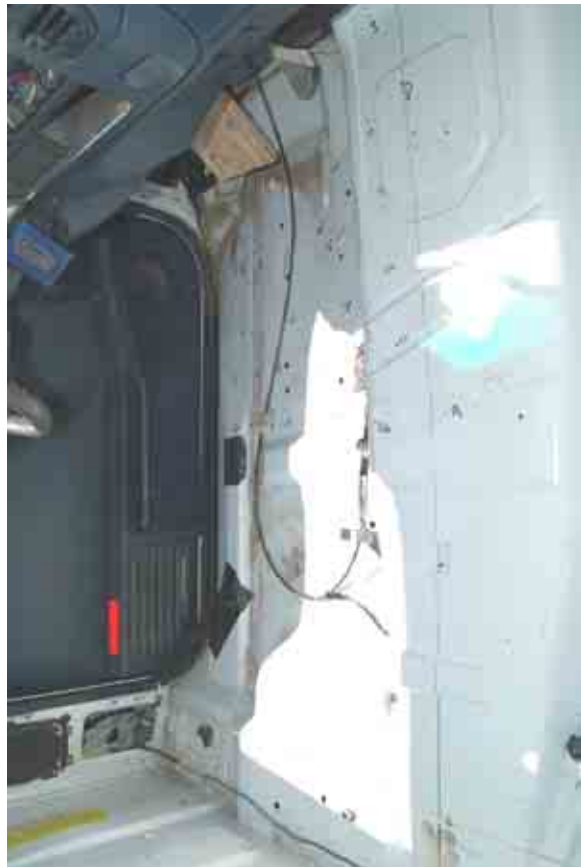
Figure 130. Vehicle Damage, MGSP-1
