**INVESTIGATION OF BICYCLE AND  
PEDESTRIAN CONTINUOUS AND  
SHORT DURATION COUNT  
TECHNOLOGIES IN OREGON**

**Final Report**

**SPR 772**

Oregon Department of Transportation

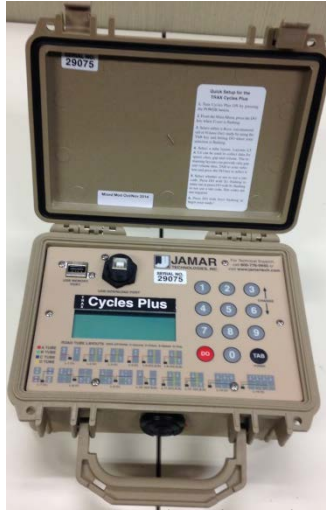
Figure 3.1: JAMAR TRAX Cycles Plus Pneumatic Tube Counter

TRAX Cycles Plus from JAMAR Technologies, Inc. is a pneumatic tube counter that is able to distinguish and count bicycles and motor vehicles in mixed traffic. It was introduced into the market in 2014 and consists of sensitive air switch sensors that are capable of recording the time stamp for each axle hit (*JAMAR Technologies 2015*). The algorithms within JAMAR's TRAXPro software allow the user to view volume, classification, speed and gap from the data collected using TRAX Cycles Plus (*JAMAR Technologies 2015*). During the course of this study bicycle-specific improvements were

made to JAMAR's classification scheme. This revised scheme was used to process data from the pilot study and the intersection site (Hall Blvd.), but not at the Columbia River Highway since these data were available to the manufacturer during the time in which JAMAR developed this new bicycle-specific classification scheme. Figure 3.1 shows a picture of the TRAX Cycles Plus pneumatic tube counter that was tested in this study.

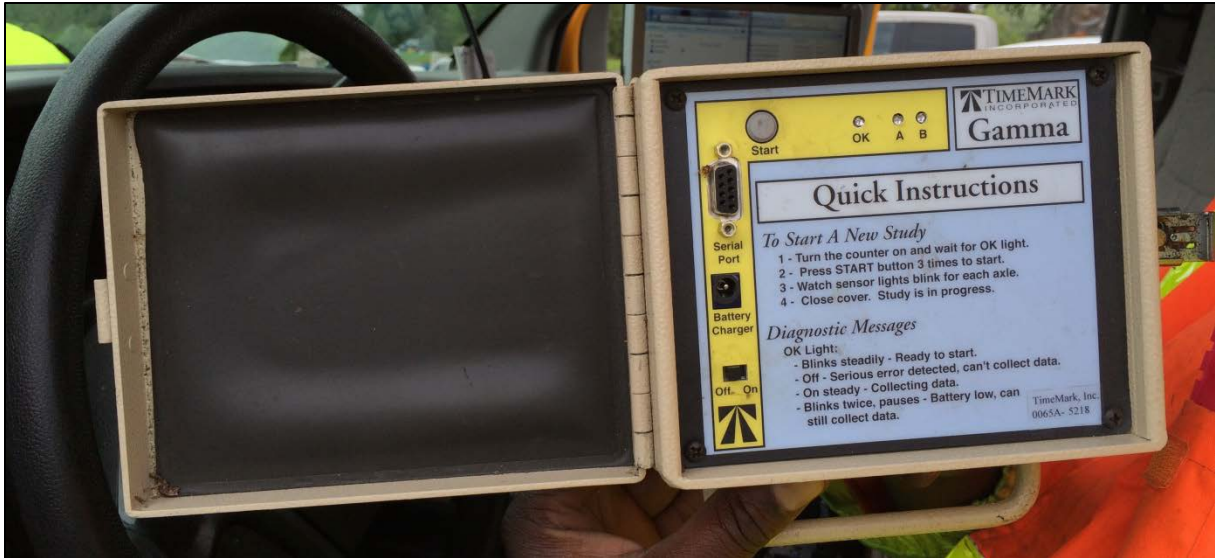
Figure 3.3: Gamma Pneumatic Tube Counter

TimeMark's Gamma pneumatic tube counter can record classification, speed and vehicle volume data for one or two lanes of traffic (*TimeMark 2015*). Typical installation consists of two tubes laid across the roadway. This counter is capable of distinguishing bicycles from motor vehicles and is also part of ODOT's inventory for gathering motor vehicle counts. Figure 3.3 shows a picture of the TimeMark Gamma pneumatic tube counter.

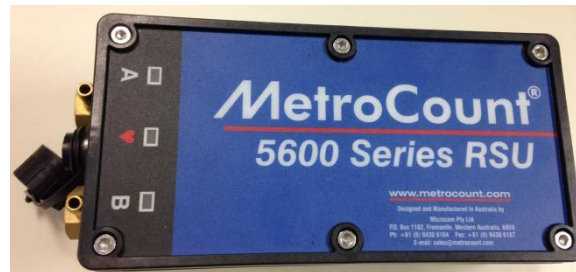
Figure 3.4: MetroCount MC 5600 Pneumatic Tube Counter

The MC 5600 is a vehicle classifier counter that records every axle that goes over each tube. This counter is capable of providing vehicle volume, speed and classification data and is capable of distinguishing between bicycles and motor vehicles. Two tubes are typically installed in the roadway and attached to the tube counter. The MC 5600 stores all the axle hits and the analysis is performed by using the MetroCount's proprietary software. Figure 3.4 shows a picture of the MC 5600 tube counter.

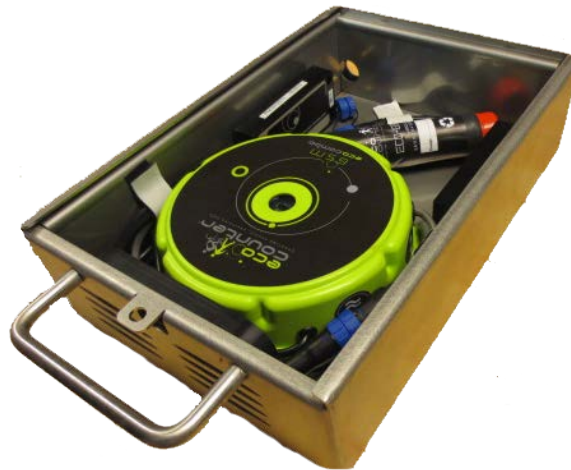
Figure 3.5: Eco-Counter Pneumatic Tube Counter

Eco-Counter pneumatic tube technology (TUBES) uses two tubes placed on the roadway to count bicyclists only. It can be used on paths or a mixed use facility and is able to distinguish bicycles from motor vehicles. It differs from the other tube technologies in

that it provides a count of bicyclists only. Figure 3.5 shows a picture of an Eco-Counter pneumatic tube counter. Eco-Counter provides specific proprietary pneumatic tubes to be used with the unit on roadways with mixed traffic. When used on paths or sidewalks, smaller diameter tubes (mini-tubes) can be used to reduce trip hazard. Eco-Counter recommends using proprietary “filter tubes” between the counter unit and the mini-tubes for higher accuracy.

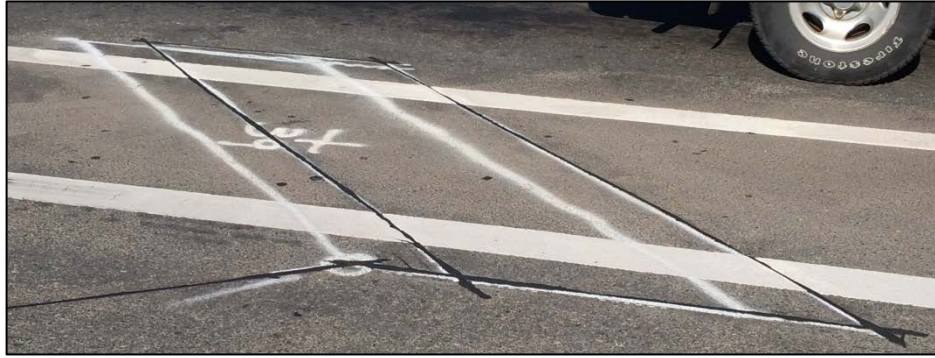
Figure 3.6: Parallelogram Loop

As the name implies, these loops are shaped as a parallelogram. The biggest advantage of the parallelogram loop over the diamond loop is the availability of a special bicycle detector card from Reno A&E that is capable of distinguishing between bicycles and motor vehicles. Figure 3.6 shows a picture of the parallelogram loop placed in a bike lane at the intersection of Hall Blvd. and 99 W in Tigard, OR Parallelogram loops were tested during the pilot and field tests, described further in Chapters 4 and 5.

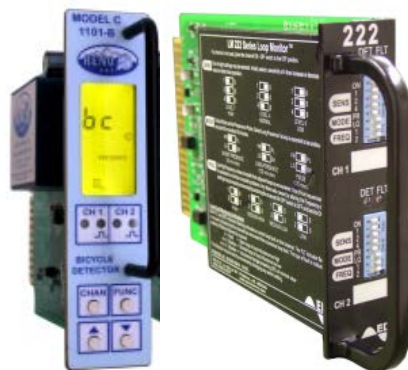
Figure 3.7: Reno A&E (Model C-1101B) and EDI (Model LM222) Detector Cards

Two types of bicycle detector cards were tested during this study. One type was Reno A&E's Model C-1101 B, which is designed for the Type 2070 signal controller and is capable of differentiating bicycles from motor vehicles. Additionally, it also offers signal timing engineers with the ability to provide bicycle specific minimum green and extension times. The second type tested was a detector card made by EDI Inc., Model LM222. The EDI card cannot distinguish between motor vehicles and bicycles. The rationale behind testing the EDI card was that it could be potentially used in locations where differentiation is not critical, such as bicycle lanes or trails that have low propensity of motor vehicles passing over the bicycle loop.

Figure 3.7 shows pictures of the Model C-1101B by Reno A&E and Model LM 222 made by EDI Inc. While both cards were tested during the pilot test, only the Reno A&E card was tested during the field test. In the mixed traffic test Reno's Model C-1100B card was tested with the diamond loop.

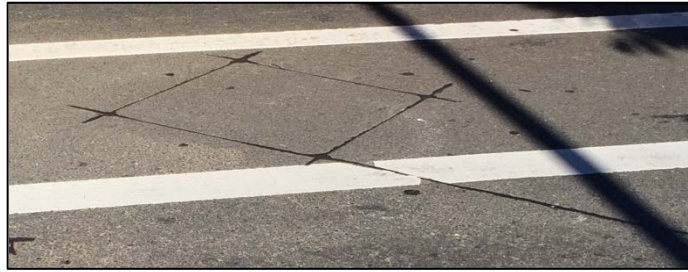
Figure 3.8: Diamond Loop

In addition to the parallelogram loops, the diamond loops were also tested in this study. Similar to the parallelogram loops, they were tested during the pilot and field tests. For the pilot test, the diamond shaped loops at TSSU facility were pre-installed. There were two diamond loops that were connected in series, which were being used to operate a

garage door. For the field test, the diamond loop was in the bike lane. Figure 3.8 shows the diamond loop in the bike lane at the intersection of Hall Blvd. and 99W in Tigard, OR.

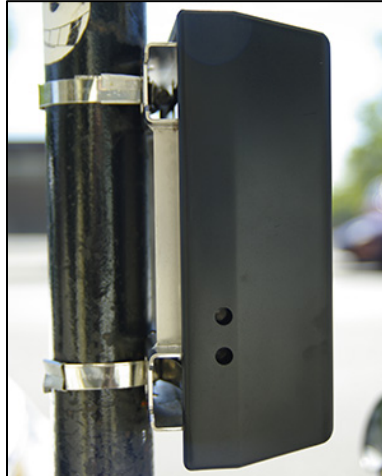
Figure 3.10: Eco-Counter PYRO-Box

Passive infrared devices detect the change in ambient temperature from pedestrians and cyclists within the range of the sensor. The Eco-Counter PYRO-Box tested has a range of 15 feet and is designed to detect two or more pedestrians traveling in a slightly staggered formation. The

PYRO-Box reports the direction of travel as either inbound or outbound (*Eco-Counter 2015*). Figure 3.10 shows an Eco-Counter PYRO-Box which can be temporarily affixed to a pole. The PYRO-Box was tested during the intersection field test to count pedestrians on the sidewalk.

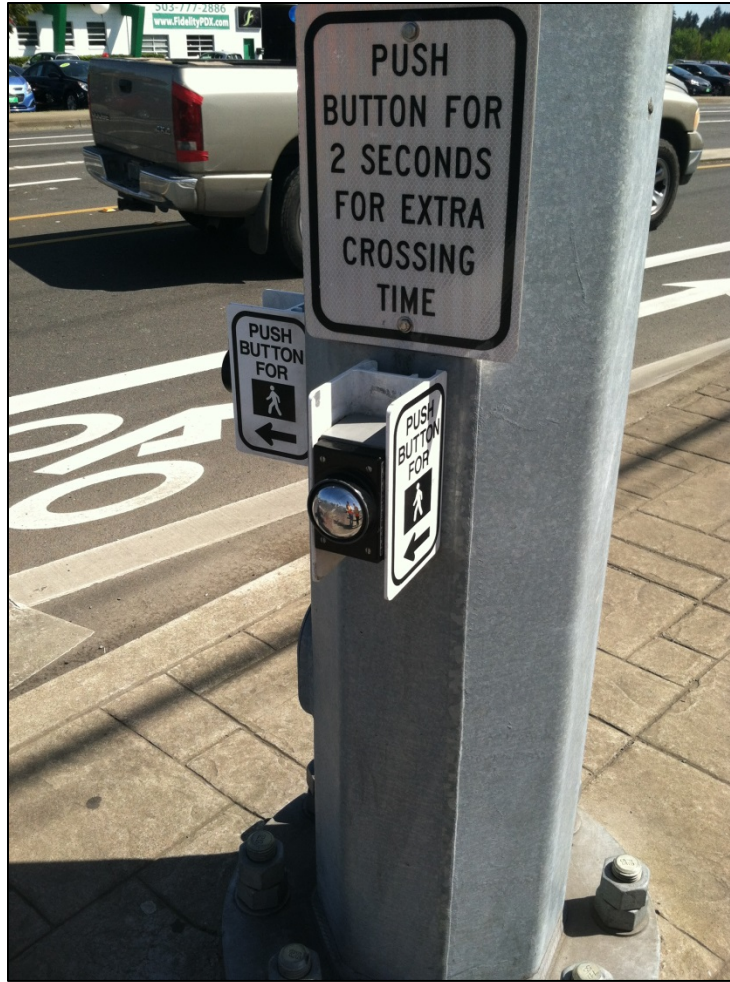
Figure 3.11: Pedestrian Pushbutton

Pedestrian pushbuttons are typically provided at signalized intersections as a means to detect pedestrians. A pedestrian phase is provided by the signal controller, when the pedestrians activate the pushbutton requesting service. Figure 3.11 shows a pushbutton at an intersection. While pushbutton actuations cannot provide pedestrian counts directly, logging pedestrian phases at an intersection can provide a general measure of the pedestrian activity at an intersection. These were studied during the intersection field test.

A ratio of crossing pedestrians per phase can be computed and used to estimate pedestrian counts, which is described further in Chapter 5. However more research is needed to generate pedestrian counts using this approach.

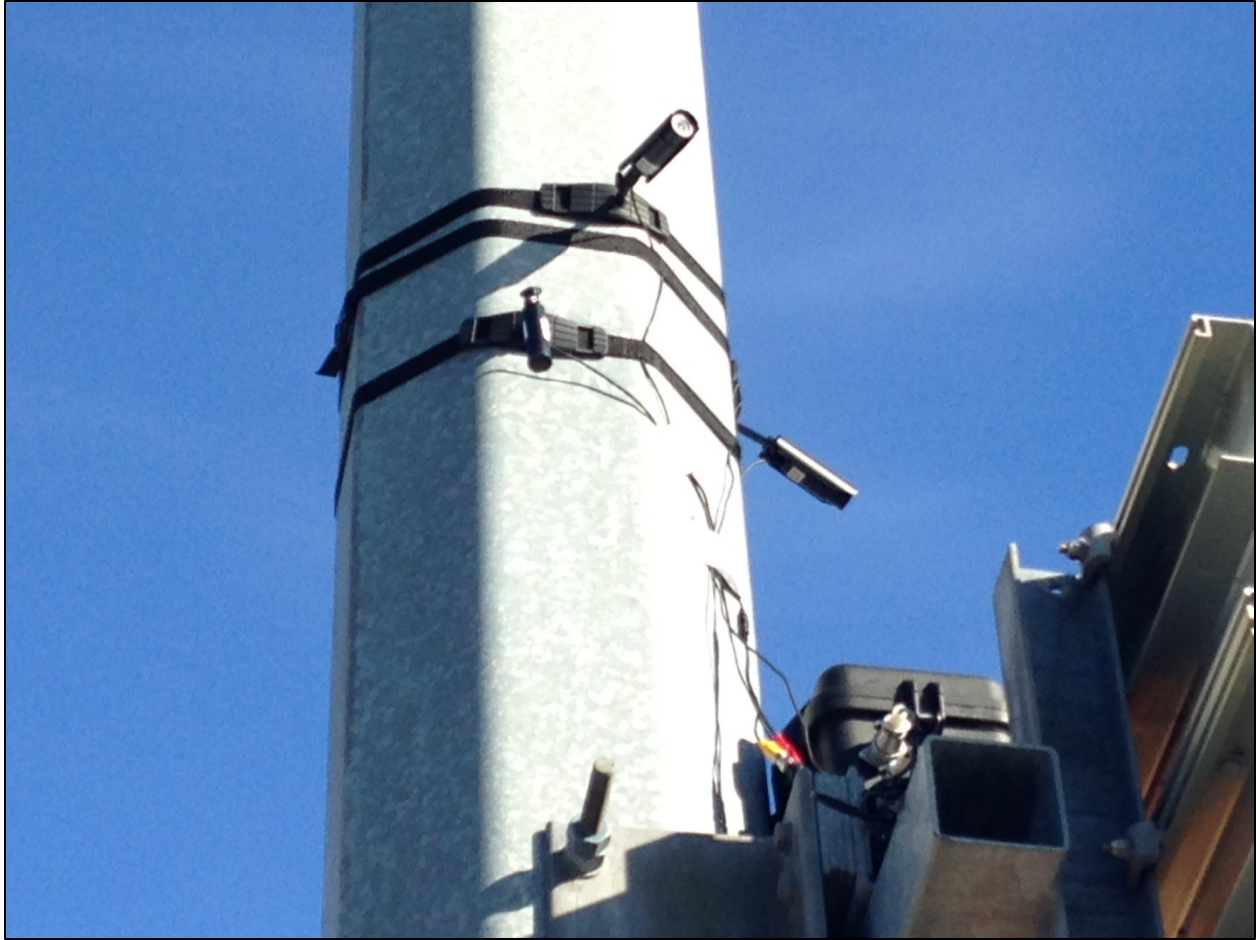
Figure 3.12: Video Camera Installation on Signal Pole

Two types of video camera were used. ODOT's Aventura CAM 52 IP 10X DN cameras, which were used the Columbia River Highway. Countingcars.com's COUNTcam cameras owned by Portland State University were used at the pilot test and at the intersection test at Hall and 99W. These video cameras were typically installed on a pole, as depicted in Figure 3.12.

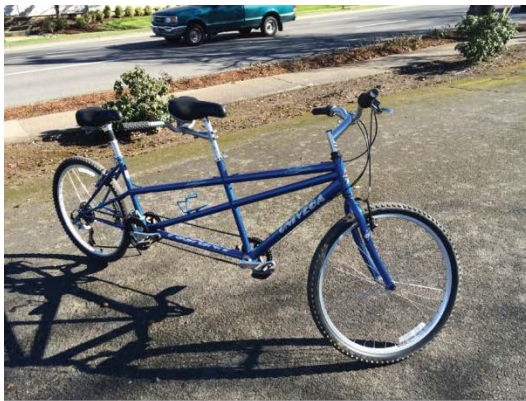
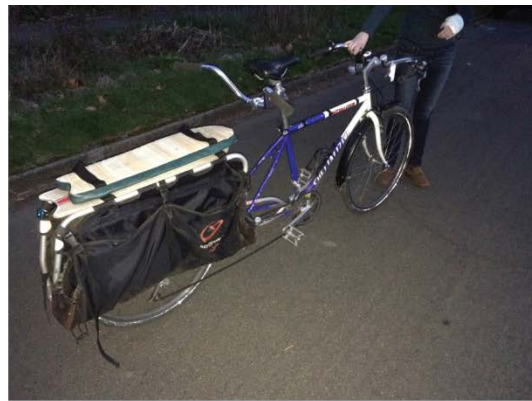
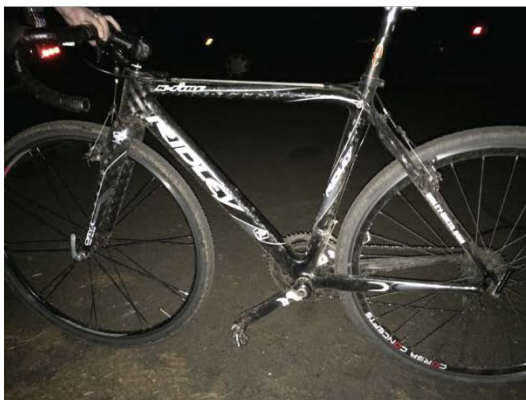
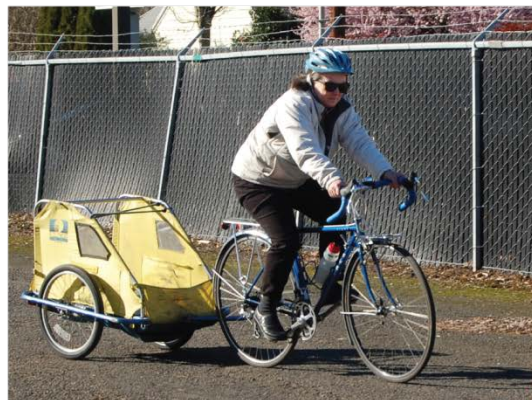
The purpose of the special cases testing was to understand how well the technologies are able to count special cases of bicycles that are encountered less frequently in the field such as tandems, bikes with trailers, carbon fiber bikes, cargo bicycles, and bicyclists riding one behind the other and side by side. Special bicycles used for the special-cases testing are shown in Figure 4.5. For the special cases tests, bicyclists were asked to ride in Zone 1 for the tubes at all times. The afternoon test was a repeat of the morning test and included standard bikes testing for one hour followed by testing of special cases for six zones but did not include Zone 7.

Tandem Bike

Cargo Bicycle

Carbon Fiber Bike

Bike with Trailer

Due to time constraints, the carbon fiber and cargo bicycles were tested in the same time five-minute time period and the tandem and bicycle with trailer were tested in the same time five-minute period. Ideally, sufficient volunteers would have been available to monitor if each bicycle was correctly counted in real time. Unfortunately, on the day of the test, there were not sufficient computers or volunteers to perform this task, except for one of the devices (the Eco-Counter which had 15-minute bins). For this reason, the results are presented for each five-minute test, instead of for each special case tested.

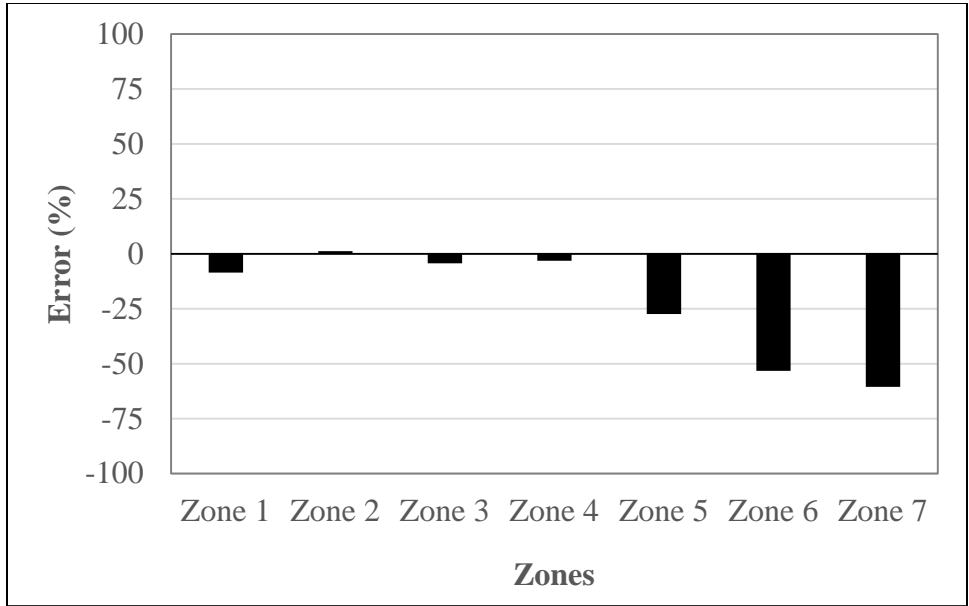
Figure 4.10: TimeMark Gamma Standard Bikes Test

increased. Figure 4.10 shows the plot of errors across Zones 1-7 for the TimeMark Gamma tube counter. With the special cases test, while the counter showed low errors when counting tandems, bikes with trailers, carbon fiber bikes and cargo bicycles (errors less than 10%), it severely undercounted bicyclists riding one behind the other (64%) and those riding side by side (38%) as seen in Figure 4.11.

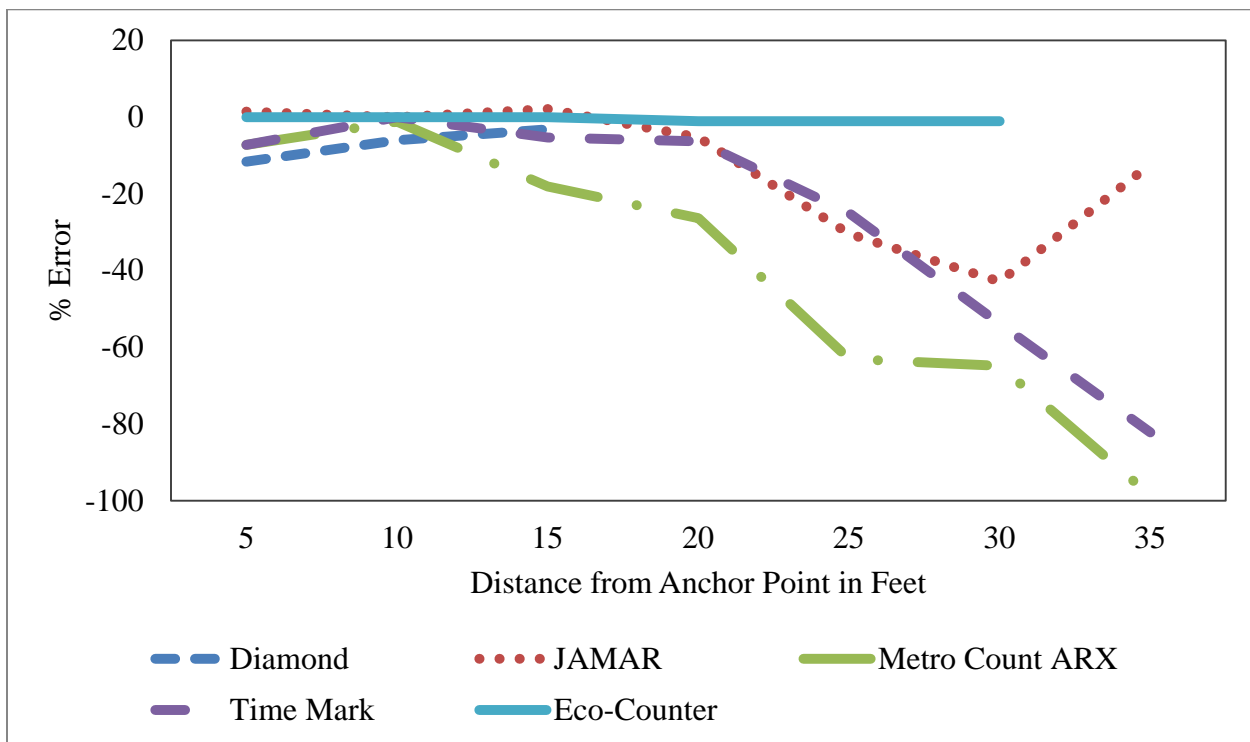
Figure 4.16: Error by Distance for Tubes Tested in Pilot Study

Note: N/A indicates that the tubes were not long enough to reach these zones.

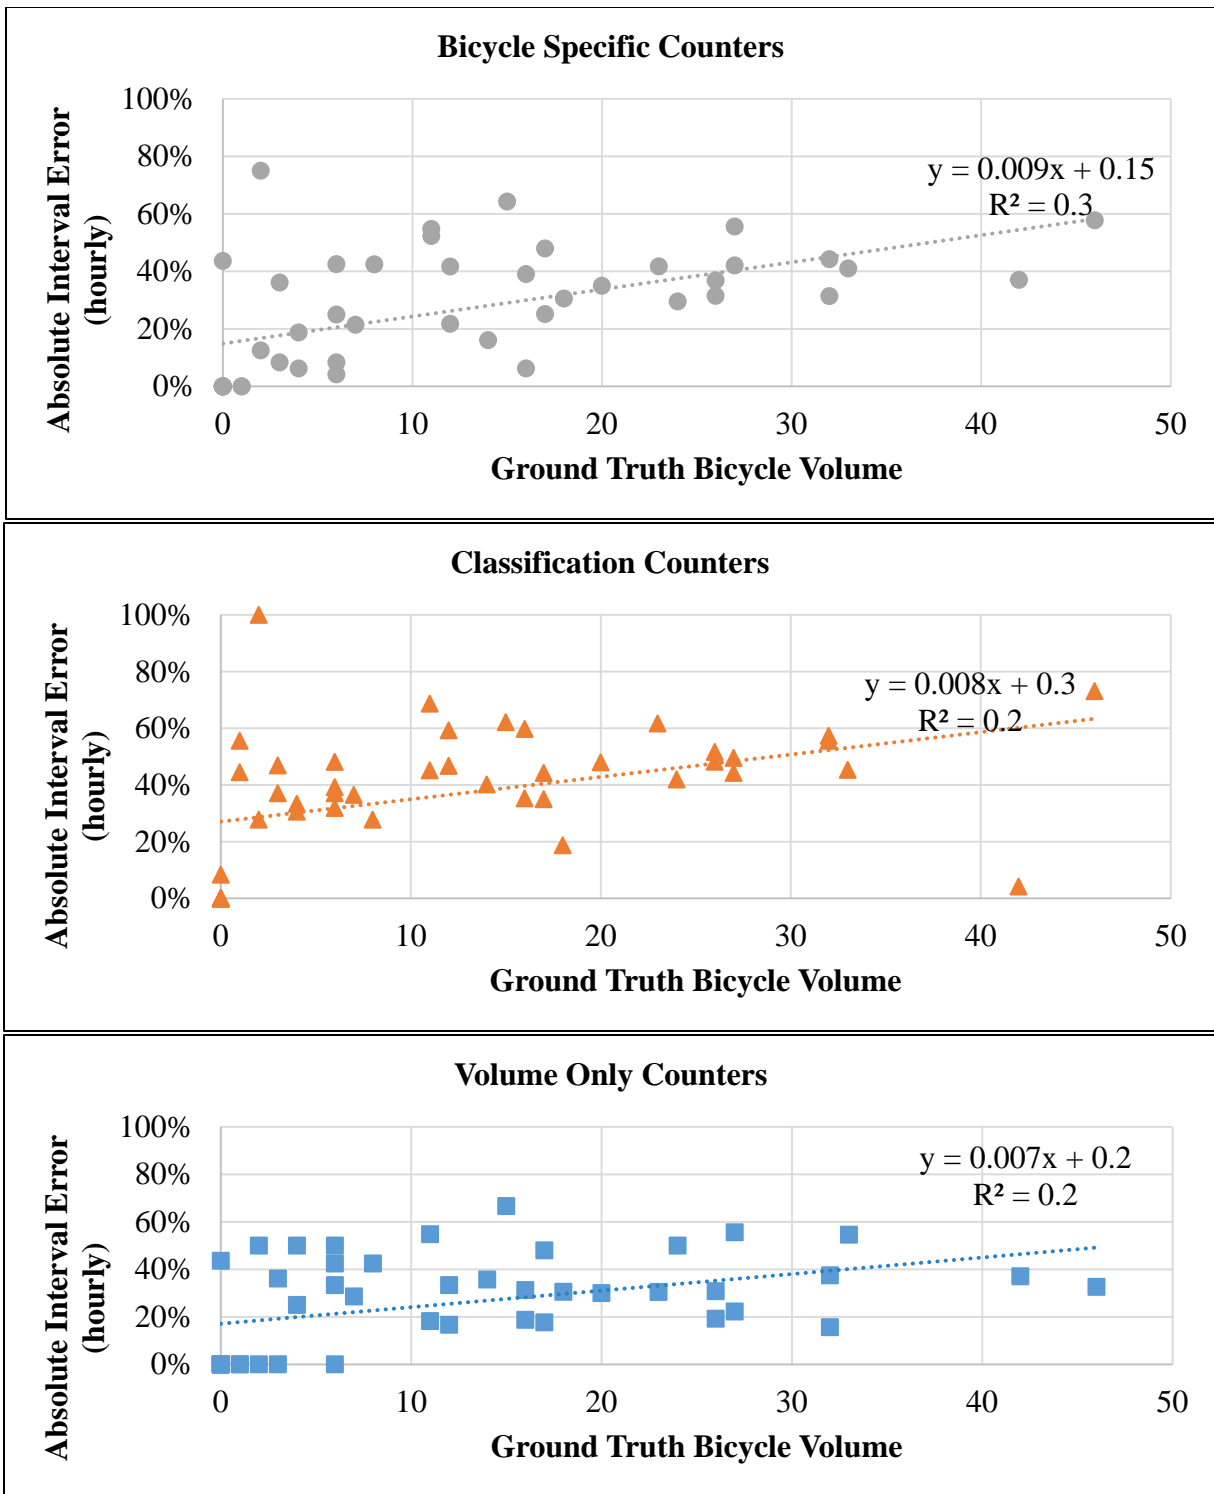
Figure 5.4: Absolute Interval Error as a Function of Bicycle Volume

What is causing the error? Figure 5.4 and Figure 5.5 examine error per count interval with bicycle and motor vehicle traffic volumes. According to Figure 5.4 and Figure 5.5, error appears to increase with increasing bicycle traffic volumes and to a lesser extent with increasing vehicle volumes. These results are intuitive since passing vehicles cause occlusion. Occlusion takes place when motor vehicles and bicyclists pass over the tubes simultaneously, or in a very short time interval, such that the pulse of air from the bicycle is not recognized by the classification algorithm.

Bicycles traveling in groups are similarly difficult to count as shown in the earlier results from the controlled environment special cases tests (bicyclists riding side by side and one behind the other). Some of the equipment tested is better than others at separating out these cases.

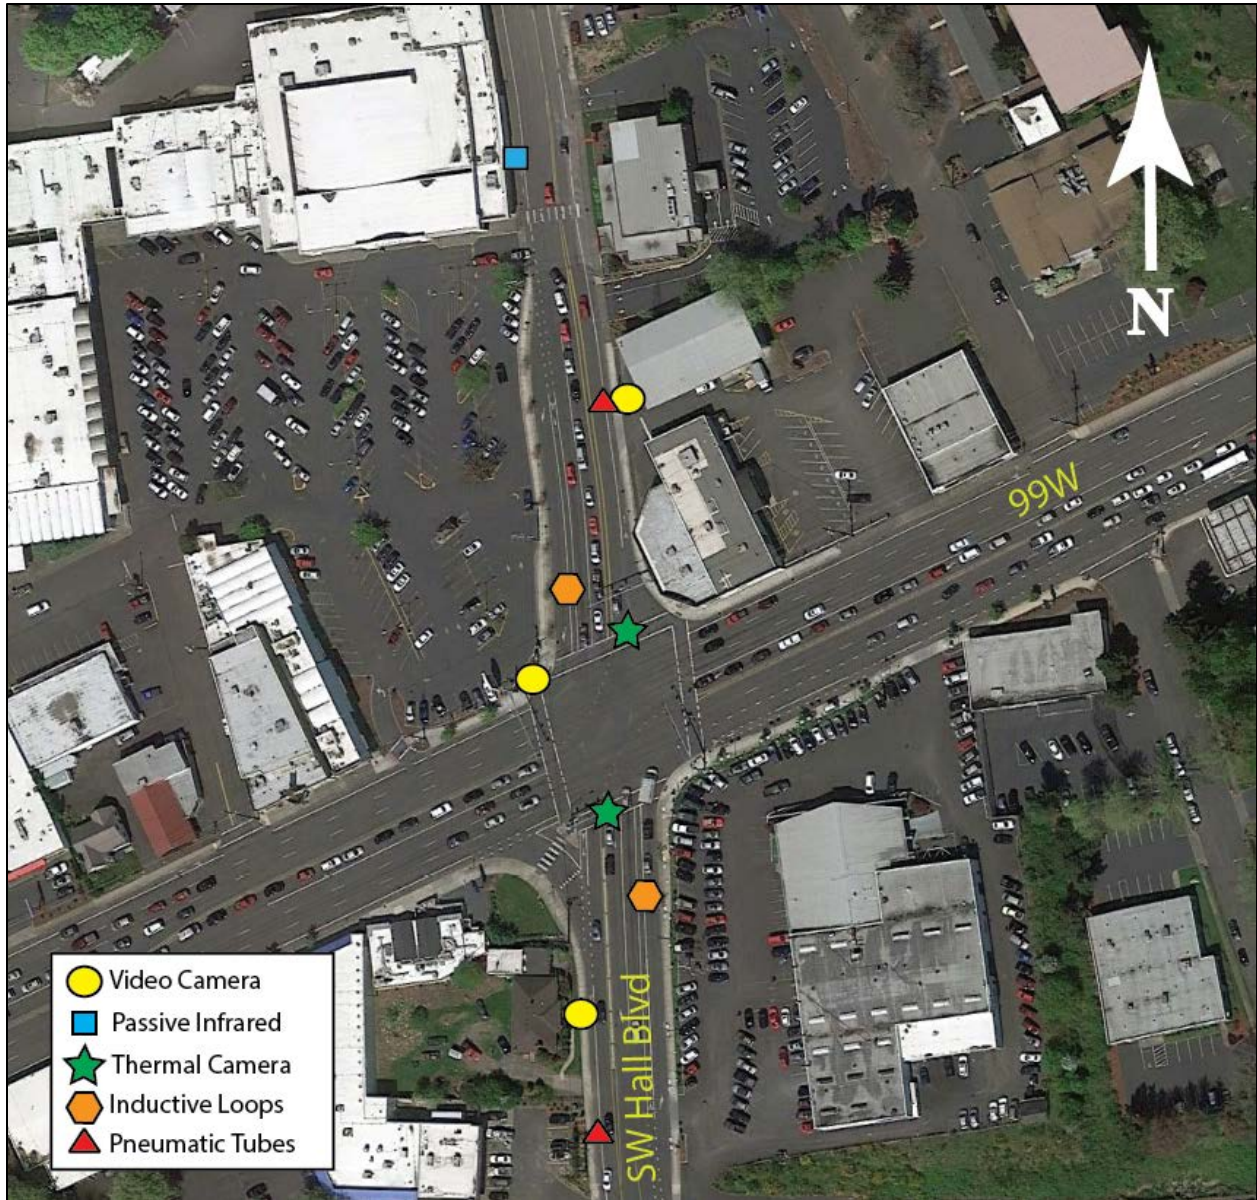
Figure 5.6: Equipment Locations at Hall & 99W

This test was conducted at the intersection of Hall Boulevard and 99 West in Tigard, Oregon from September 8, 2015 to September 11, 2015. Figure 5.6 shows the intersection layout as well as locations of the cameras, inductive loops, tubes and passive infrared. Three cameras mounted on poles were used to record video that was later used to obtain ground truth counts. The first set of cameras was strapped to a utility pole on north Hall Boulevard. One of these cameras was pointed at the Eco-Counter infrared counter across the street, another was pointed downward at the northbound tubes, and the other was pointed directly across 99 W at the northbound loops. The second set of cameras was positioned on the traffic signal just above the street sign on the northwest corner of Hall and 99W. One camera was pointed directly downward to view pedestrians using the crosswalk push button, and the other was pointed at the north Hall loops and FLIR zones. The third set of cameras viewed the tubes on the south side of Hall Boulevard.

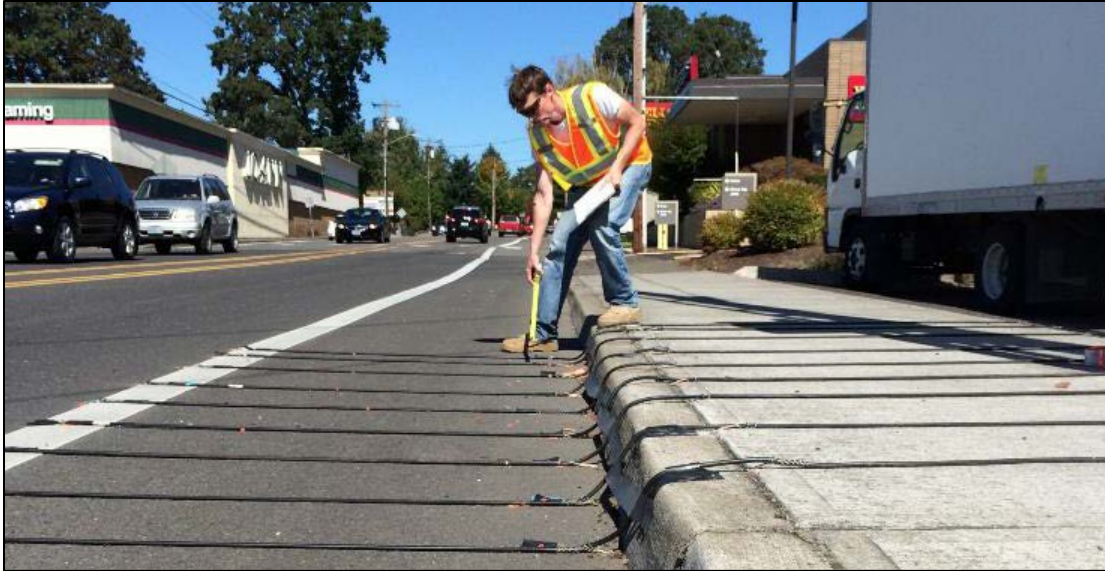
Figure 5.9: Tube Installation on Hall Blvd. North of 99W Looking North

For this test, researchers decided to install pneumatic tubes across only the bike lane and sidewalk to count bicycle traffic. The sidewalk was included because a previous study conducted at the same intersection found that 50% of the bicyclists rode on the sidewalk (Figliozzi et al. 2014). Figure 5.7 and Figure 5.8 show the tube setup for the northbound and southbound directions on Hall Boulevard. The photo in Figure 5.9 shows how the tubes were taped and anchored on both sides of the sidewalk and both sides of the bike lane.

The research team hypothesized that longer tube lengths contributed largely to the higher errors obtained during testing at Columbia River Highway site. Therefore, for this test, tube lengths were kept as short as possible (10 to 15 feet). In addition, small diameter tubes (mini-tubes) were used for all of the tube counters. Others have found smaller tubes associated with higher accuracy (*Brosnan et al. 2015*), but the main reason for this change was to reduce the potential for pedestrians, rollerbladers, and skateboarders to trip on the tubes.

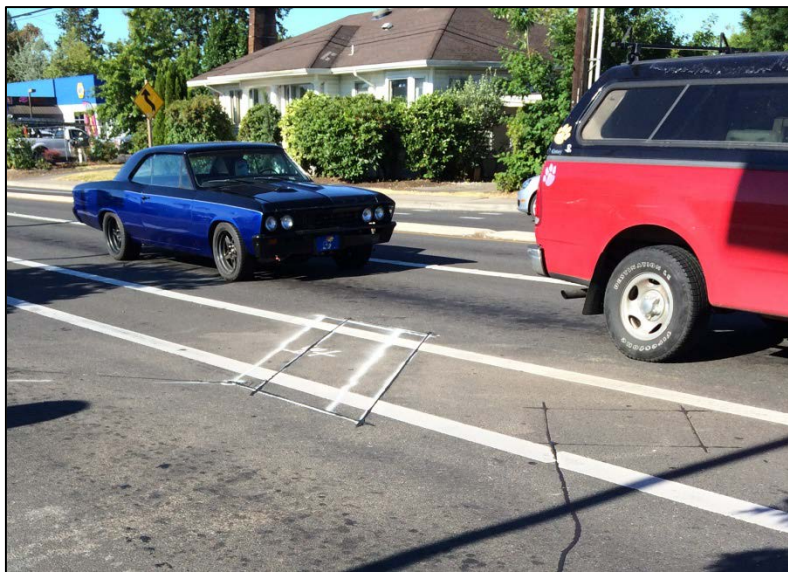
Figure 5.10: Parallelogram and Diamond Loops

Parallelogram and diamond loops were installed in succession in the bike lane in order to ensure that both counters were counting the same bicyclists. Figure 5.10 shows the installation in the field. The dimensions of the north and south loops are detailed in Figure 5.11 and Figure 5.12.

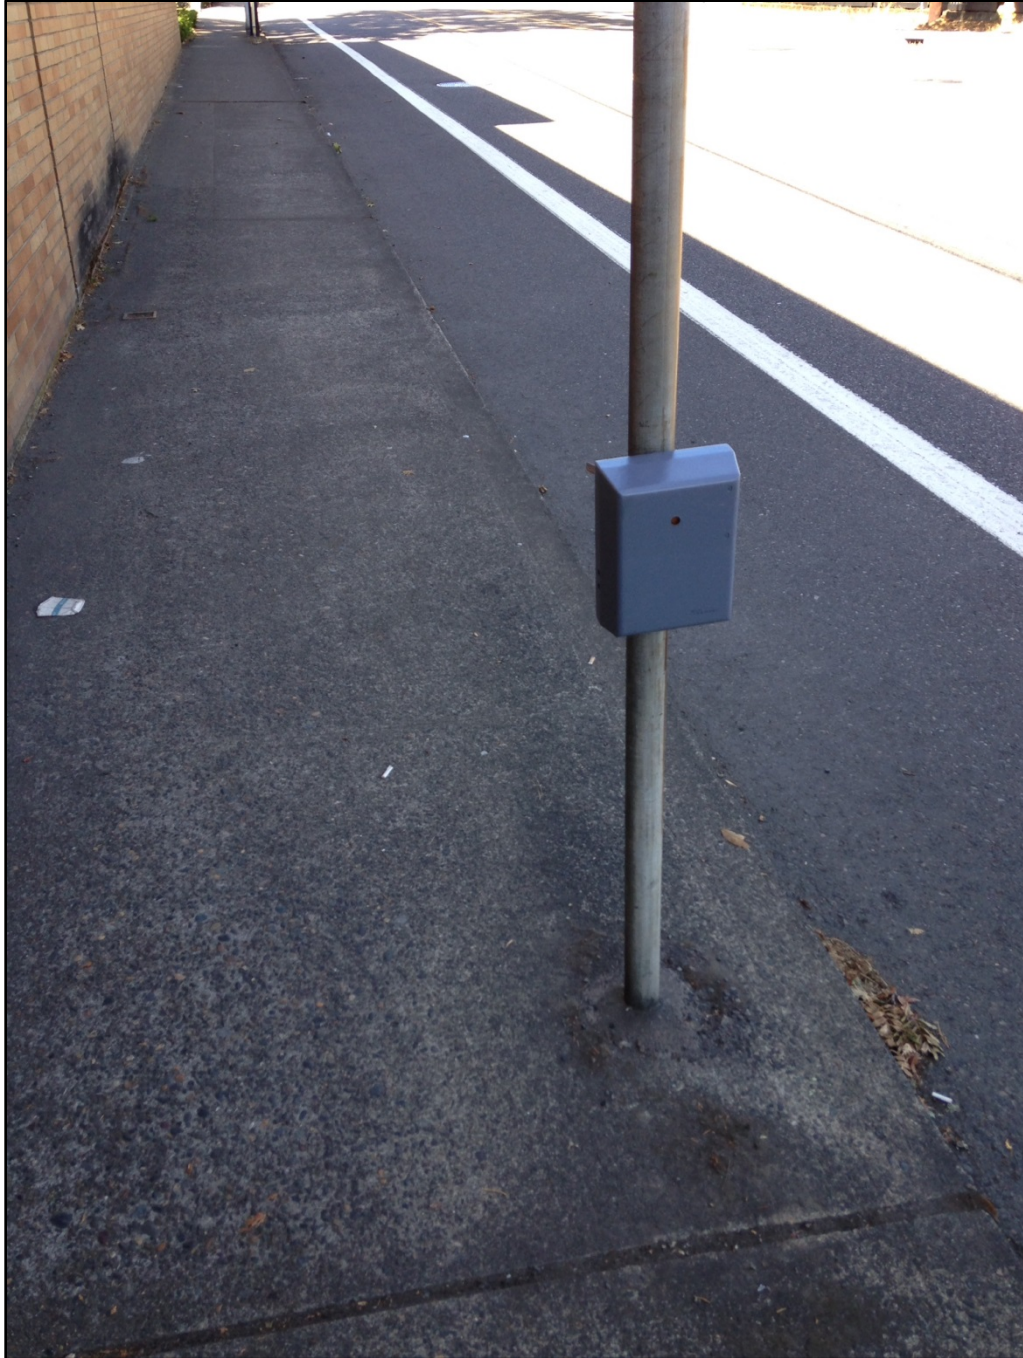
A passive infrared counter, an Eco-Counter PYRO-Box, was installed on a signpost according to manufacturer's specifications in order to detect pedestrians and cyclists traveling along a sidewalk near a commercial shopping center. The box was mounted such that the infrared sensor was 27 inches above the sidewalk. The sensor was positioned pointing directly toward the brick wall of a commercial building. The distance between the counter and the wall was 4.7 feet. Figure 5.13 shows the setup configuration. Although the sidewalk is adjacent to a southbound bicycle lane, pedestrians and cyclists on the sidewalk were observed traveling in both directions.

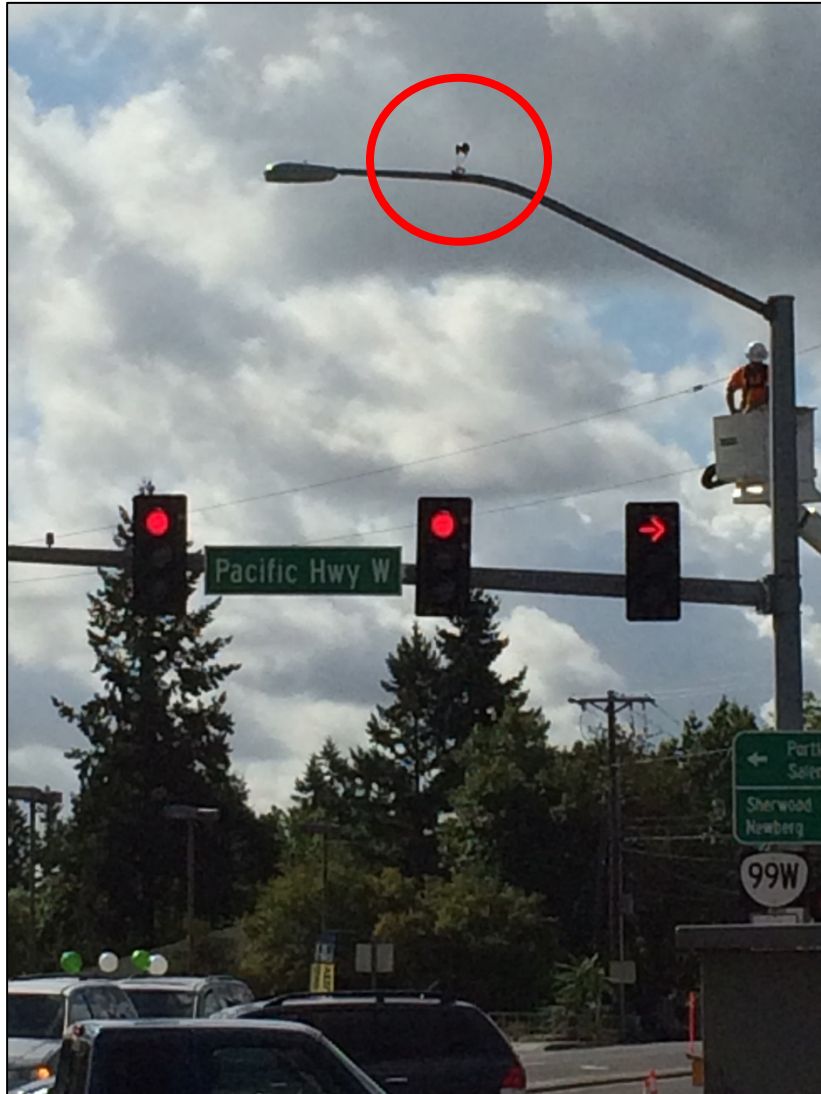
Figure 5.14: FLIR Trafisense Thermal Camera Placement *Photo by Authors*

The FLIR TrafiSense thermal camera was installed on luminaire arms for the northbound and southbound approaches on SW Hall Blvd in order to detect bicycles and pedestrians in the left and right turn lanes, bicycle lane, and the adjacent sidewalk. Figure 5.14 shows the location of the FLIR TrafiSense.

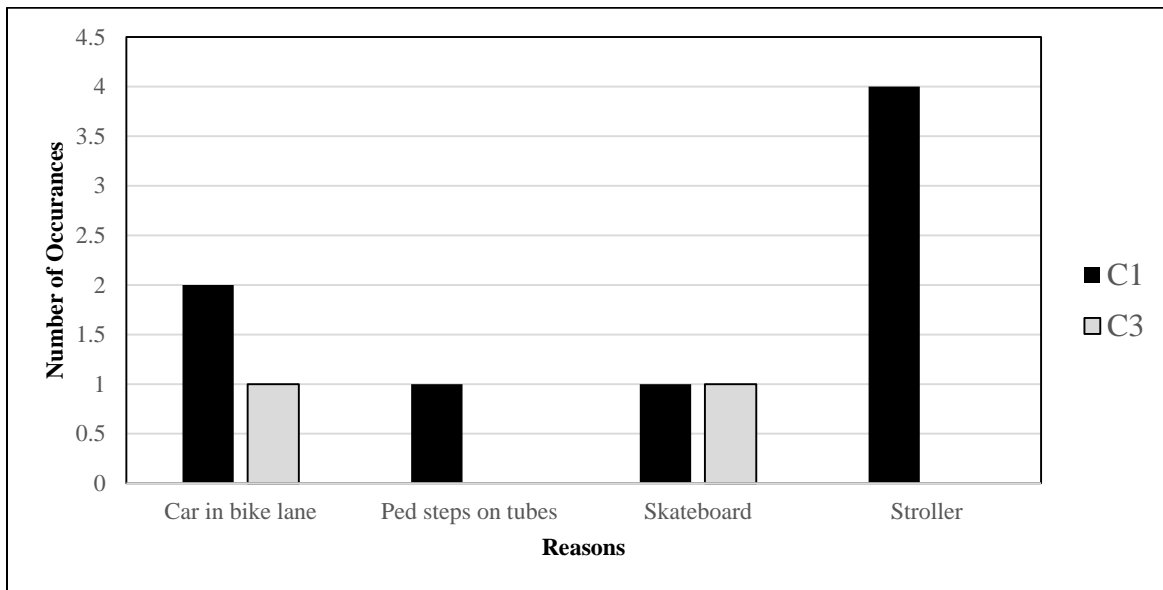
**Figure 5.15: Causes for Overcounting**

An in-depth analysis was undertaken on the time-stamped data provided by three counters C1, C2 and C3 to determine the causes of error. Each overcount and undercount was identified on the video. Figure 5.15 and Figure 5.16 identify the causes for overcounting and undercounting respectively. For overcounts, C1 tube counter showed a greater tendency to overcount compared to the other tube counter. Factors linked to overcounting include a motor vehicles swerving into the bike lane, pedestrians stepping on the tubes and skateboards and strollers being incorrectly classified as bicycles. C2 tube counter showed the highest propensity to undercount. The highest undercounts were due to cyclists riding one behind the other, resulting in the C2 tube counter counting only one bicyclist instead of two. Another factor associated to undercounting includes cyclists swerving out of the bike lane to avoid the tubes and stopping on the tubes. There were 12 instances of bicycles not being counted for no apparent reason.

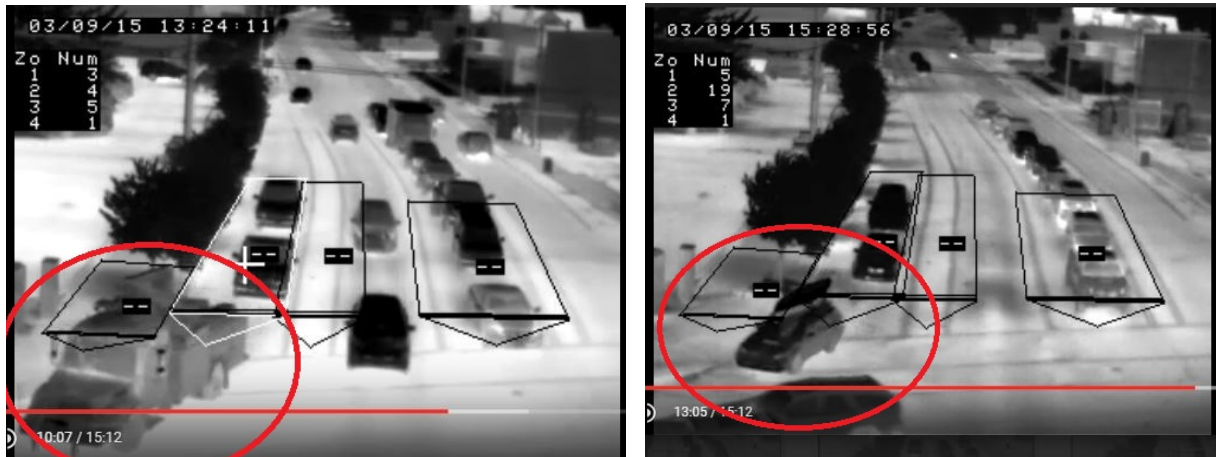
Figure 5.17: FLIR False Positives – Southbound Right Turn Lane Hall & 99W

Many vehicles, with irregular shapes and sizes such as trucks with protruding equipment and cars with roof attachments appear to be common sources of false positives as shown in Figure 5.17.

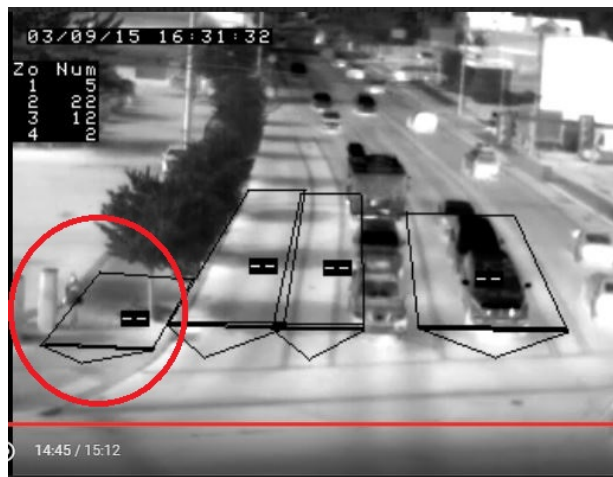
Figure 5.18: Thermal Camera False Negative – Sidewalk SB Hall & 99W

The thermal camera detected 27% (3) of the pedestrians traveling on the sidewalk. The remaining 73% (8) of pedestrians were observed traveling along the outer boundary of the thermal camera detection area as shown in Figure 5.18. This suggests that bypass errors may result if the zones are not set up correctly to capture the entire area.

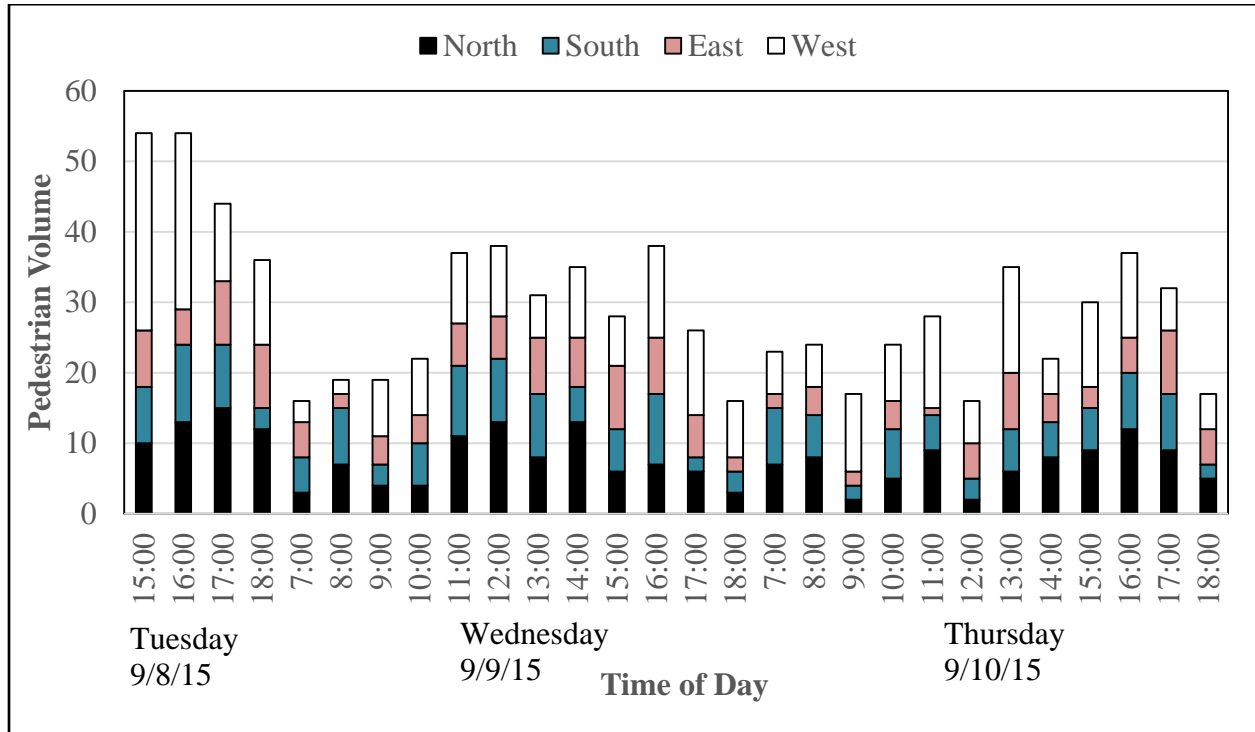
Figure 5.22: Pedestrian Volume by Time of Day

location of crosswalk are presented in Figure 5.22. Each pedestrian represents a single movement. Therefore, if a pedestrian crossed in more than one crosswalk, two pedestrian movements were counted.
