Isolation Testing of Hardened Coated Steel (HCS) Washers

Date of Test: November 7, 2008

Product Tested: 6" inch Class 300 VCS Isolating Gasket with HCS washers with 2 applications of Dielectric coating (1-1.5 mil thickness per layer).

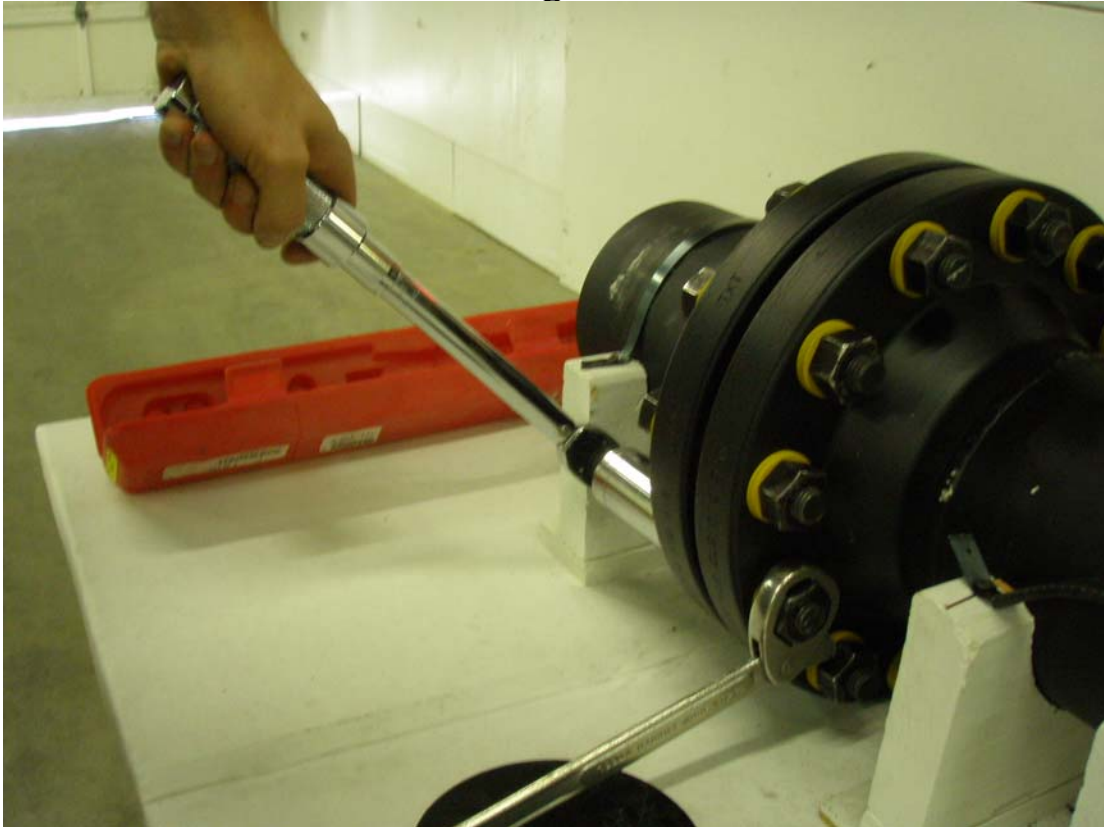
Figure 1 – Torque Being Applied

The Pikotek VCS gasket was installed between the flanges and the flanged assembly was made up with a torque value of ~150ft-lbs using a standard torque wrench. After the gasket, sleeves, and washers were assembled in the test set-up, a Megger® insulation tester (model 481) was used to validate the gasket’s isolation properties. The device was set to the highest voltage position of 1000V DC and applied to one side of the flanged connection. Using the same setting, the voltage was then applied to four bolts, 1 located on each quadrant of the flange. The outputs of both tests were measured on the opposing flange as resistance in Ohms.

See **Figures 1-5** for test procedure photos

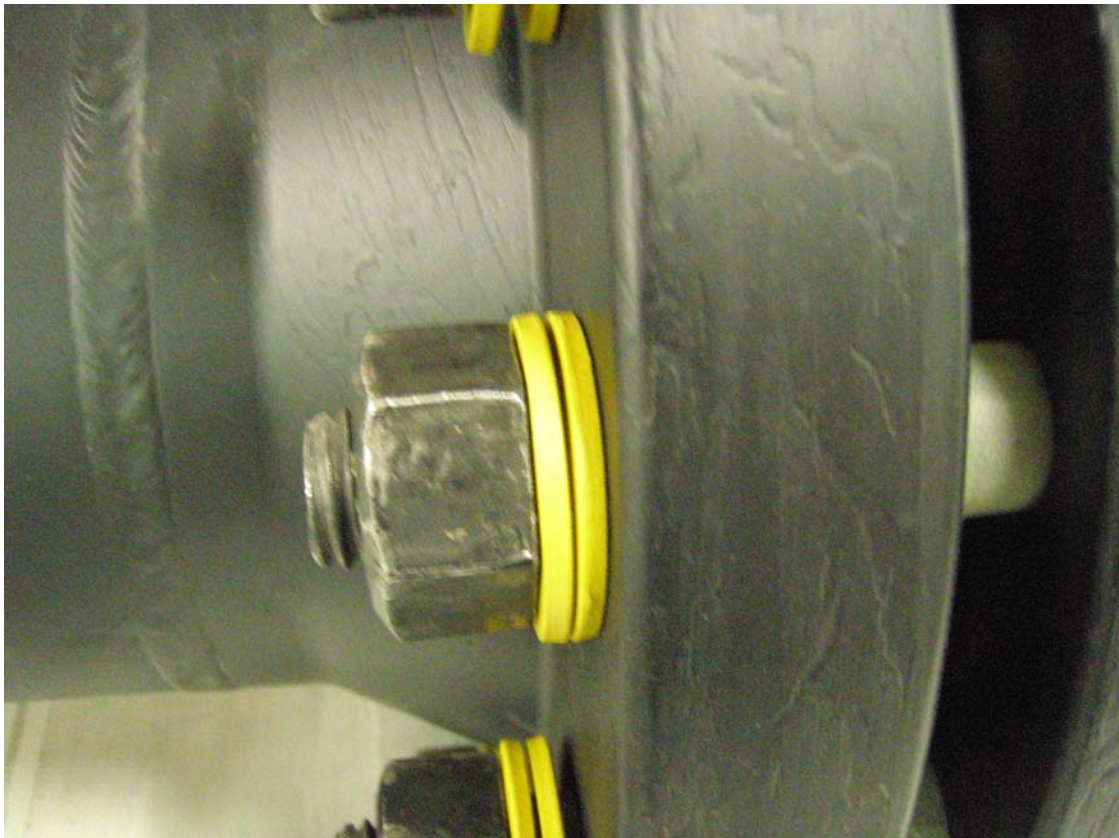
Figure 2 – Close-up of two HCS washers

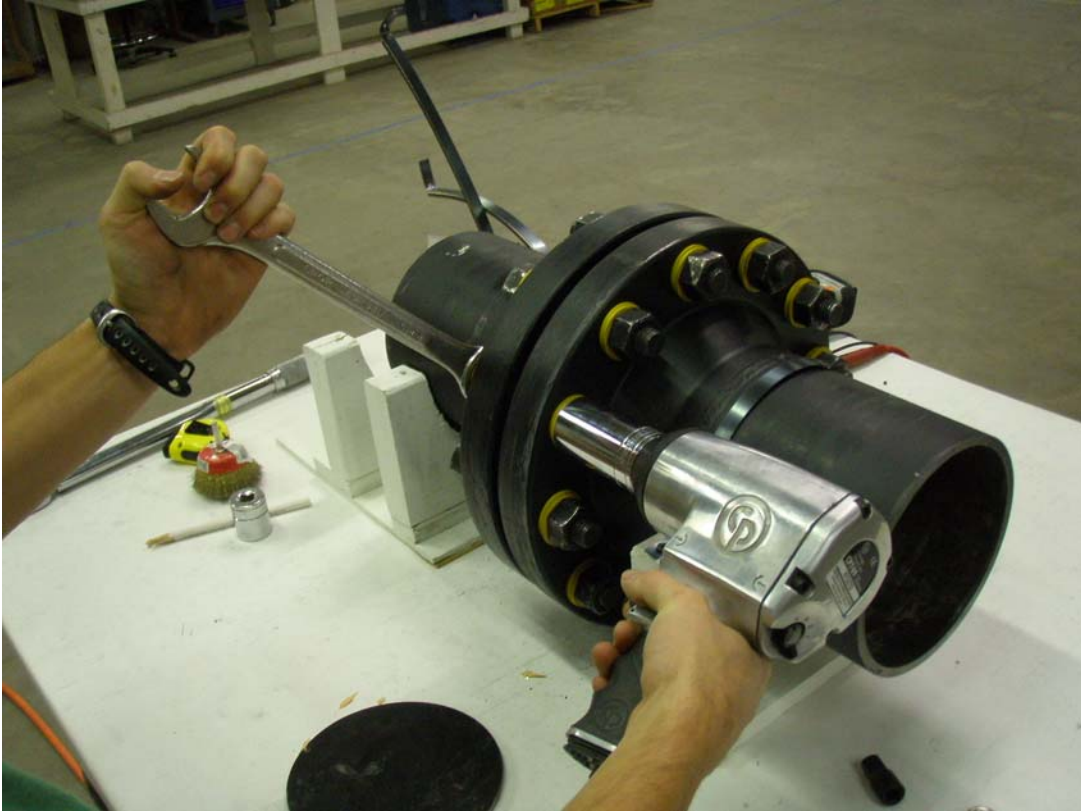
Figure 3 – Impact wrench used to unbolt the flanges

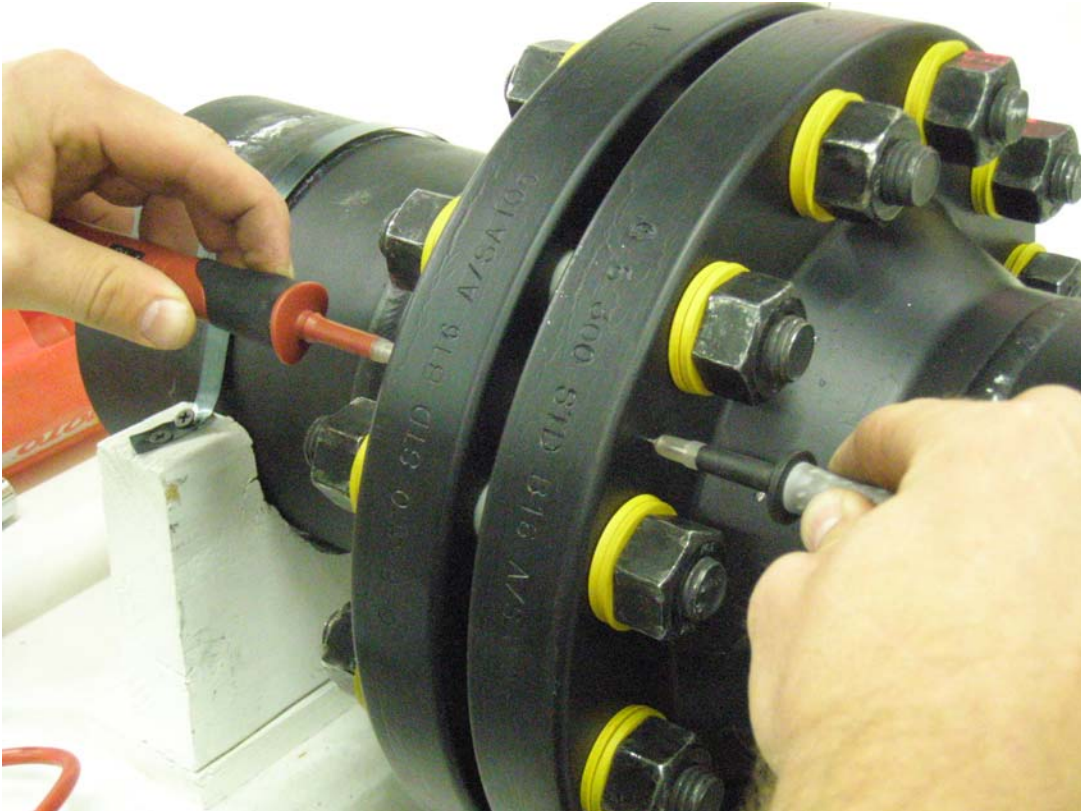
Figure 4 – A flange-to-flange measurement being taken

A Megger[®] Insulation Tester was used to measure resistance/isolation from Flange to flange and Bolt to Flange. The highest voltage setting of 1000V was used.

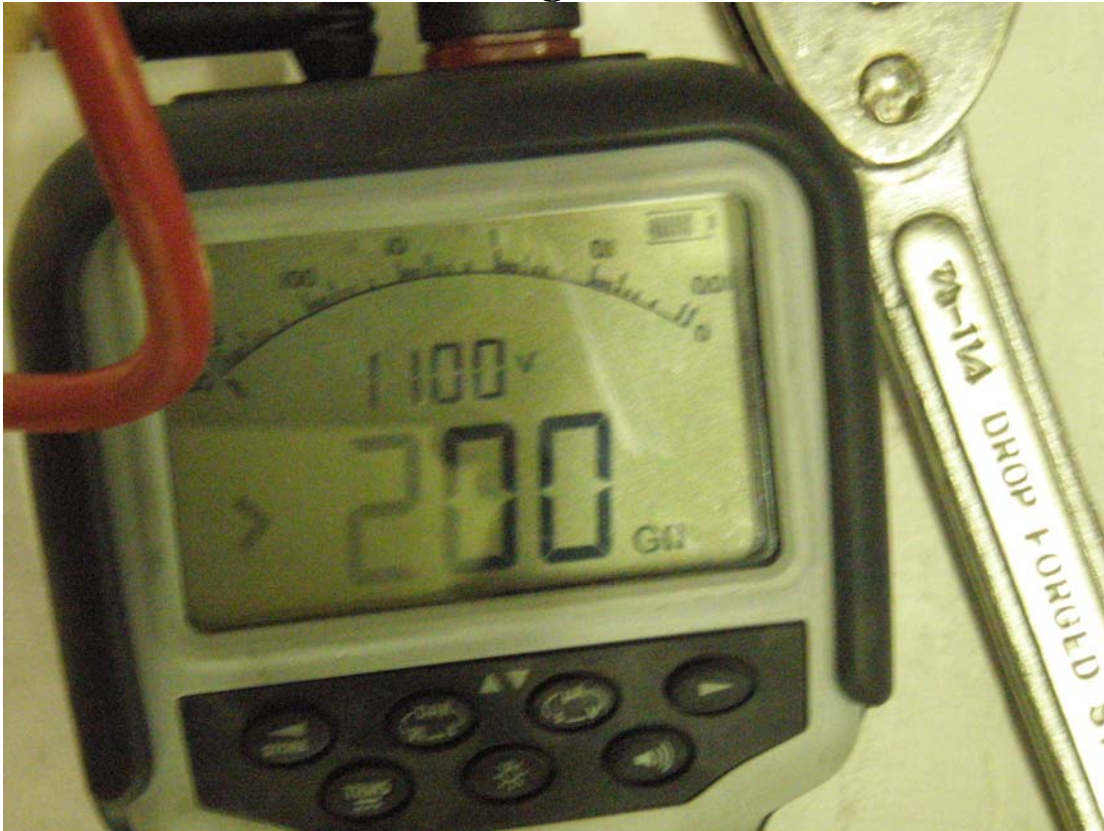
Figure 5 – The resultant measurement of figure 4

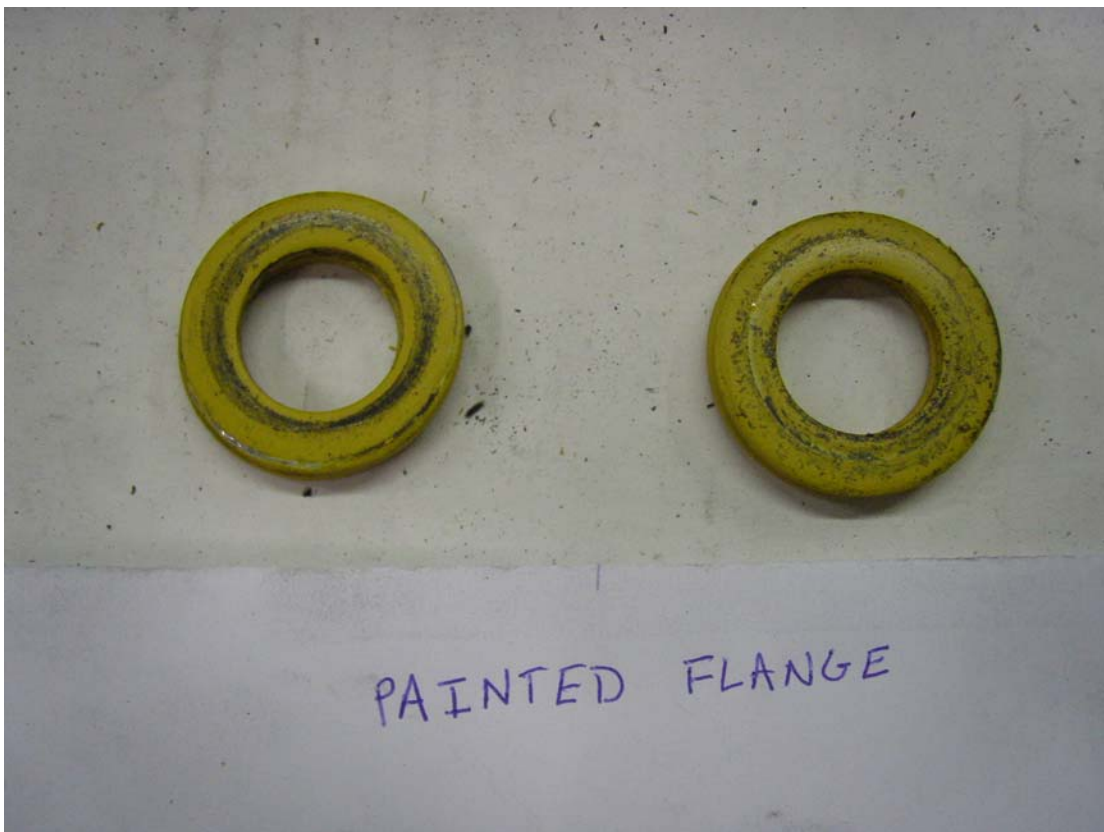
Figure 6 – Test Series 1 Post 3rd Bolt-up Washer-Nut Faces

After completion of both test series, the flange halves were disassembled and the washers were inspected and photographed. **(Figures 6-8)**

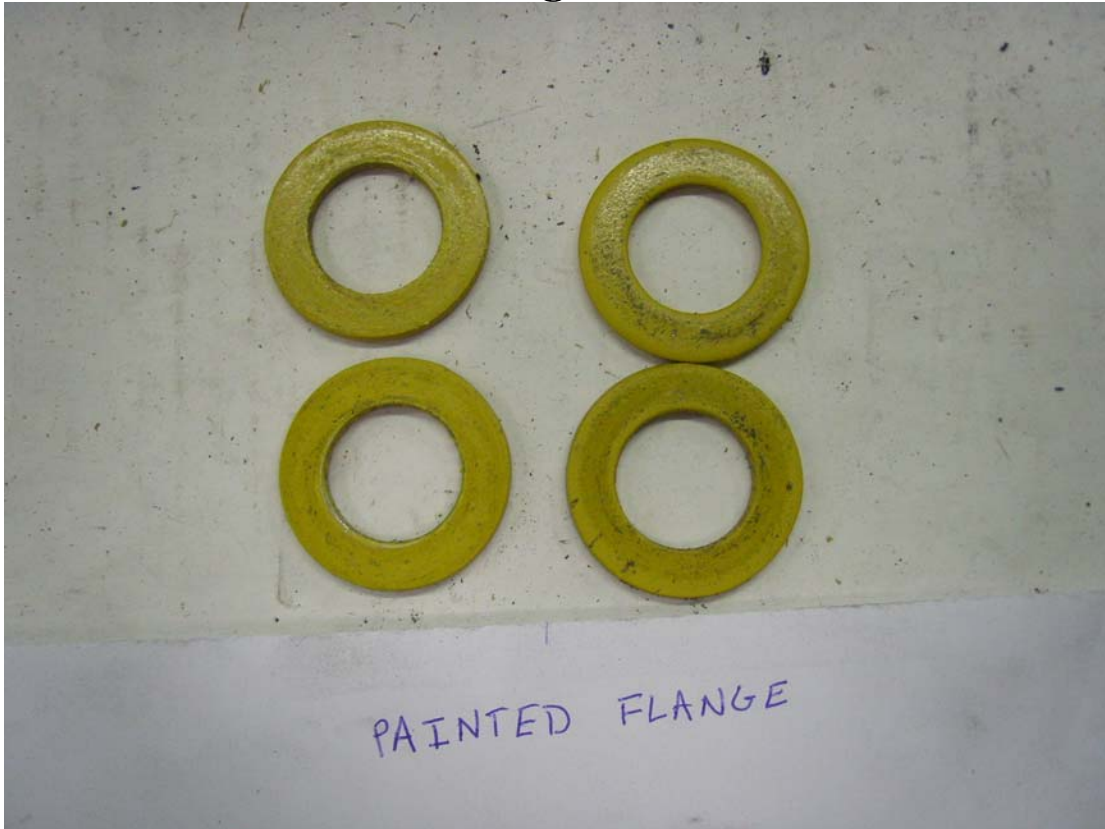
Figure 7 – Test Series 1 Post 3rd Bolt-up Washer-Washer Faces

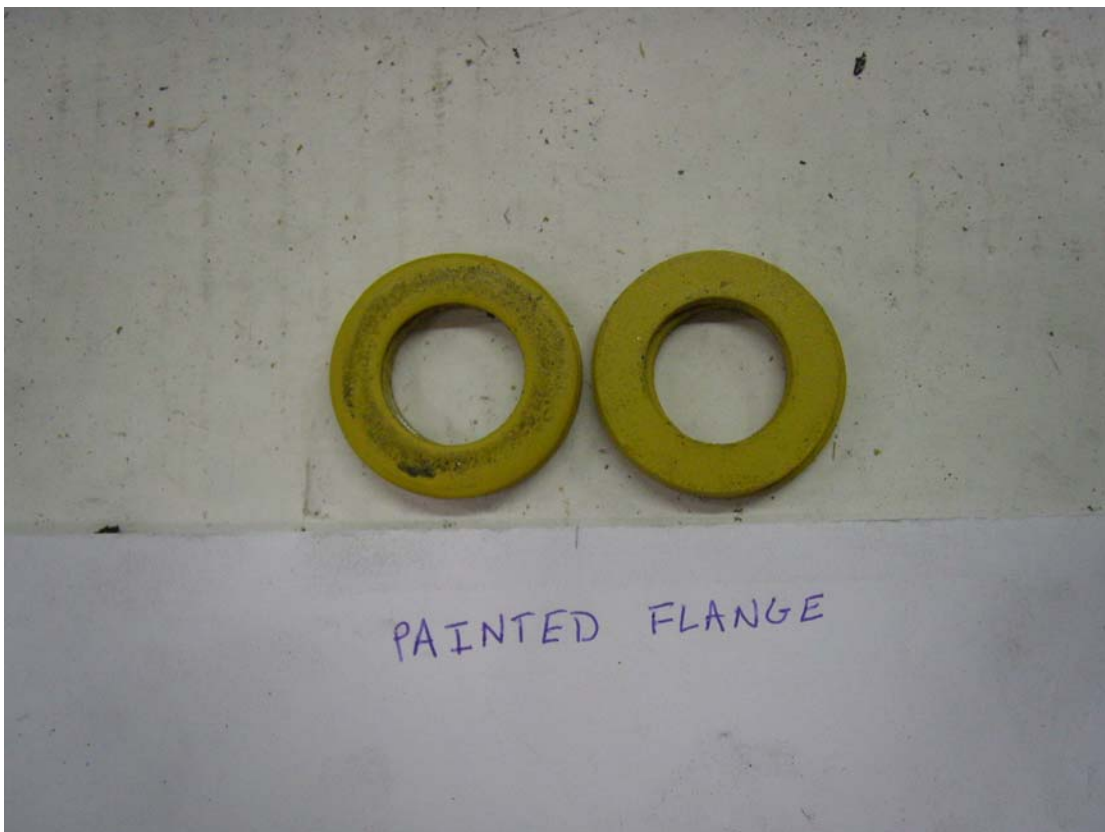
Figure 8 – Test Series 1 Post 3rd Bolt-up Washer-Flange Faces

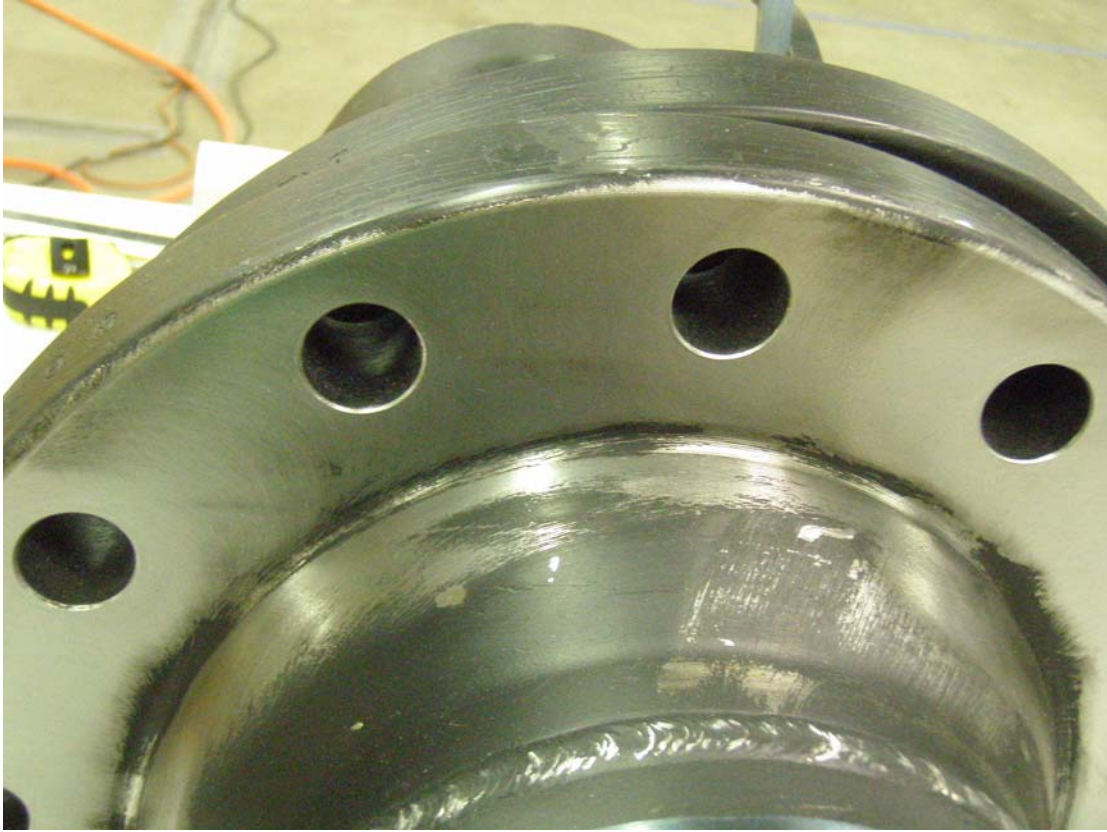
Figure 9 – *Test Series 2* Paint removed from flange

During the first test series where 2 washers per side were used, the portion of the flange that comes into contact with the washers was coated in thin layer of paint. This layer of paint likely added to the resistance values being measured. To be as conservative as possible the painted was removed during test series 2 when only one washer per side was used. **(Figure 9)**

1. Remove paint from the flange where the washers come into contact. **(Figure 9)**
2. Install Pikotek VCS isolation gasket between the flanges using isolating sleeves and 1 HCS washer per side. Torque the nuts on the assembly to 150ft-lbs.
3. Use the Megger insulation tester set at 1000V DC and test isolation flange-to-flange and flange-to-bolt (flange to bolt measurements to be taken on each quadrant of the flange and the averaged).
4. Unbolt the assembly and make sure all of the washers are loose and not stuck to either the flanges or to a nut.
5. Repeat steps 1-3 two more times
6. Inspect the washers on both sides
